## **Incident report**

B 3/2000 L

# **Engine damage at Helsinki-Vantaa Airport on 17th October, 2000**

OO-SSH  
Airbus A319

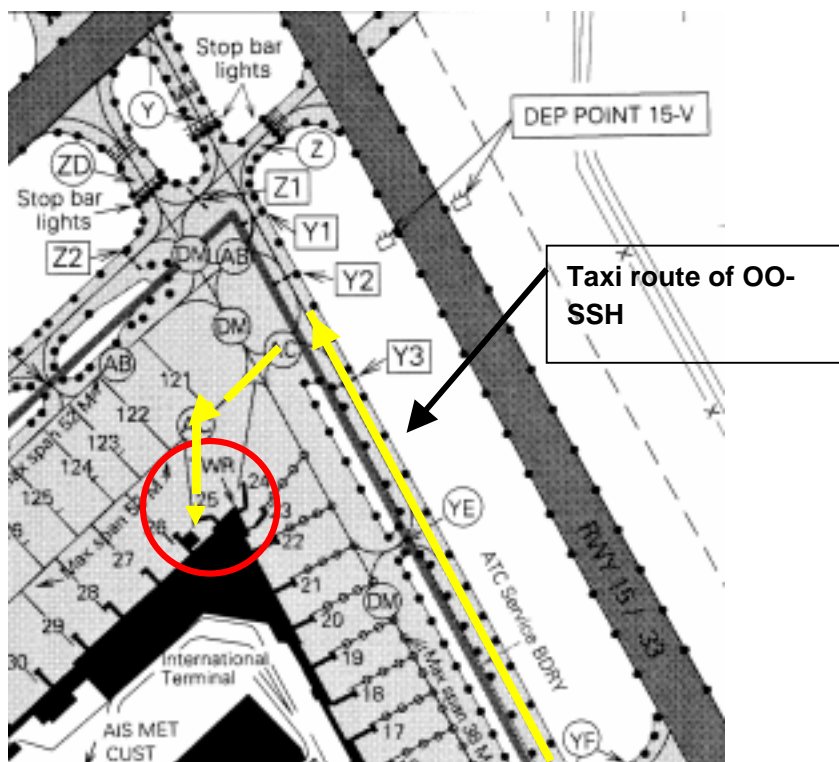
Picture 1. The Helsinki-Vantaa Airport general arrangements at the apron area and the taxing route of OO-SSH to aircraft stand number 25, where the engine incident occurred

Aircraft stand number 25 is located by the airport terminal according to picture 1. and is equipped with a passenger bridge as well as APIS system. There was no surveillance camera system at the stand at the time of occurrence.

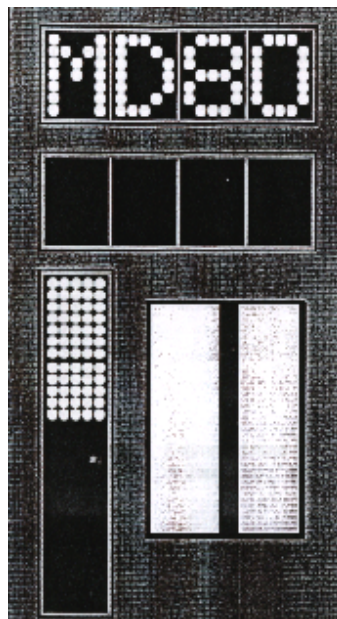
Picture 8. APIS display, when aircraft type MD80 selected into the system is on the parking centerline within a distance of 6.61-7.19 meters from the stop position

Vertical line on the display shows the position of aircraft in proportion to the approach line. If aircraft deviates from the centerline, the guiding line changes to a arrow shaped double line indicating which direction (left or right) the aircraft should be steered to regain the approach line.

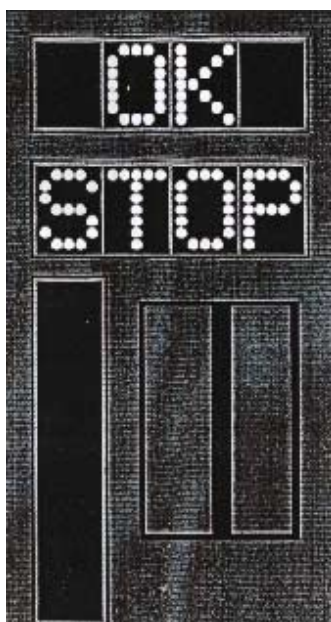
Picture 9. APIS display, when aircraft is within the correct parking area according to the system

If taxiing continues beyond the approved area, STOP sign will be altered with TOO/FAR display. There is a possibility of not being able to operate the passenger bridge, until aircraft has been pushed back with a pushback vehicle. At this kind of circumstances the engines of narrow-body aircraft equipped with wing engines come dangerously close to fixed structures, for example the distance of A319 is at the most approximately 70 cm.
