Aircraft Incident Report

C 19/2000 L

Loss of separation over Espoo on 15.12.2000 Disappearance of aircraft from ATC radar

RA 86532 IL62M
OH-LMG DC-9-83

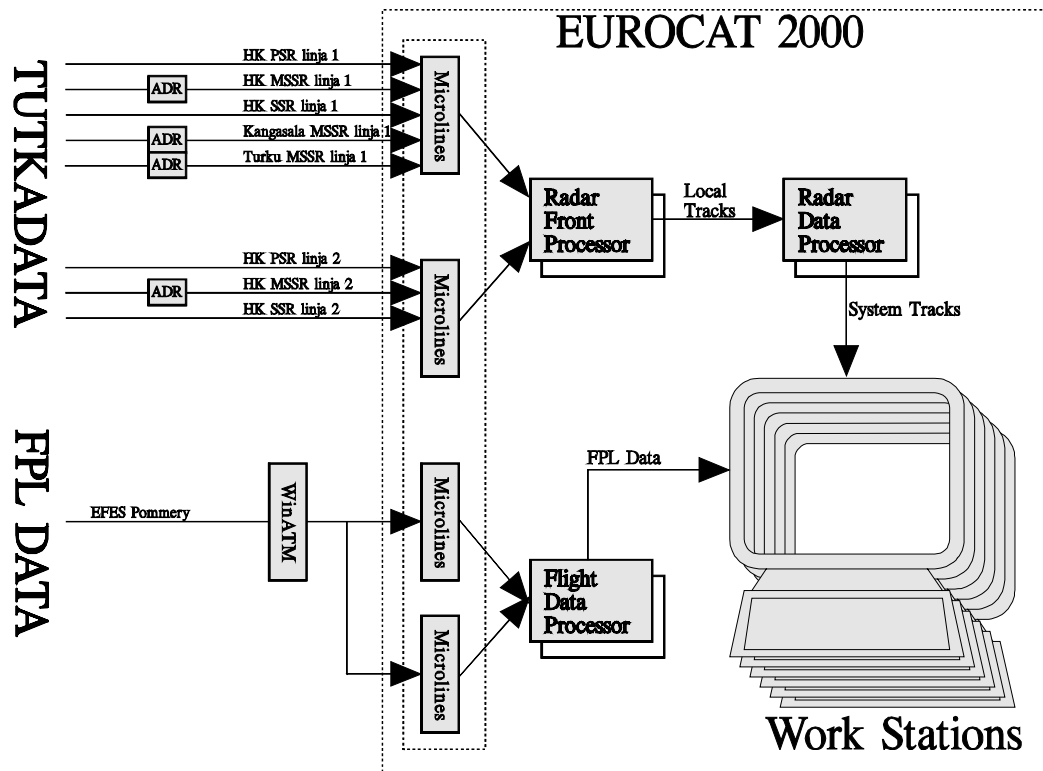
ATC radar data is updated every four seconds, as the radar antenna rotates 15 times per minute. For an aircraft within radar coverage to become visible on the screens at controller workstations, the radar must receive three acceptable replies from the aircraft transponder during successive radar antenna rotations. If one reply received from the transponder of an aircraft shown on the radar screen is not acceptable, the system will calculate an estimated position, which is shown on the display with a different symbol. In case the next transponder reply is acceptable, the aircraft will be shown normally on the screen. Instead, if a transponder reply is not received during three successive radar antenna rotations, the aircraft symbol will disappear from the radar screen. In that case, three successive acceptable transponder replies are required before the aircraft becomes visible on the radar again.

Figure 3. Eurocat 2000 radar display system used at Helsinki ATC.

Buildings in the airport area have caused occasional interference in the SSR. For this reason, ATC discontinued the use of SSR data in summer 2000, during which time the operations were based on MSSR alone. The SSR was connected back to the system on 15.10.2000.
