Investigation report

B 5/2001 L

Aircraft damage in hailstorm west of Helsinki on 21.7.2001

Douglas DC-9-81

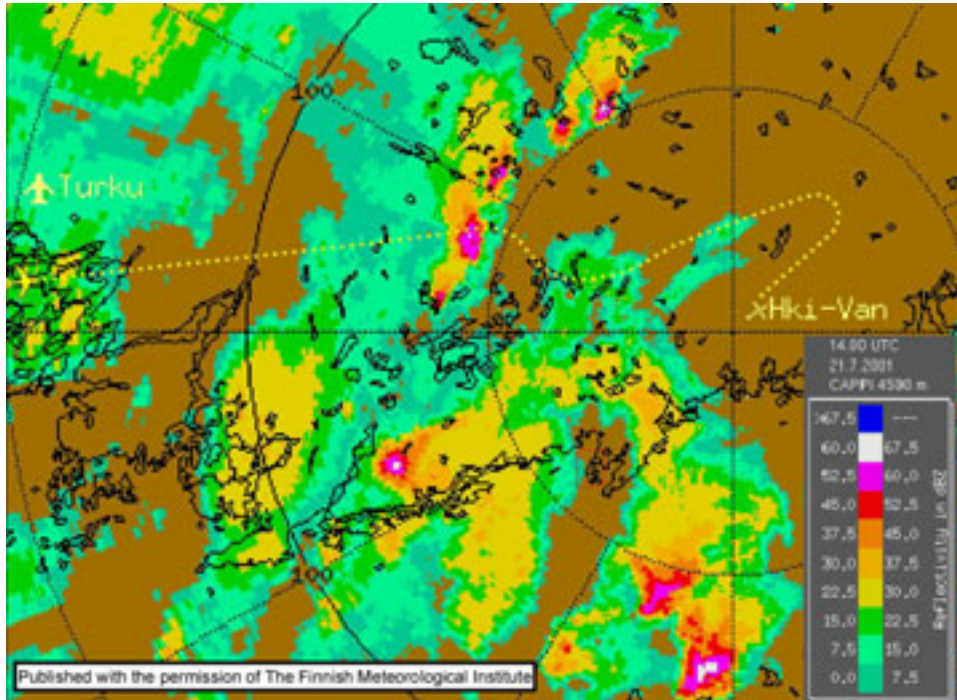
Figure 3. Weather radar image at 14.00 from the altitude of 4500 m

SAS1700 flew into a cell in the CB cloud at 14.07. Figure 3 depicts the aircraft at flight level 290 before commencing the descent. The future flight path is marked with a dotted line. In figure 4, the plane is approaching runway 22. The actual flight path is marked with a solid line. The cloud moved north-northeast between the times of figure 3 and 4.
