Investigation Report

C 3/2002 L

Violation of the Radar Separation Minima in the Vicinity of Helsinki Terminal Area on 17 January 2002

HA-LMD Fokker F28 Mk0070

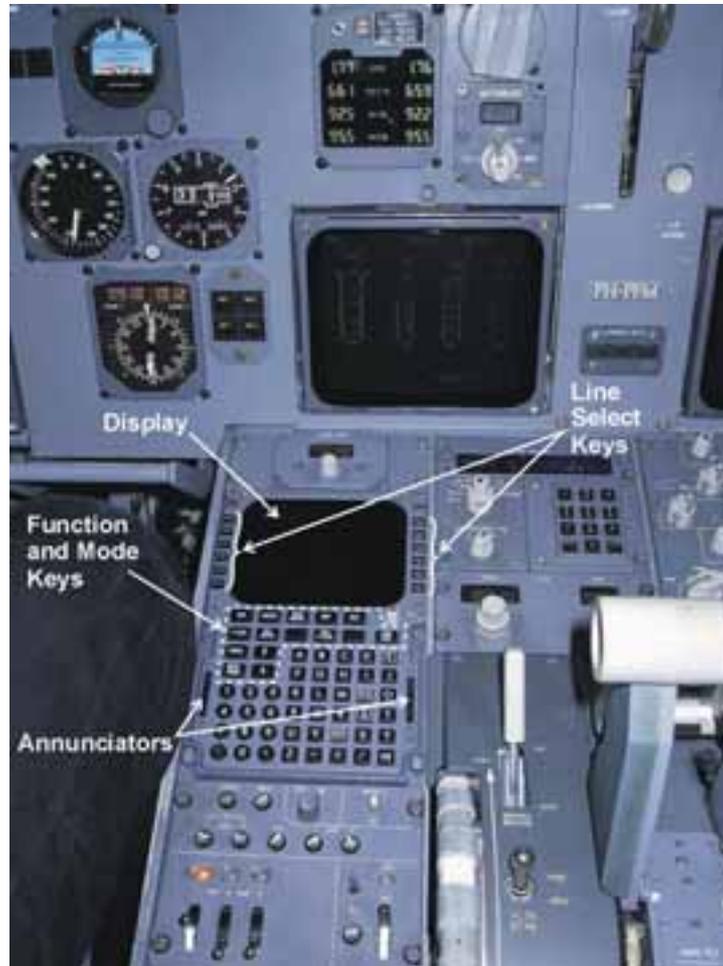
Picture 3. CDU of Fokker 70/100 simulator

If the master FMC of the aircraft fails, the selected mode (NAV/PROF) goes out of function. After this, the second FMS will take care of the navigation, when the necessary selections have been made on the FMP. If any device used for navigation fails or gets into a phase where the system logic identifies that the device is not able to give reliable navigation information, the Flight Guidance System turns into basic mode. At the same time AP goes off. When the navigation responsibility is transferred to a functioning system, AP can be switched on again.

The navigation accuracy of FMS is reduced, if information cannot be retrieved from one or more sensors. The FMS will continue functioning, but the failure will be displayed on CDU.

A message will appear on the scratchpad of the CDU about the previously mentioned important failures or malfunctions and a signal light will be lit on some of the four annunciators beside the keyboard of the device. FAIL light will be illuminated when the CDU

fails. DSPY light will be lit, when the page on the display does not correspond to the actual flight phase. MSG light will be lit when an important message appears or can be selected on the scratchpad of CDU. OFST light will be lit when the aircraft is flying an adjacent flight route deviating from FMC data. The last five messages due to any other reason than the actions of the crew will be saved in the FMS and they can be read one by one from the CDU.

The conclusion from the above mentioned facts is that pilots receive different notices and warnings about failures or malfunctions in the FMS. In this occurrence under investigation, according to the cockpit crew, no warnings were displayed.

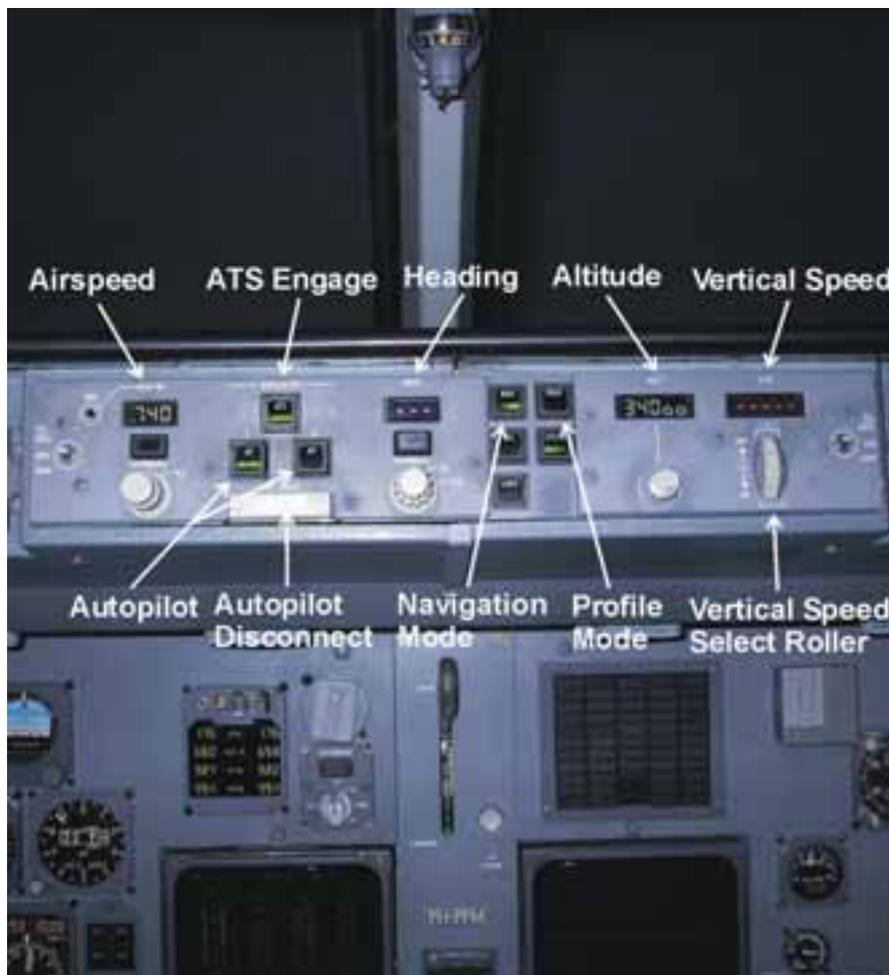
Picture 4. Flight Mode Panel (FMP) of Fokker 70/100 simulator

PF told having selected the short PVO 1C transition route in the FMS and not the long transition route PVO 1D. The crew performed the whole flight with lateral navigation NAV mode on. PF adjusted the airspeed by selecting Autothrottle (AT) from the FMP. When ATC told MAH742 to maintain high speed, PF set the IAS to 280 kt, and maintained that selection all the time until 6000 ft. After that he adjusted the speed to 250 kt, because that is the speed limit of the aircraft below 5000 FT. After having been cleared to 3000 FT, PF set the IAS to 220 KT, to be able to slow down to the designated speed of 220 KT for the base leg turn given in the Jeppesen chart. At first, PF set the rate of descent to 1700 FT/MIN by using the roll selector of the FMP. For altitudes below 5000 FT, he set the rate of descent to 500 FT/MIN according to the standard operating procedures of the company.

PF disengaged the NAV function after HK707 by switching off the AP, which after he continued the flight manually by turning left to heading 180° as instructed by the ATC. PF noticed having flown over HK707. FMS had just initiated the turn for base leg in the PVO 1C transition, when ATC ordered the aircraft to make the turn.
