Investigation report

C6/2005L

Helicopter accident in the vicinity of the Vuomaselkä in Sodankylä on 21.9.2005

OH-HAY

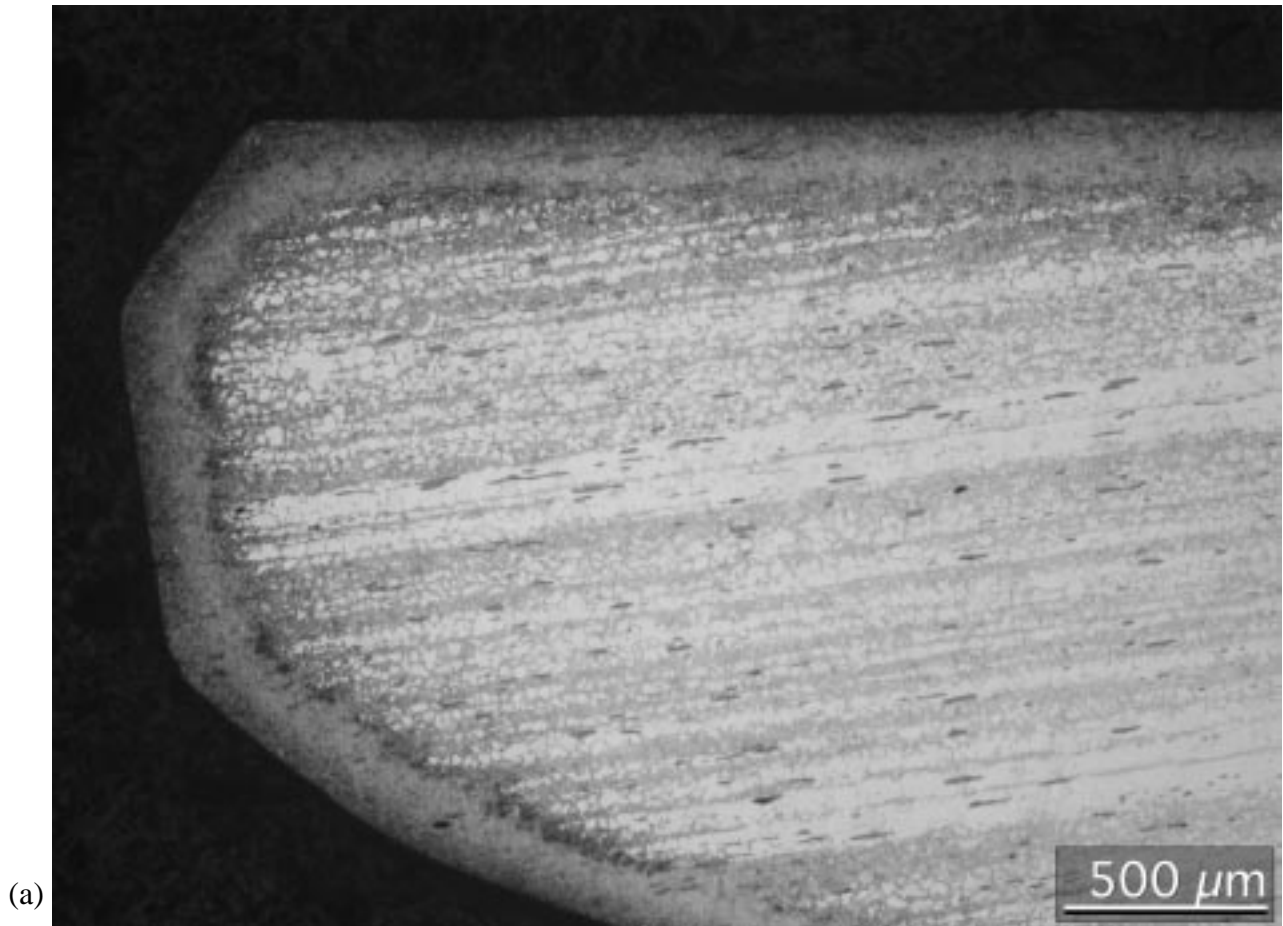
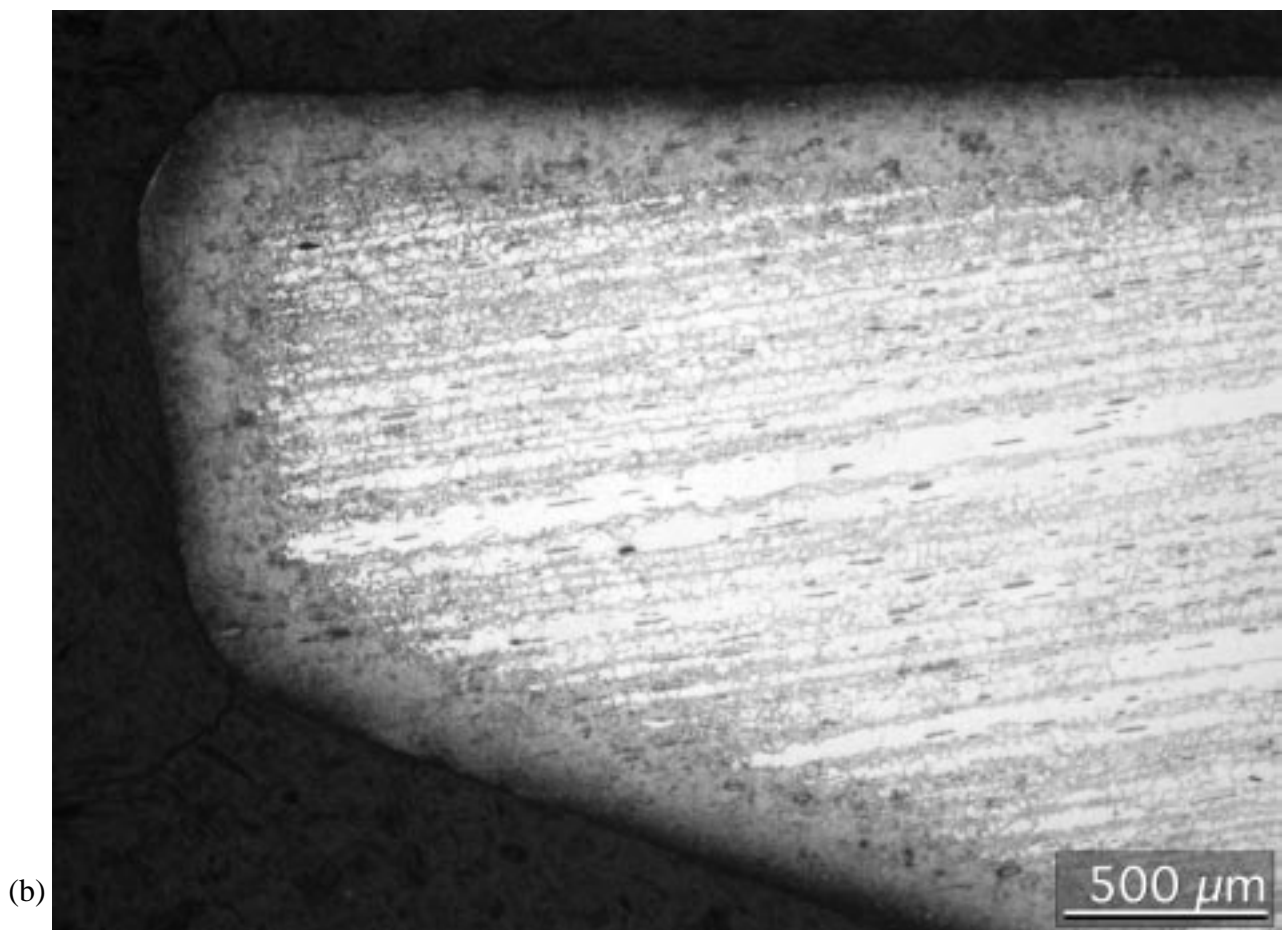
Fig 5. Case hardened layer (dark) on a spring seat (cross section is shown in fig. 2c), (a) Spring seat SMP, (b) Spring seat KLI. Optical microscope.

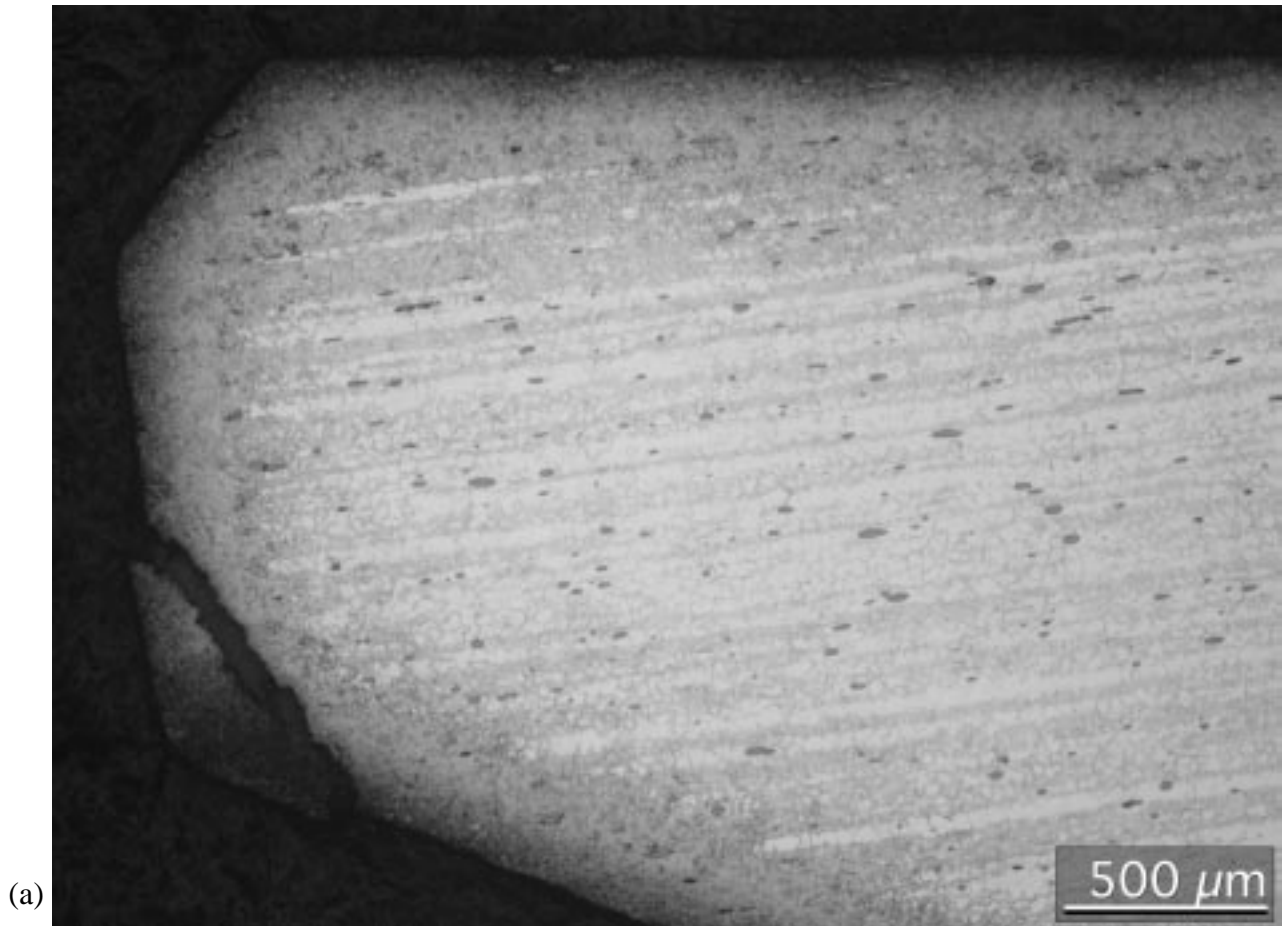
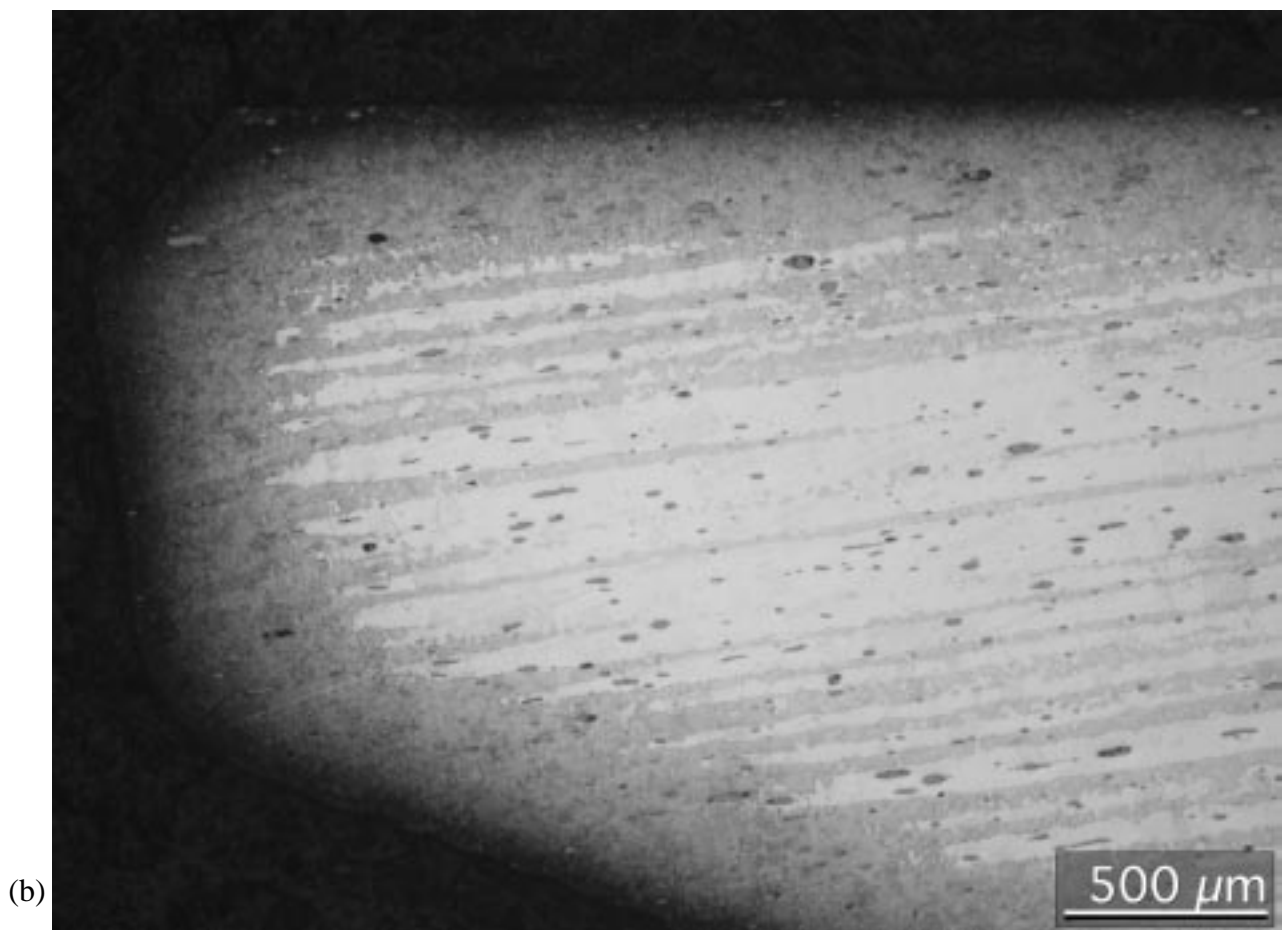
Fig 6. Case hardened layer (dark) on a spring seat (cross section is shown in fig. 2c), (a) Spring seat “WITHOUT CODE”, (b) Spring seat KLI-0. Optical microscope.

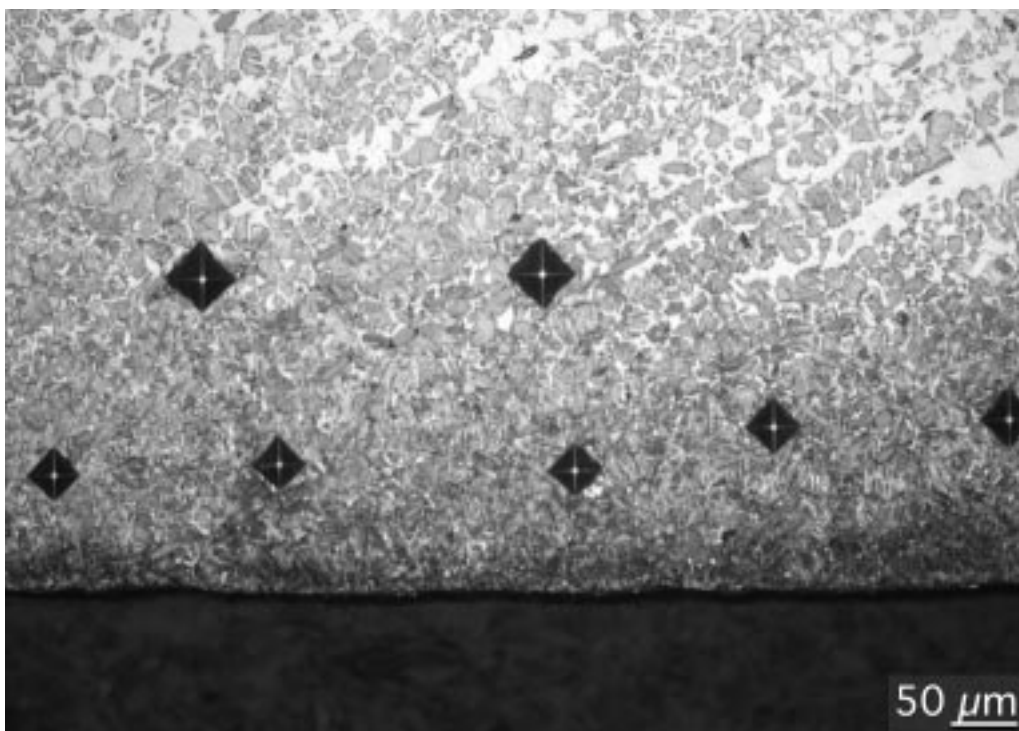
hardness values in the case hardened layer (measuring site in fig. 2) near the surface (circa 100 μm from surface) in the failed spring seats are 553-601HV0.5 and in the reference spring seats 665-844HV0.5. The case hardened depth, corresponding to the distance from the surface at which the hardness is equal to 550HV (SFS-EN ISO 2639), is circa 0.16mm in the reference spring seats. In the failed spring seats, the hardness profile is mainly below the threshold value of 550HV. (**Table 2, Figs. 7,8**).

Fig 8. Vickers (HV 0,5) indentations on the case hardened layer of the spring seat (cylinder 2) (the measuring site is shown in fig. 2c). Optical microscope.

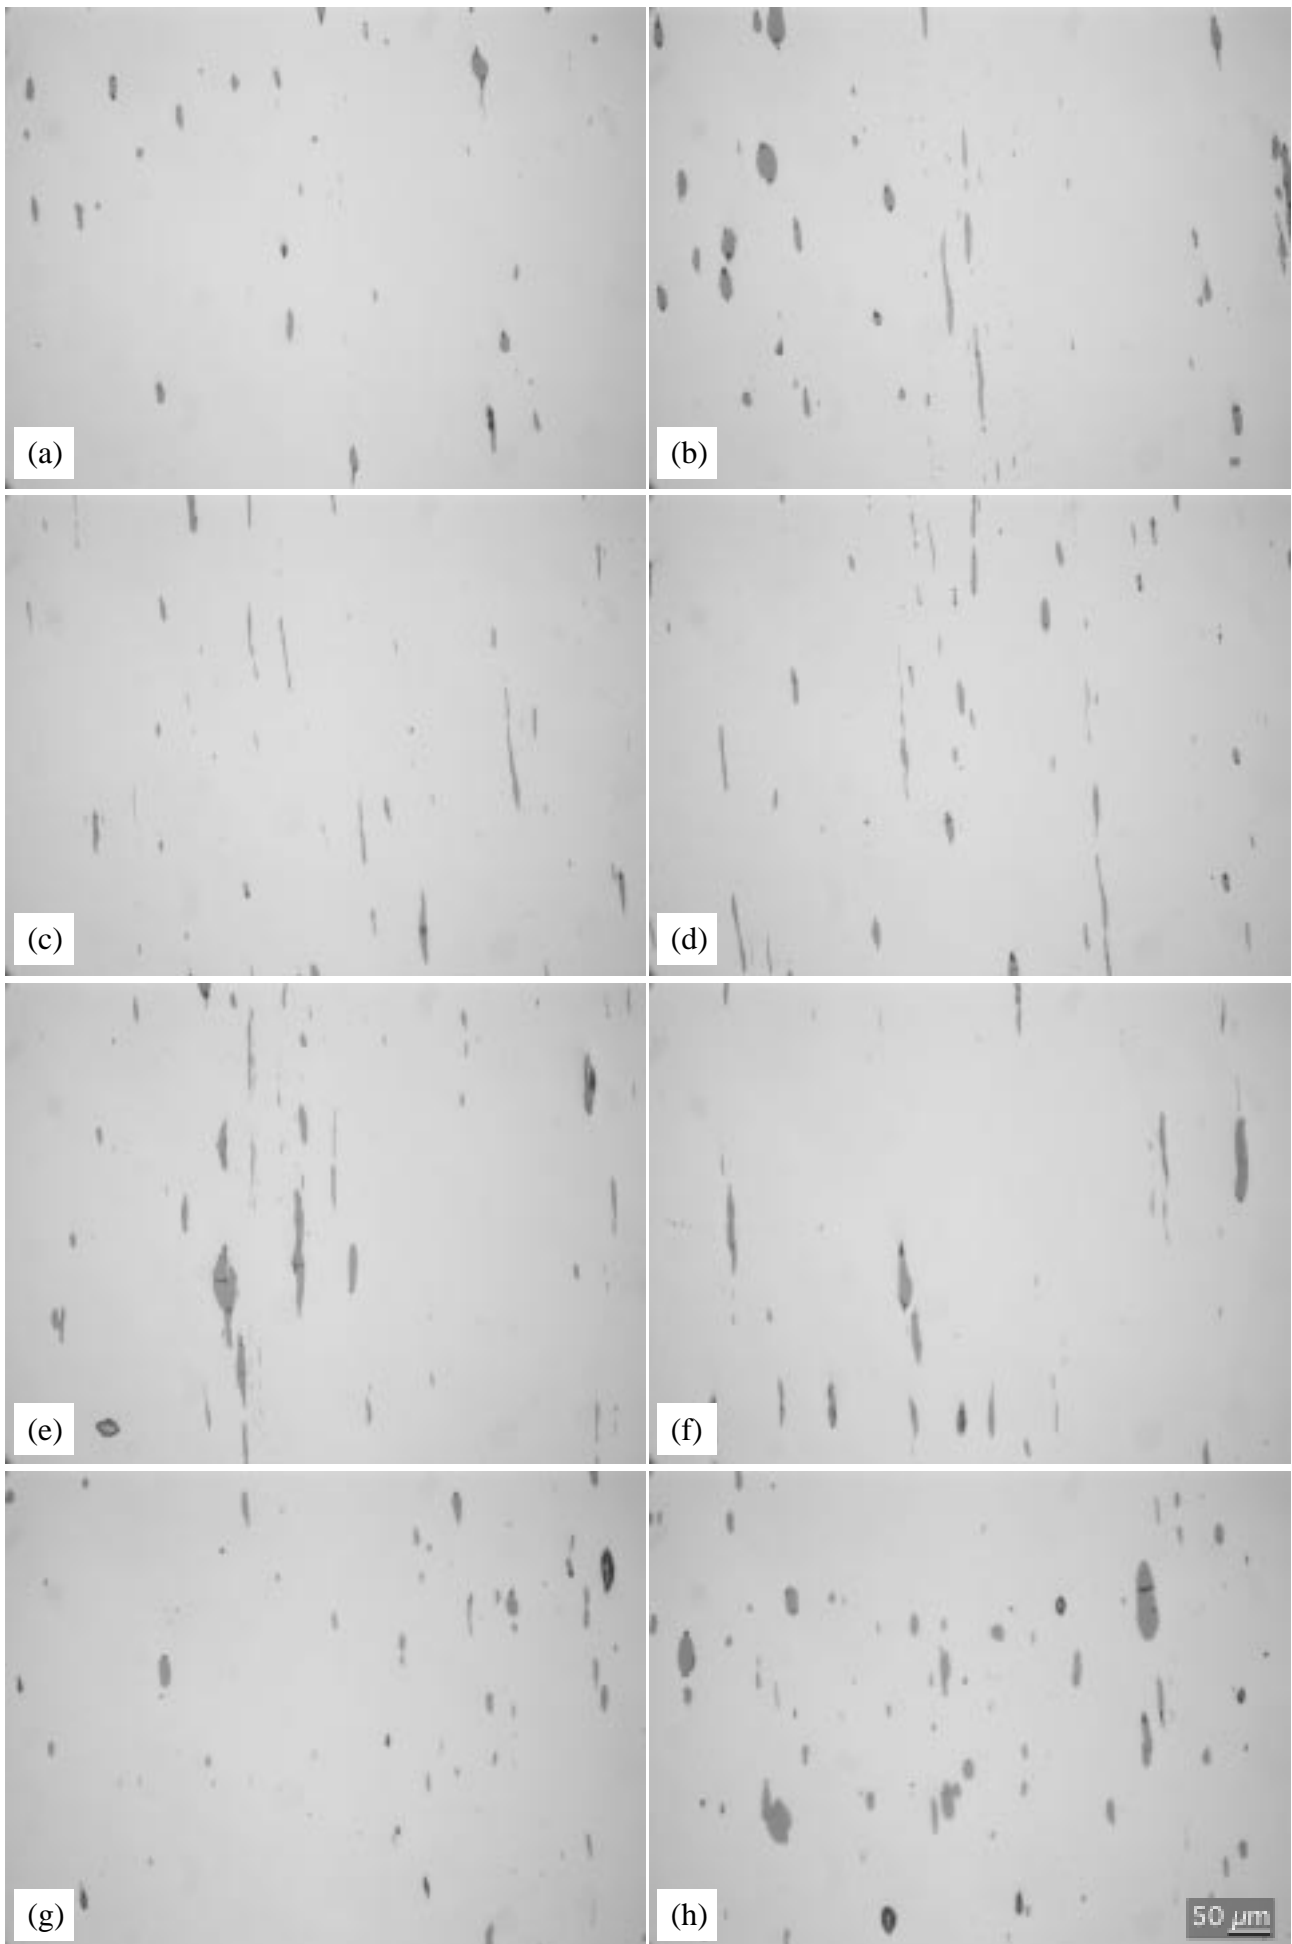
According to the digital image analysis (**Figs. 9,10, Table 3**) the phase fraction of MnS inclusions in the failed spring seats is 1.4-1.8% and in the reference spring seats 1.1-2.0%, whereas the number of inclusions is 447-639kpl/mm² and 153-204 kpl/mm², and the average area is 24-32 μm^2 and 98-119 μm^2 , respectively.

Fig 10. Inclusion structures of the spring seats (cross section in fig. 2c).**(a,b)** WITHOUT CODE, **(c,d)** KLI, **(e,f)** SMP, **(g,h)** KLI-0. Inclusion analysis in table 3. Ground and polished surface. Optical microscope.

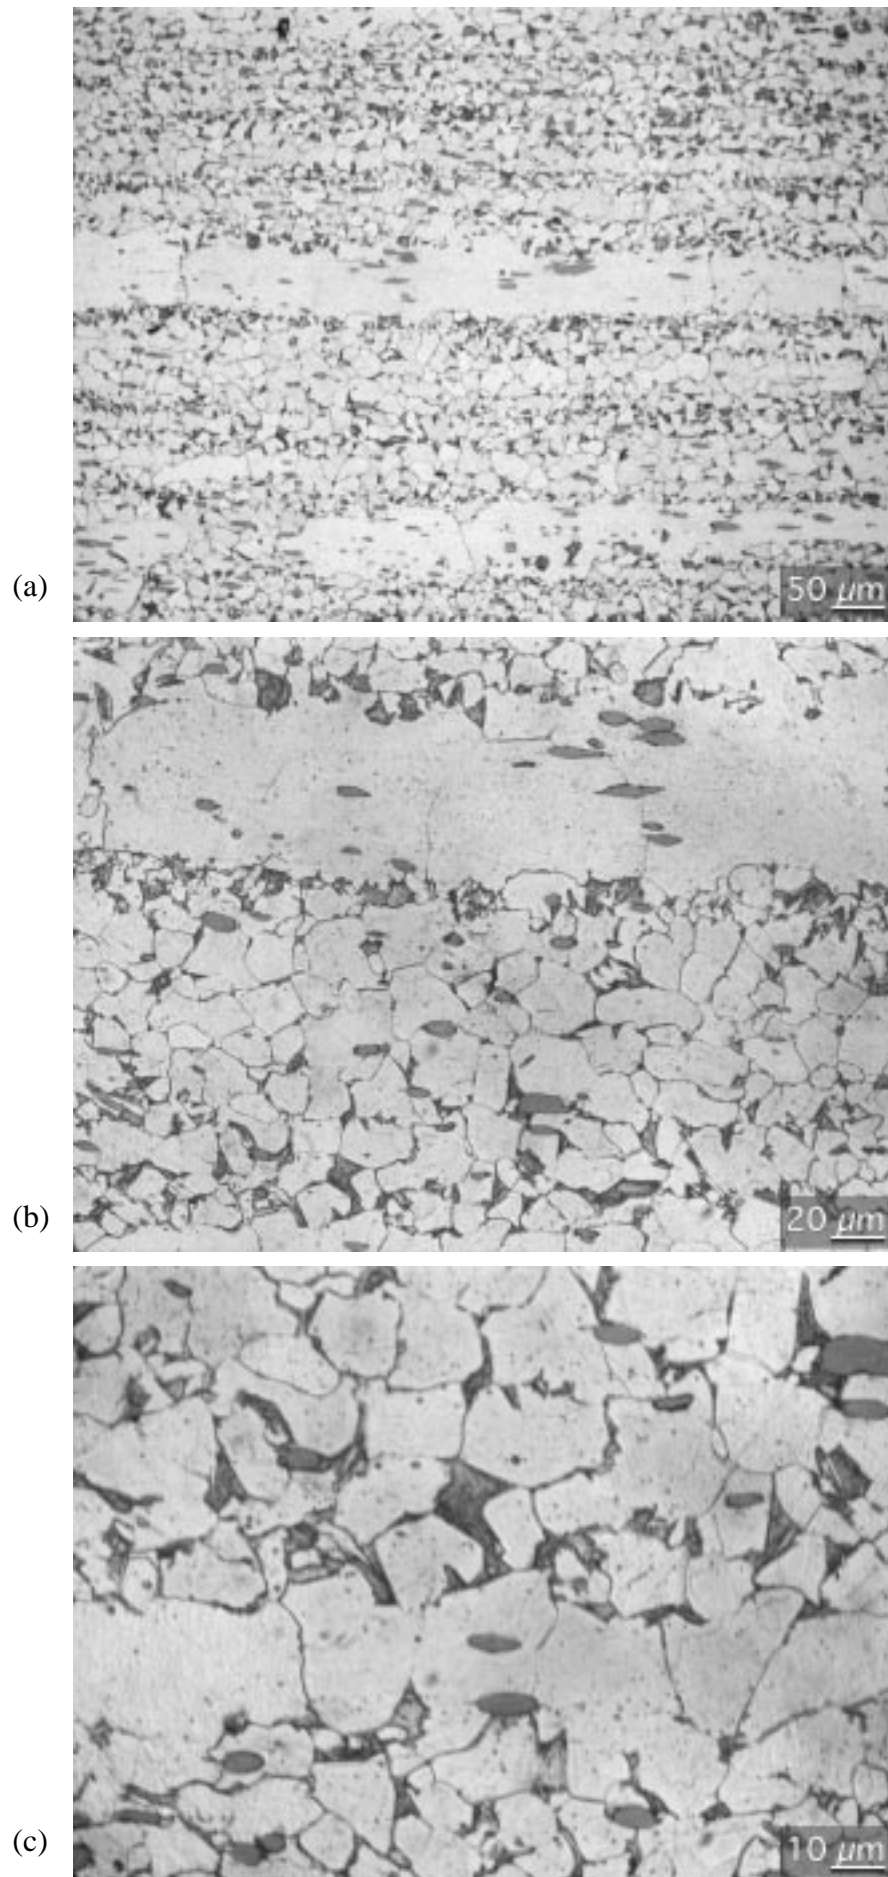
The spring seat core has a banded microstructure, where fine grained ferrite-pearlite bands (or ferrite-bainite bands) and coarse grained ferrite bands alternate. In the failed spring seats the ferrite grain size in ferrite band is on average larger than in the reference spring seat (**Figs. 11,12**). In addition, in failed spring seats a ferrite network in many places extends to the surface of the case hardened layer at the location of the ferrite band (**Fig. 13**). Similar ferrite network is also visible in the microstructure observed on the surface of the spring seat 2 at the crack site (**Figs. 2f,14**). Instead to that, in the reference spring seats the corresponding network was not found.

Fig 11. Micrograph of the spring seat core (cylinder 1). Optical microscope.

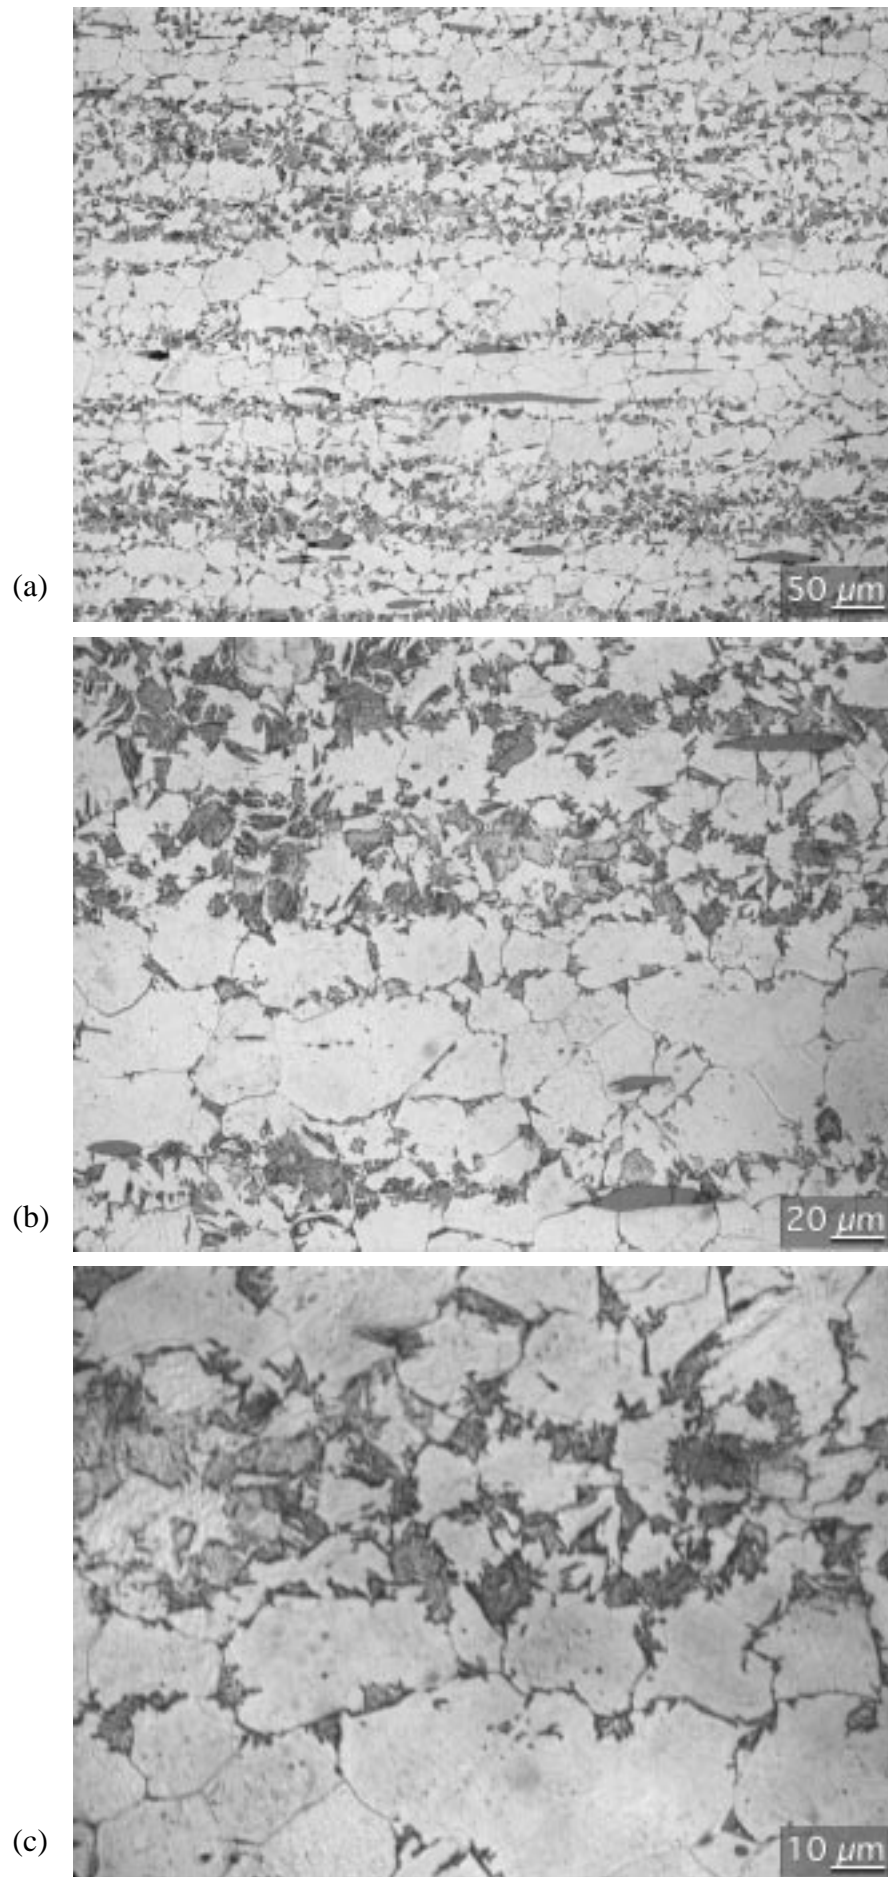
Fig 12. Micrograph of the spring seat core (SMP). Optical microscope.
