## Investigation report

B3/2008L

# In-flight structural failure at Taipalsaari on 15 August 2008

Piper PA-28R-200 Arrow II

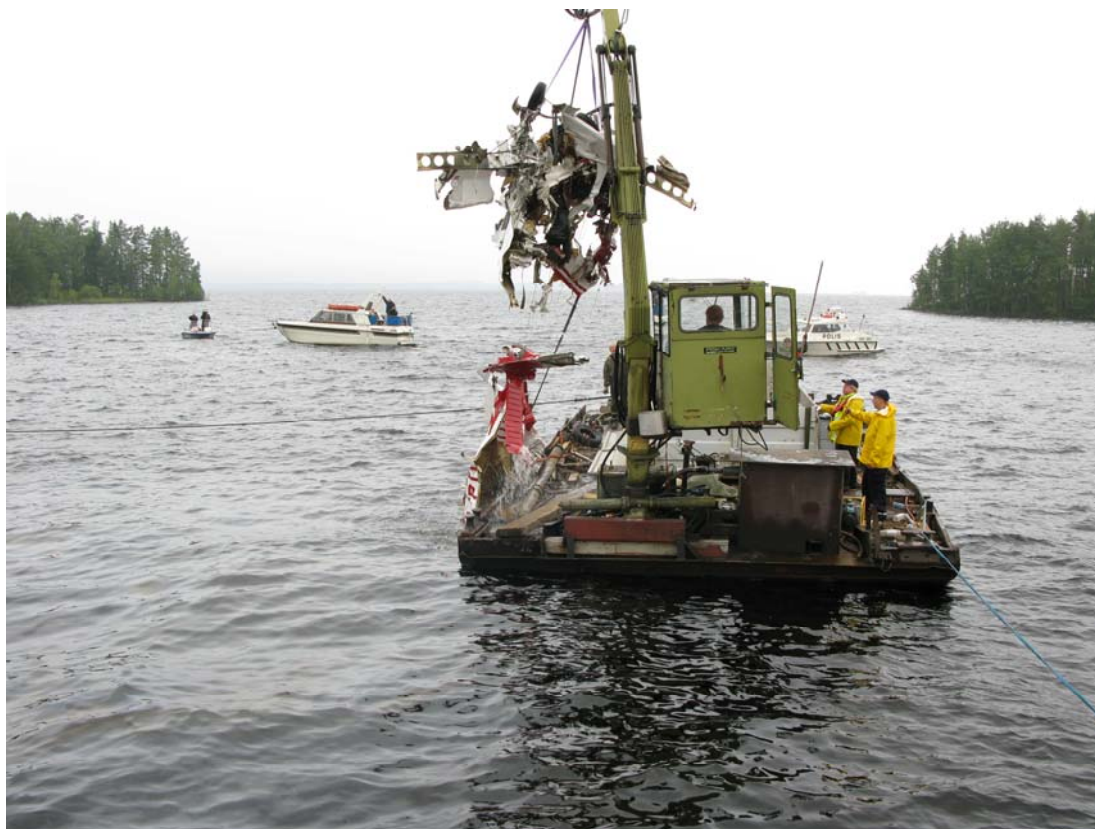
The recovery of the wreckage was planned on the basis of the divers' videos. The remains of the wreckage were lifted onto a pallet, mainly in one go, for preliminary investigation and transportation. The divers then collected the small parts and other loose material. The biggest missing parts were the outboard sections of both wings, including the ailerons, as well as the right stabilator and its trim tab. Detailed investigation of the wreckage was done at Helsinki-Vantaa Airport.

Figure 2. Recovering the wreckage at the accident site
