Investigation report

C4/2008L

Terrain clearance infringement in Helsinki Terminal Control Area on 26 March 2008

BOEING 737-300

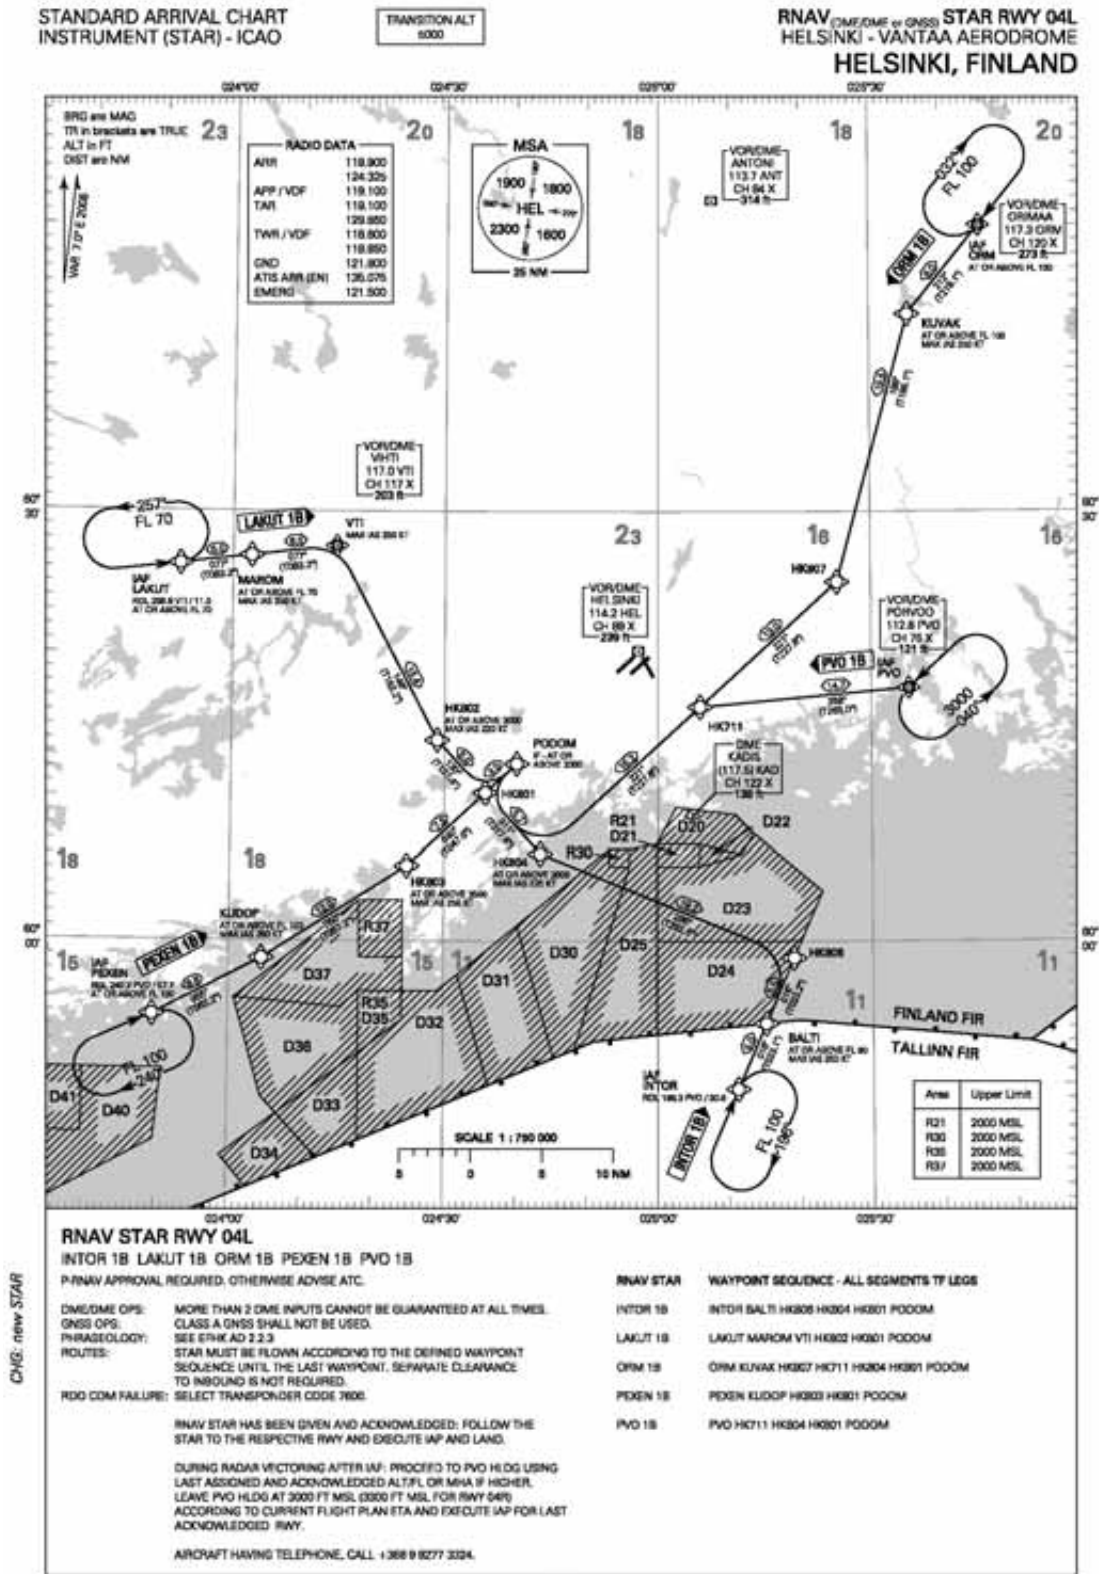
Figure 4: INTOR 1B standard arrival route (© Finavia, Permission 4/590/2007)

Next the air traffic controller instructed AUI621 to reduce speed to 230 KT, which the aircraft read back correctly. Then the controller cleared AUI621 to descend to 2300 FT, which is also the Minimum Sector Altitude. This guaranteed a terrain clearance of at least 1000 FT from all obstacles within the aircraft’s radar track. After the aircraft read back the altitude the controller told it to turn to heading 340. By maintaining this heading, followed by a turn towards a 30 degree angle with the final approach track the aircraft would have captured the ILS localizer at approximately 7.5-8 NM from the touchdown point. The aircraft would have then established on the ILS LLZ before following the 3 degree glide path. Runway 04L glide path begins at 2300 FT, 7 NM from touchdown. The vectoring of AUI621 was executed in accordance with ATS regulations and training as well as ICAO recommendations.

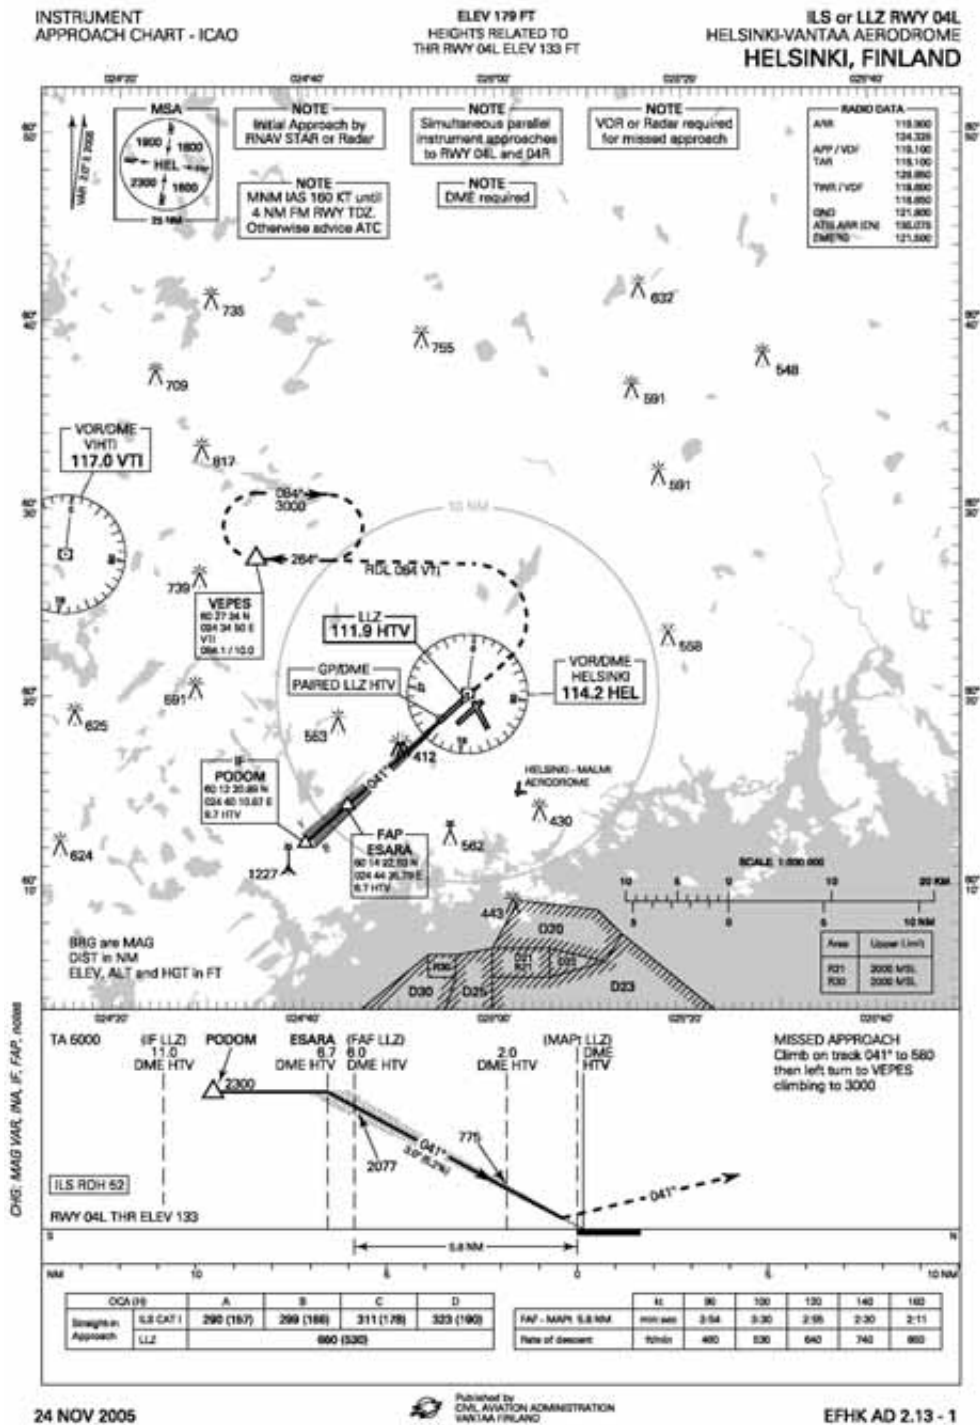
Figure 5: ILS 04L (© Finavia, Permission 4/590/2007)

at which time the altimeters are to be set to the correct QNH. Furthermore, the PNF shall verify and call out the altimeter settings. The co-pilot said that the captain did not call out passing the transition level because he was busy monitoring the weather, informing the co-pilot about a snow cloud on the radar screen. The co-pilot, in turn, said that he was concentrating on flying the aircraft because they were already close to the final approach track of their runway.

The co-pilot said that he had spotted the ground and noted that the altimeter indication did not correspond to his idea of their true altitude. He noticed that they had forgotten to set their altimeters to the local QNH, which he then set and initiated a climb. After this he ordered that the QNH be set and the DESCENT-APPROACH checklist be read. The checklist was read at the behest of the co-pilot, albeit belatedly. The captain reported the completion of the checklist.
