## Investigation report

B4/2009L

# Hard landing for helicopter in Porvoo on 7 May 2009

Bell 412EP

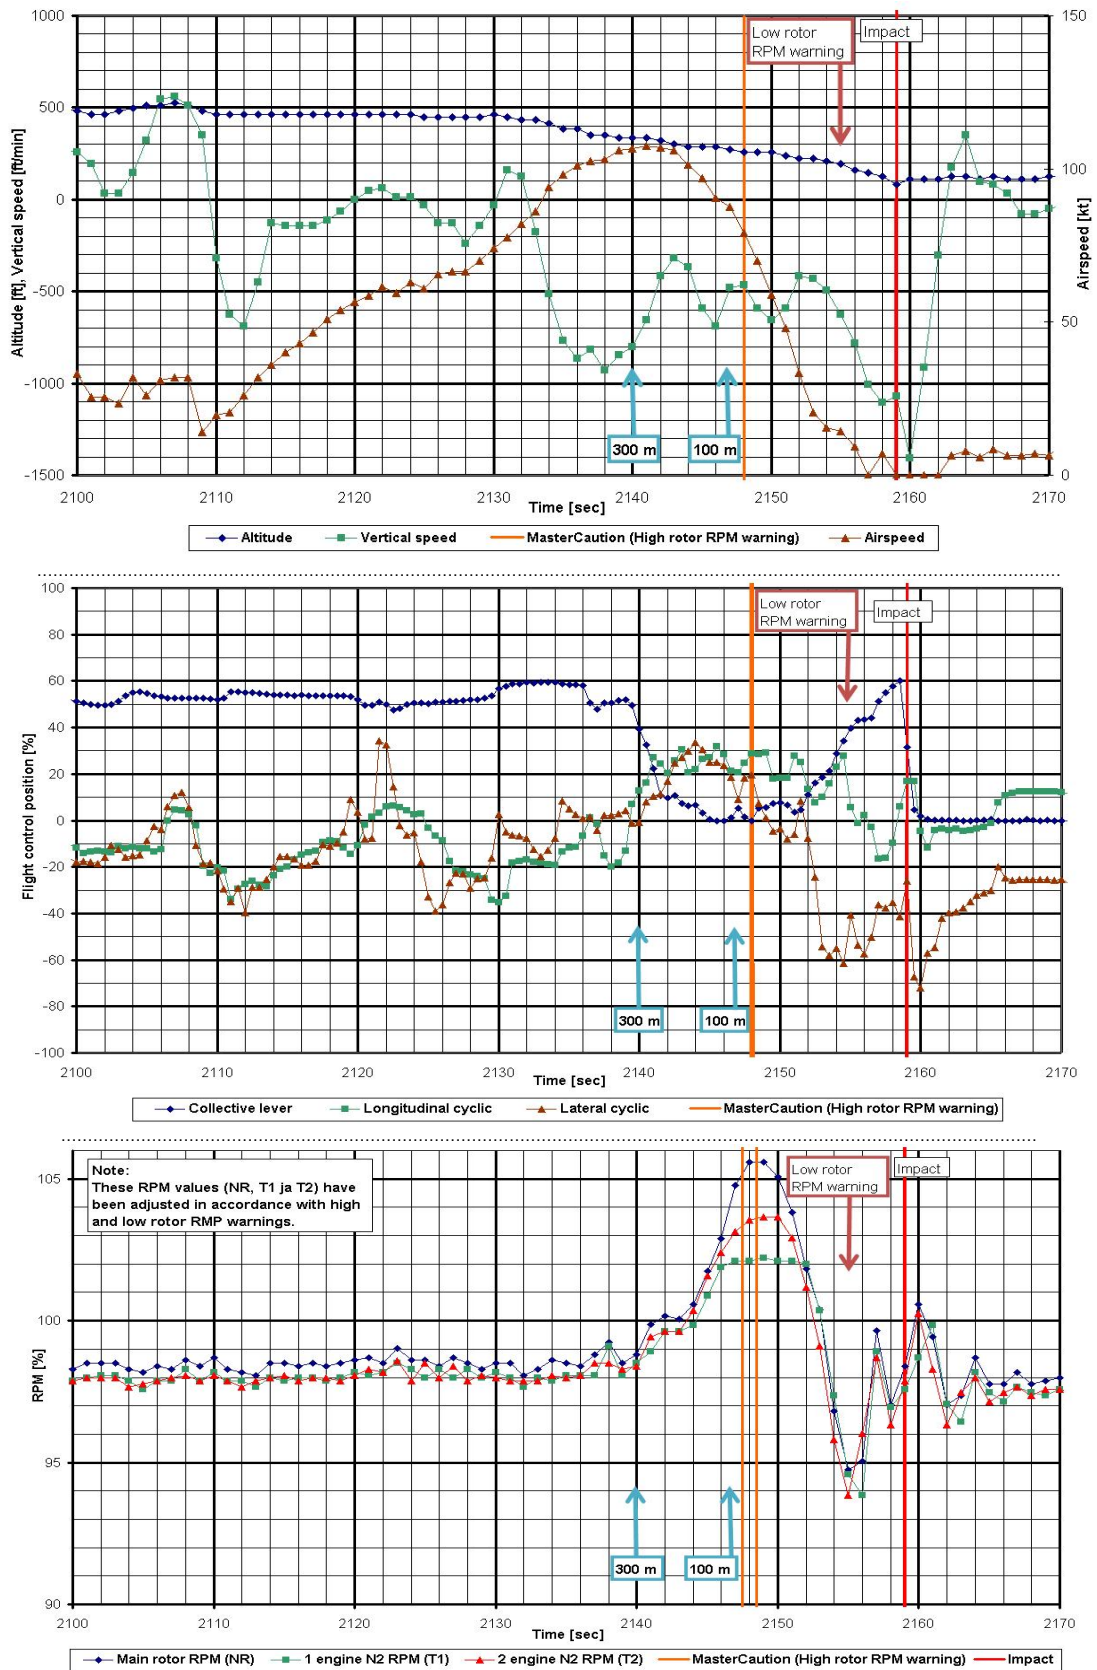
Figure 3. Flight recorder data.

- The collective was raised from nearly the bottom position and was paused when the main rotor low RPM warning (aural warning) was activated. Once the RPM increased the collective was again raised (Cf. figure 3, flight control positions).

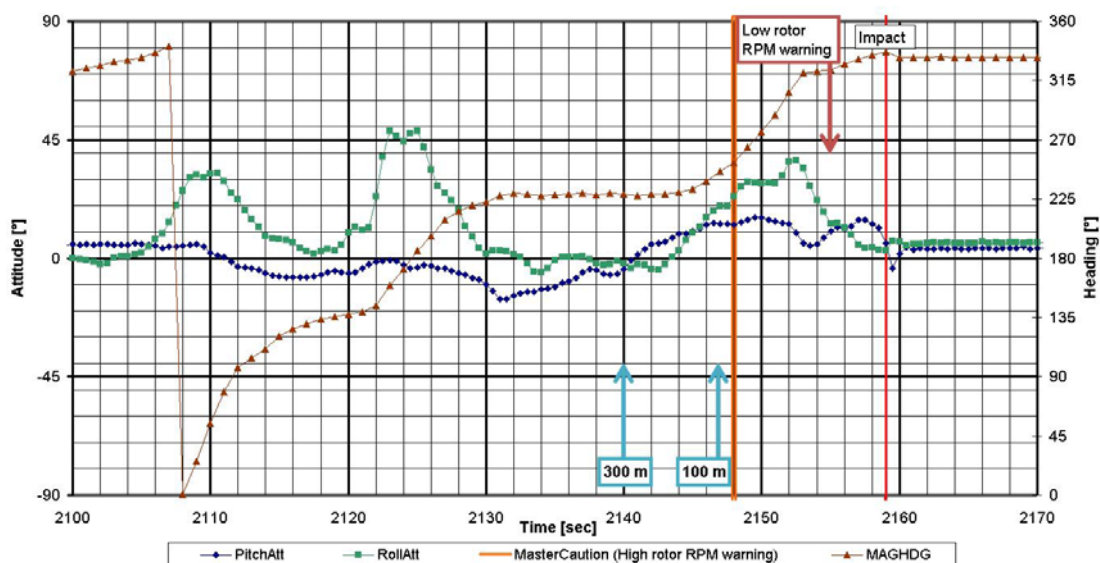
Figure 4. Flight recorder data.

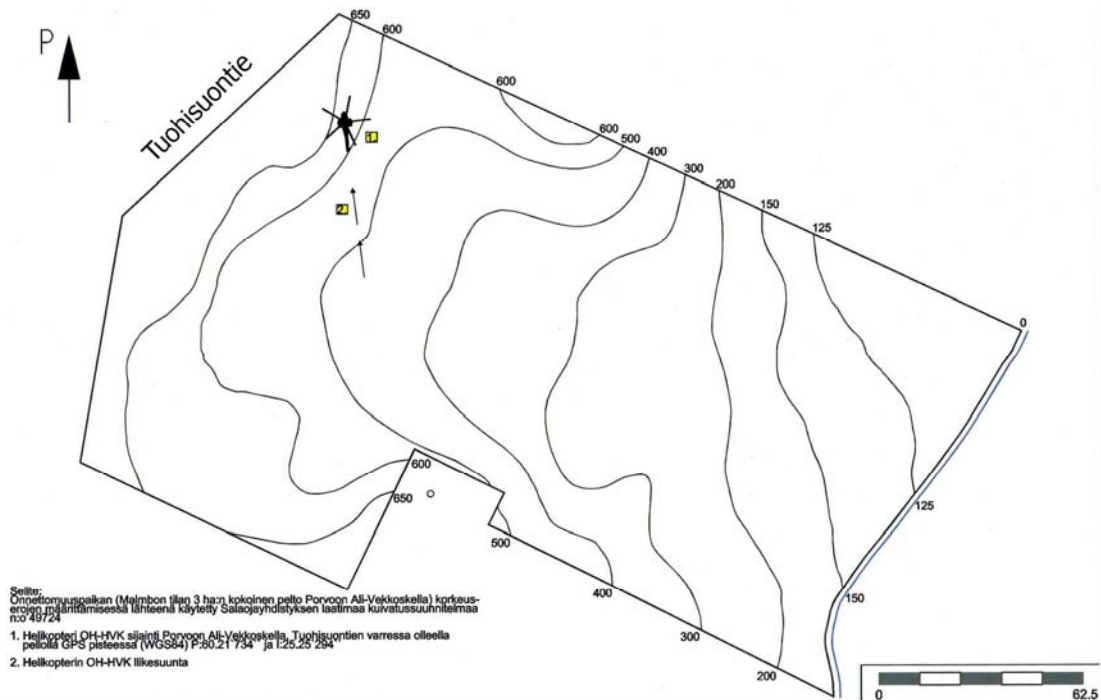
Figure 7. Map of the landing site. (Base map: The Finnish Field Drainage Association, Photo: Finnish Police)

The accident site is approximately 25 m from Tuohisuontie road at the northern corner of a three hectare ploughed field. The lowest point of the field is at the eastern corner, 225 m from the accident site. From there the field gradually rises towards the site, being approximately 6.5 m higher.

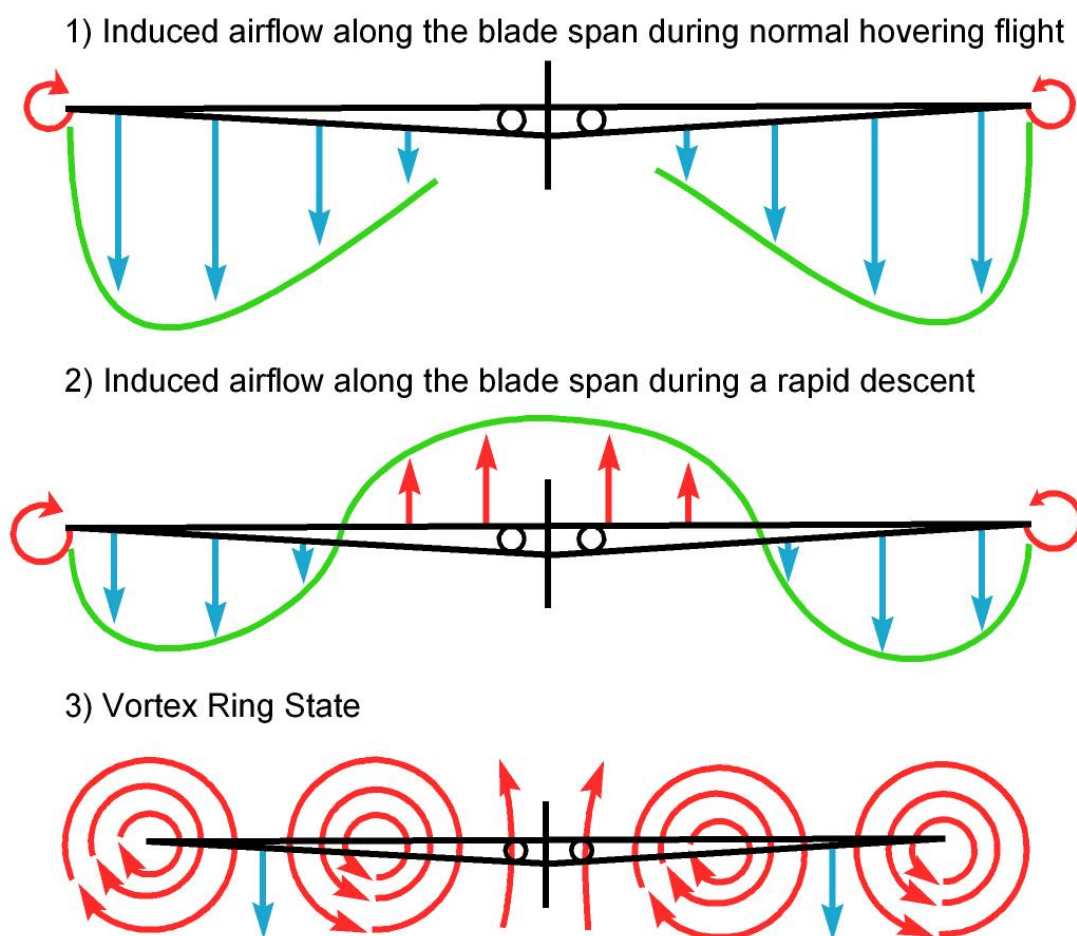
When the airspeed is low (below 20 kts), the engine power is between 20-100% and the rate of descent exceeds 300 ft/min, there exists the risk of the main rotor entering a Vortex Ring State<sup>5</sup> (VRS, figure 10). In a normal hover the helicopter is able to remain stationary by propelling a large mass of air down through the main rotor. Some of the air is recirculated near the tips of the blades, known as tip vortices. As the sink rate increases the airflow of the inner blade sections becomes upward relative to the disc. The upward airflow from the inner blade sections then re-enters the outer disk, which generates a secondary vortex ring about the point on the blade where the airflow changes from up to down. If allowed to develop, both vortices intensify which results in loss of thrust and a so-called vortex ring state.

It is not normally possible to recover from a VRS by raising the collective, as this only makes the situation worse. Recovery must be carried out as in airplane stall recovery - by increasing the forward airspeed (reduce collective, apply forward cyclic).

Figure 10. Vortex Ring State.

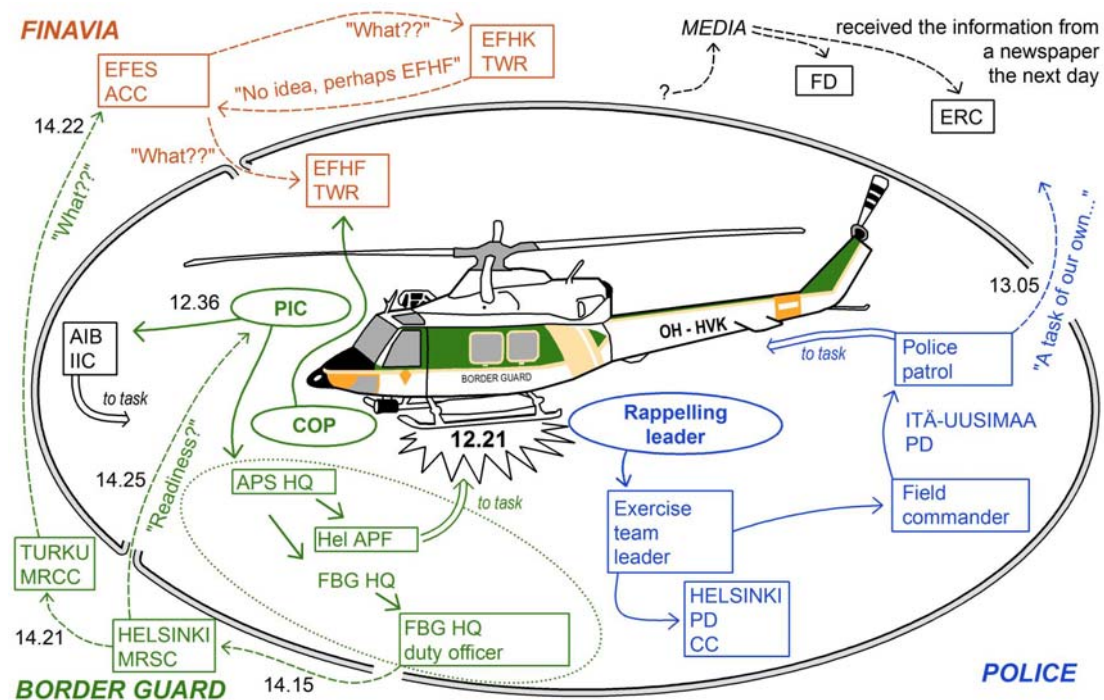
The helicopter’s co-pilot reported a ‘hard landing’ to Malmi tower. The air traffic controller did not report the occurrence to Aeronautical Rescue Co-ordination Centre Finland (ARCC), to the aviation authority or to the Accident Investigation Board of Finland. The investigation commission later learned that Finavia Oyj handled the matter as a (quality) nonconformity.

Figure 11. The flow of information following the accident. The flow of information between the police is shown in blue, the Border Guard in green and Finavia in brown, respectively.

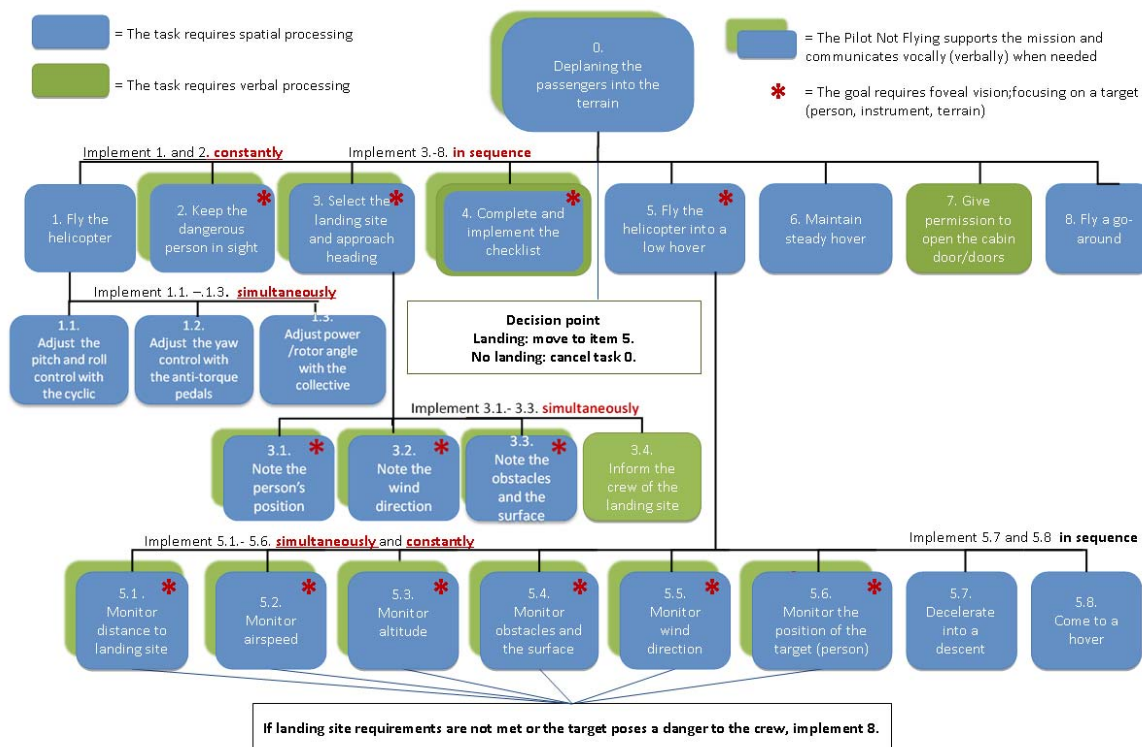
Figure 15. A hierarchical task analysis depicting the actions taken on a flight similar to the accident flight as per the Flight Operation Manual and flight procedures.

The task analysis (figure 15) shows that the piloting task requires mostly visuospatial processing. The task load is created from multiple concurrent spatial tasks which in addition require using a shared sensory modality (vision) for perception. Especially in item (sub-task) 5, in which the goal is to come to a low hover, several visual sources of information need to be simultaneously monitored. Furthermore, the targets' visuospatial features (e.g. location, direction, distance, size, shape and visual details) change during the course of the approach. The demands only increase when the landing site and visual conditions are unfamiliar. Since perception requires sequential monitoring of the environment, the time allotted to the task is a significant factor as regards time-sharing and workload.

- The crew was unfamiliar with the landing site and its perceptual environment.
- The piloting task comprises several simultaneous spatial tasks that require using a shared sensory modality (vision) (figure 15). The time allotted for the task becomes a key factor with regard to the mental workload.

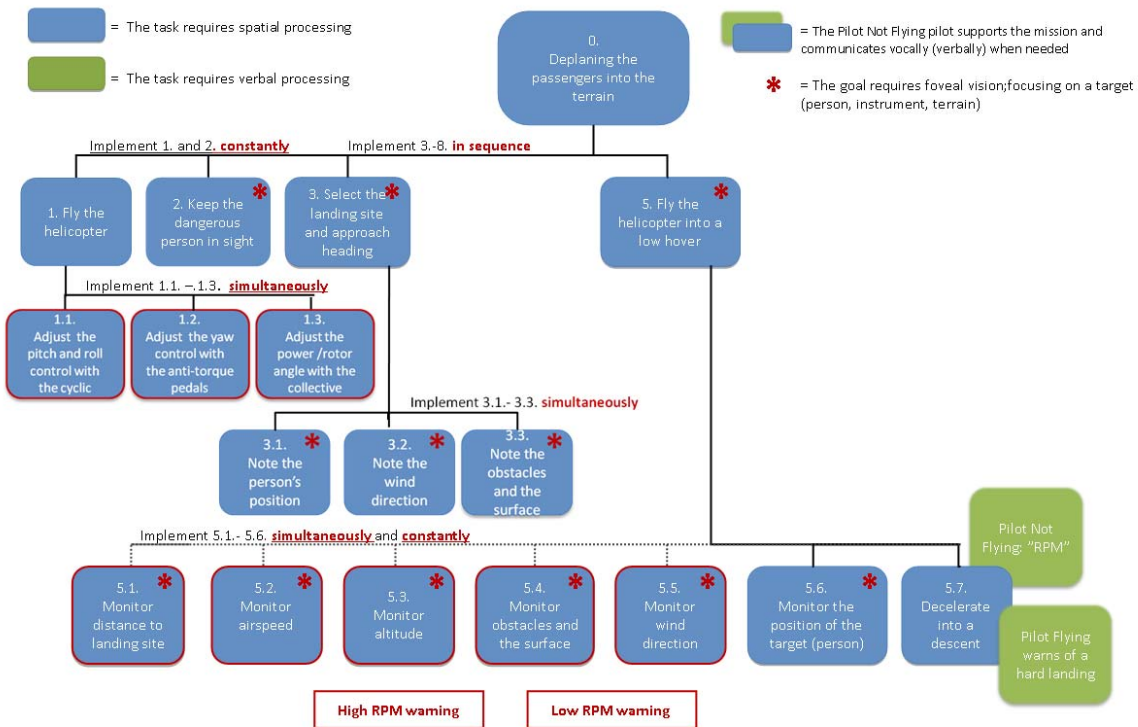
Figure16. A hierarchical task analysis of the actions taken during the actual flight.

The relationship between the aforementioned cognitive factors to the events on the accident flight were assessed by preparing a corresponding depiction of the accident flight (figure 16). The description was based on crew interviews as well as DFDR and CVR data. The flight profile analysis notes that deceleration was initiated too late. This infers human error when it comes to estimating the helicopter's state of flight and visual cues regarding the distance of the landing site (figure 16, items 5.1-5.6).
