## Investigation report

C2/2009L

# Serious incident at Helsinki-Vantaa Airport due to tread separation and hydraulic failure, 22 June 2009

Airbus A340

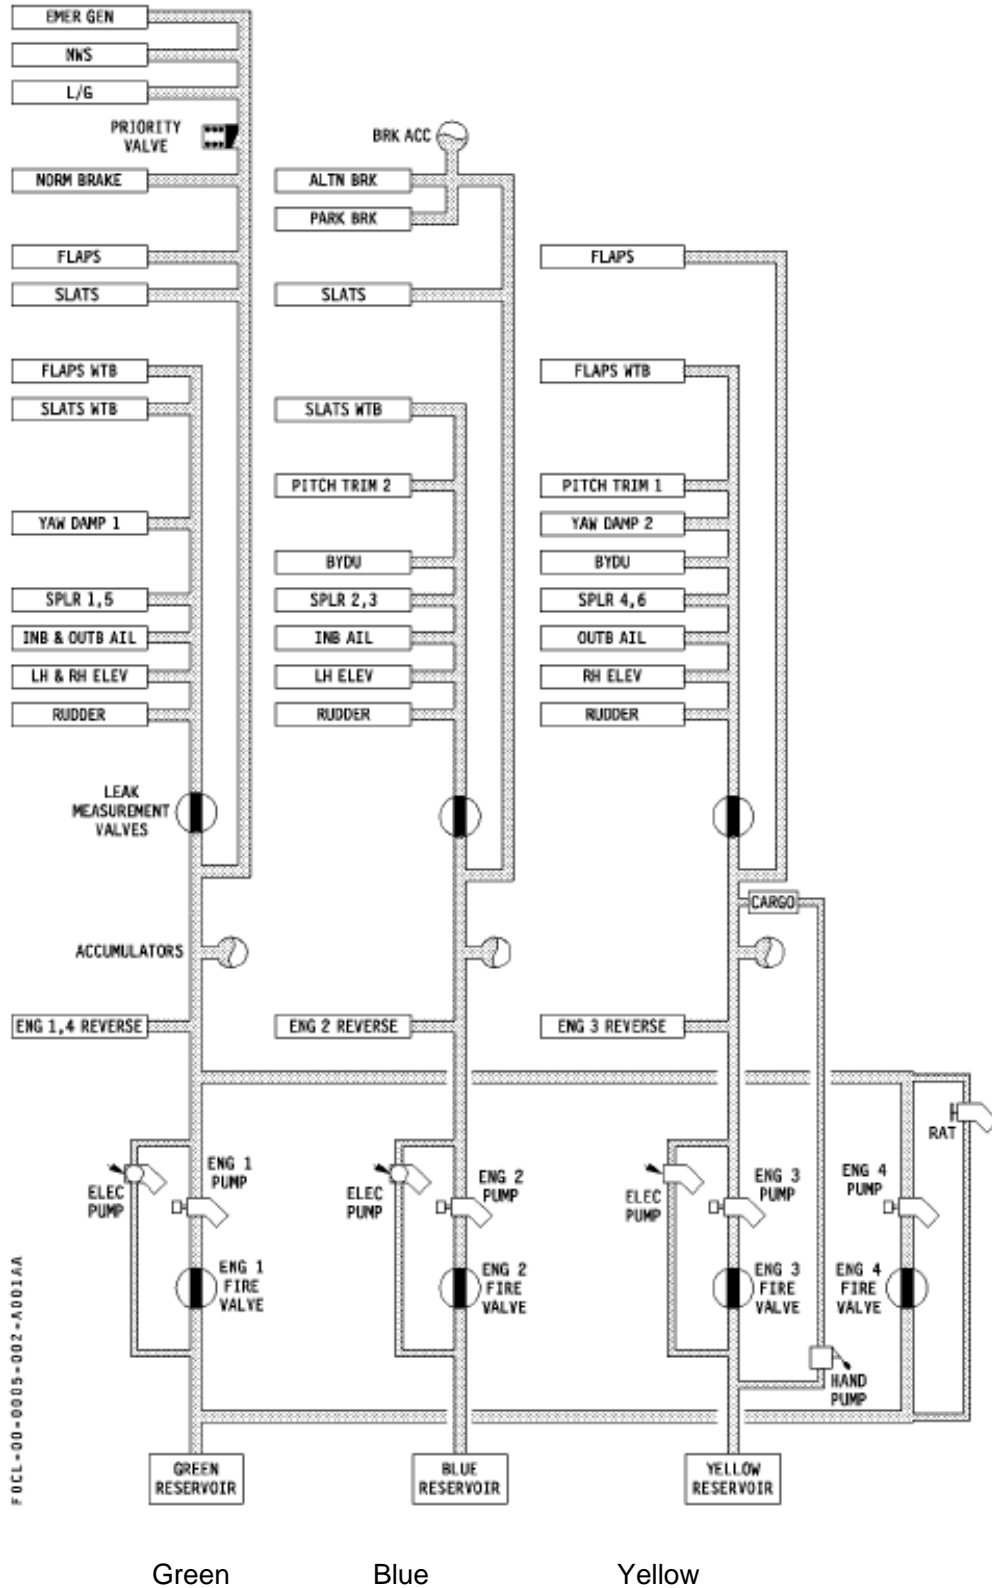
Figure 8. Airbus A340 hydraulic systems (source: Airbus 340 AOM)

The Airbus 340 has three hydraulic systems: green, blue and yellow. Each system has its own hydraulic reservoir, pumps and pressure accumulators. The pumps operate at 3000 psi (206 bar). The Hydraulic System Monitoring Unit oversees the systems.
