## Investigation report

B2/2010L

# Ultralight aircraft accident at Jämijärvi on 30 June 2010

OH-U430

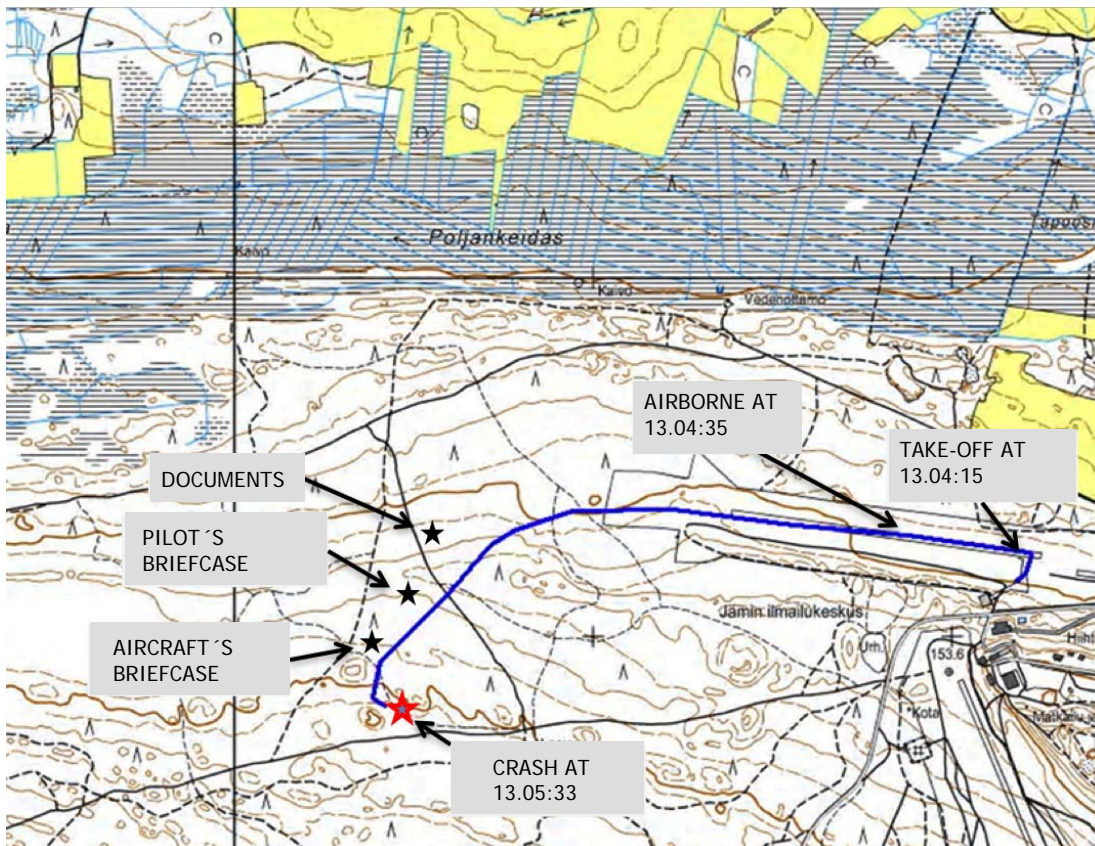
Picture 1. The flight route of the ultralight aircraft extracted from the on board GPS satellite locator. (The map: KTJ/Oikeusministeriö/MML)

On the aircraft's approach route to about 500 m distance from the accident site there were papers and items fallen from the aircraft, among others the aircraft's and the pilot's briefcases. Some of the items and their locations are shown in picture 1.
