Investigation report

C11/2010L

A330 Jetliners' Engine Bleed Air System Failures: Serious Incidents on 11 and 22 December 2010

AIRBUS A330-302

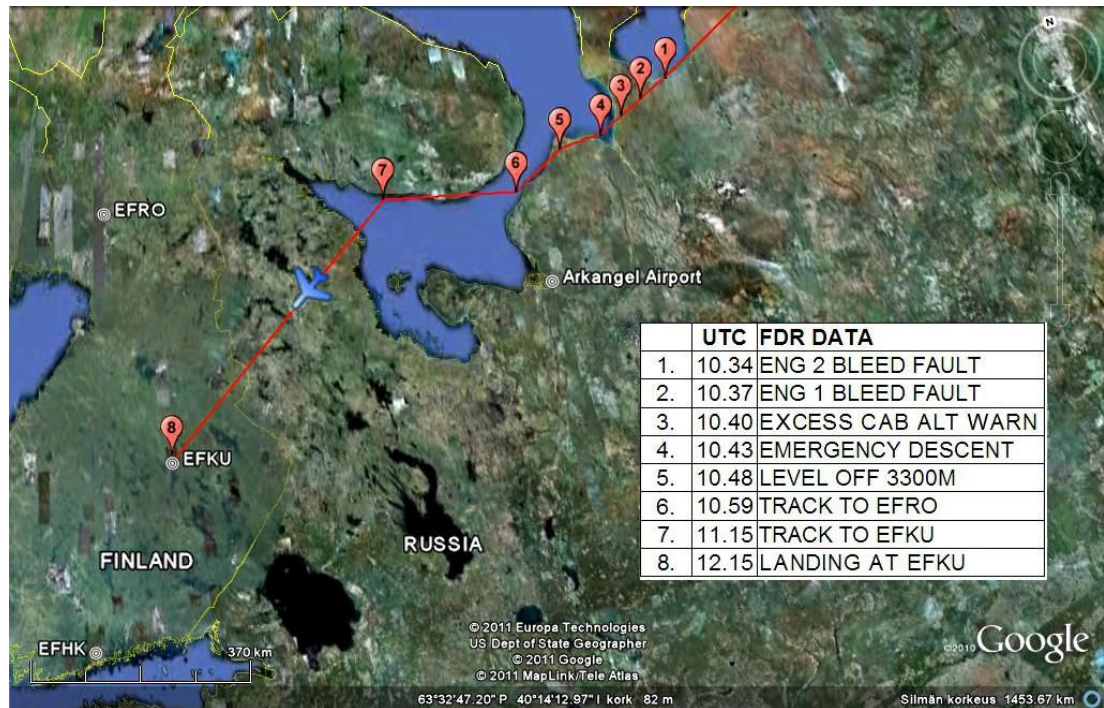
Figure 1. Key events associated with the serious incident of OH-LTO.

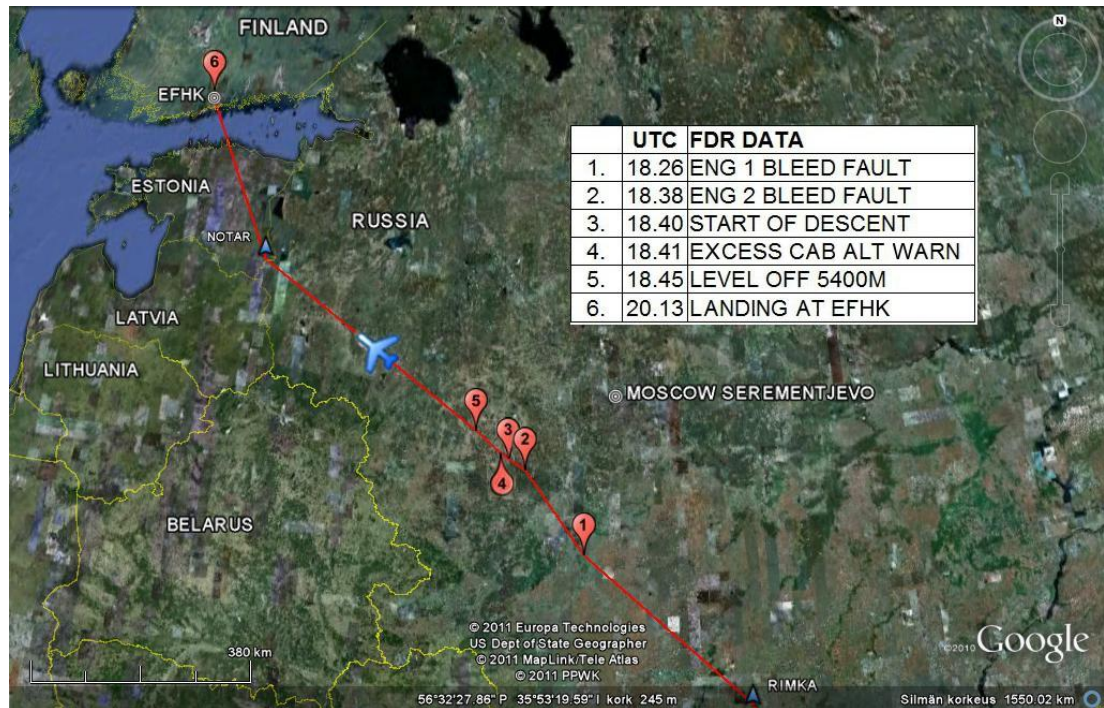
Figure 2. Key events associated with the serious incident of OH-LTS.

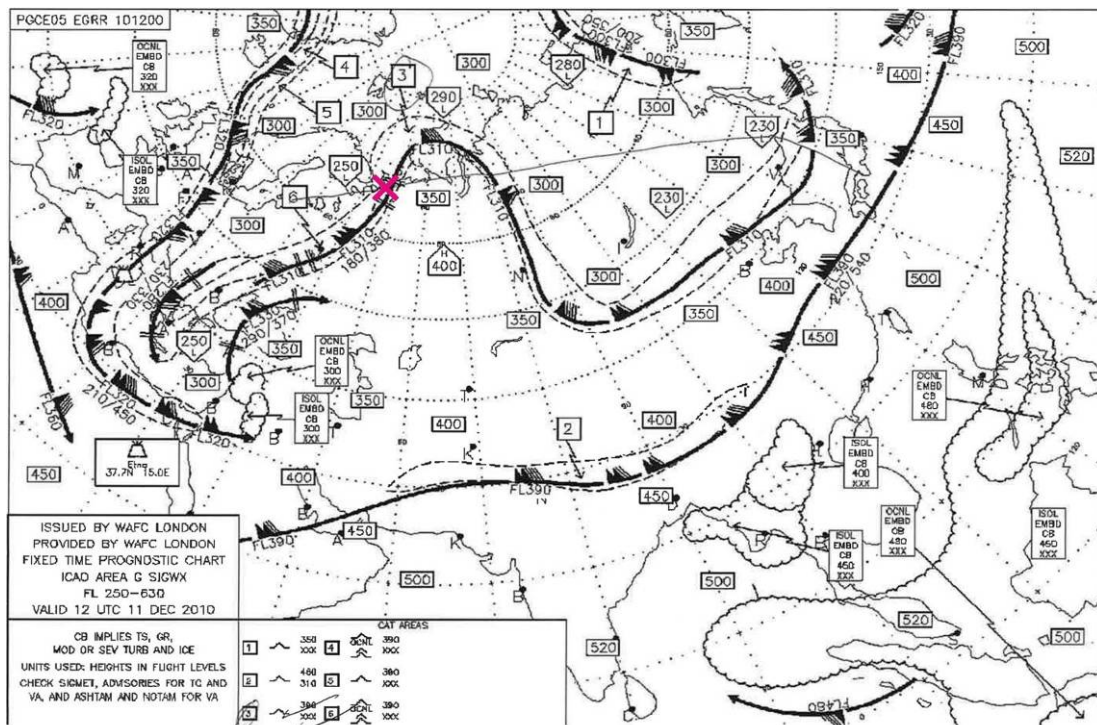
The Significant Weather Chart (SWC) valid 12 UTC 11 Dec 2010 (Figure 4) that was used in flight planning indicates a strong upper atmosphere jet stream at 9450 m (FL310), east of the Kola Peninsula and close to the location of the occurrence. The occurrence flight's route first crossed the jet stream approximately two hours before the incident and then momentarily before the incident.

Figure 4. The flight crew's SWC valid 12 UTC 11 Dec 2010. The location of the occurrence was later marked with a red X.

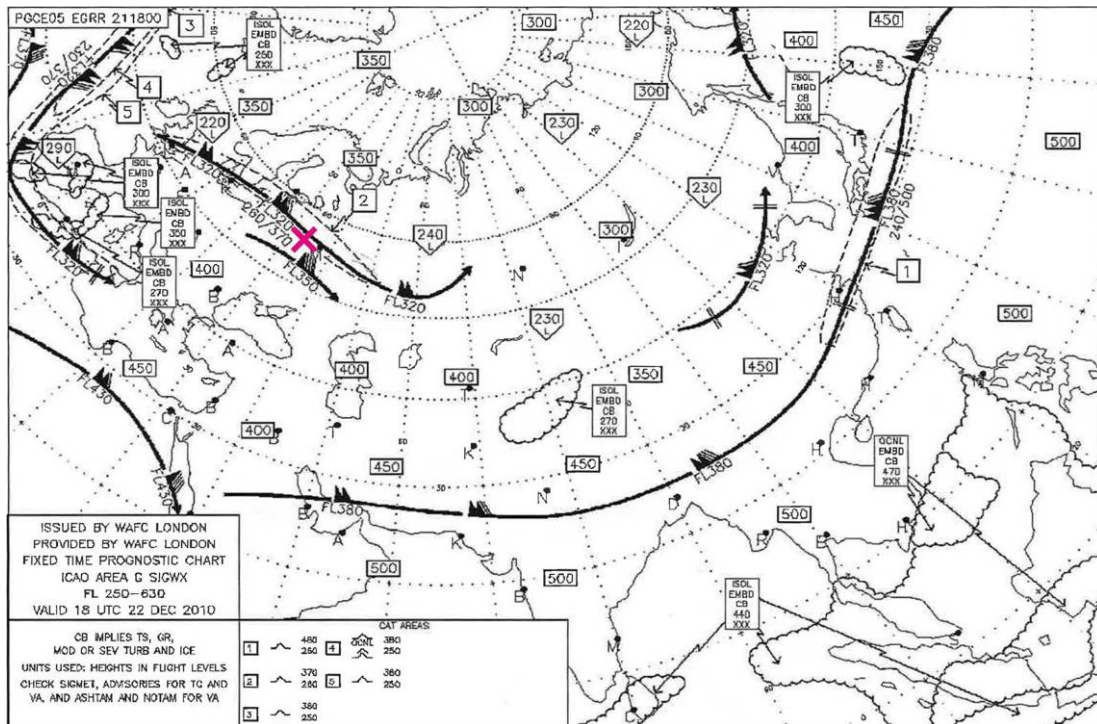
Figure 6. The flight crew's SWC valid 18 UTC 22 Dec 2010. The location of the occurrence was later marked with a red X.

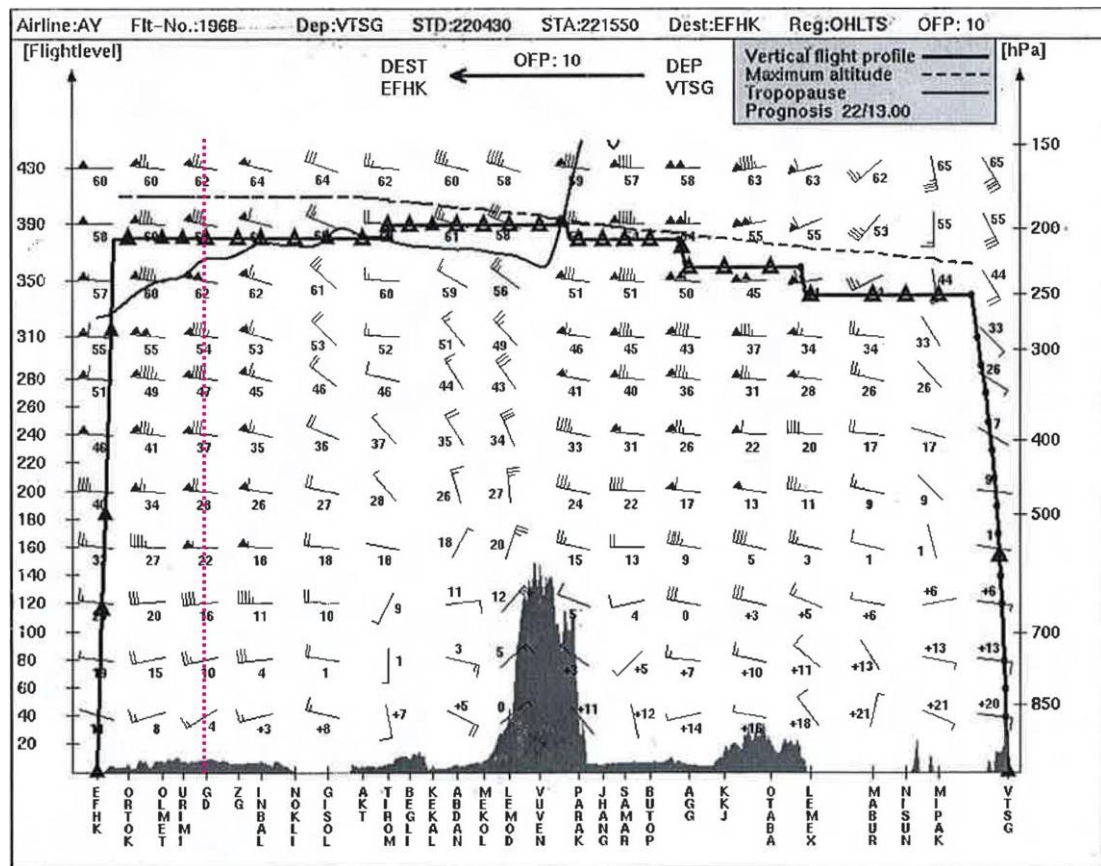
In addition, the flight crew had access to a vertical flight profile (Figure 7). The profile forecasts the tropopause at their planned cruising altitude before the location of the occurrence. Moreover, the coldest ambient temperatures enroute, below -60°C , are also forecasted to the same area where the incident occurred. The coldest FDR-recorded temperature in this area was -71°C . The red-dotted line in Figure 7 represents the first bleed air loss.

Figure 7. The flight crew's vertical flight profile for the flight on 22 Dec 2010. The red-dotted line was added later.

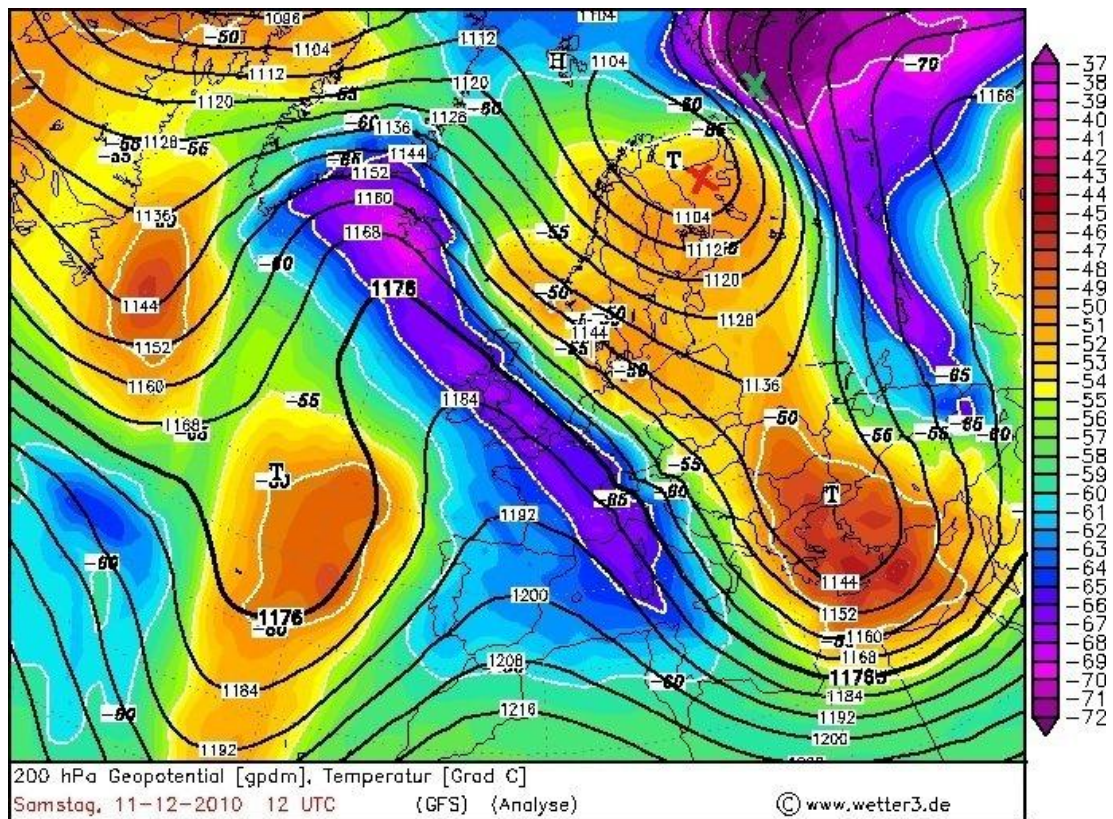
At the time of the occurrence flight a strong thermal gradient formed between the high-pressure ridge and the upper trough (from Novaya Zemlya over the Kola Peninsula towards the southeast). According to FDR data the ambient temperature rose from -77 °C to -60 °C in less than an hour of flying. The cruising altitude was at the height of the tropopause as well as within the range of the strongest thermal gradient.

Figure 8 depicts a reanalysis of 200 hPa streamlines (at approx FL390) at 12 UTC 11 Dec 2010, generated by the American Global Forecast System (GFS). It's different colours represent the large-scale low pressure system (amber) extending from Scandinavia to the Balkans as well as the Siberian High (violet). In addition, the green X and red X on the chart indicate Naryan-Mar and Kem weather stations, respectively, in northern Russia. Their actual radio-soundings are shown in figures 9 and 10.

Figure 8. GFS weather model reanalysis for 200 hPa streamlines at 12 UTC 11 Dec 2010. Source: www.wetter3.de.

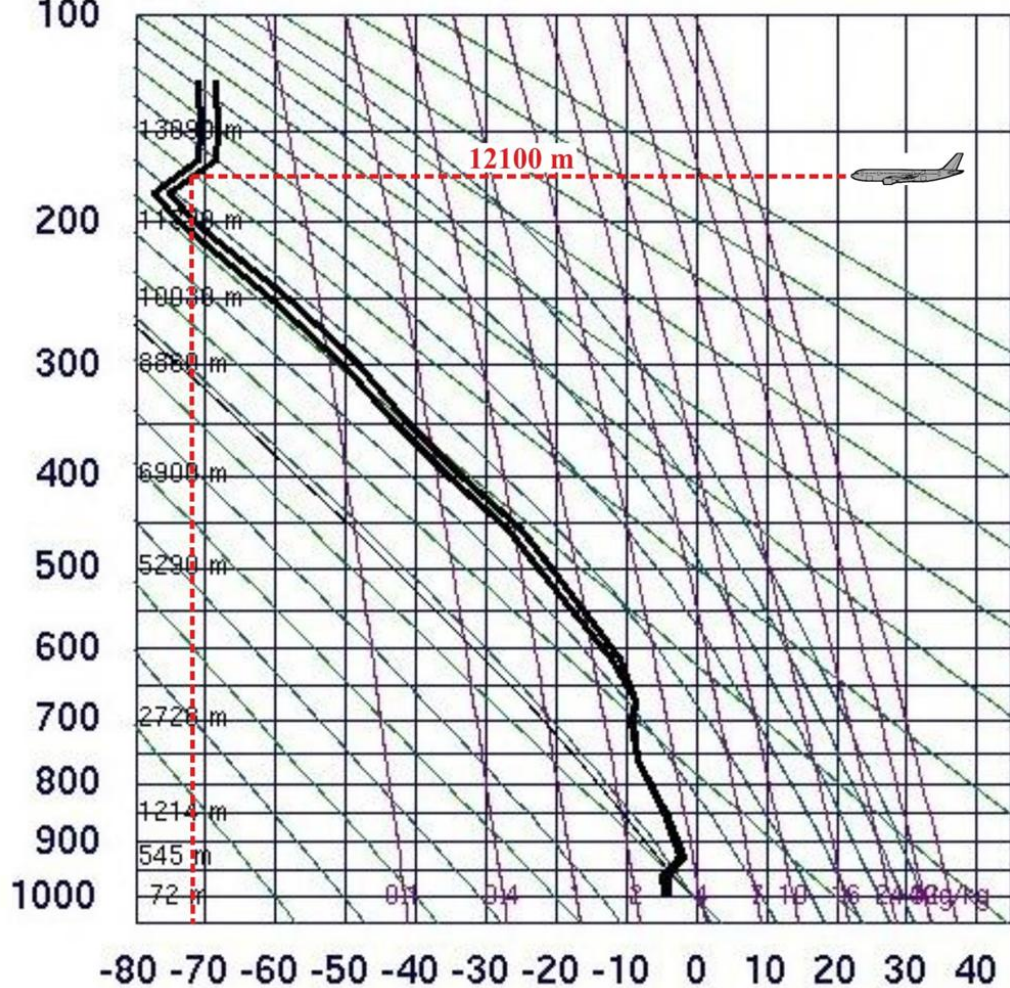
The Naryan-Mar radio-sounding (Figure 9) depicts the (mid-latitudes) air mass of the typically very high (ca. 11800 m) and cold (ca. -75 °C) tropopause. The cruising altitude (12100 m, 39700 ft) of the occurrence flight was at the height of the extremely cold and well-defined tropopause.

Figure 9. Atmospheric temperature as a function of altitude in the Naryan-Mar sounding. The horizontal axis shows temperature [°C] and the vertical axis pressure altitudes [hPa] and metres. The left plot is the dewpoint curve and the right one is the air temperature curve. Source: weather.uwyo.edu.

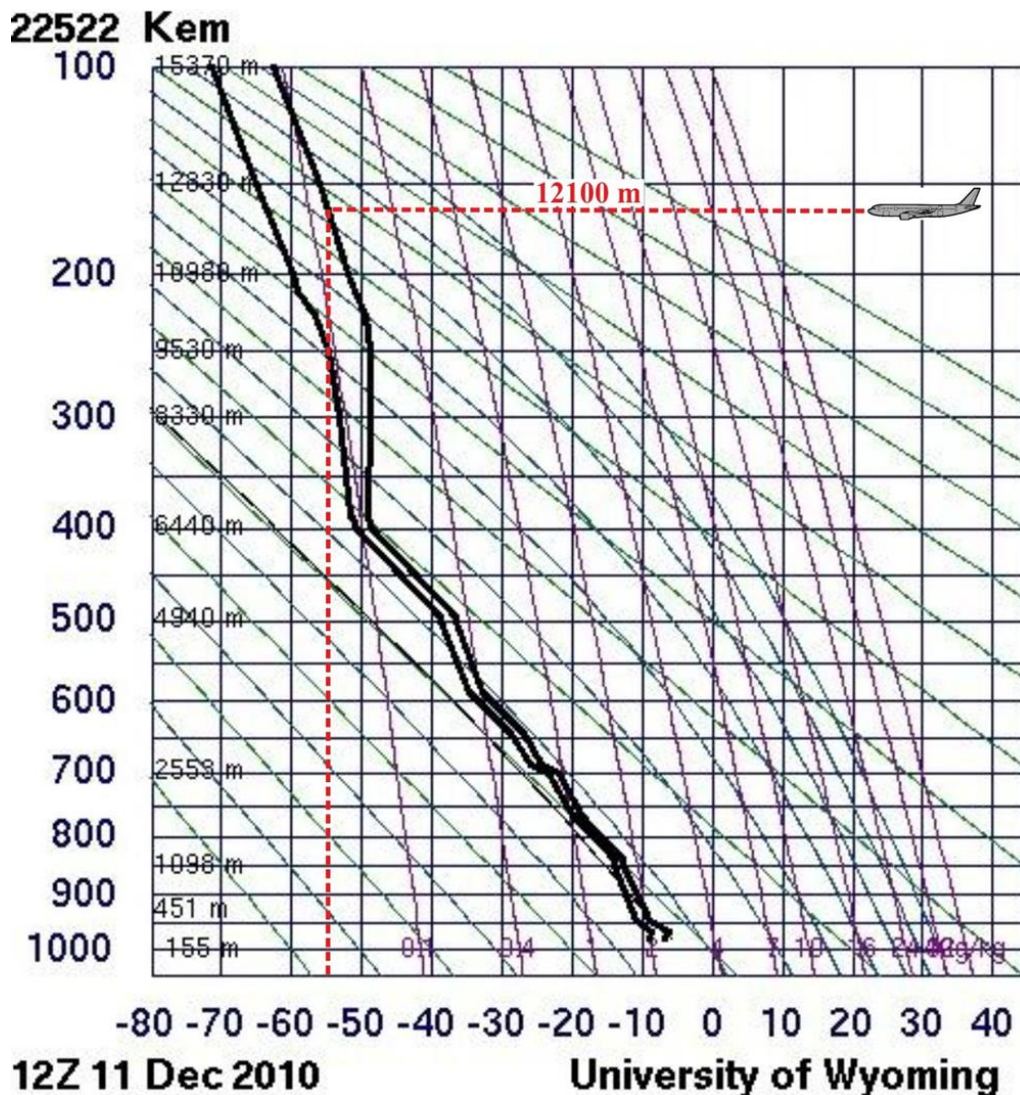
The Kem weather station sounding (Figure 10) depicts an air mass with a clearly lower (ca. 6500 m) and warmer (ca. -50°C) tropopause.

Figure 10. Atmospheric temperature as a function of altitude in the Kem sounding. The horizontal axis shows temperature [°C] and the vertical axis pressure altitudes [hPa] and metres. The left plot is the dewpoint curve and the right one is the air temperature curve. Source: weather.uwyo.edu.

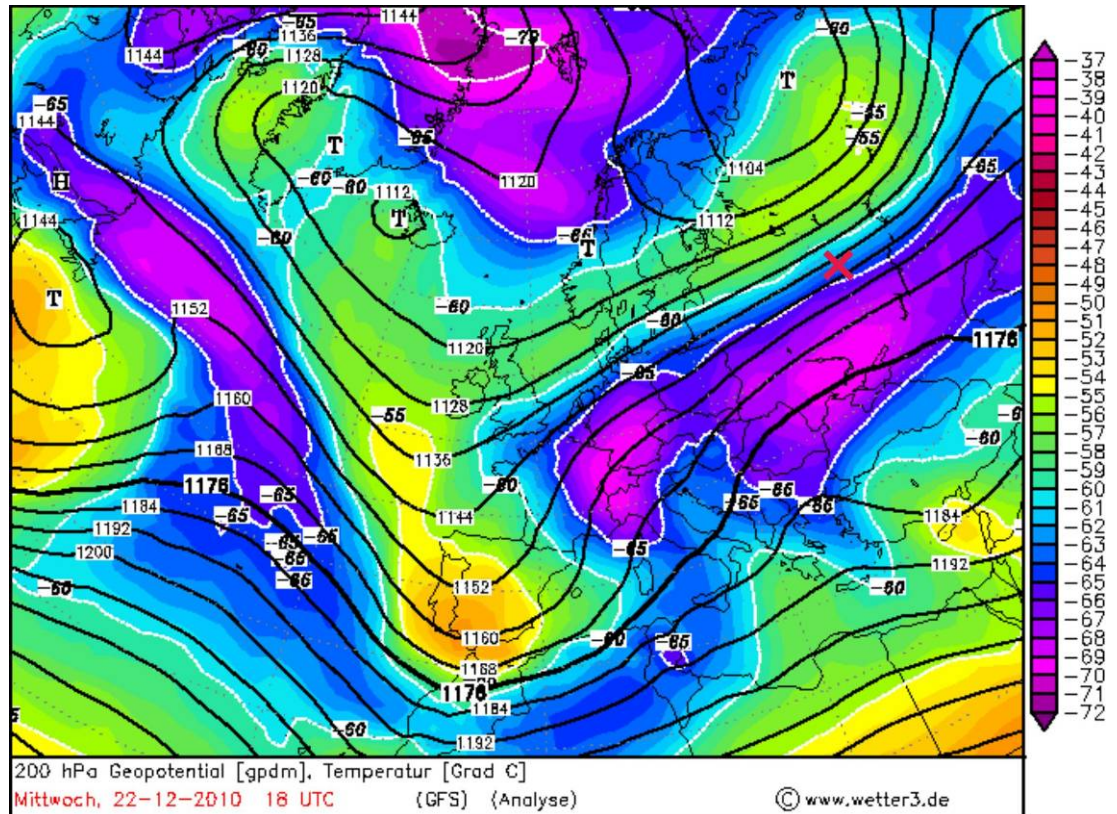
Figure 11 depicts a reanalysis of 200 hPa streamlines (at approx FL390) at 18 UTC 22 Dec 2010, generated by GFS. It's different colours represent the low pressure system (green) extending from Iceland to Siberia and the high-pressure area (violet) extending from central Europe to the east. The temperature of the air mass north of Moscow is approximately -56 °C. The coldest air mass, approximately -70 °C, is further south and

west-southwest. According to FDR data the ambient temperature rose from $-71\text{ }^{\circ}\text{C}$ to $-63\text{ }^{\circ}\text{C}$ within about an hour's flight time.

Figure 11. GFS weather model reanalysis for 200 hPa streamlines at 18 UTC 22 Dec 2010. The red x indicates the location of Ryazan. Source: www.wetter3.de.

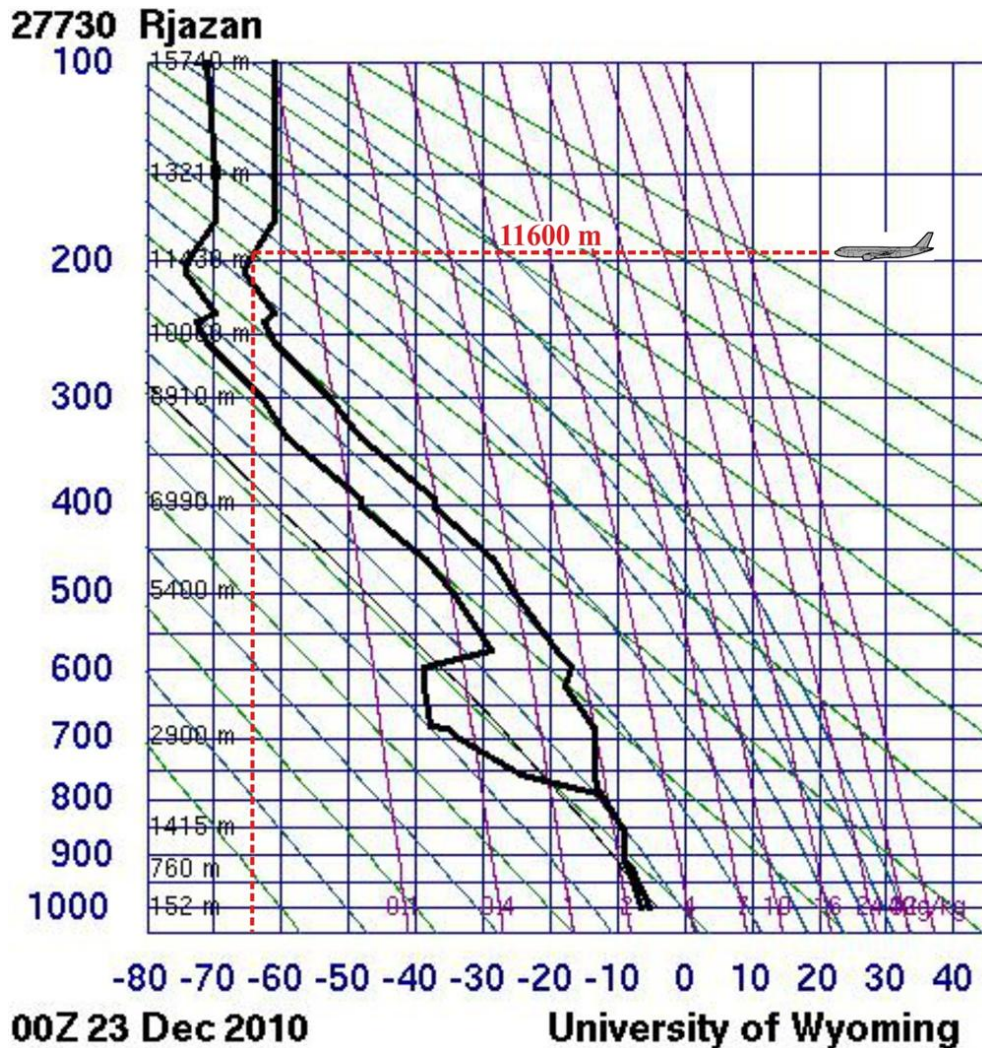
In figure 12 the circumstances with the occurrence flight are shown on a radio-sounding diagram (at 00.00 UTC 23 Dec 2010) from Ryazan, approximately 200 km southeast from Moscow. It shows the cold (ca. $-65\text{ }^{\circ}\text{C}$) and mid-latitudes air mass with a high (ca. 11400 m) tropopause. The cruising altitude of the occurrence flight was 11600 m (38100 ft).

Figure 12. Atmospheric temperature as a function of altitude in the Ryazan sounding. The horizontal axis shows temperature [°C] and the vertical axis pressure altitudes [hPa] and metres. The left plot is the dewpoint curve and the right one is the air temperature curve. Source: weather.uwyo.edu.

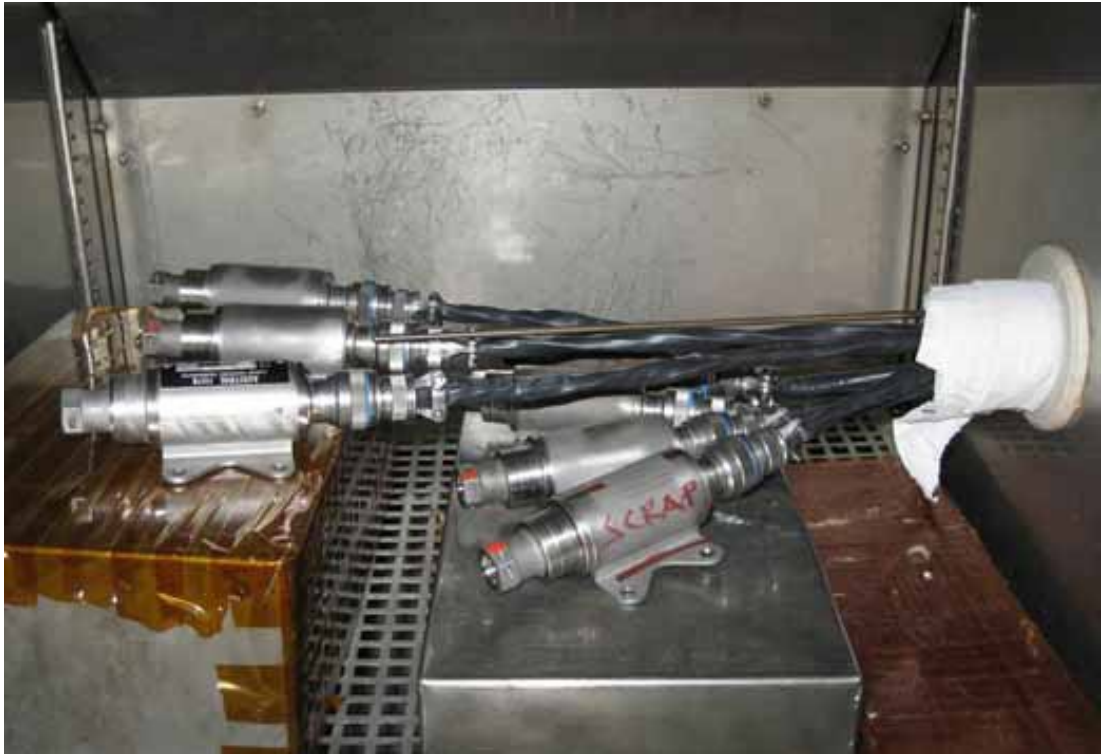
Following the visual inspection all pressure transducers were subjected to the output signal stability test. Test arrangements are explained in figure 18. Tests detected water in three transducers. The clearest indication of this came from OH-LTO's transducer s/n ASA12571. The output signals of OH-LTO's transducers s/n ASA12736 and ASA12735 were inconstant during temperature changes. This is why they, too, were determined to contain water. Nonetheless, the presence of water in them was not as evident as in pressure transducer s/n ASA12571. Some of the water may have disappeared during removal and/or transportation. One of OH-LTO's pressure transducers, s/n 188, was of the first version manufactured. It passed the stability test. The ACMM does not require stability testing for first version pressure transducers.

Figure 18. Pressure transducer output signal stability test arrangements in the test chamber. Source: Esterline-Auxitrol⁵.

Three pressure transducers that contained water on the basis of output signal stability test results were put into a 100 °C oven for two hours. After this, the stability test was repeated. Throughout the test the output signal of each pressure transducer remained constant. In other words, they passed the test. The result graphs of this test are also shown in appendix 9.

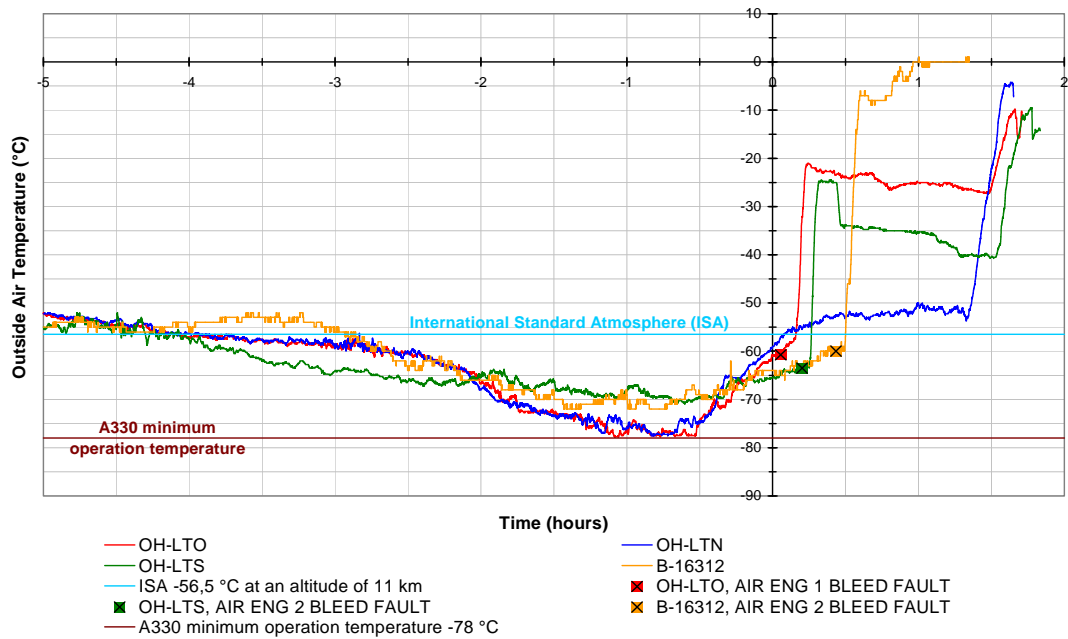
In addition to the occurrence flights, reference material was collected from two other flights. Due to identical flying weather conditions the investigation used measured ambient temperatures as reference material. Figure 19 shows the measured ambient temperatures of all four flights as a function of time for the final five hours before the first bleed air loss. The aircraft used for reference were A330s and the engines were type GE CF6-80E1.

In figures 19 and 20 the graphs of all reference flights meet the zero of the time axis at the point where the first bleed air losses occurred. The second bleed air loss points are marked on the graphs.

Figure 19. Ambient air temperatures on the reference flights as a function of time.

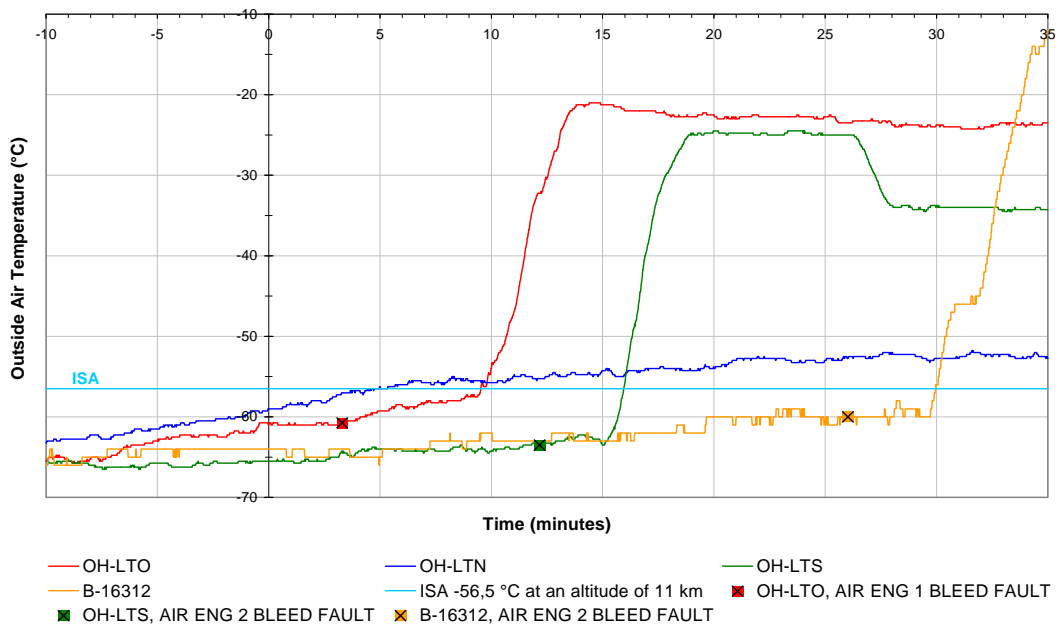
Figure 20. Enlargement of figure 19.
