Nose landing gear malfunction in aircraft OH-BEX at Helsinki-Vantaa airport on 26 August 2015

Investigation number: L2015-02

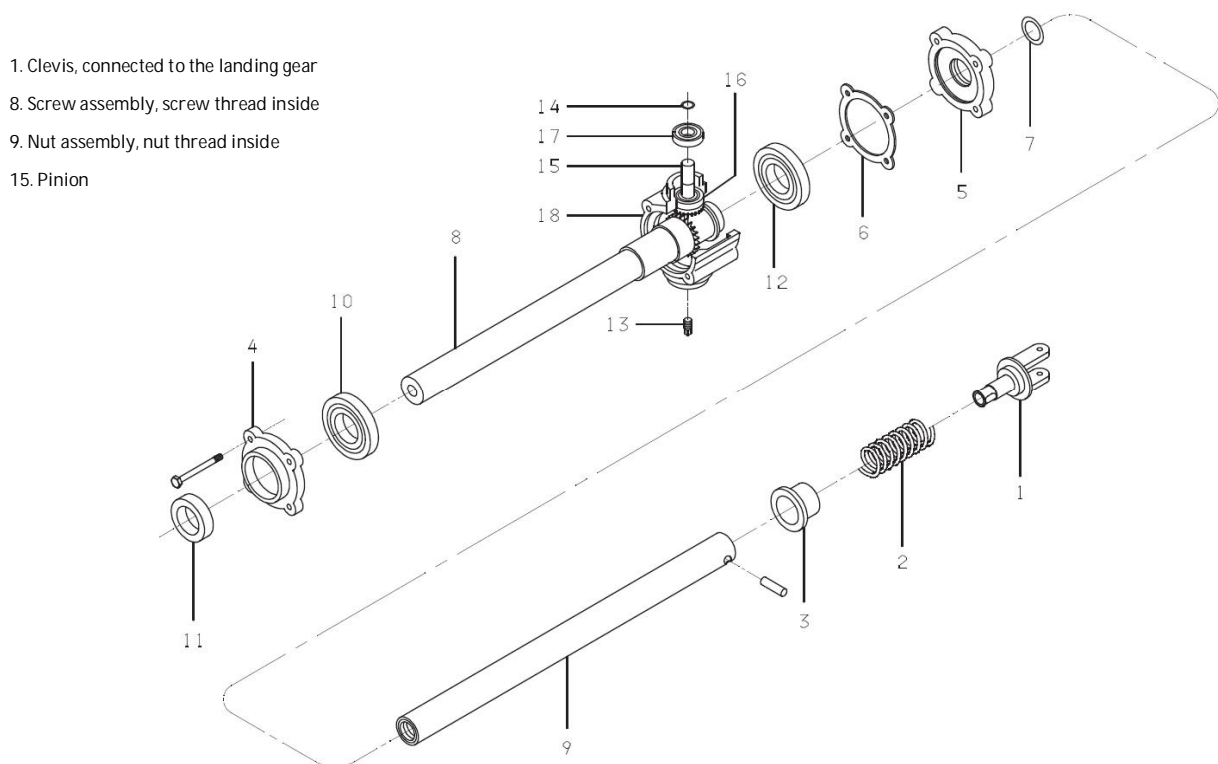
Figure 2. Parts breakdown of the nose landing gear actuator based on a screw assembly. (Source: Hawker Beechcraft Corporation)

The aircraft was moved to the company hangar at Helsinki-Vantaa airport for technical investigations. To locate the fault, the mechanics removed the nose landing gear actuator (Figure 2) while the SIAF investigators were present. During preliminary investigations, the fault was located in the missing threads of the actuator.

Based on an analysis carried out at the material laboratory, the screw assembly appeared to contain a normal amount of lubricating grease. This was revealed when the nut part of the screw assembly was sawed lengthwise in two. In accordance with the maintenance instructions¹², the tube-formed nut assembly (Figure 2, no. 9) must be filled halfway with lubricating grease.
