Final report RL 2018:05e

Accident at Siljansnäs Airport, Dalarna County, on 30/06/2017 involving the aircraft OH-PHE of the model Piper PA-28-161, operated by Blue Skies Aviation Oy.

File no. L-71/17

9 March 2018

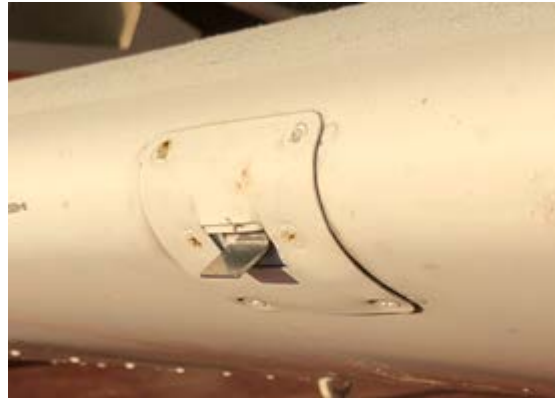
Figure 3. Stall warning vane.

The stall warning system consists of a movable metal vane (see Figure 3) that is mounted on the leading edge of the left wing. The metal tongue activates a micro switch when the angle of attack is so high that the air begins to flow from the underside of the wing towards the upper side of the wing. The system is calibrated so that a constant aural warning is activated in the cockpit five to ten knots above the stall speed. The aural warning is sent out from a loud-speaker mounted under the instrument panel and is not linked to the internal communication system (intercom). The stall warning's fundamental frequency is 3 000 Hz.

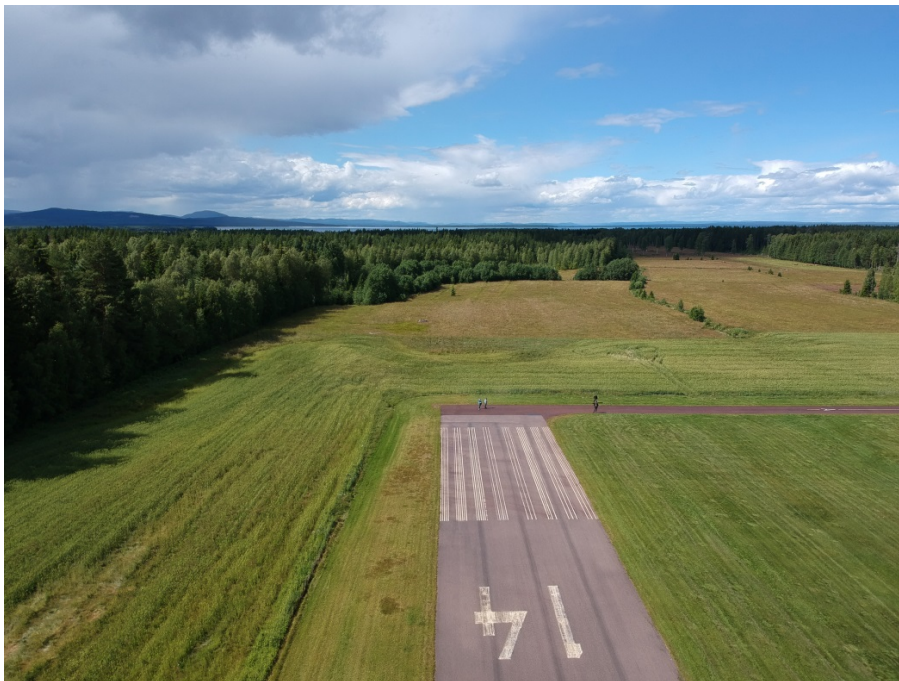
Figure 7. Overview image of the runway end with surrounding terrain.

Figure 7 shows the surrounding terrain in the take-off direction.

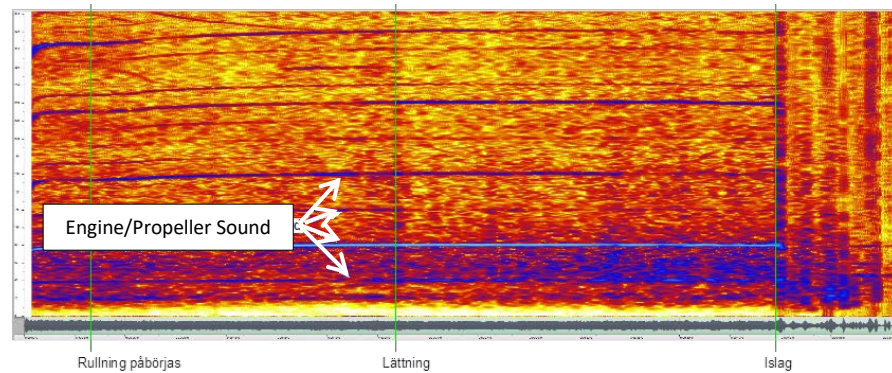
Figure 10. Spectrogram of the sound from the entire video film. The vertical scale goes from 0 to approximately 340 Hz and the horizontal scale from 0 to 52 seconds.

Based on the sound from the video film, a spectrogram has been extracted at commenced ground roll (four seconds into the film) and at rotation (22 seconds into the film).

The sound information shows that the engine speed was first approximately 2 310 RPM, which then quickly increased to approximately 2 400 RPM ($60 \times \text{frequency}/2$), after which it was constant until impact. SHK has calculated that the engine RPM corresponds to full power with the prevailing meteorological conditions.

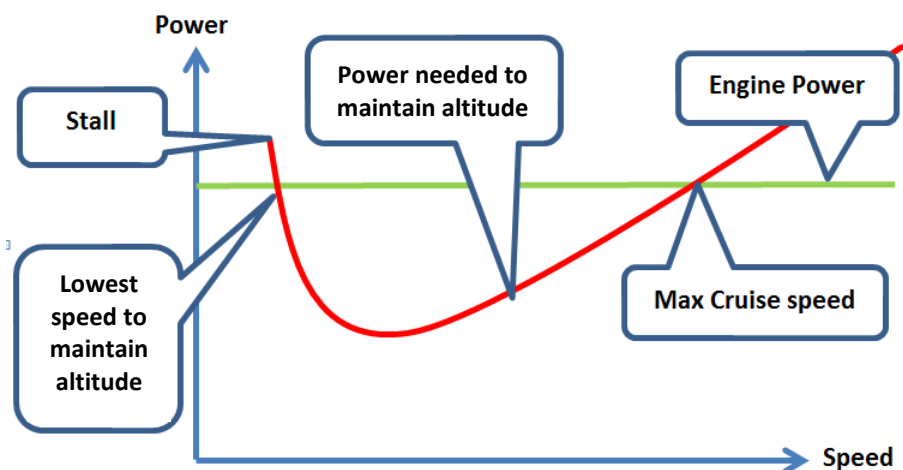
Figure 11. The relationship engine power – speed.

The diagram in Figure 11 shows the principle of available engine power in level flight at different airspeeds. The green horizontal line symbolizes the maximum available engine power which at high speed provides a constraint corresponding to the maximum cruise speed in flight. The only way to further accelerate is to descend towards lower altitude.

Similarly, there is a minimum speed to maintain the altitude with the maximum available engine power. If the airspeed drops further it becomes impossible to keep the altitude, which is due to the increased air resistance.
