Smoke in Cabin and Evacuation of Airliner at Turku Airport on December 3, 2017

L2017-06

SYNOPSIS

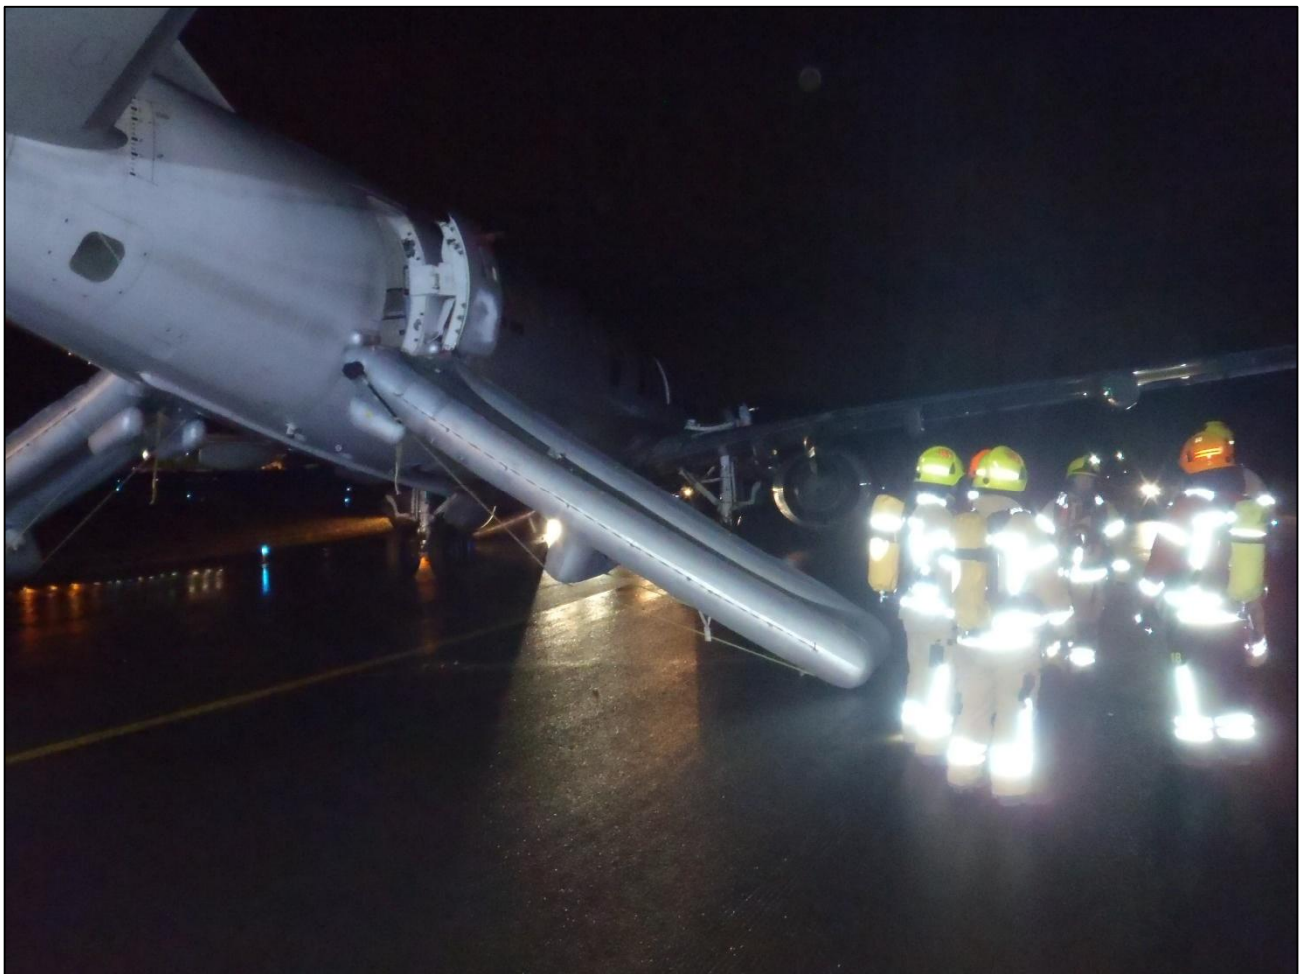
The rescue crews did not see any smoke coming from the airplane during the evacuation. The overwing exits were opened and used by several passengers to move onto the wings, where some congregated at approximately mid-span. Since no fire was observed inside the airplane, the rescue crews told these passengers to re-enter the cabin and evacuate via the slides in order to prevent them from dropping off the wings. The passengers complied. Entry into the airplane to examine it for a fire was possible only after all passengers had exited. The rescue crews assisted the passengers who were evacuating via the slides and guided them away from the airplane. The rescue units' searchlights were used to illuminate the airplane to ensure a safe evacuation. The rescue crews asked for and received interpreter assistance from the cabin crew in order to communicate their instructions to the passengers. An assembly area was designated on the grass adjacent to the airplane. Since some passengers wore only light clothing, they started to feel the cold and were issued with blankets from the rescue units. Children and their parents were taken into the rescue vehicles for protection from the cold.

Figure 2. The airplane after the evacuation. (Photo: Finavia Corporation)
