Incident on Helsinki-Vantaa Airport Runway 22L on January 18, 2019

Investigation: L2019-02
Investigation report 15/2019
ISBN: 978-951-836-562-7 (PDF)

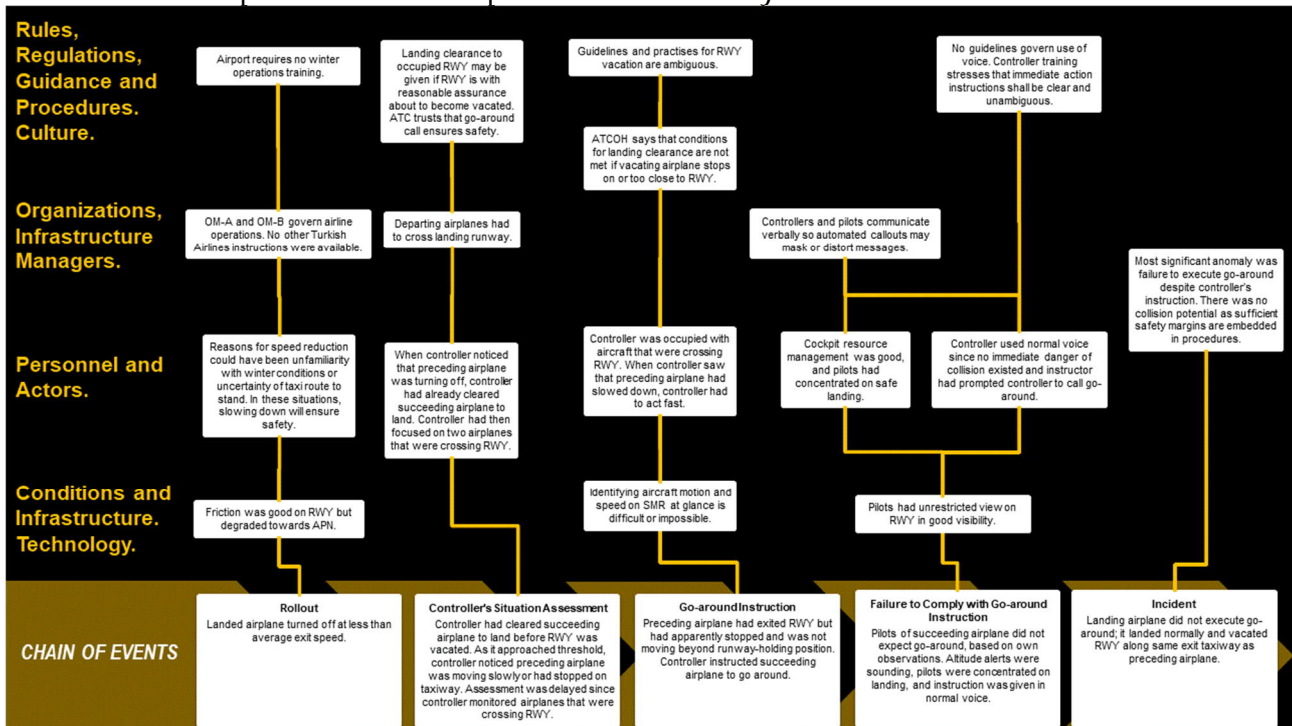
Figure 5. Accimap diagram of occurrence

The Accimap⁵⁴ approach, further developed by Safety Investigation Authority Finland, was used in the analysis of the occurrence. The structure of the analysis text is based on the Accimap¹⁷ presentation drawn up by the investigation. The accident is depicted at the bottom of the presentation as a chain of events. The underlying factors of the chain of events are illustrated in the presentation as separate levels of analysis.
