Investigation report

A 1/2004 Y Abridged translation
of the original Finnish report

A head-on collision involving a heavy vehicle combination and a charter coach on highway 4 at Konginkangas near the town of Äänekoski, Finland on 19.3.2004

The vehicle combination: Road tractor REY-481 and full trailer PZU-497

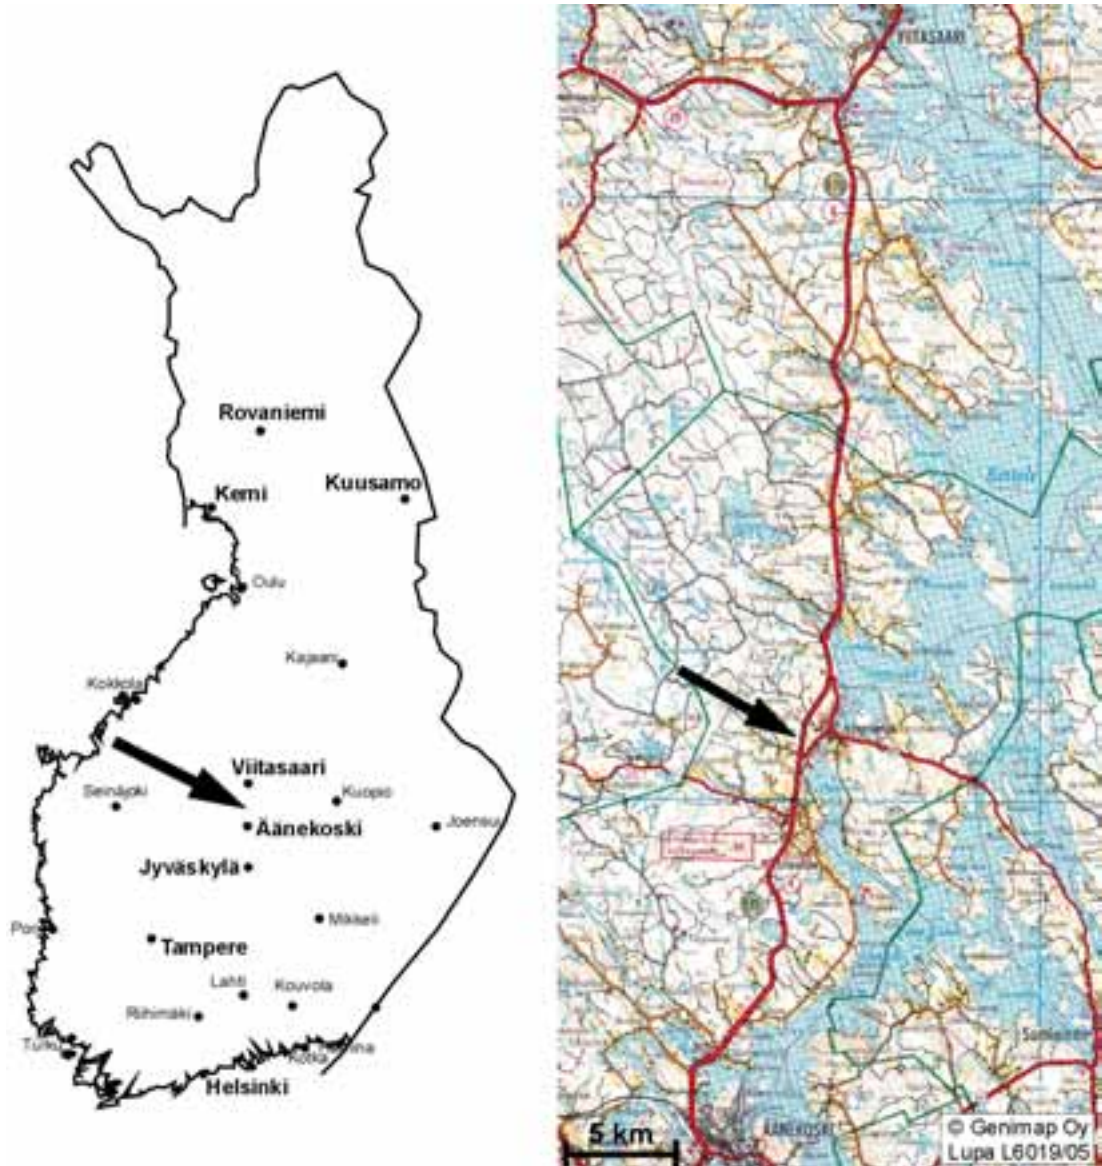
Figure 1. The accident site

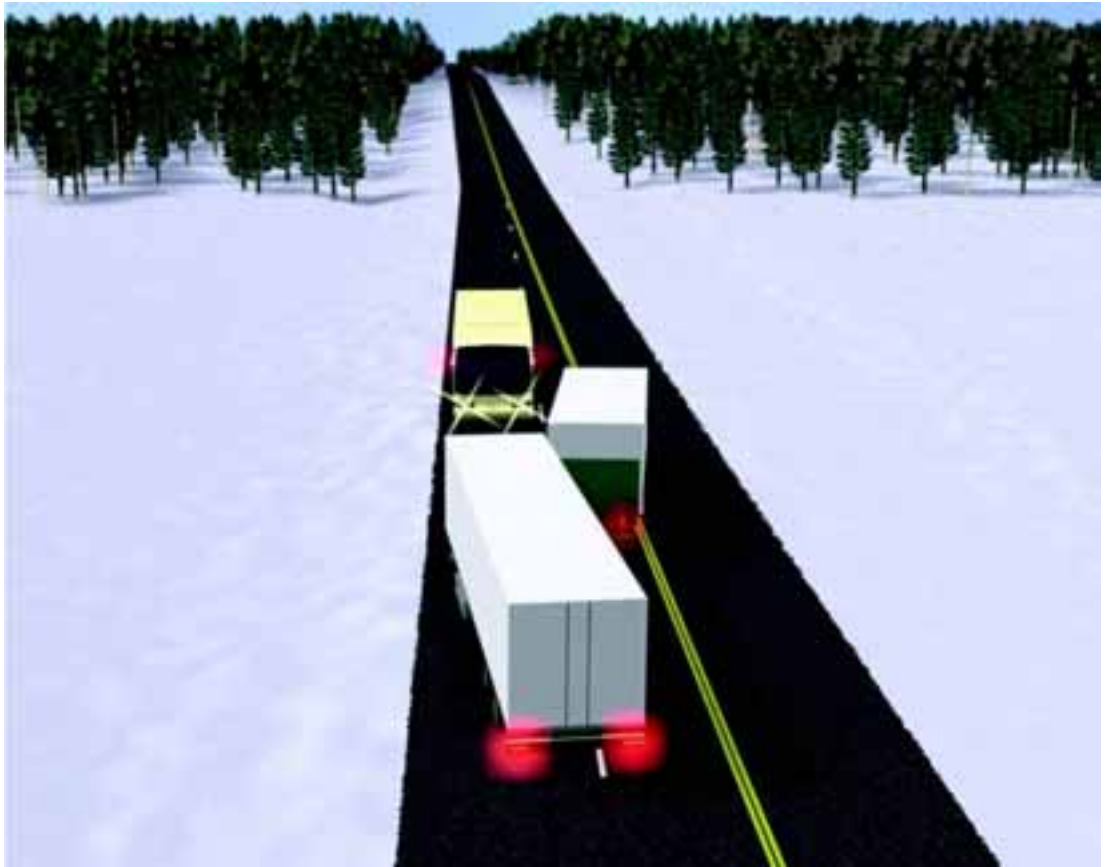
Figure 2. The investigation commission’s view of the vehicles’ relative positions immediately before impact.

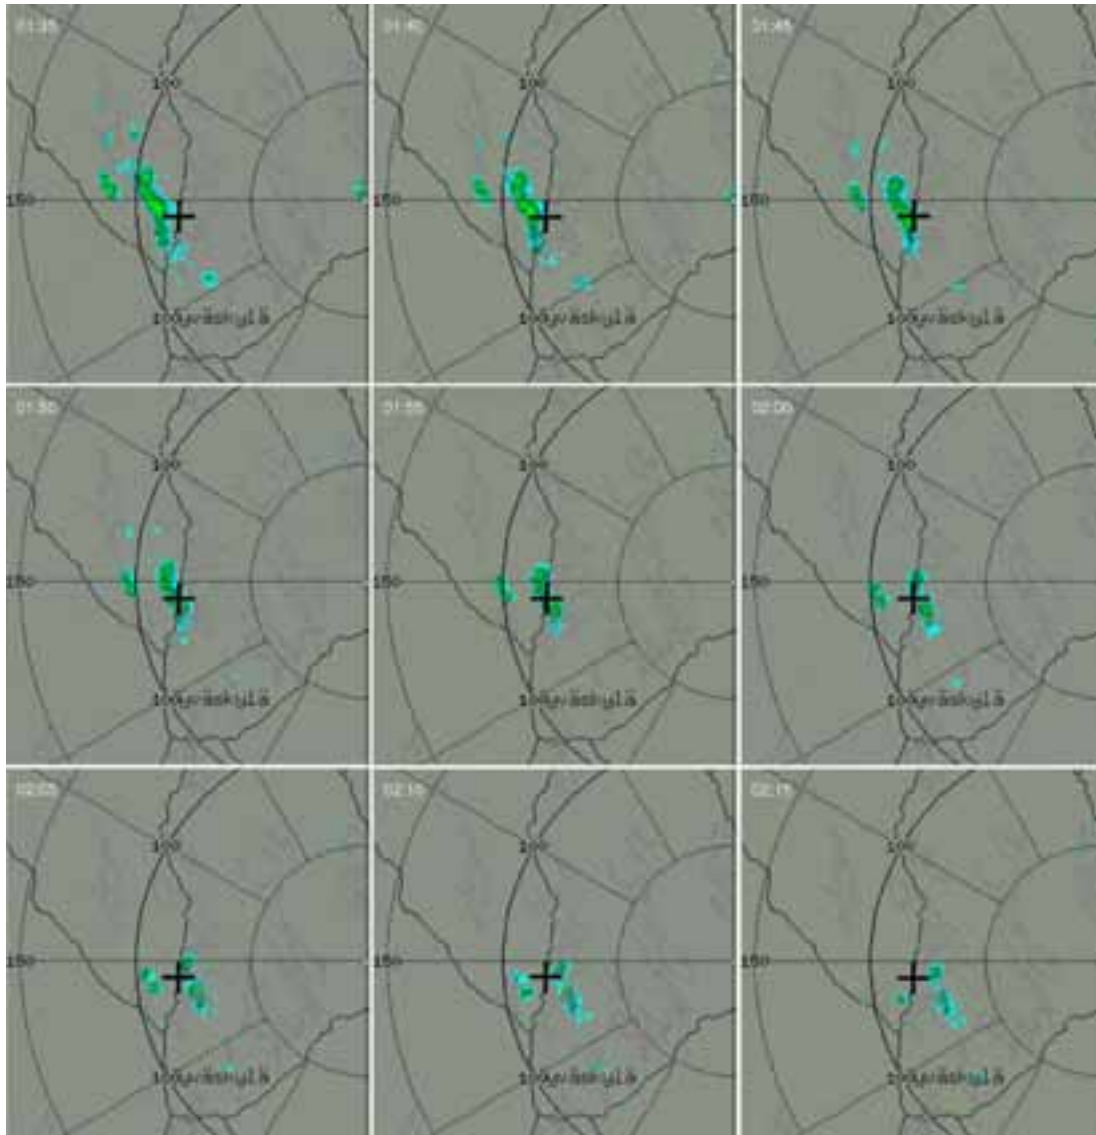
Figure 3. Partial doppler weather radar picture close-ups from the area where the accident happened. The cross marks the accident site.

Showers, partly wet snow or partly rain, had weakened but there was still enough precipitation to wet the road surface - at least in places. At the time of the accident, the road surface temperature was below dew point and, therefore, humidity was condensing on the road surface. Meteorologically speaking the road surface was either icy or frosty.

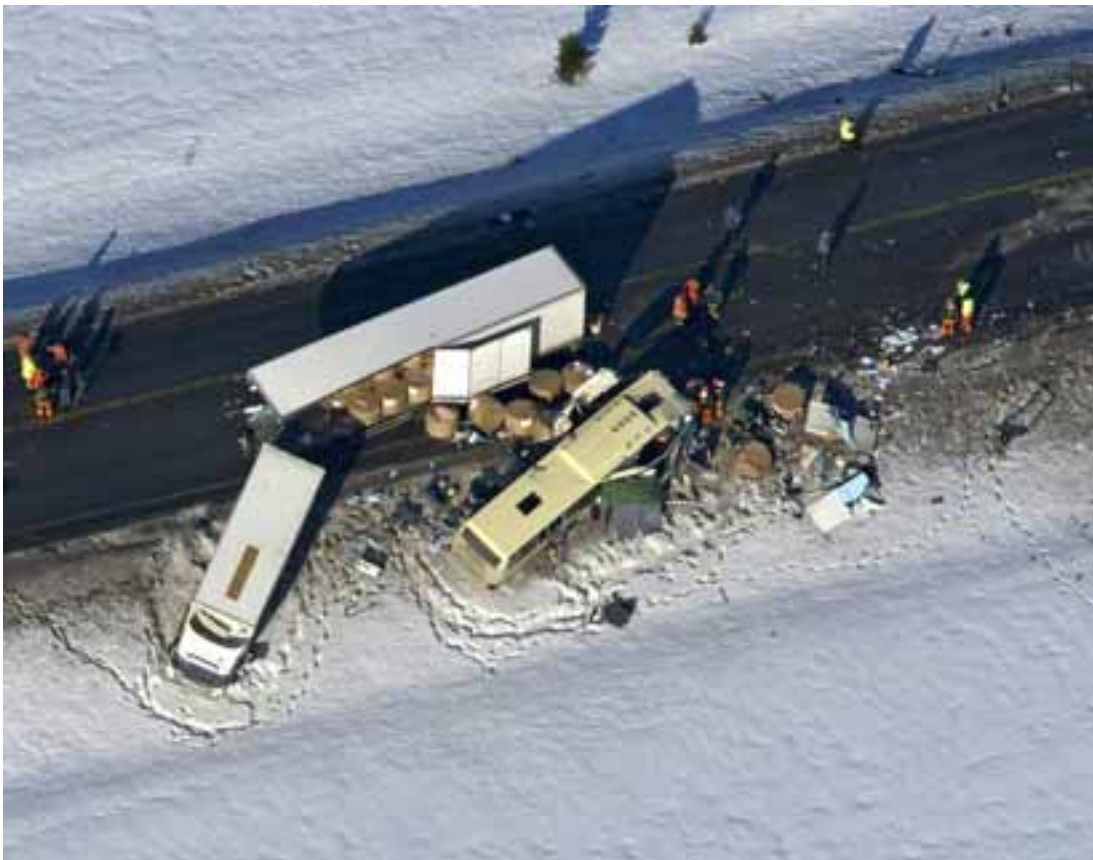
Figure 5. Aerial photograph of the accident.

slope in front of the point of impact and in front of the coach there were three paper reels as well as two side door panels that had been ripped loose from the left side of the trailer. One of the door panels had split into two. Six paper reels were resting on the road between the trailer and the coach.

The road tractor lay in the ditch approximately eight metres behind the coach, cabin forward. The rear of the tractor was at the edge of the asphalt. The front wall of the swap body was broken, pressed by the paper reels. The collision guards at the front of the swap body base had given way and as a result, the swap body had plunged forward. The paper reels had also bent the back wall of the cabin inwards.

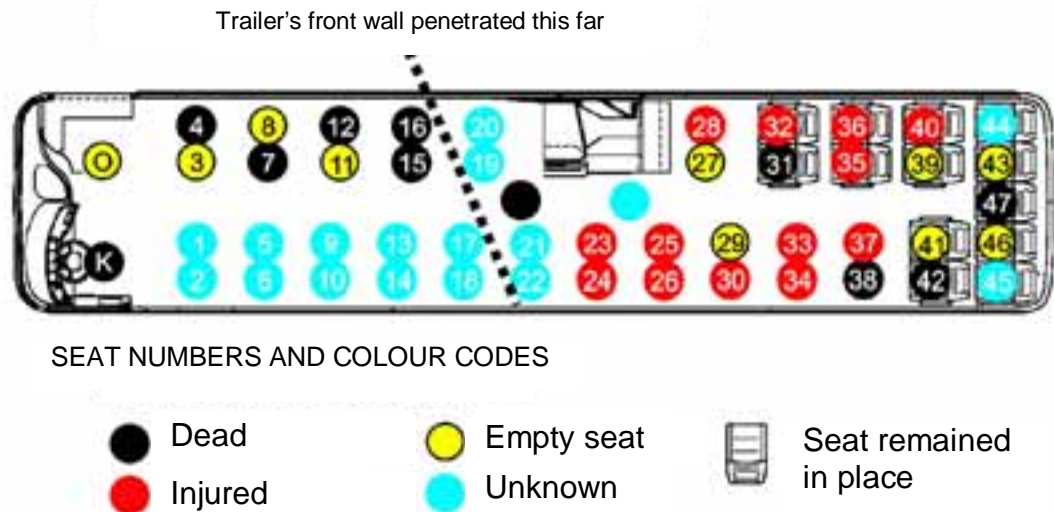
The driver of the coach as well as 22 passengers died as a result of their injuries. Of the 14 surviving passengers, all received various degrees of injuries. The penetration of the trailer's front wall and paper reels into the cabin compartment increased the number of casualties and exacerbated the severity of the injuries. The toilet in the middle of the cabin compartment stopped the progress of the trailer's front wall and prevented the paper reels from advancing into the rear of the cabin. The passengers also sustained injuries from having been thrust into the cabin's inner structures as well as from the high forces of deceleration (g forces) that prevailed during the collision. Every seat in the coach had a seat belt but no one used them.

Figure 9. The position of passengers inside the coach at the time of impact.

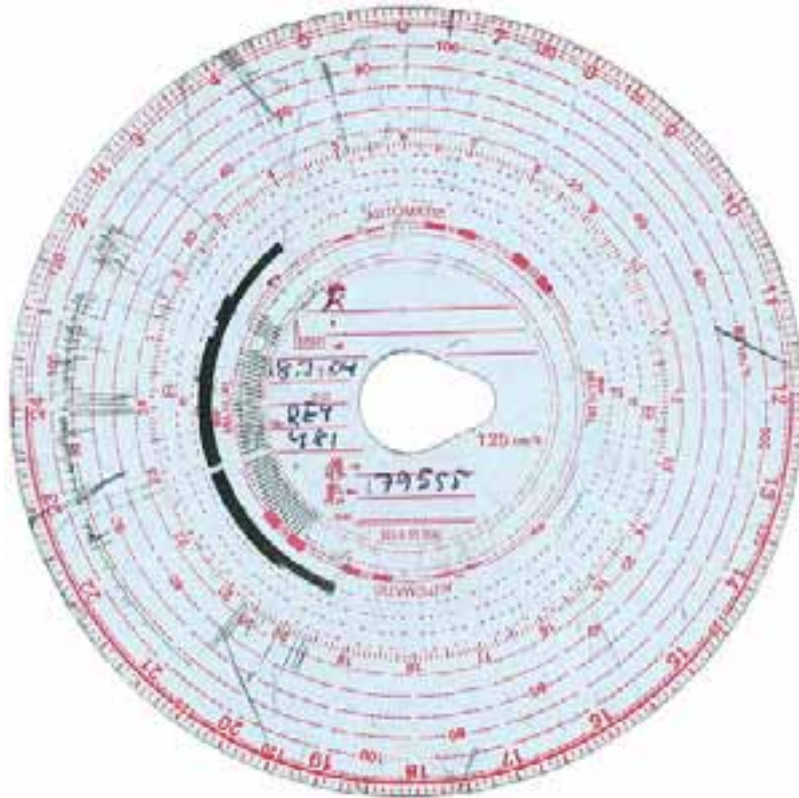
The tractor's tachograph was a BLU-8-125 DUAL. The name of the driver, the route designator "Helsinki", the date 18.3.2004, the odometer reading 179 555 and the licence plate number REY-481 were written on the face of the disc.

Figure 10. The tractor's tachograph disc.

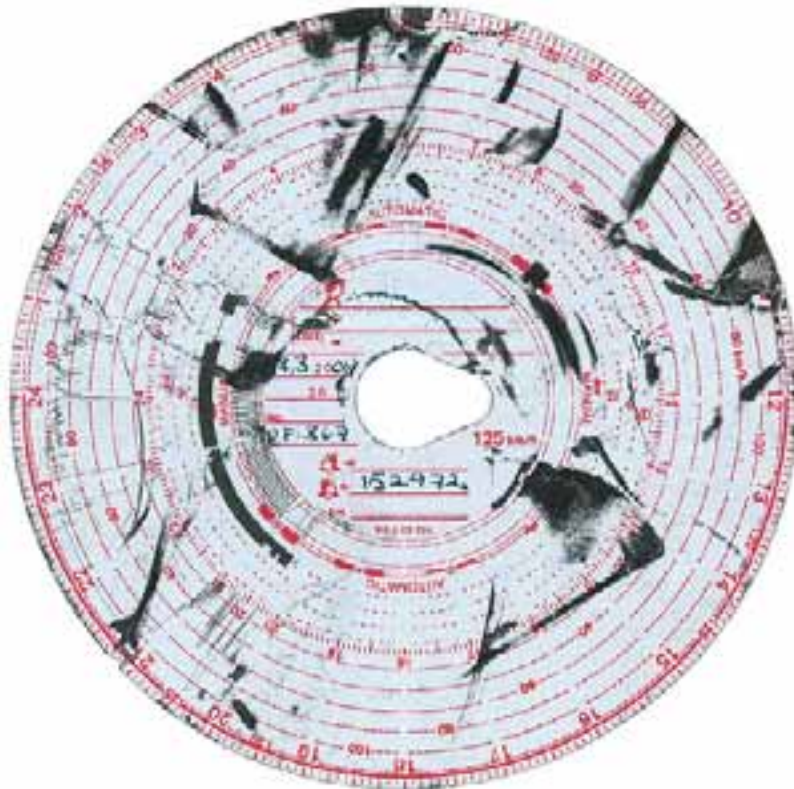
Figure 11. The coach's tachograph disc.

The coach's tachograph was a BLU-8-125 DUAL. The name of the driver, the route designator "Vantaa", the date 18.3.2004, the odometer reading 152 972 and the licence plate number IUF-867 were written on the face of the disc.

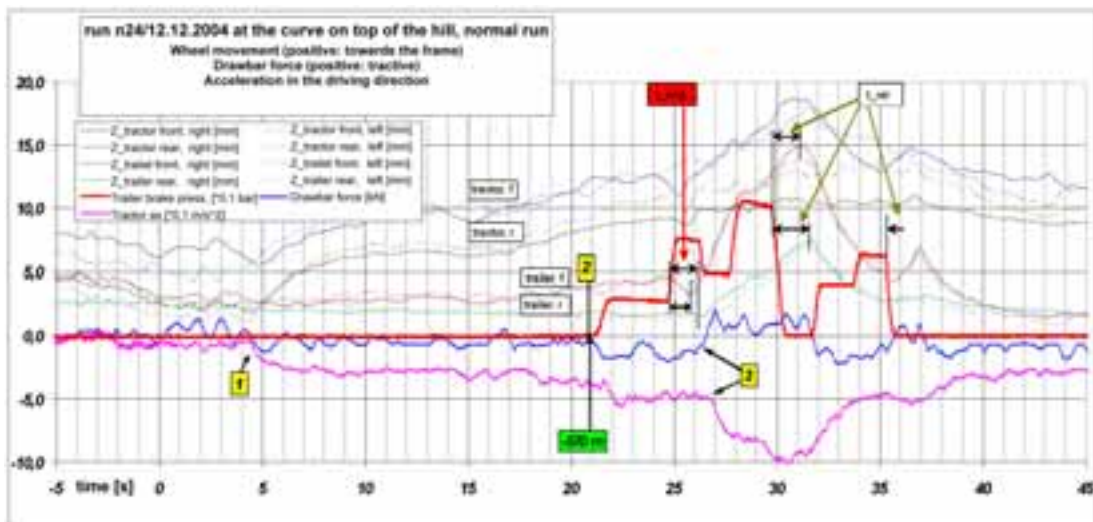
During the test runs both the brake lag and the release lag were measured (i.e. how much later the trailer begins to brake in comparison to the tractor and how much later the trailer stops braking after the release of the brake pedal). During the test runs (figure 13) brake modulation was light, as is generally customary in slippery conditions. When the measurement was taken the trailer’s brake chamber pressure was 0.7-1.0 bar. Timed from the instance when the brake chamber pressure exceeded 0.3 bar, the front axle brake lag measured at 1 s and the rear axle brake lag at 1.5 s, respectively. At the onset of braking, drawbar force pushed the tractor, at about 2 kN. The trailer brake release lag was 1.4-1.8 s. During the braking and the release the force on the drawbar was tractive, at about 2 kN.

Depending on the manner of braking on the downhill section prior to the accident site, forces on the drawbar varied. These forces, however, were very small (the scale of 2 000N, ca 200kp). The calculated lateral force (the so-called jackknifing effect) was only about 20N (ca. 2kp) because the maximum drawbar angle was only 0.4 degrees.

Figure 13. Measured brake lags and forces on the drawbar during test runs on 12.12.2004.

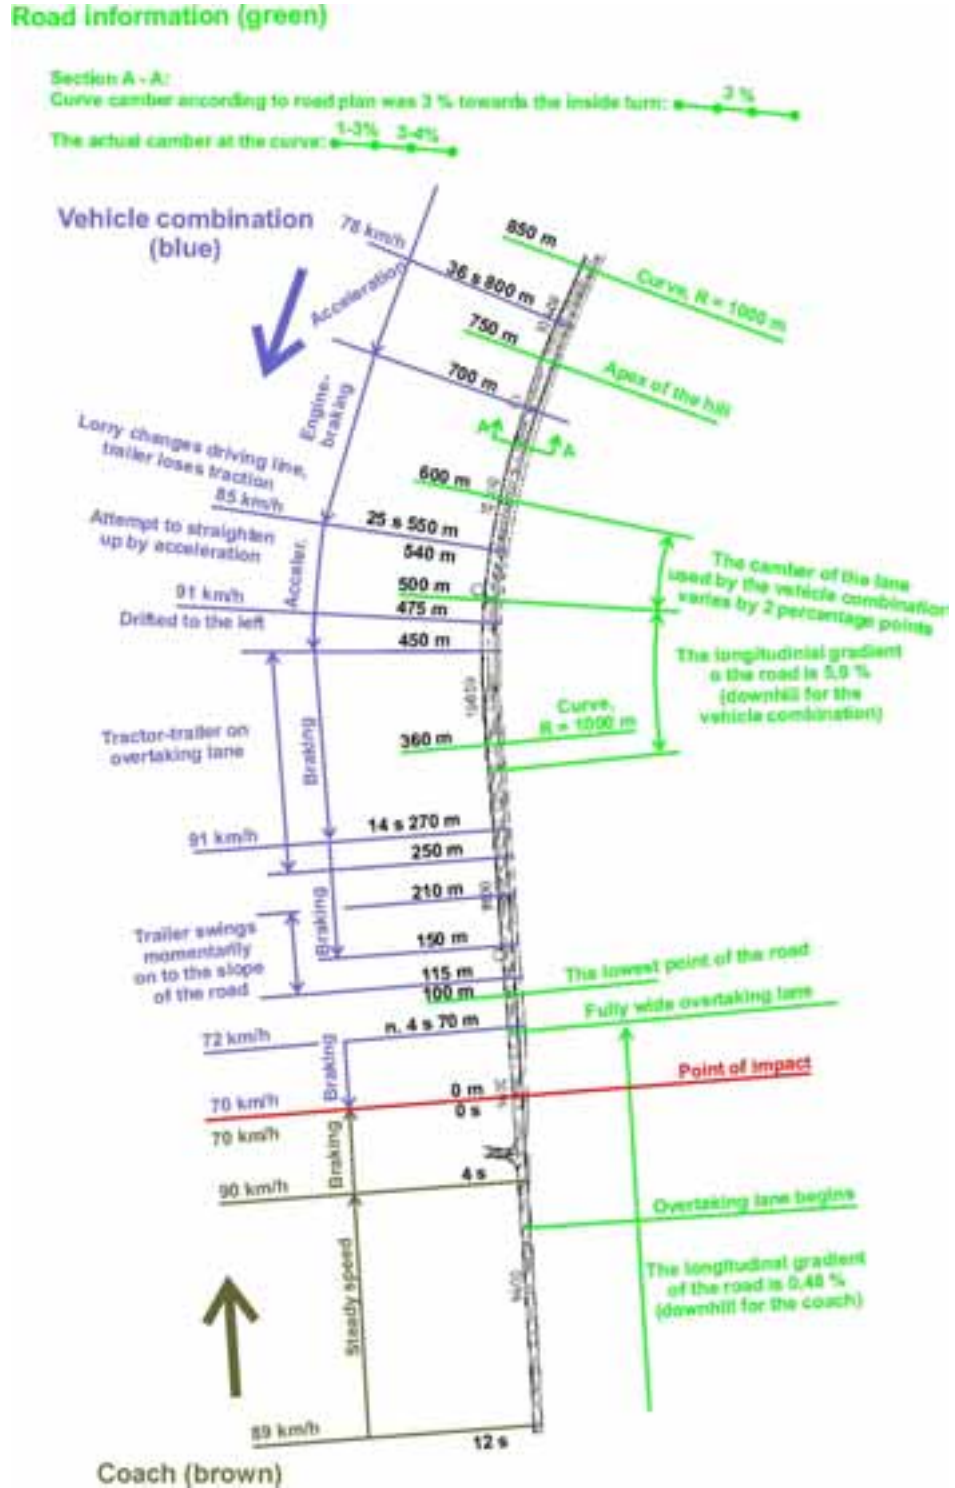
The loss of control has been analysed as a chain of events linking several different factors. The events are shown in figure 16, mirroring the section of the road. The left side of the figure lists the driving events, speeds, times and the distance measured from the point of collision. The right side of the figure details the road itself. Figure 17 contains the vehicle combination's driving dynamics graph for the final 1 600 metres augmented with event data construed from the commission's opinion of the accident.

Figure 16. Drawing of the section of the road at the accident site and the investigation commission's view of events.

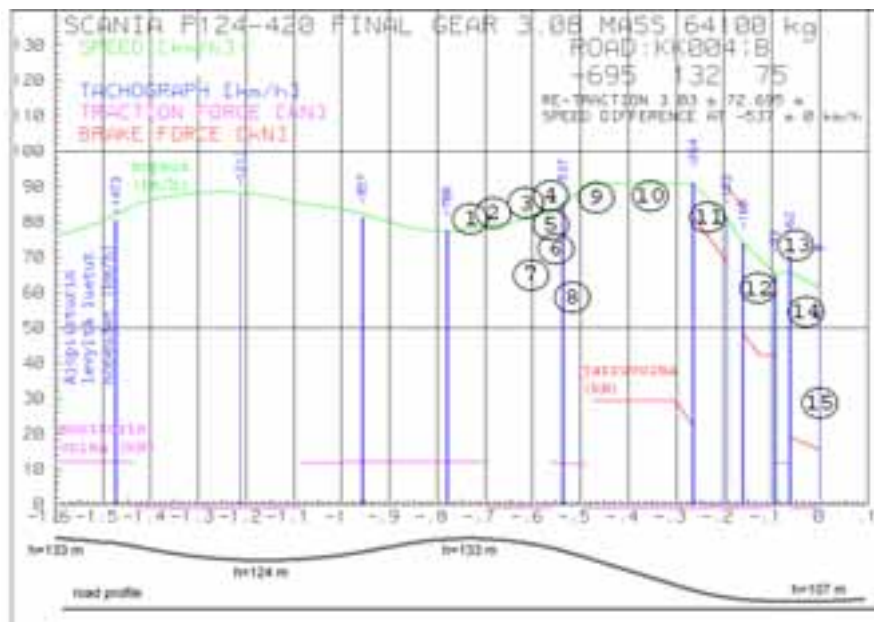
1. The highest point of the road (750 m from the point of impact)
2. Engine power on until this point, commencing engine braking (ca. 700 m)
3. The vehicle combination was either at the left edge of its lane or on top of the barrier line (ca. 600 m)

4. The driver saw the headlights of the oncoming vehicle and dipped his lights to low beam (600-550 m)
5. The driver steered the vehicle back from the left edge to the centre of the lane (600-550 m)

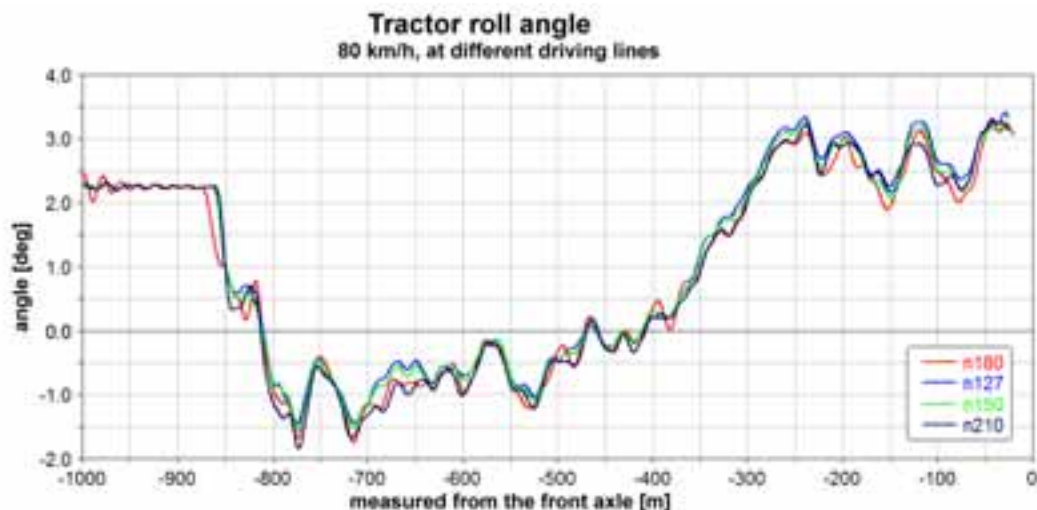
Figure 18. Positive angle = roll to the right. Coordinate 0 = point of collision.

Figure 18 graphs the roll angle of the tractor's frame. It shows that different driving lines result in different roll angles. However, large oscillations such as the ones at 750 m and

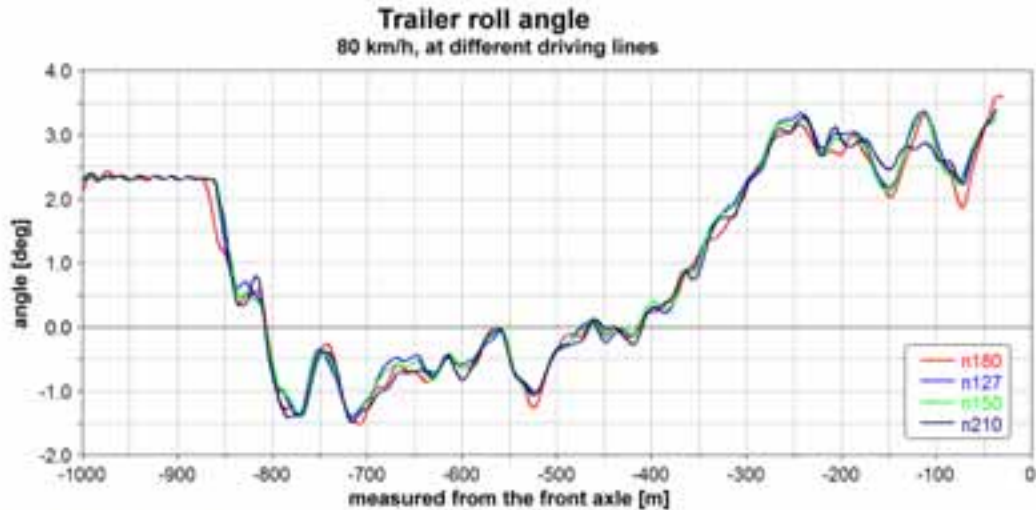
575 m are almost identical in different driving lines. The trailer frame's roll angle graph in figure 19 also demonstrates the corresponding result.

Figure 19. The trailer frame's roll in different driving lines. Positive angle = roll to the right. Coordinate 0 = point of collision.

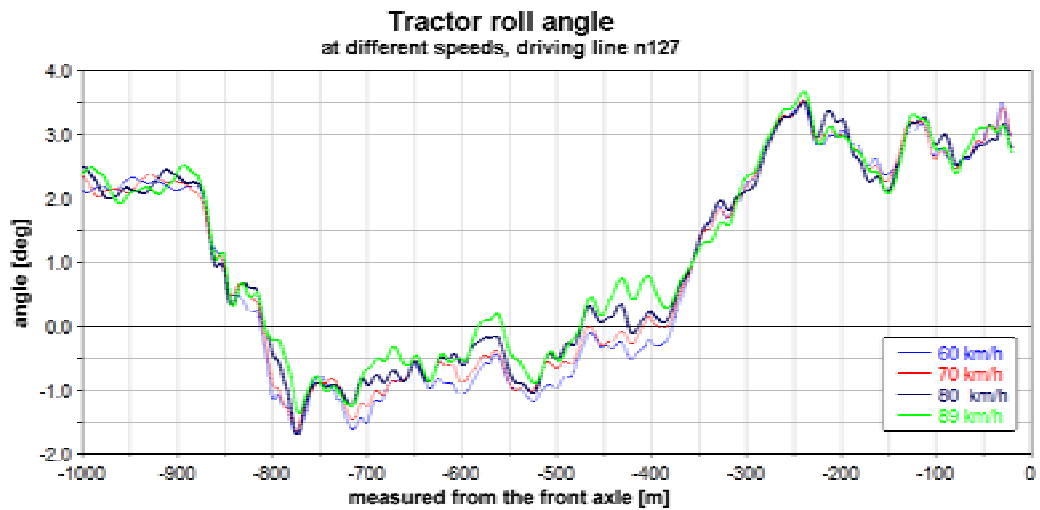
Figure 21 shows that changes occur in the tractor frame's roll as speed increases.

Figure 21. The tractor frame's roll angle at different speeds. Positive angle = roll to the right.

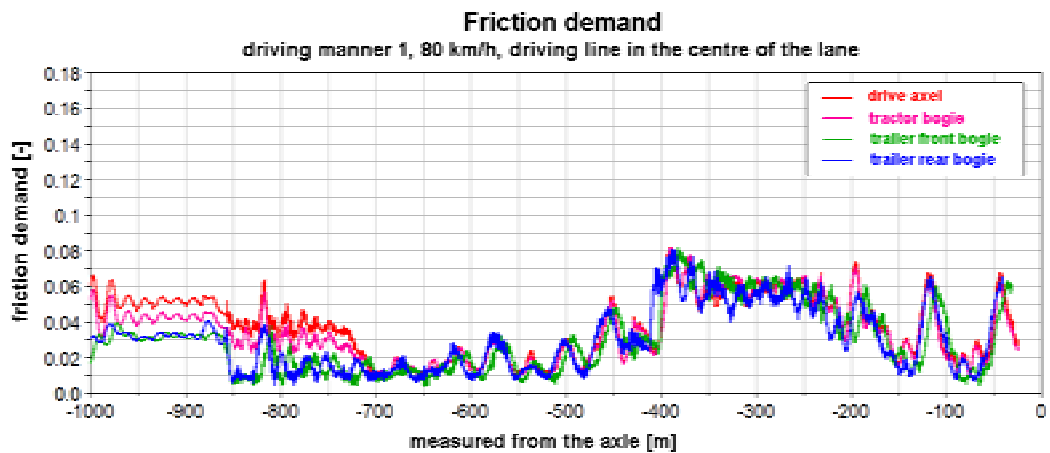
Figure 23 illustrates the friction demands on the tractor's drive axle and bogie as well as on the trailer's front and rear bogies during driving manner 1. The drive axle was observed separately so as to explore the onset of the critical drive traction zone. The bogie-specific friction demand, for its part, better depicts the friction demand required for turning, i.e. the steerability of the vehicle combination. The figure shows that for traction, the most critical phase is during the downhill braking, where the maximum friction demand is 0.08. On the uphill section, the tractor's drive axle is the most critical, demanding the maximum friction of 0.07. Friction required to complete the turn between 700 m and 500 m is fairly low, approximately 0.03.

Figure 23. Friction demand during driving manner 1 in the centre of the lane.

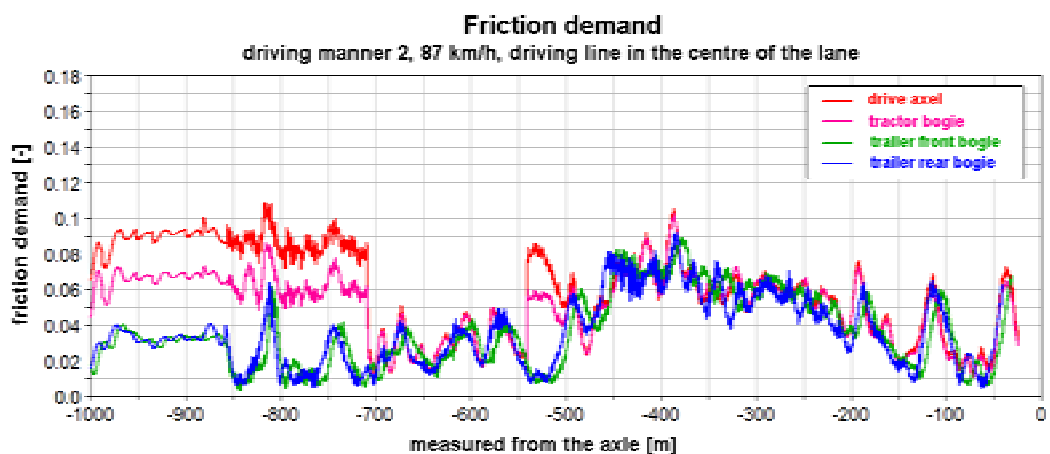
Correspondingly, figure 24 illustrates the friction demand during driving manner 2. It shows that when one attempts to maintain a higher speed the drive axle is most traction-critical on the uphill section. The friction demand at maximum is approximately 0.11. The same friction demand is experienced at the beginning phase of the braking. Based on this, had the friction been below 0.1, the driver should already have noticed the slipperiness when climbing the hill.

Figure 24. Friction demand during driving manner 2 in the centre of the lane.

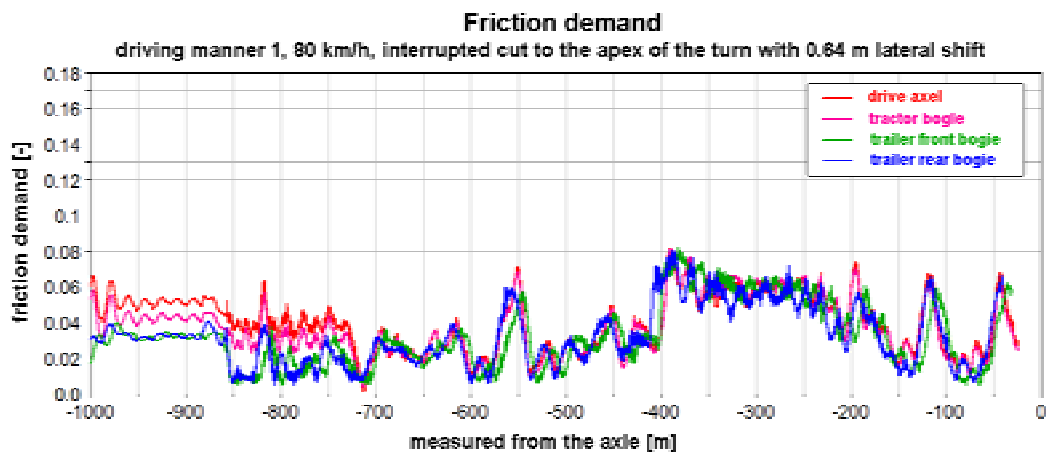
Via driving manner 1, friction demand decreases from 600 m onwards as one steers towards the centreline of the lane, i.e. as the driving line is made more gradual; figure 26. When the vehicle reaches the centreline of the lane one must countersteer in order to complete the turn. At this point friction demand shows a spike at 550 m.

Figure 26. Friction demand during driving manner 1 by interrupting a cut to the apex of the turn.

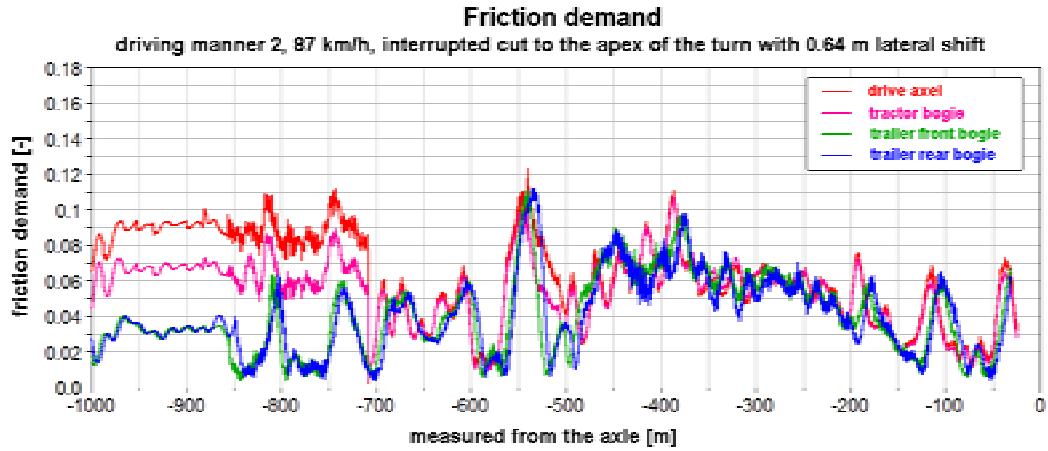
Figure 27 shows that due to the speed during driving manner 2 the spike at 550 m is clearly higher compared to driving manner 1. However, friction demand at this point is approximately the same as friction required for uphill drive traction.

Figure 27. Friction demand during driving manner 2 by interrupting a cut to the apex of the turn.

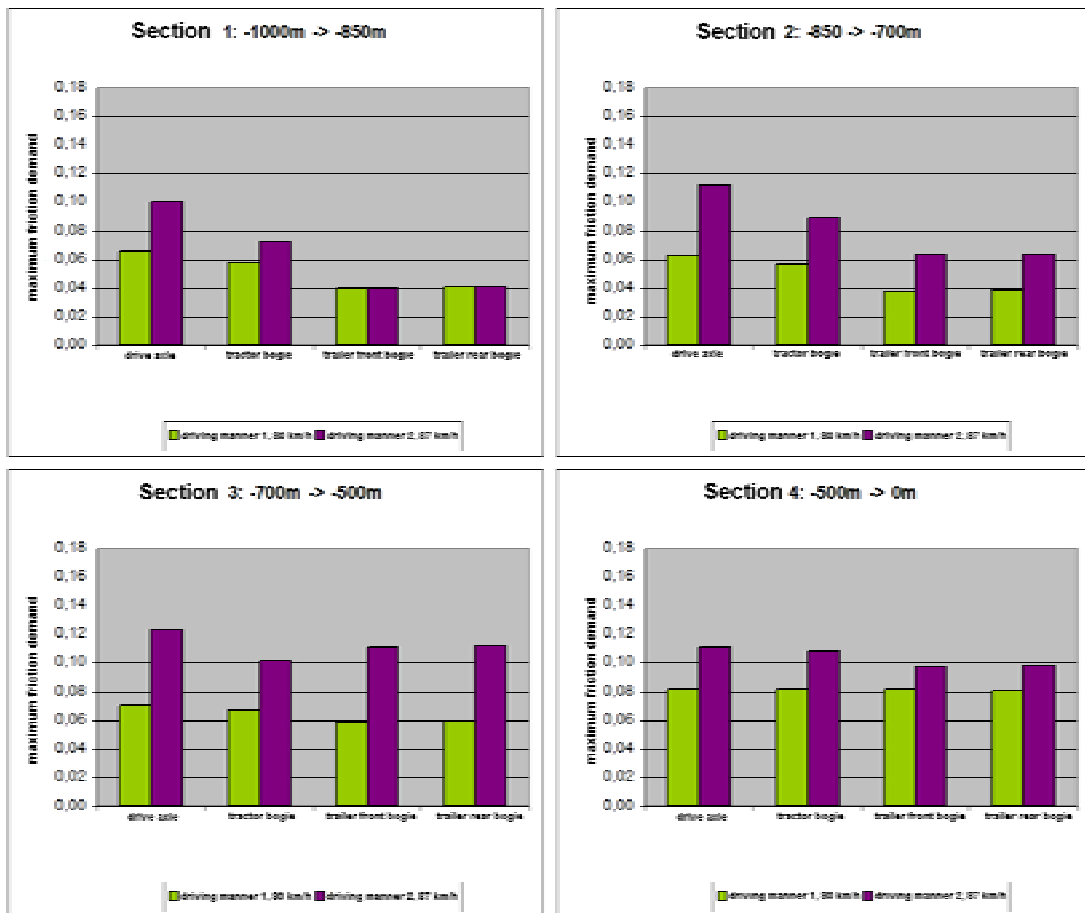
Figure 28. Summation of friction demand maxima on the different sections of the road when the cut to the apex of the turn is interrupted.

As one studies the friction demand maxima in figure 28 from the point of view of the vehicle combination's steerability, i.e. from the bogies' friction demand, the following is noticed: the highest friction demand 0.11 is placed on the trailer's bogies on section 3 dur-

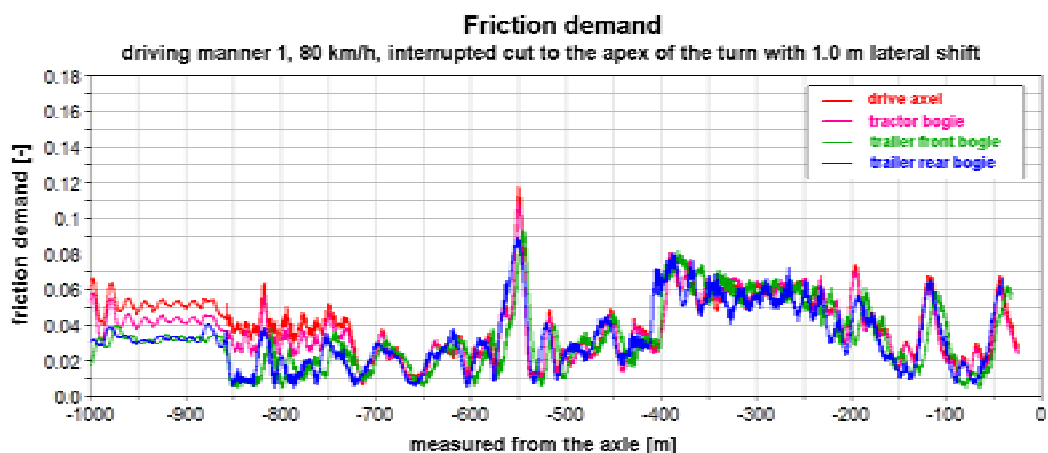
Figure 29. Friction demand during driving manner 1 by interrupting a one metre lateral shift cut to the apex of the turn.

Due to the more pronounced lateral shift, friction demand peaks at 0.12 at the distance of 550 m; figure 29. The bogies' friction demand at this point, too, exceeds the demand required by uphill drive traction.

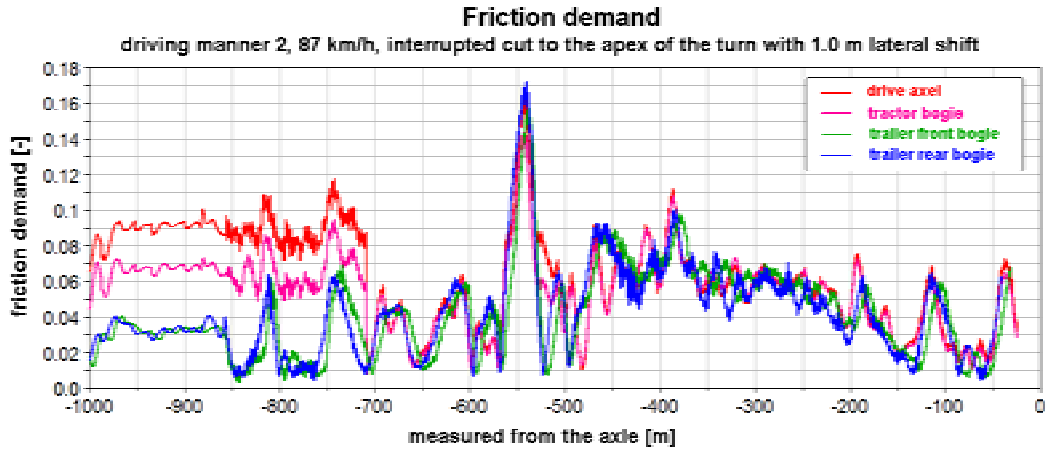
The effect of speed on friction demand is markedly accentuated on a driving line such as this one. Figure 30 shows that the maximum friction demand on trailer bogies is greater than the maximum friction demand on the tractor bogie.

Figure 30. Friction demand during driving manner 2 by interrupting a one metre lateral shift cut to the apex of the turn.

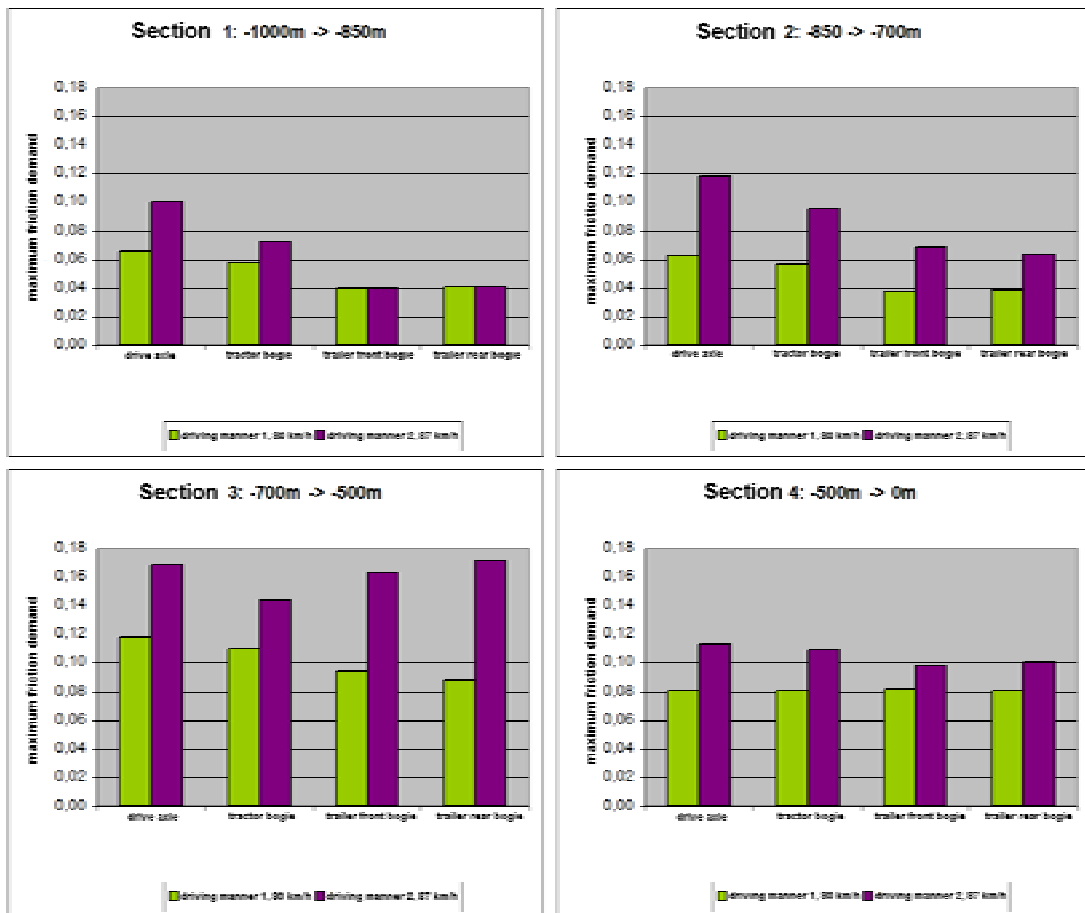
Figure 31. Summation of friction demand maxima on the different sections of the road when a one metre lateral shift cut to the apex of the turn is interrupted.

Figure 31 shows that the highest friction demand is placed on the trailer's rear bogie on section 3 during driving manner 2. Friction demand at the end of the cut to the apex

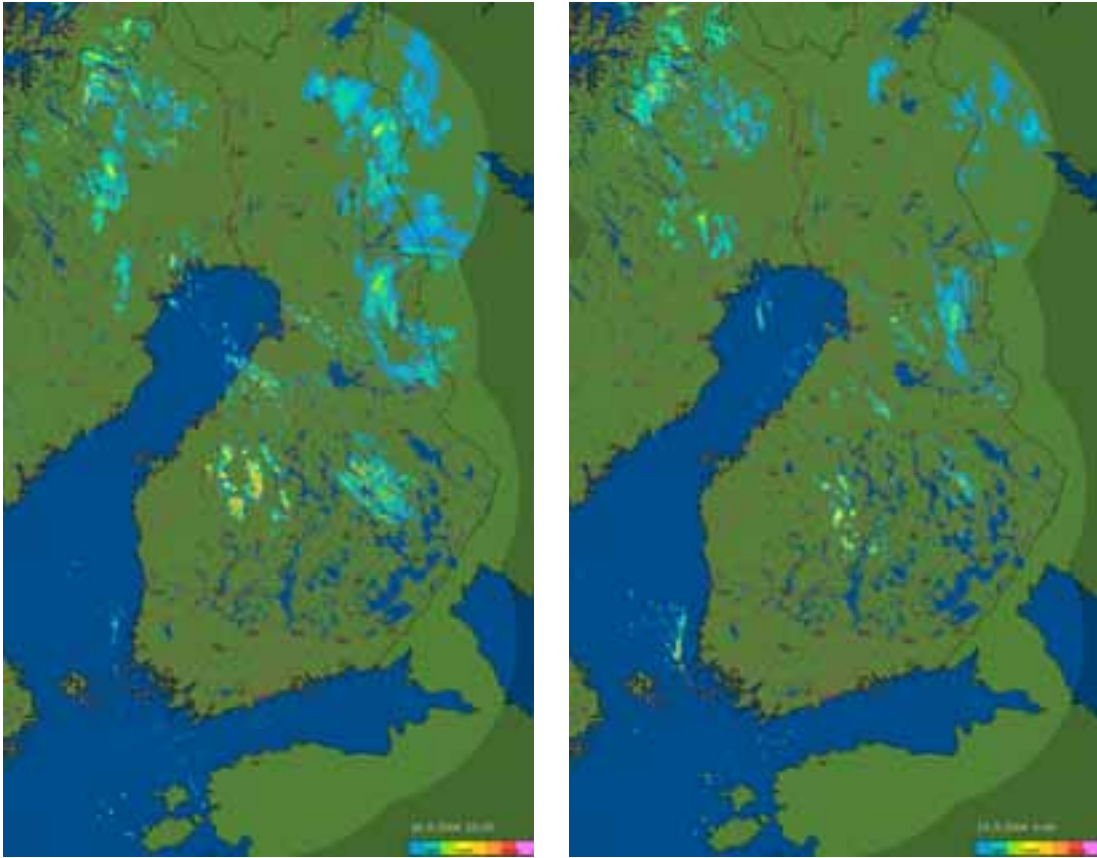
Local scattered showers formed in the Bothnia region moving east-southeast during the evening before the accident. The Finnish Meteorological Institute's doppler weather radar picture showed that the showers passed Kyyjärvi municipality at around 22:00. It rained at Konginkangas at around 23:00 but at that time the road surface temperature was above freezing. It is probable that the pavement dried due to traffic because the driver of the tractor-trailer held that, as he was on his way towards Viitasaari at around 01:00, the road was dry.

Figure 32. Doppler weather radar pictures at 22:00 and at midnight. Due to a technical malfunction the doppler weather radar picture was not updated after midnight.

The last updated doppler picture at midnight showed the next rain shower front close to Kannonkoski, some 30 km west-northwest from Konginkangas, moving towards the accident site. At that time the Konginkangas and Äänekoski road weather stations indicated that road surface temperatures were about one degree below freezing. The rain, extending about 10 km both north and south from the accident site, fell on highway 4 at around 01:30.
