Fire that resulted in the deaths of four people in a flat in Vuosaari, Helsinki on 9 December 2016

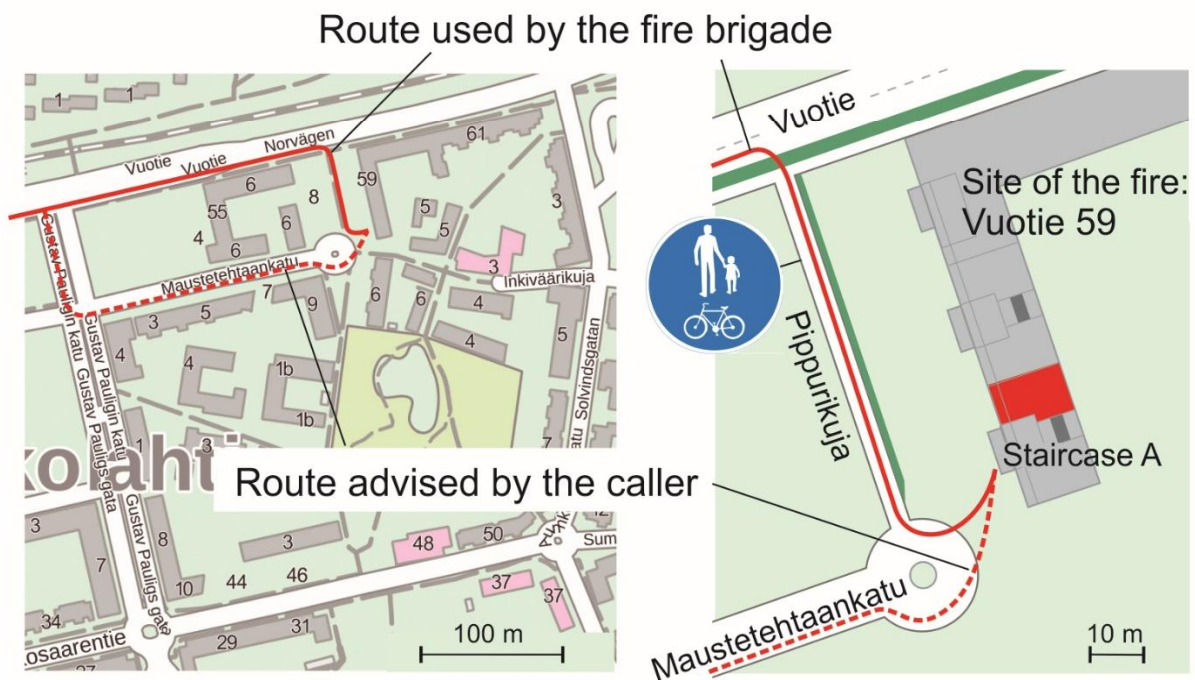
Kuva 2. A map of the fire brigade's driving route. In order to reach the site, the first rescue unit first crossed a lawn and continued along Pippurikuja, which is a combined cycleway and walkway. (Pictures: SIA, includes material from the National Land Survey of Finland's Background Map series 04/2017 and 05/2017)
