Investigation report

C 11/1997 M

**ms GRIMM, grounding outside port of Kotka, October 1,
1997**

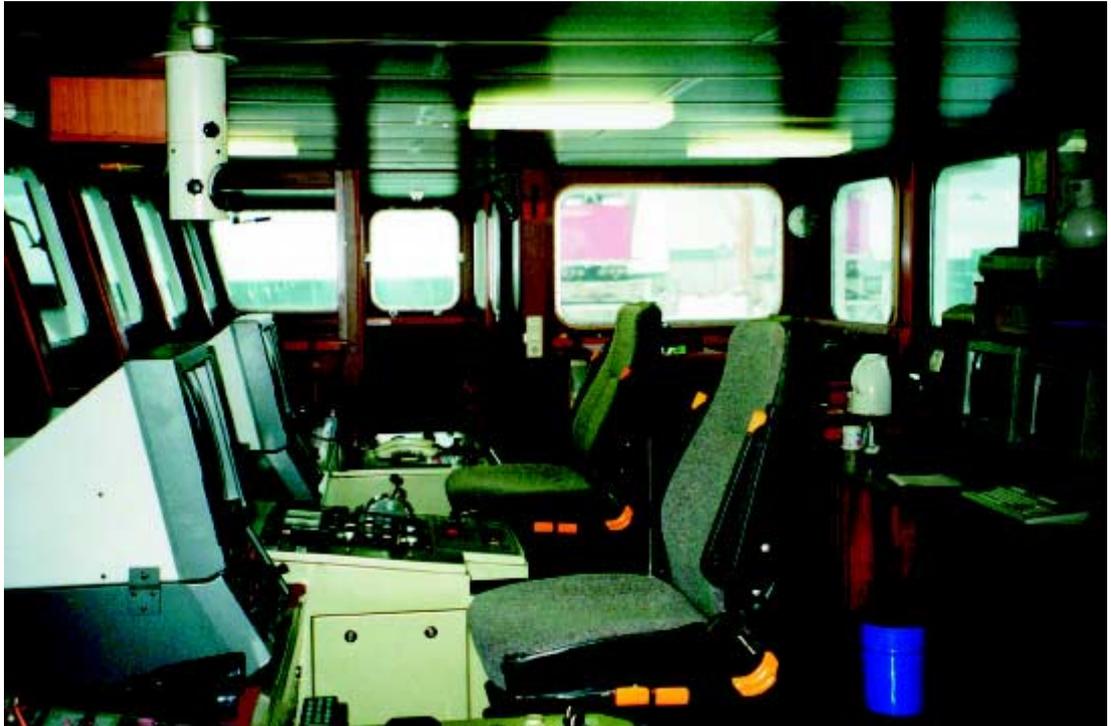
Figure 2. Bridge of ms GRIMM

The steering device was selected from the starboard steering place in the control unit of the TENFJORD rudder machine (Figures 6 and 7). The TENFJORD panel had a rudder angle indicator (Equipment 3 in Figure 7a and Figure 7b), but this was very small so it is probable that the indicator in the ceiling (Figures 8b and 2) had to be resorted to for piloting.
