Investigation report

B 2/2000 M

**ms FINNFELLOW, grounding near Överö in Aland, April 2,
2000**

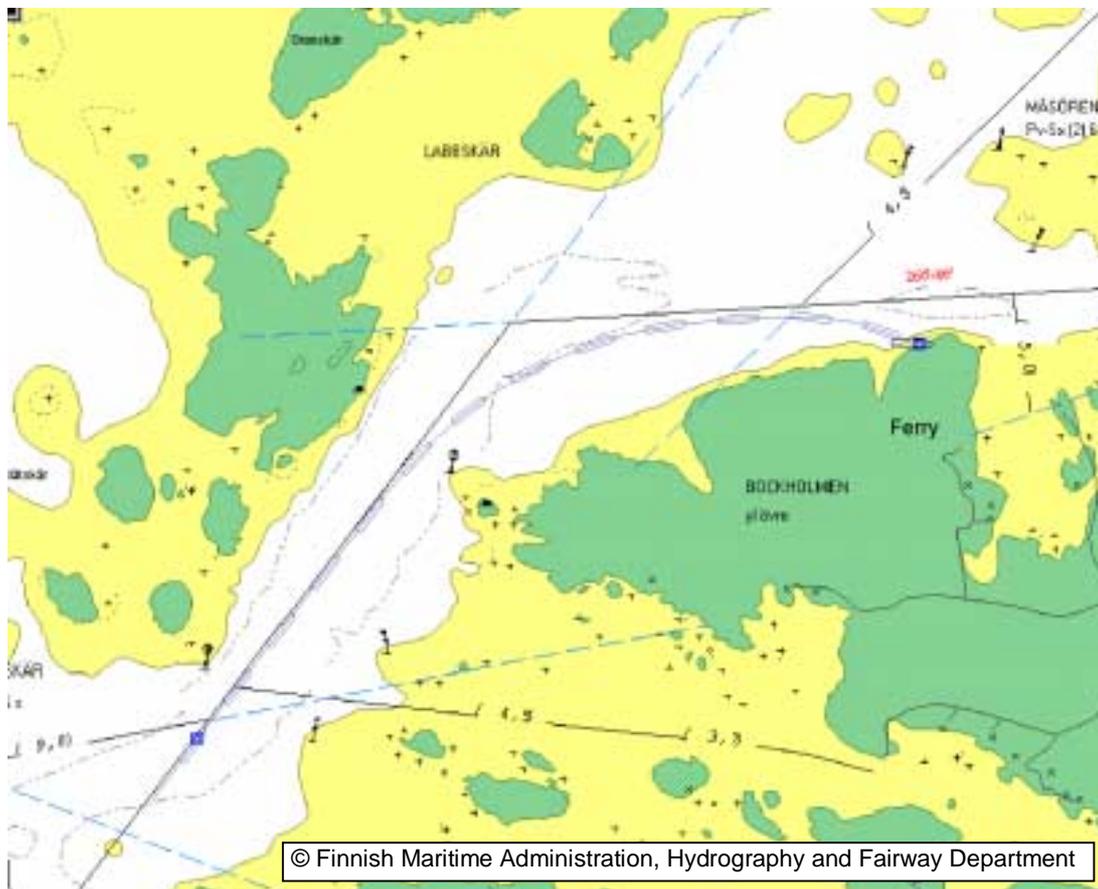
Figure 4 Reconstructed grounding of ms FINNFELLOW based on data registered on board.

The officer of the watch alerted everyone on the bridge that the vessel was about to impact with the shore. The vessel's speed had dropped to about 14 knots. The FINNFELLOW ran aground on the north shore of Bockholmen, in western Föglö (Figures 4 and 5). According to the officers on watch, two thuds were felt and the Överö harbour lights laid to starboard of the vessel's bow.

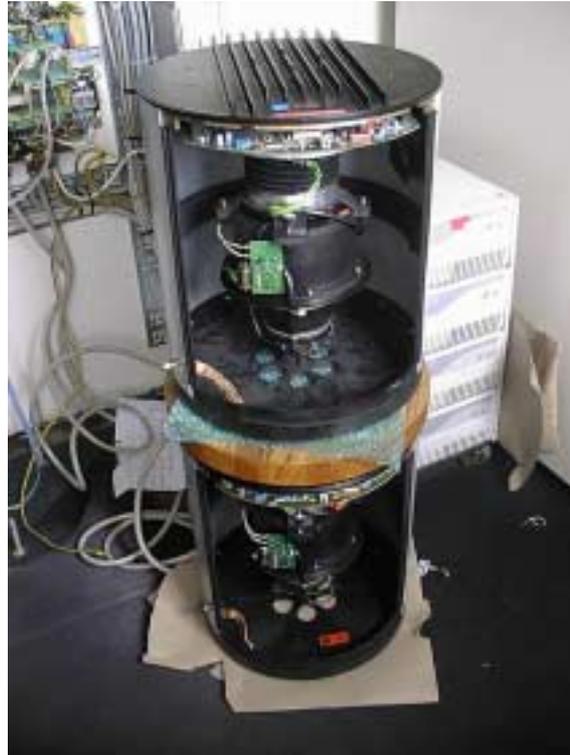
The gyrocompasses were placed on top of each other at the same angle in order to simulate the HEATING status (see Figure 13). Gyrocompass 1 was selected as the compass giving the heading.

The HEATING status of gyrocompass 1 was simulated by spraying cold spray on its fluid temperature sensor to cool it. When its temperature dropped, the message 'HEATING' appeared on the compass system control panel and the heading readings on the repeaters disappeared (three lines). No alarm sounded and the heading information remained on the autopilot and radar screens. When both gyros were turned the same amount during the HEATING status, no change could be seen in the heading information on the autopilot screen, which meant that the heading readings had jammed to the value they had before the HEATING status. When the temperature of the gyro fluid again reached again 45°C, the heading readings reappeared on the repeaters and the autopilot display was updated to show the correct heading information. The differential alarm between the gyros was activated every time the gyros were turned more than seven degrees during the HEATING status. The printout taken from the control unit after the grounding contained no differential-alarm activations. The differential alarm does not work at all during the HEATING status. It is possible to switch the gyro giving the heading during the HEATING status because the compass system does not interpret the HEATING status as an alarm. The crew on the bridge could not react promptly to the fault in the compass system because the crucially important sound alarm was missing.

Figure 13. Gyrocompasses on top of each other during testing in Turku.

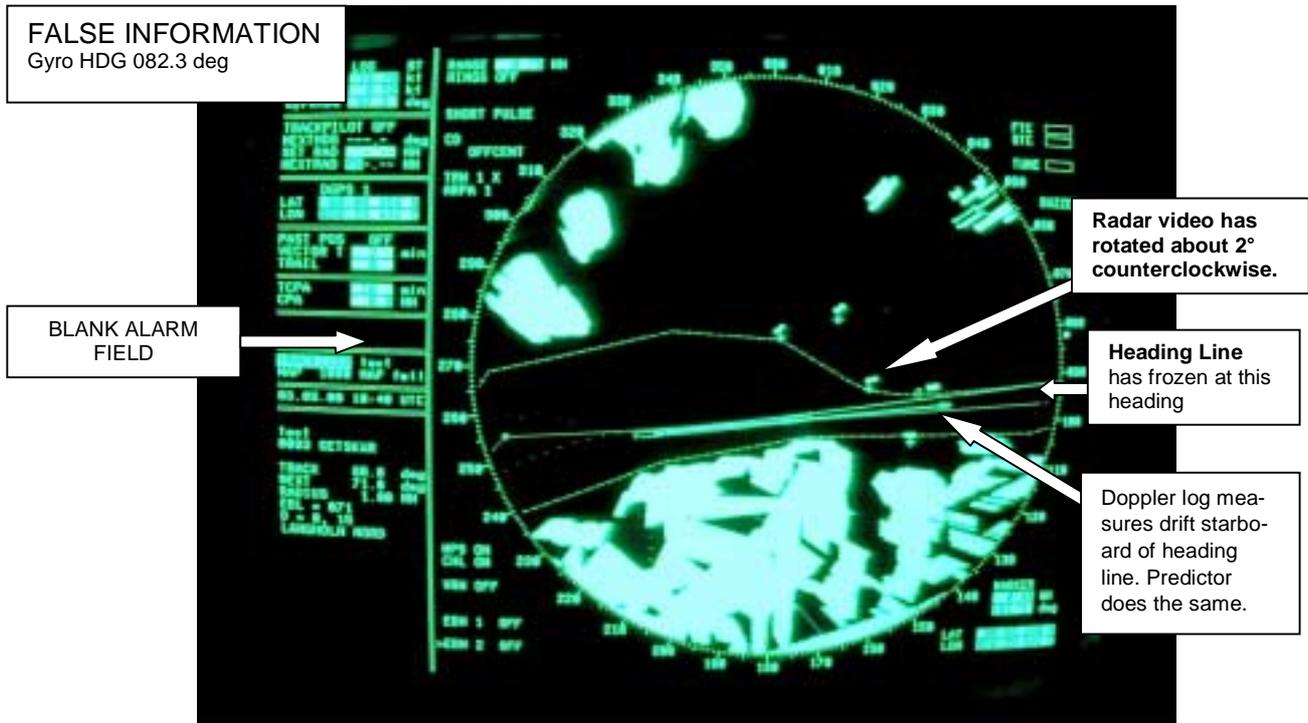
The turn is nearing its end in Figure 19. Curved Headline (CHL) has disappeared from the display. The lines connecting the waypoints have been included on the radar image. The radar video has rotated 2° anticlockwise. The IMO allows for an error of this magnitude in its performance standards for radars. The error is not yet detectable.

Figures 19 and 20 correspond to the situation when the gyro has been jammed at 82.5° for 15 seconds. The autopilot display NCC showed false heading information after the gyro jammed:

Figure 19. 15 seconds after the jamming of the compass. No report of the compass malfunction. Time of picture corresponds to 02:31:17 (UTC 23:31:17).

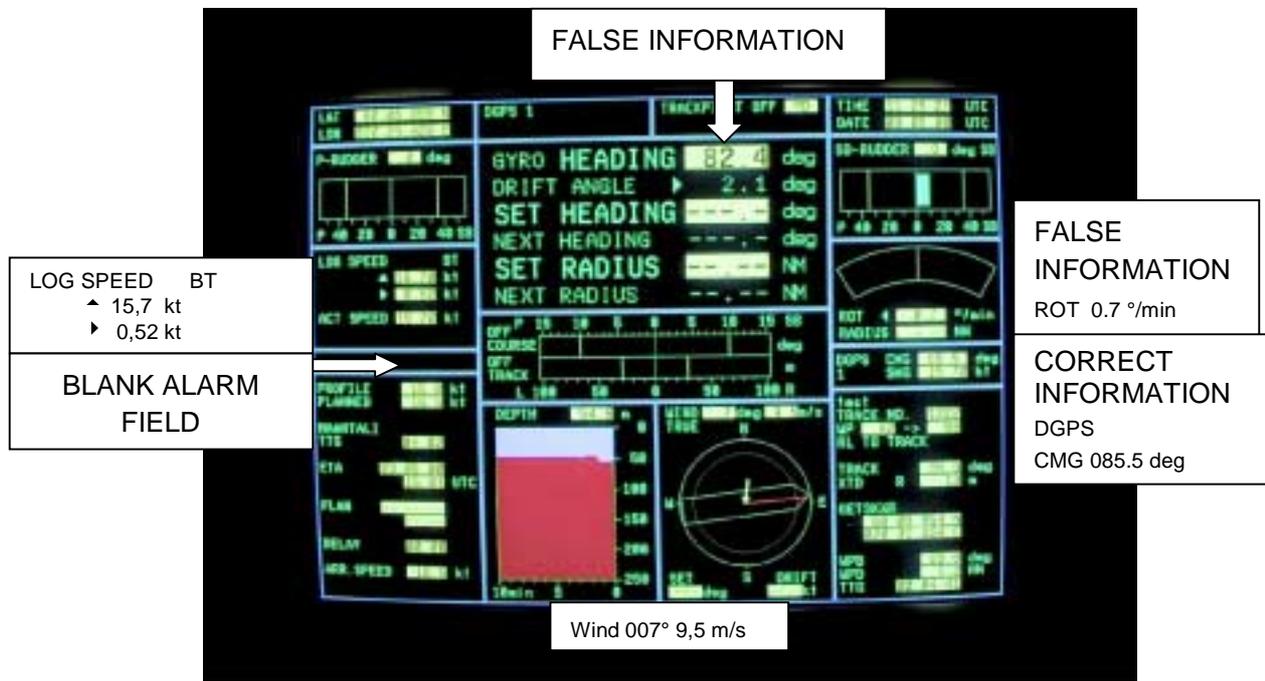
Figure 20. 15 seconds after the jamming of the compass. The picture corresponds to the situation in radar image 19.

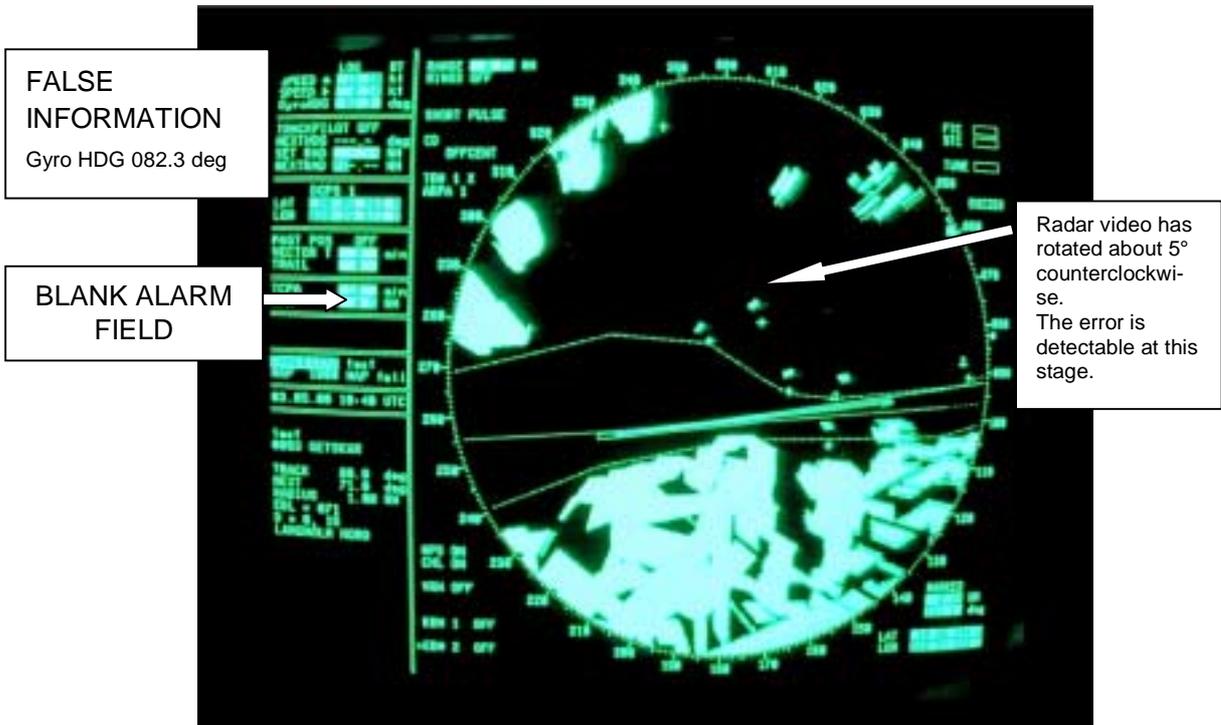
In figures 21 and 22 (30 seconds after the jamming of the compass) the true heading was about 5° starboard of the HEADING reading on the screen. The autopilot tried to turn to starboard to the requested heading 85° from heading 82.5°.

Figure 21. 30 seconds after the jamming of the compass. Time of the picture corresponds to 02:31:32 (UTC 23:31:32). Error can be seen.

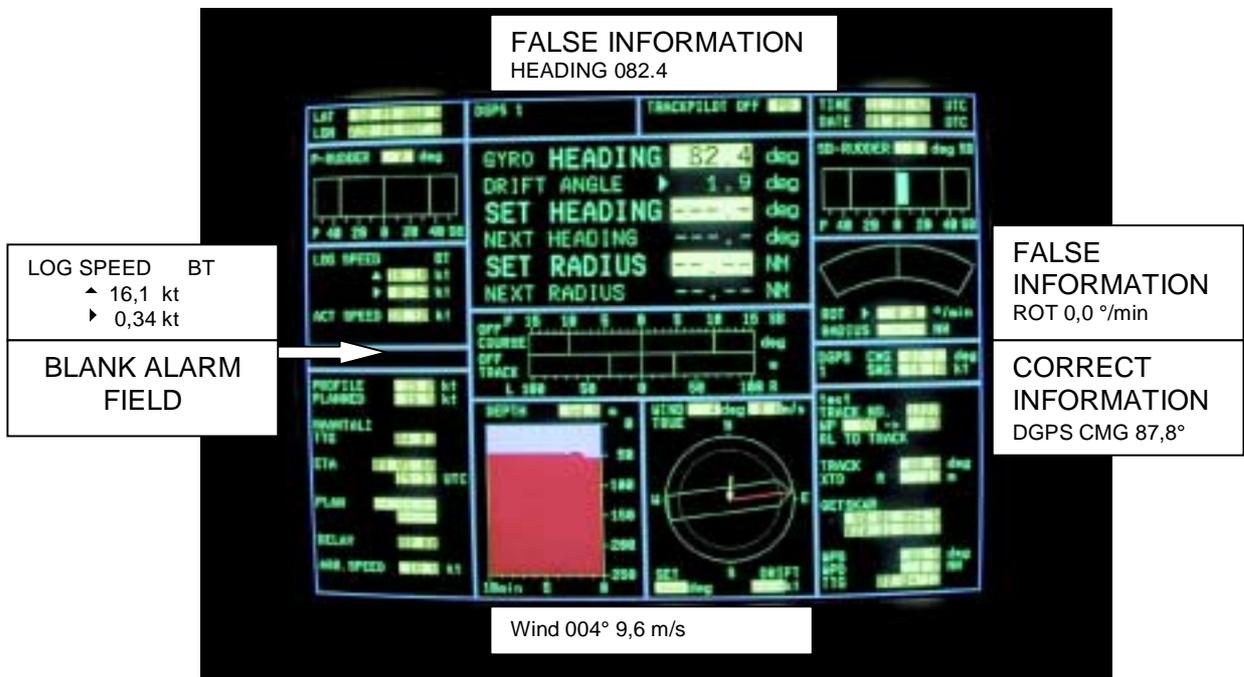
Figure 22. 30 seconds after the jamming of the compass. The picture corresponds to the situation in radar image 21.

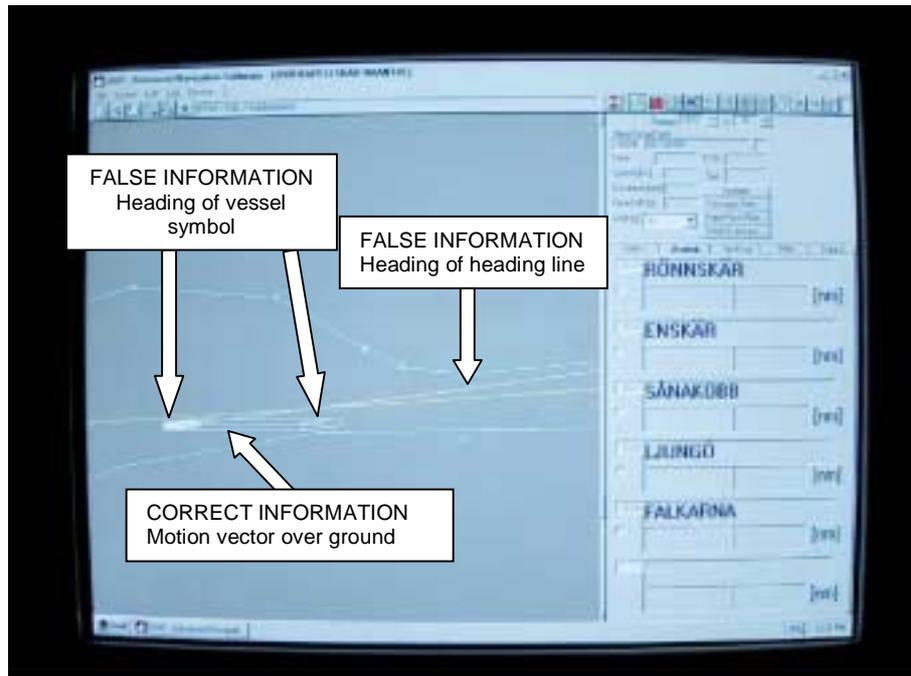
- The NACOS calculates motion over ground for the vessel based on the heading given by the gyrocompass and on the longitudinal and lateral speed from the doppler log. When the compass information is jammed, the drift is plotted based on the old bow heading, which is wrong. The heading line, motion vector and predictor are all wrong (Figure 23).
- The ANS calculates motion over ground for the vessel based only on the DGPS. The predictor, therefore, is not based on the compass heading but on the current tangent of the arc. The ANS cannot, however, display the prediction as an arc because the rate of turn is zero as it is calculated from the gyrocompass heading. The predictor shows the direction of motion for the vessel correctly. (Figure 25).

The ANS display gave a more realistic presentation of the actual situation than the radar screen. Figures 23 and 25 represent the same situation.

Figure 25. ANS display 45 seconds after the jamming of the compass. The picture corresponds to the time of figures 23 and 24.
