Investigation report

C 13/2001 M

MS TRADEN, incident caused by cargo shift in the Atlantic, October 19, 2001

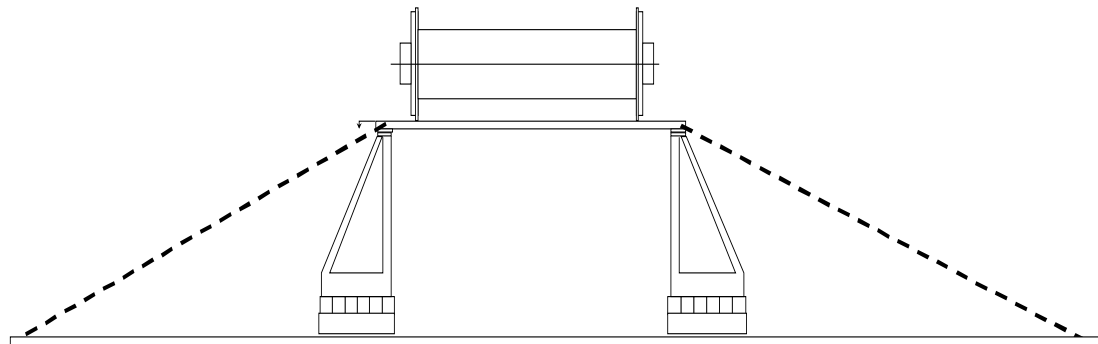
The Pendolino railway carriages loaded on the ship were supported on specifically manufactured trestles of about 1 m in height located below the carriage wheels, Figure 6. The carriages were lashed from their wheels to the trestle's upper beam, which was further lashed from both ends by chains attached inclined to the ship's deck. The leg of the trestle and the upper beam were connected by a twistlock, Figures 7 and 8. The twistlock connects a steel plate holding the upper end of the leg together, and a plate combining the two parts of the beam. The junction is rather flexible for transverse bending forces. The lower part of the leg lay on a wooden base consisting of non-fixed 100 x 100 mm bars of about 0.5–0.6 m in length. They were set crossways in two layers between the leg's lower end and the ship's deck. The lower end of the leg was not secured to the deck either. The only lashings to the deck were thus the sloped chains of the upper beam of the trestle.

The chief officer had prepared a stowage plan for the ship, according to which two carriages were to be stowed at bow and four sideways aft of them. This would have prevented effectively their possible transverse movement. However, the railway carriages could not be loaded according to this plan, except the two bowmost ones, because the carriages with trestles were wider than previously informed. The shipper gave the instructions for stowage and securing.

According to the interview of the chief officer, the supporting of the carriages was criticized from the ship's side, and rubber mats were proposed instead of the bars but the shipper required the above-mentioned support. This arises also from the protest written by the master on October 24, 2001.

Figure 6. Supporting and binding the Pendolinos to the TRADEN's main deck.

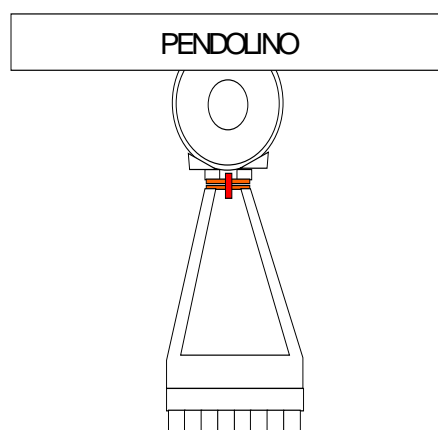
Figure 7. The junction combining the leg and the upper beam of the trestle.

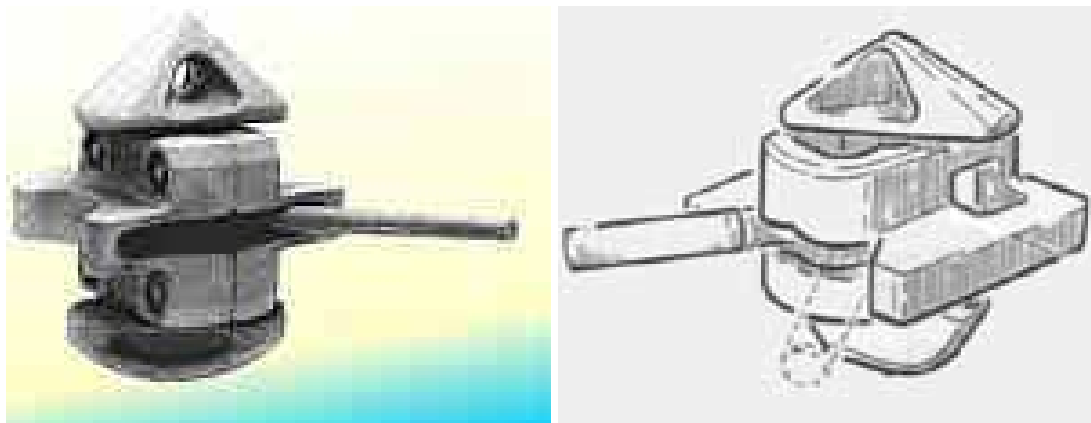
Figure 8. The twistlock.

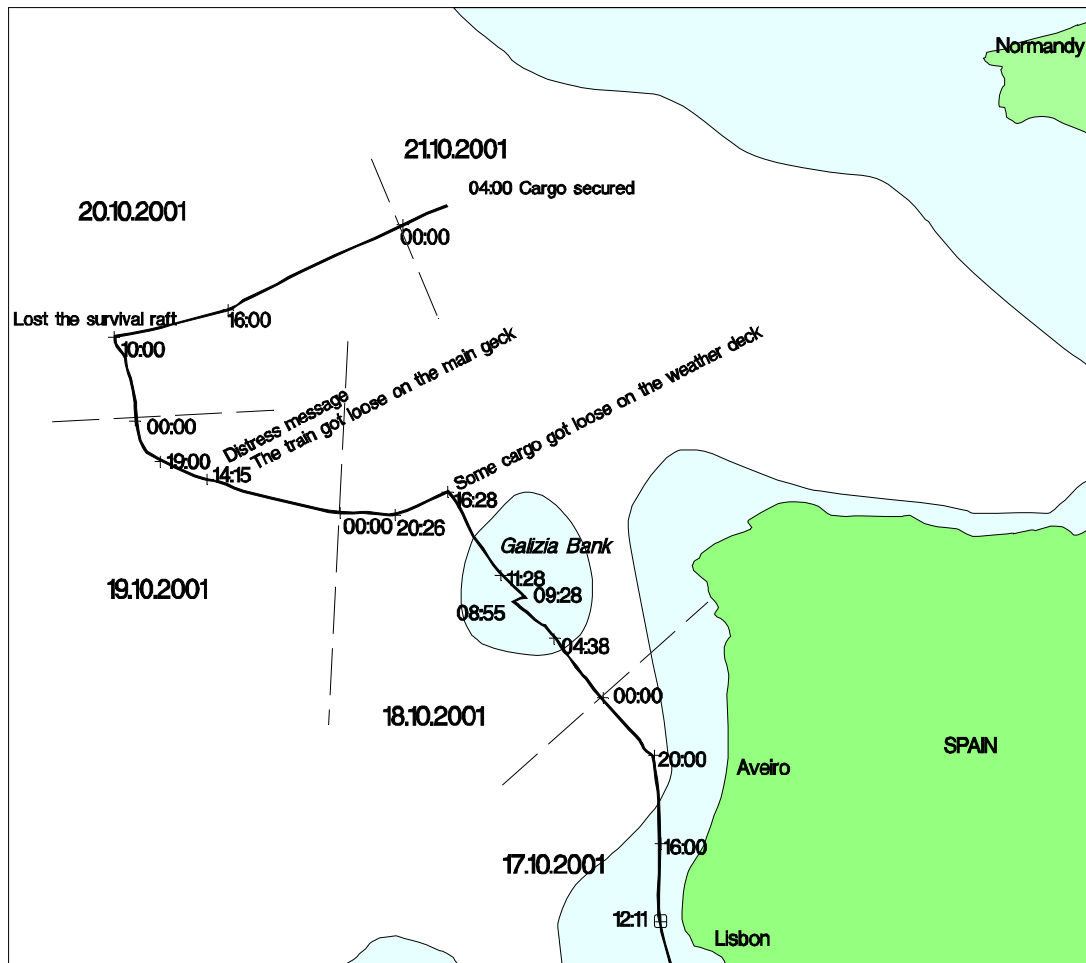
In Wednesday evening on October 17, 2001, the master stayed also at the wheelhouse in addition to the crew on the watch. The weather deteriorated further and the ship started to roll at about 20 o'clock. The master steered according to waves and turned towards north-west, Figure 10. During the small hours of Thursday morning, the ship was able to maintain a moderate speed but the speed varied between five and ten knots during the morning because the sea conditions were so rough.

Figure 10. TRADEN's voyage in the storm during three days in the Atlantic (UTC+2).

TRADEN started to roll in high swells at about 20 hours on Wednesday evening October 17. The heading had to be turned towards north-west, Figure 10.

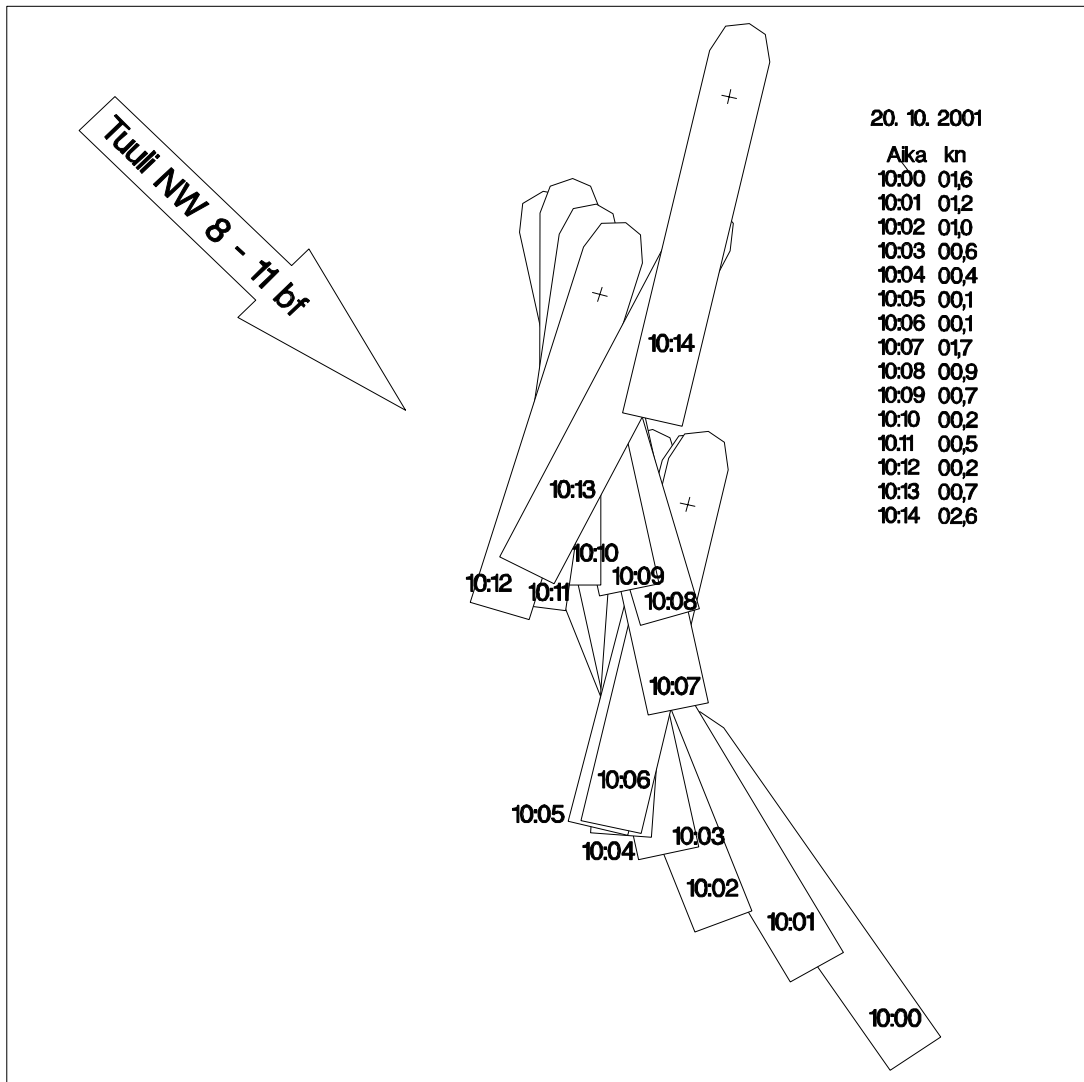
On Saturday morning, October 20, the entire crew began to feel exhausted³. It was first attempted to keep the TRADEN at heading 15°–20°, and the crew wore survival suits and stayed at the wheelhouse. At about 10 o'clock the crew members wanted to try to rescue with a raft to DOLE AFRICE, which was near the bow. DUNCAN ISLAND was on the right-hand side. The bow thruster was turned on during the launch of the raft. Ship's movements according to the Navi-Sailor back-ups during this instant are shown in Figure 11. A couple of waves filled the raft, the painter line broke and the raft was lost. Part of the crew wanted to try still with another raft but the master denied it. He wanted to save it to the last moment.

Figure 11. On October 20, 2001, between 1000 and 1014 a raft was launched and lost. The figure is compiled on basis of data recorded by the Navi-Sailor – program.

On Saturday, October 20, at 0200, it was tried to keep the ship at a list of 15°–20°. The speed was only 4–5 knots. At 0600 it was stated that the situation in the hold was unchanged. Between 1000 and 1014 a raft was launched but it was lost. DUNCAN ISLAND and DOLE AFRICA observed near by. Wind started to settle after this.

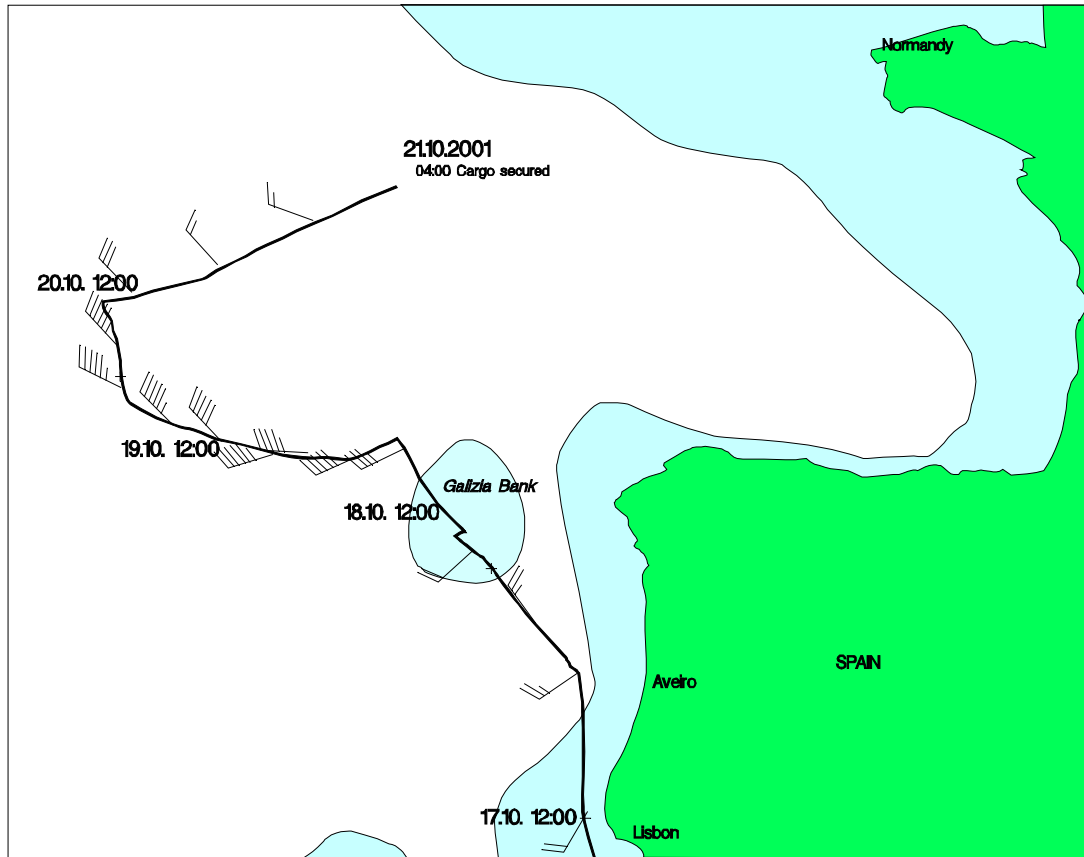
Figure 13. Summary of wind direction and speed according to TRADEN's log book on October 17 to 20, 2001.

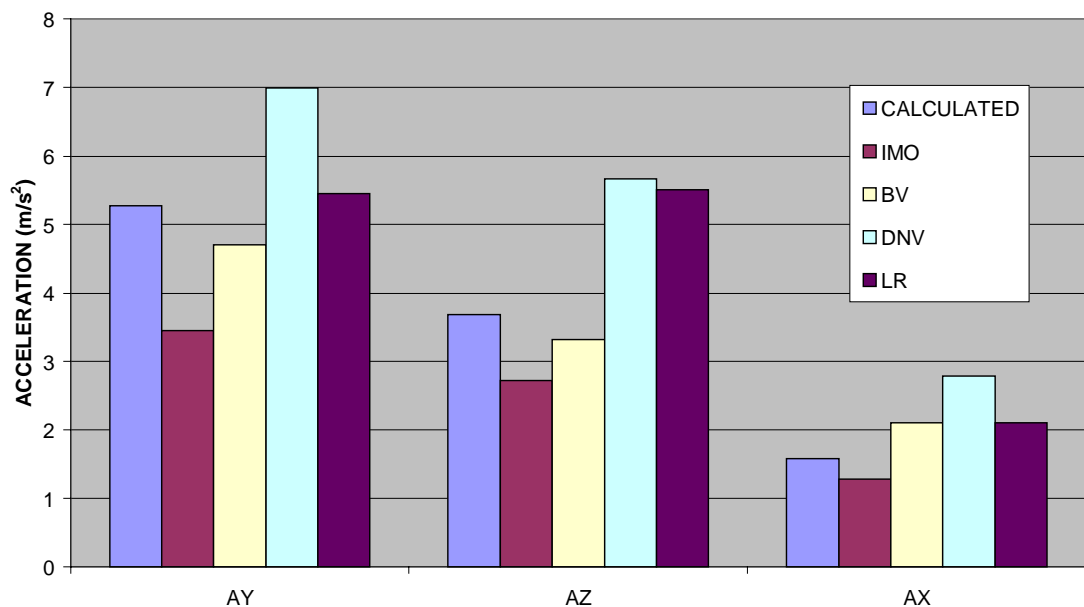
It can be observed from the results that the IMO accelerations were exceeded clearly in transverse and vertical directions and moderately in the longitudinal direction.

Classification societies have published guidelines in their rules to calculate motion quantities and accelerations. These were applied in the investigation at the centre of gravity of the aftmost railway carriage. Bureau Veritas (BV), Det Norske Veritas (DNV) and Lloyd's Register of Shipping (LR) were selected as objects of investigation. The rules differ in many details but their treatment is limited outside this work. Accelerations for the aftmost railway carriage are shown in Figure 20. Transverse and longitudinal accelerations lie quite close to the mean of values of classification societies, but vertical acceleration is smaller than the corresponding mean value. Location of the examined railway carriage near midship reduces in particular vertical accelerations compared with the bowmost railway carriage.

Figure 20. Comparison of accelerations in different directions for the aftmost railway carriage.
