## **Vesiliikenneonnettomuuksia ja vaaratilanteita Waterborne accidents and incidents**

MS ANTARES, MOB lifeboat falling into the sea in the port of Uusikaupunki,  
FINLAND, July 5, 2001

## **Investigation report**

C 6/2001 M  
Jnr. 397A/01

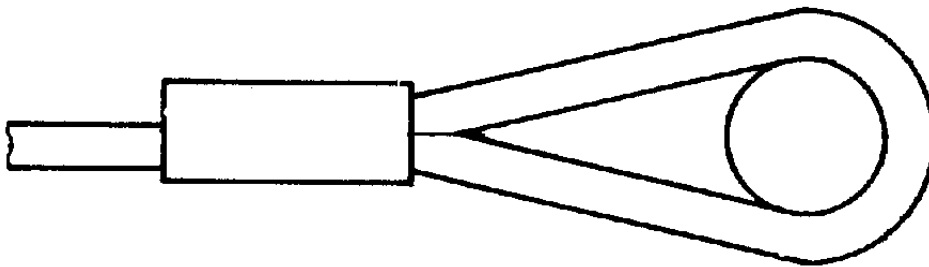
A talurite clamp (mechanical splice) was fitted to one end of the fall wire before it was installed on the MOB boat. The mounting of the talurite clamp was not done on board but by a company in Aarhus, Denmark on September 26, 2000.

Figure 5. Extract from Standard SFS 4759, Ferrules, showing a typical mechanical splice, talurite, ferrule (all three terms are used in this report).

The talurite clamp had a length of approximately 13 cms. The thickness of the clamp is unknown (the talurite clamp is missing as it fell into the water at the time of the accident).

The talurit splice of the fall wire to the MOB boat failed in the accident: it exploded under lifting conditions. This happened either as a result of a fault in the splicing process, or because it had been subjected to external stress or an outside force during its use prior to the accident.
