Investigation report

C 2/2002 M

**MS CITY OF SUNDERLAND, grounding off Hanko,
January 1, 2002**

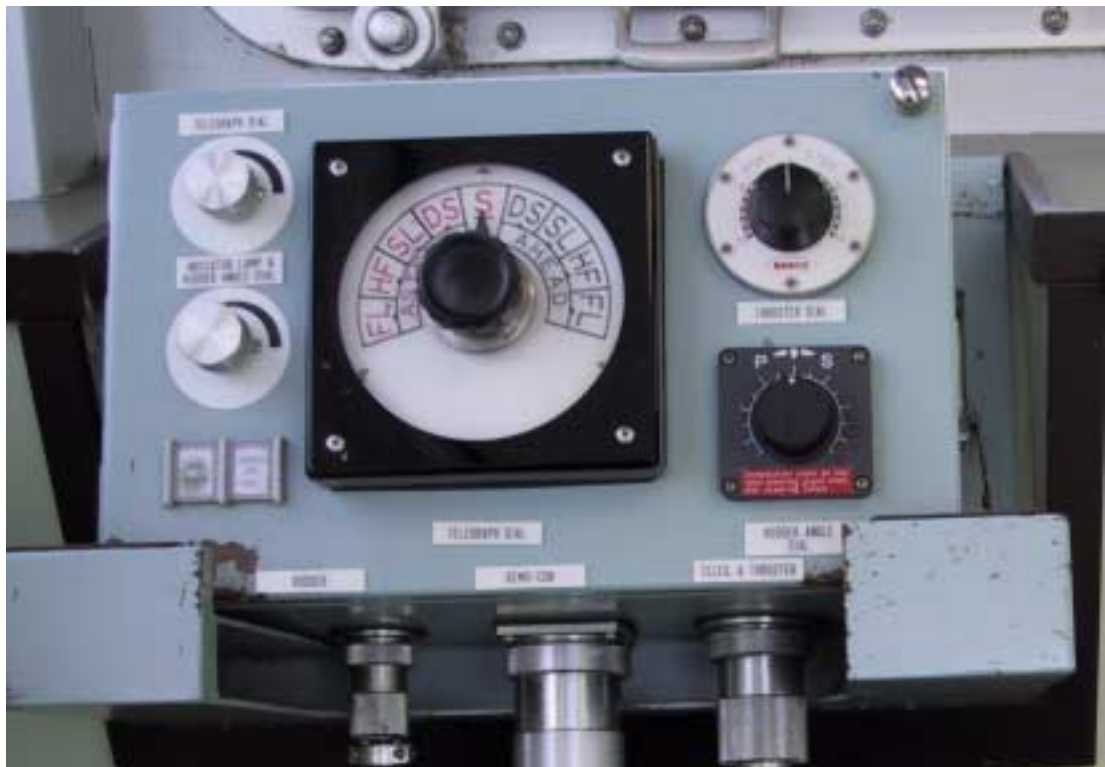
Figure 5. Controls on the starboard wing of the bridge.

no	Indicating	no	Indicating
1	Two FURUNO radars	5	Console with a.o. course plotter
2	TOKIMEC steering post	6	Desk with a.o. radio telephone and barometre.
3	FURUNO DSC VHF radio telephone	7	Two computers, printer, telefax.
4	Controls and commands for main engine	8	GMDSS radio station
9	The vessel had one portable set of controls for engine commands, rudder angle and bow propeller that could be moved from one wing to the other. See Figure 5.

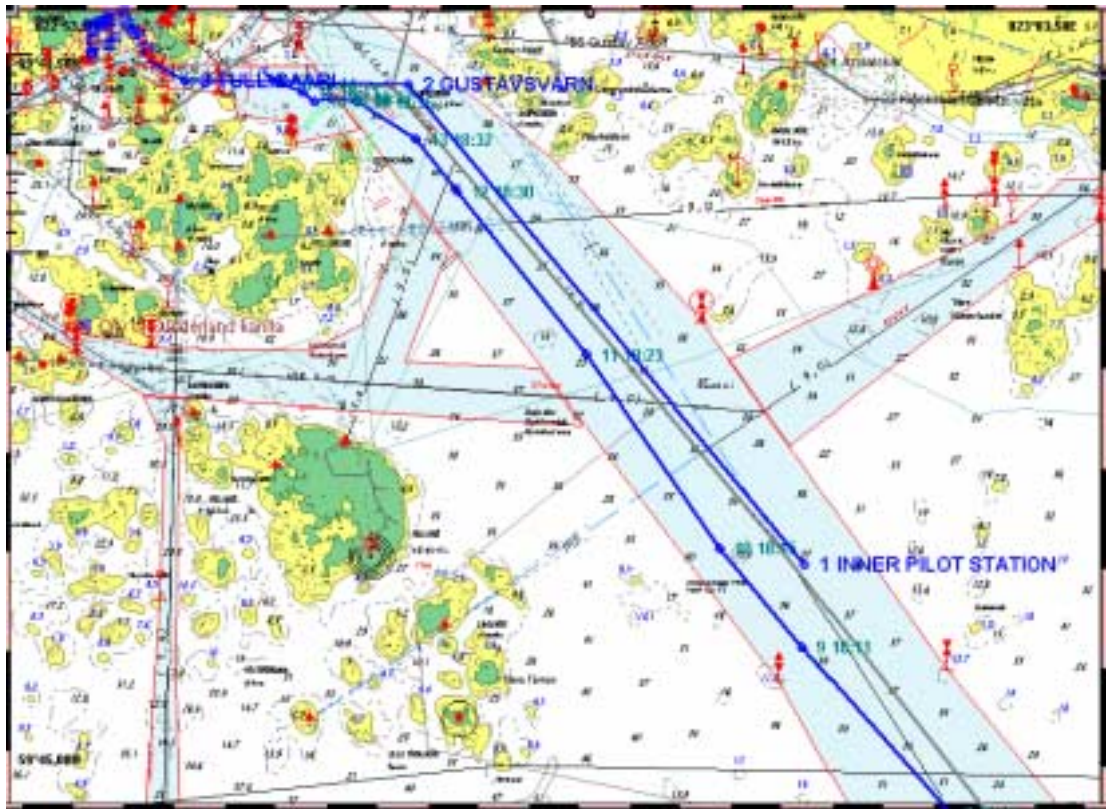
Figure 7. The CITY OF SUNDERLAND's passage plan from the pilotboarding point to the Tulliniemi strait and the vessel's passage according to the passage report of the Hanko VTS.

At 1615 hrs the mate, who was officer of the watch, reported to the Hanko pilot station that the CITY OF SUNDERLAND would arrive at the pilot boarding point at 1815 hrs (figure 7), with the pilot ladder on the starboard side. The mate notified the engine room that engine commands would start in 30 minutes.

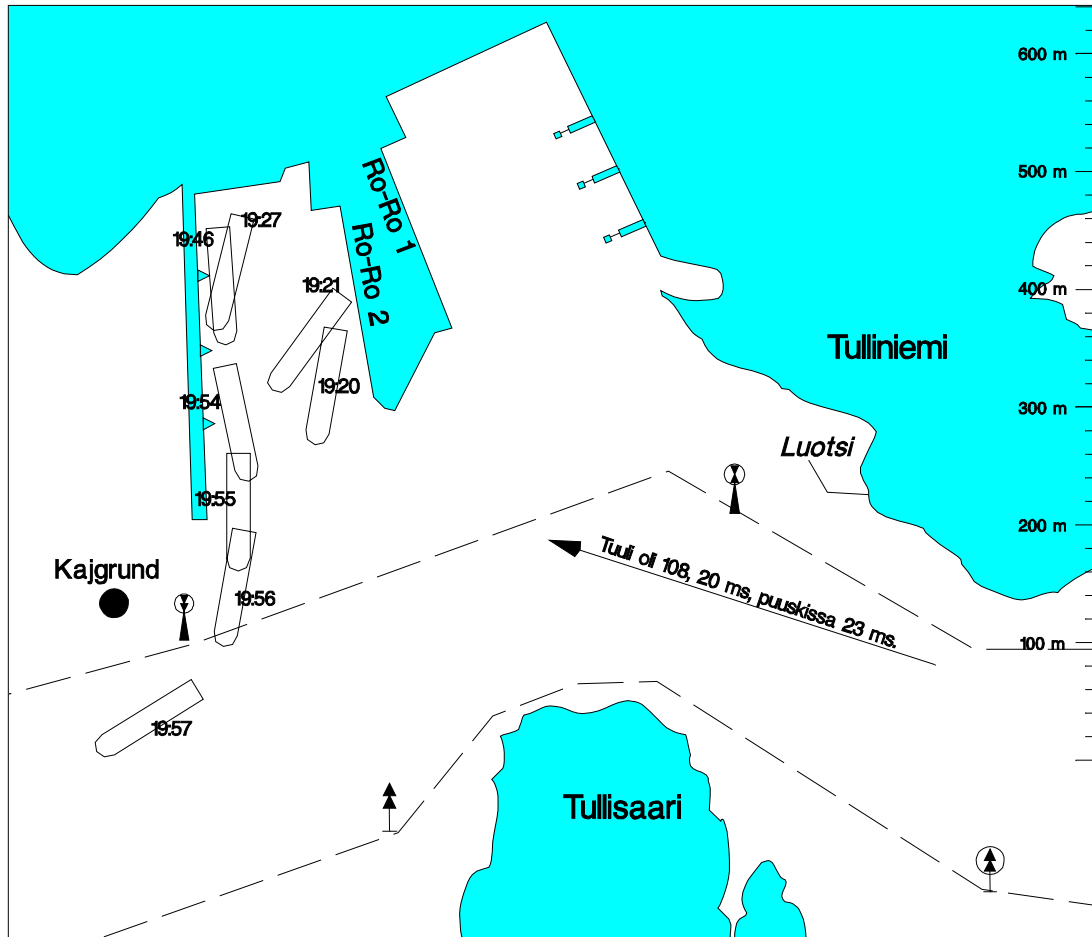
Figure 9. The CITY OF SUNDERLAND's position in the harbour basin is estimated, based on the Maritime Declaration, the witness statements and the course plotter.

The master ordered the crew to the bow and to the stern, to be ready to moor the ship. The mate went to the bow and the first mate went to the stern. At 1920⁴ hrs the vessel was turned in the outer port, south of pier 2, and she then approached the pier stern first (figure 9).

According to the Tulliniemi station, the wind direction during the attempted berthing was 108°, the average wind speed was 19.3 m/s, and the wind was gusting to a maximum speed of 22.8 m/s.

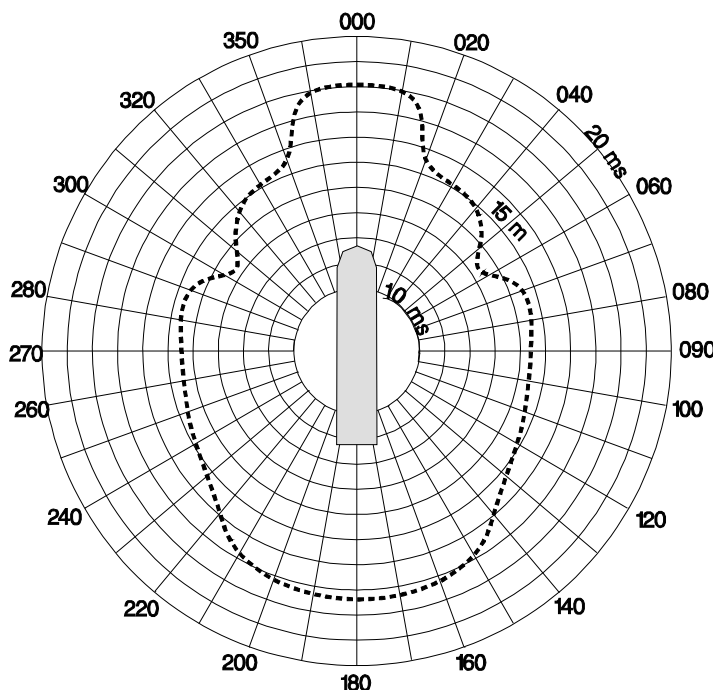
Figure 13. Imaginary example of wind limit without tugs.

Figure 13 represents the wind limit curve for an imaginary car ferry. The vessel has no speed within the harbour area. The wind speed is at 10 metres above sea level, since weather reports indicate wind speeds at this height.

The limit curve is defined so that the vessel is driven towards an imaginary berth. The wind limit is defined at an interval of 10 degrees by increasing the wind force by about 2m/s for each run until steering difficulties begin to appear. Then the precise limit value is defined.

Water depth is fed into the program that uses a mathematical model. The program also needs the parameters for the piers and the shallow water mark. The easiest solution is to simulate this on an electronic chart. As a minimum requirement, the master should have the information in figure 13. The tugs can be added to the program by putting them in the middle of the run in predefined positions. If there are tugs assisting it is impractical to define the wind limit, since the wind limit cannot be defined for all tug types. The wind limit for tug use should always be defined separately.

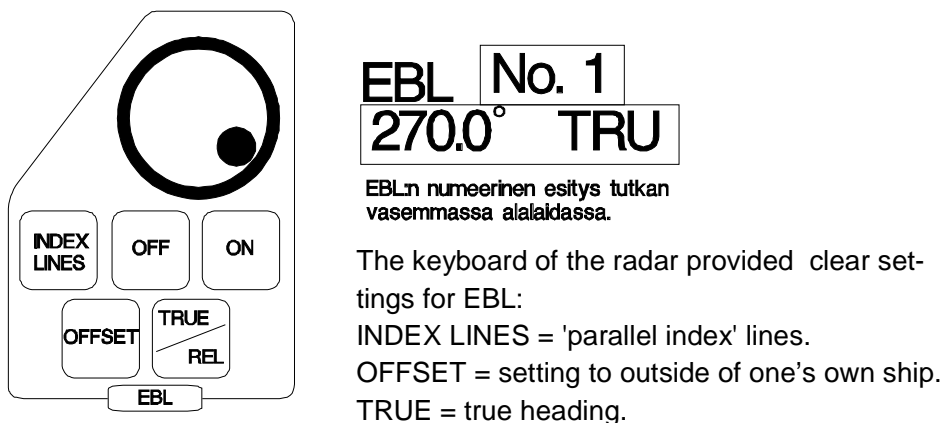
Figure 16. Radar bearing settings.

There was no mention in the Maritime Declaration of the radar's EBL having been used. After the tug's release, the true heading into the strait between Västertistro and Albertsklackarna was 121°. The CITY OF SUNDERLAND's course over ground, according to the VTS register, was about 137° (from 20:16:06 to 20:19:57). The vessel's compass headings according to the course plotter are presented in table 11.
