Investigation report

B 1/2004 M

M/V FINNCLIPPER, grounding off Kapellskär 20.01.2004

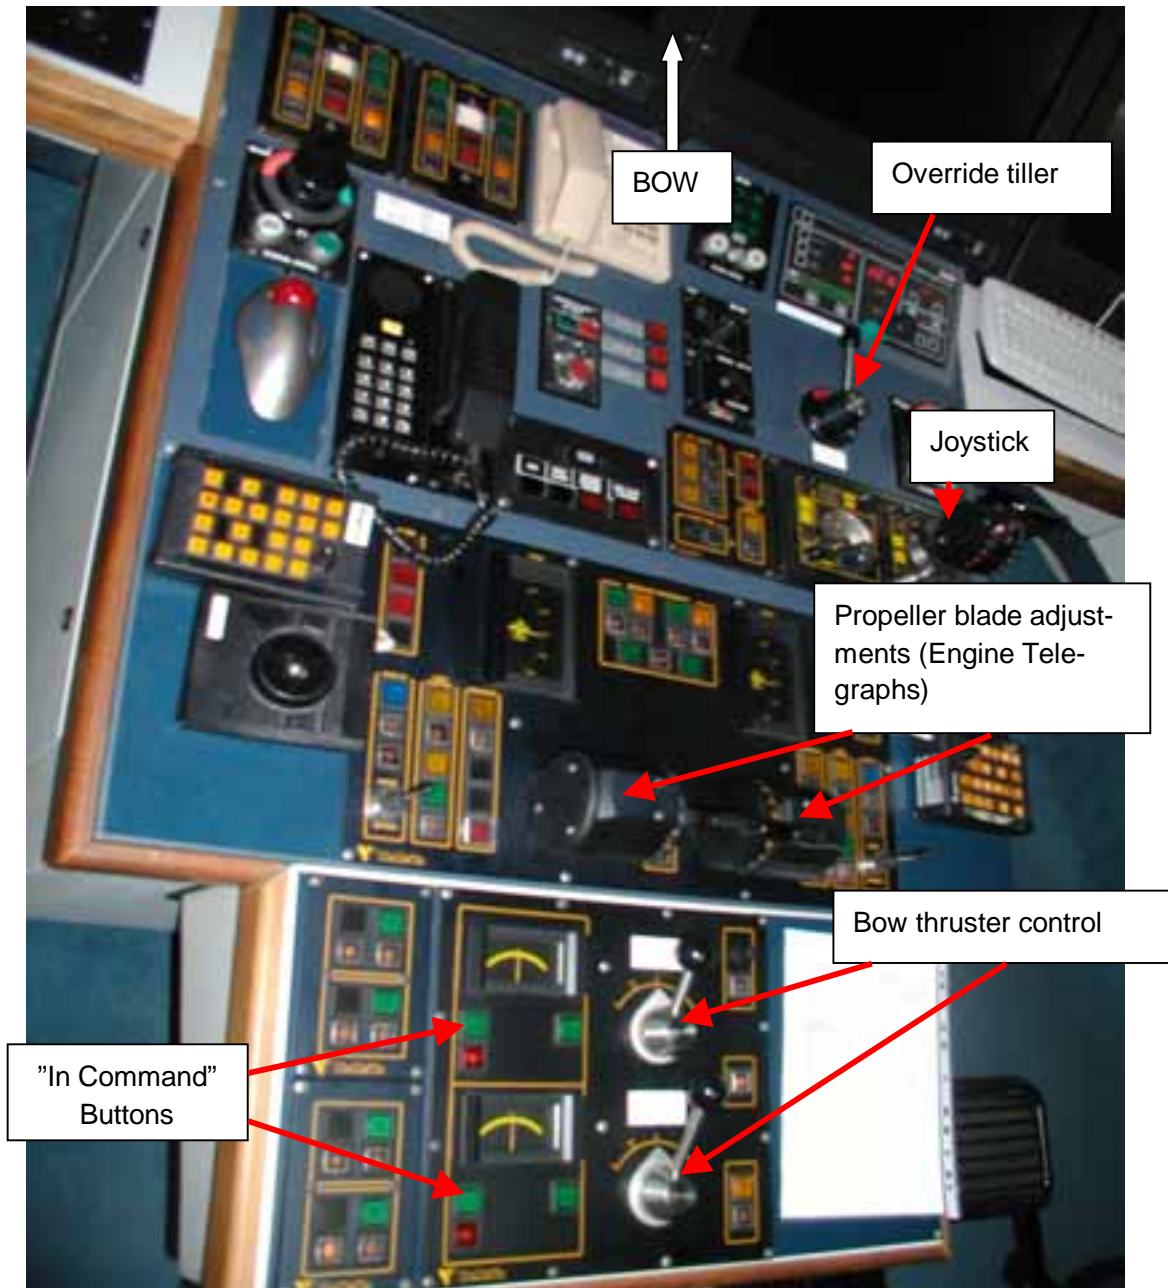
Image 3. Center console.

There are two rudder controls in the centre console and they are situated on both sides of the console beside the left and right control location. Rudder's controls are activated by pushing *accept* button beside the rudder control and the rudder control is shifted from the earlier position to the centre console. The two rudders cannot be separately handled from the centre console.

Override tiller is for the rudder, which is located beside the rudder control in the front of centre console. Turning the control handle activates *override tiller* and the rudder control from other places is shifted to the *override tiller*. There is also *the KaMeWa-joystick*, which is located between rudder and engine controls. *KaMeWa-Joystick* was not used.

Control panel for the Bow thrusters is situated behind the OOW's chair and this makes its difficult to use the bow thrusters when you are handling the ship from the centre console. When one is changing the manoeuvring place from the bridge wing to the centre console, one has to go behind the chair to activate bow thrusters control and then move in front on the chair at the sb- side of centre console to continue driving the ship (see image 3).

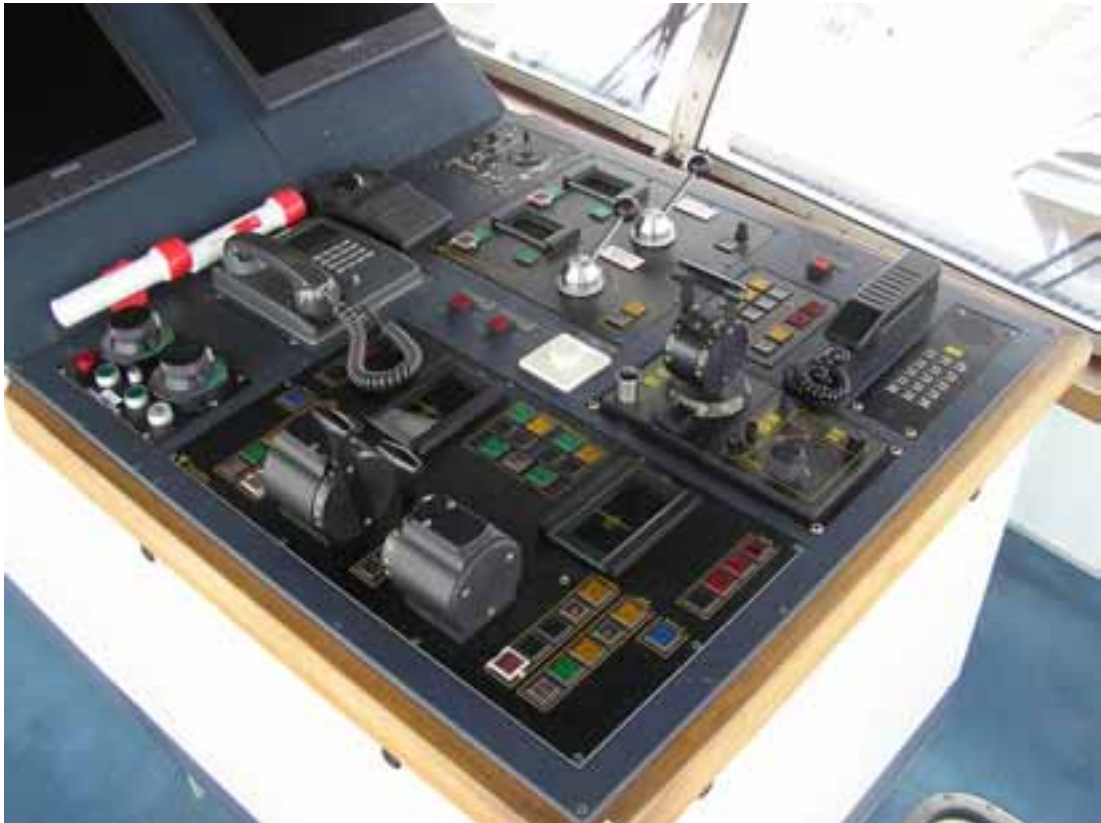
Image 4. Control console on the sb-wing.

The respective controls, which are in the centre console, are also on the bridge wing consoles. The only difference is that the rudder can be separately moved with the controls on the bridge wing. There are two methods in the rudder control panel, which can be chosen either *separate* or *synchron*. Rudder and propellers independent use is built to give more transversal power to the stern when used in certain ways. Without increasing or decreasing the ahead/aster speed.

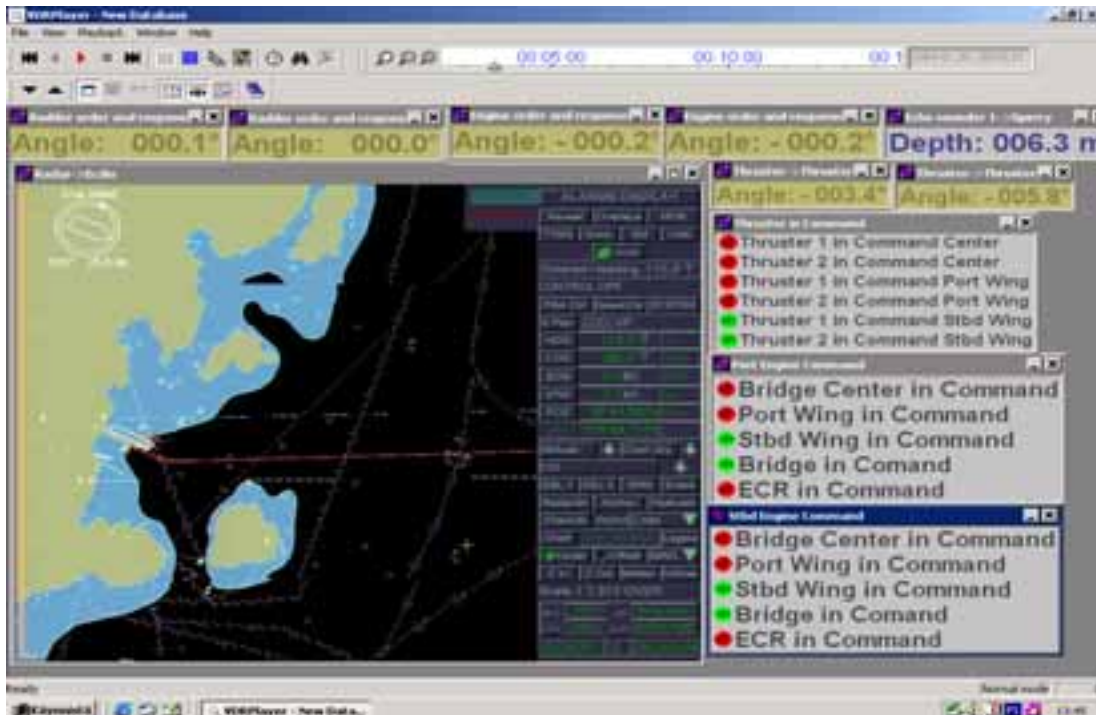
VDR Image 1. Time 02:03:30 before the departure manoeuvring is on the starboard bridge wing. Wind information is shown in the left upper corner as true wind and speed. 30 degrees and 12.9 m/s (25 knots).

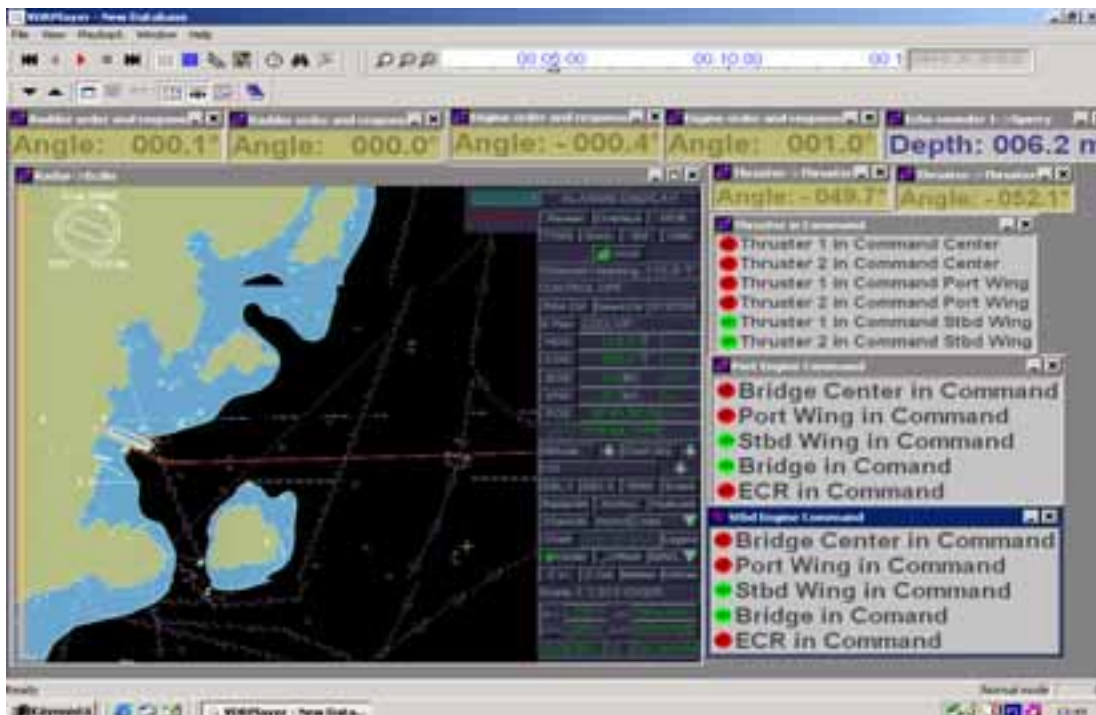
VDR Image 2. Time 02:04:50 bow thrusters output 50 % to port at the departure. All the other manoeuvring controls are neutral.

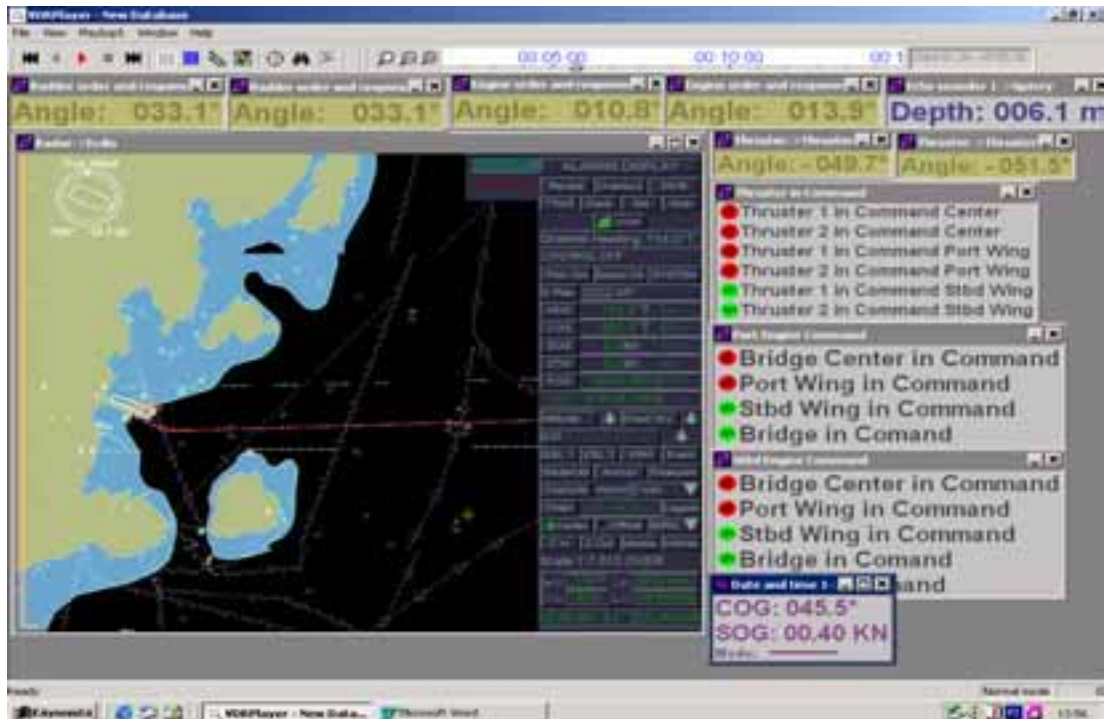
VDR Image 3. Time 02:05:35 head and stern lines are released. Rudders are 21° to starboard and the propeller output is 12 % ahead.

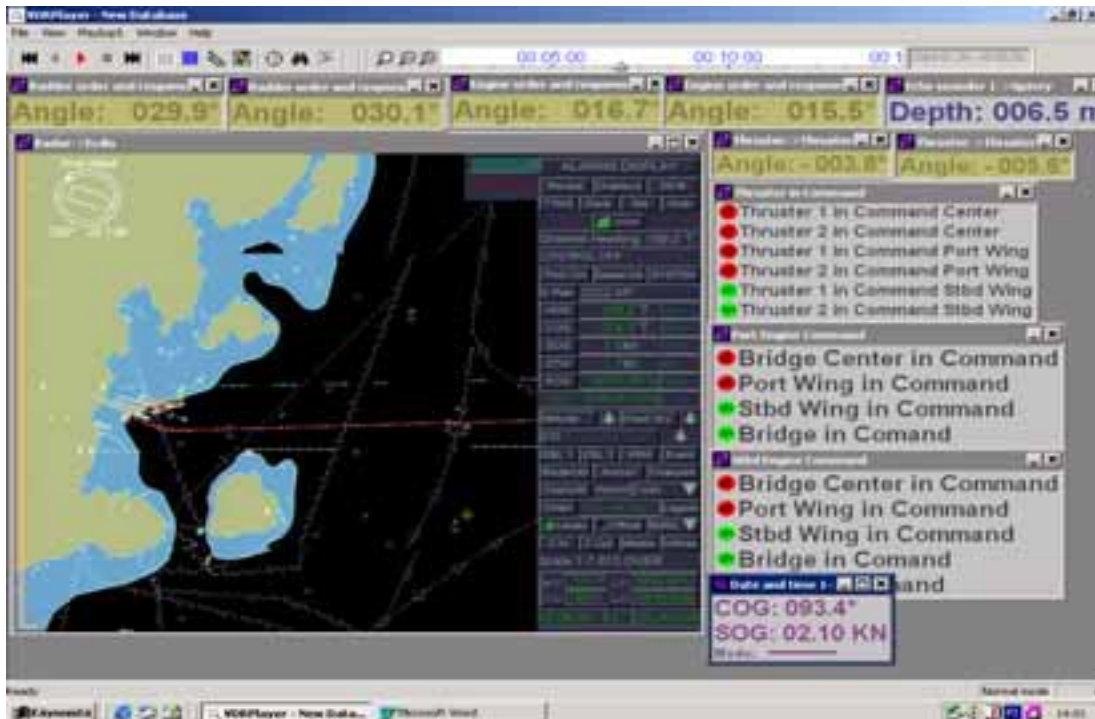
VDR Image 5. Time 02:06:35 rudders are 30° to starboard and the bow thrusters output is neutral. Ships speed over ground is 2.1 knots.

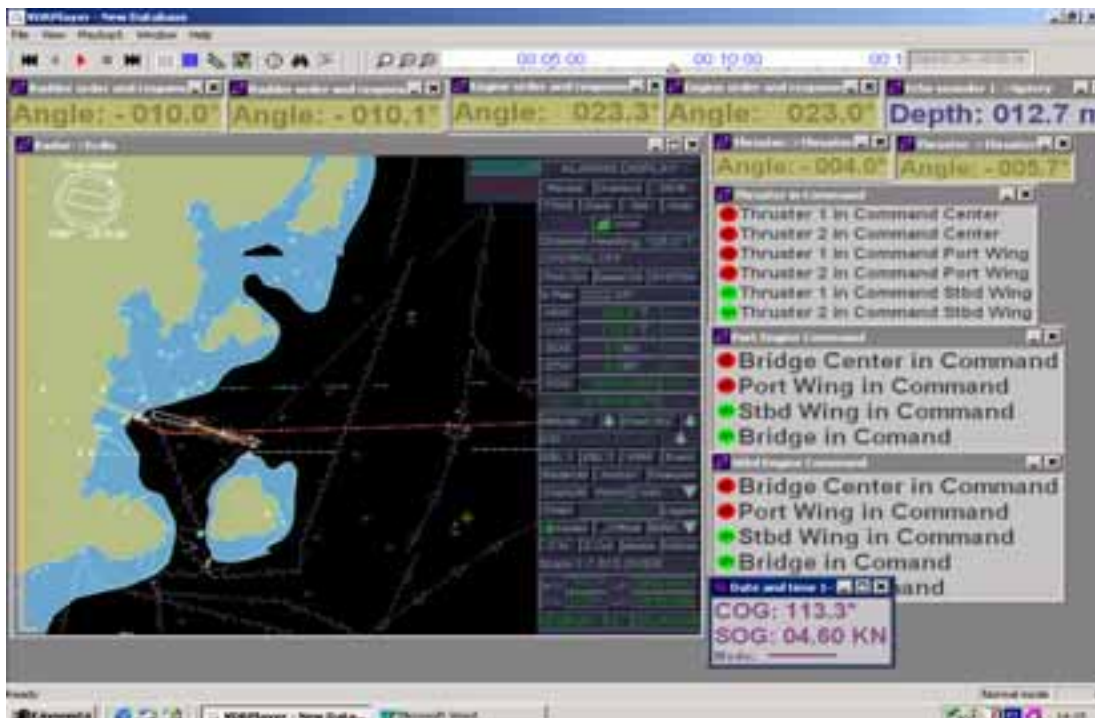
VDR Image 6. Time 02:08:20 rudders are 10° to port and the propeller output is 23 % ahead. Ships speed over ground is 4.6 knots.

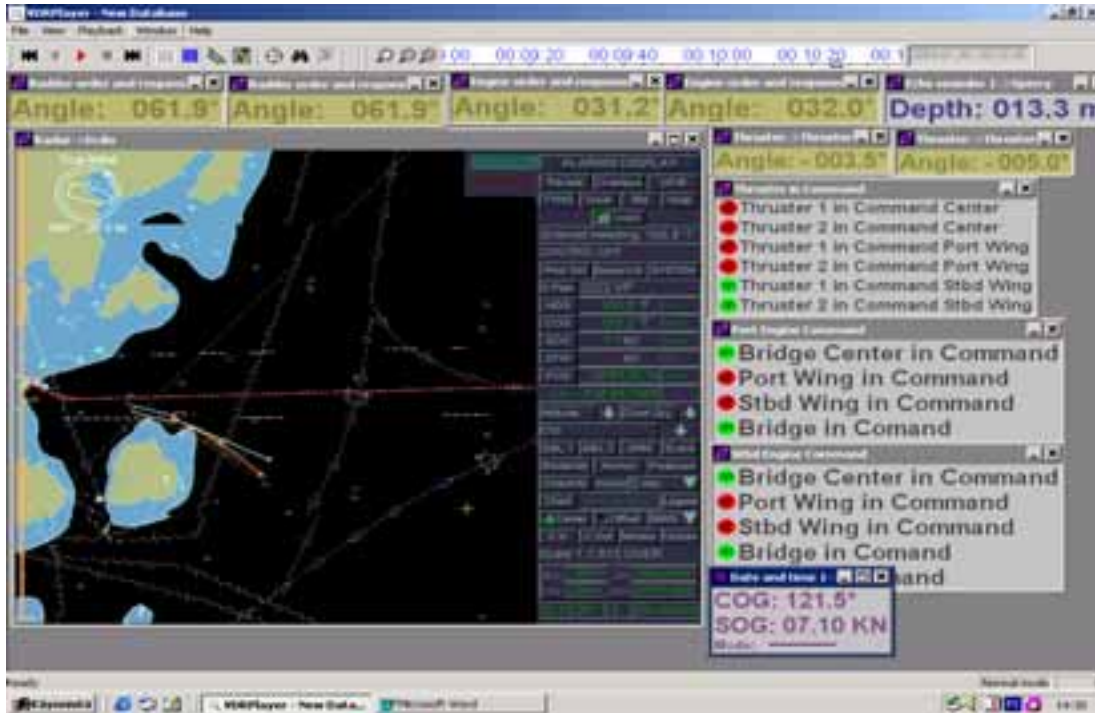
VDR Image 9. Time 02:10:20 rudders are 62° to starboard and the propellers output is 32 % ahead. Ships speed over ground is 7.1 knots.

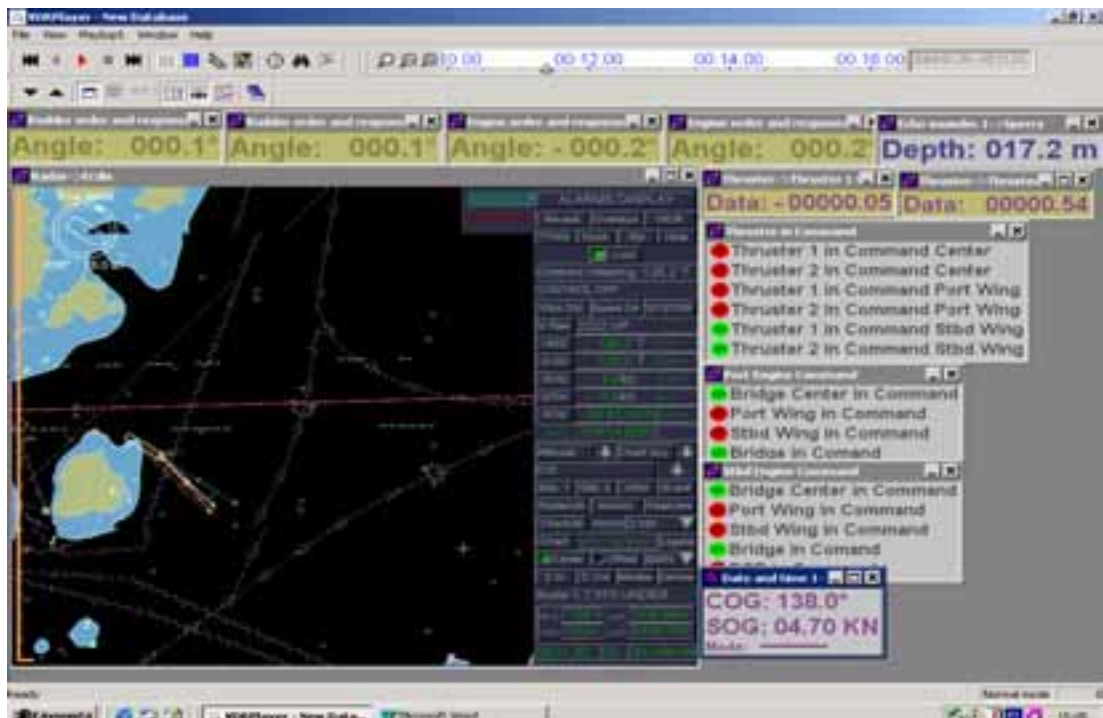
VDR Image 12. Time 02:11:23 all manoeuvring devices are neutral.

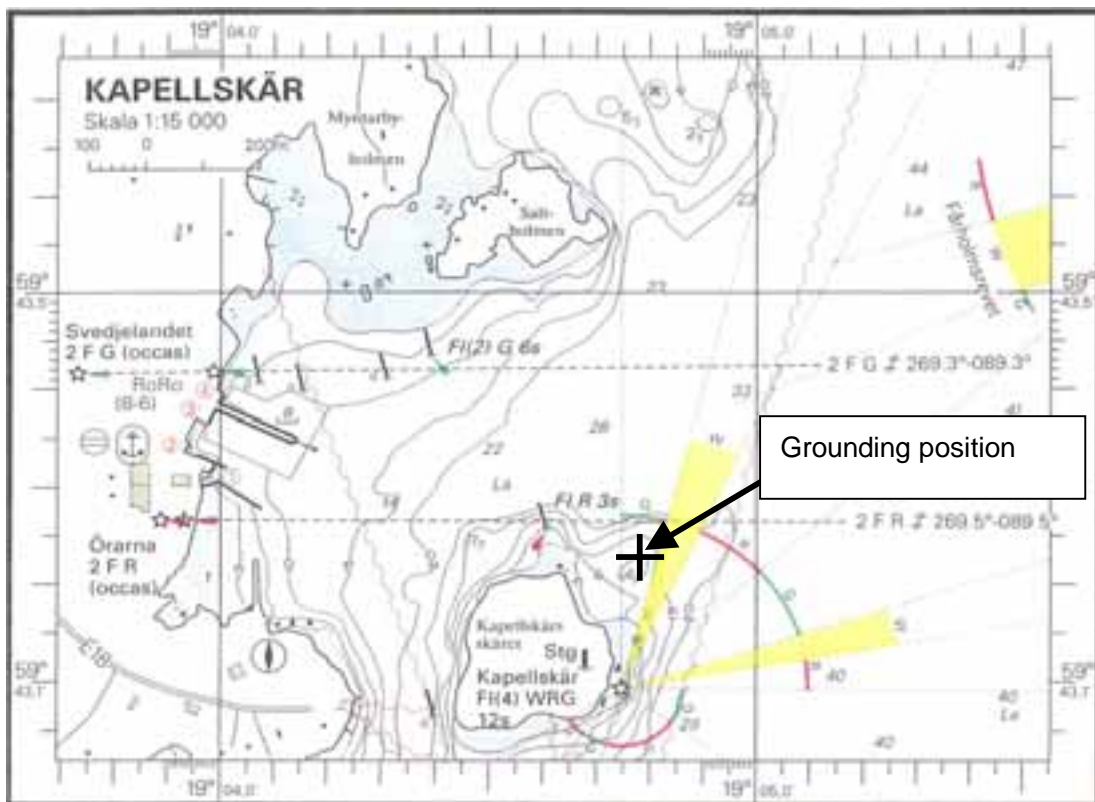
Figure 6. Extract from Kapellskär special seachart 1:15000 (© Sjöfartsverket)

Kapellskär's Ro-Ro harbour is located outside Stockholm in position 59° 43,4 N 019° 04 E. The harbour is busy and it is used by both passenger- and Ro-Ro vessels. Berths 3 and 4 of the piers are most often used by FINNCLIPPER. When leaving to the accident voyage the vessel was in berth 4. The pier is in direction about 296°–116°. The fairway in which the vessel approaches and departs is in direction 269,5–089,5 degrees. The fairways northern edge is indicated by Svedjelandet line marks and the southern edge by Örna line marks. Both line marks are in line 269,5–089,5 degrees. The breadth of water area indicated by these line marks is 300 meters wide. If ship's handling in the harbour so requires can master, who is familiar to the area, get advantage also from the southern water area over the southern edge of the fairway just after the pier (see chart). The centre line of fairway is neither marked on the chart and nor in the nature. The northern reef of the Kapellskärs skäret is marked with buoy which is 20 meters south from the line of Örna. The 4.1 meters reef which is located northeast from Kapellskärs skäret is not marked with navigational safety device.

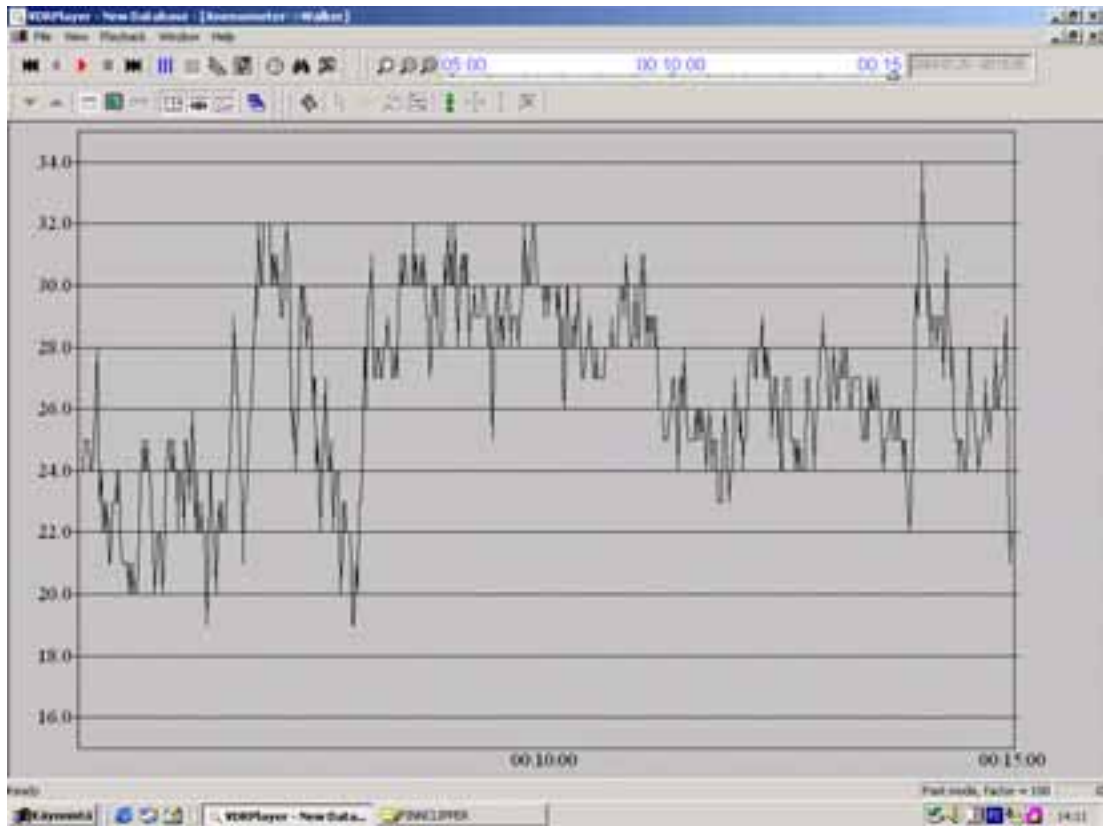
Figure 8. Graphically shown wind registration in knots from the VDR

Captain made a note in the departure checklist that the wind was 12 m/s from a direction of 020 degrees. There was no wind registration made in the ships log for the time of accident.

Image 8 displays wind velocity in knots recorded by VDR.

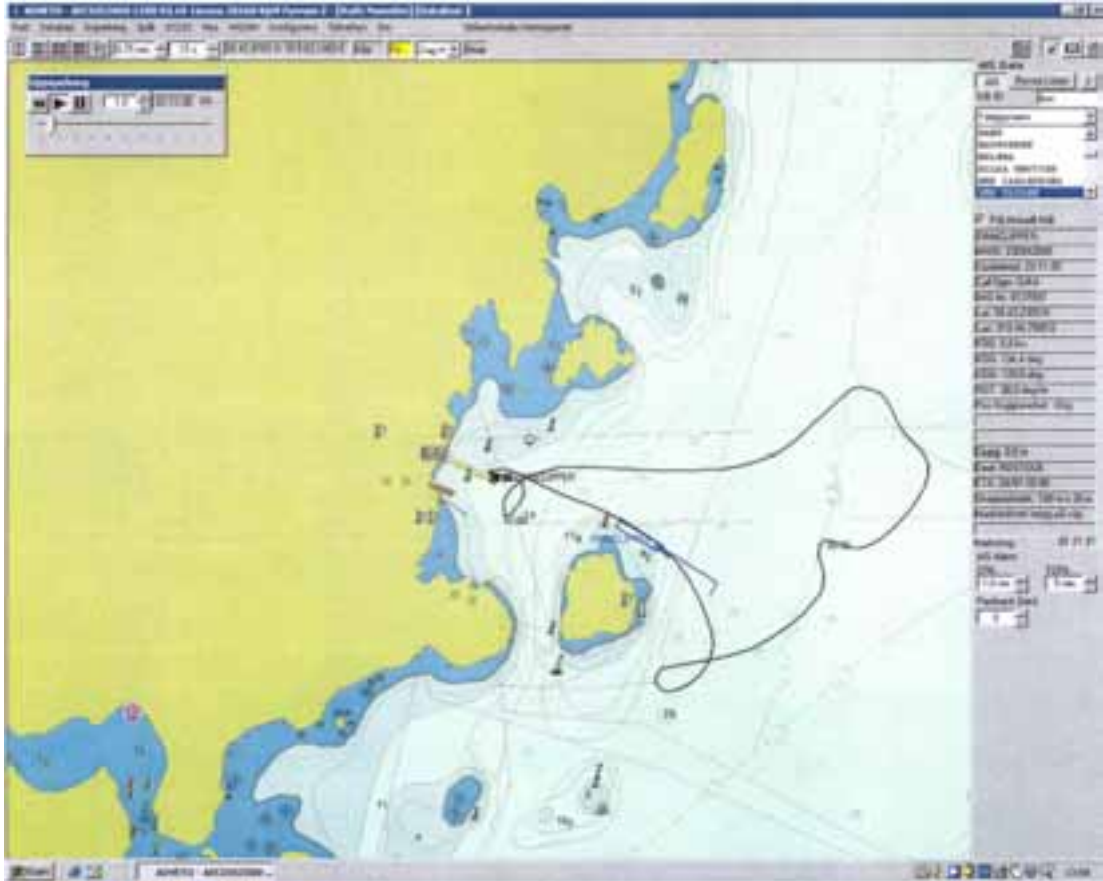
Image 10. Extract from ADVETO-chartdevice, which describes the vessels track from berth to berth.
