Investigation report

B 7/2004 M

Ms SUPERFAST VII, grounding off Hanko on 12.11.2004

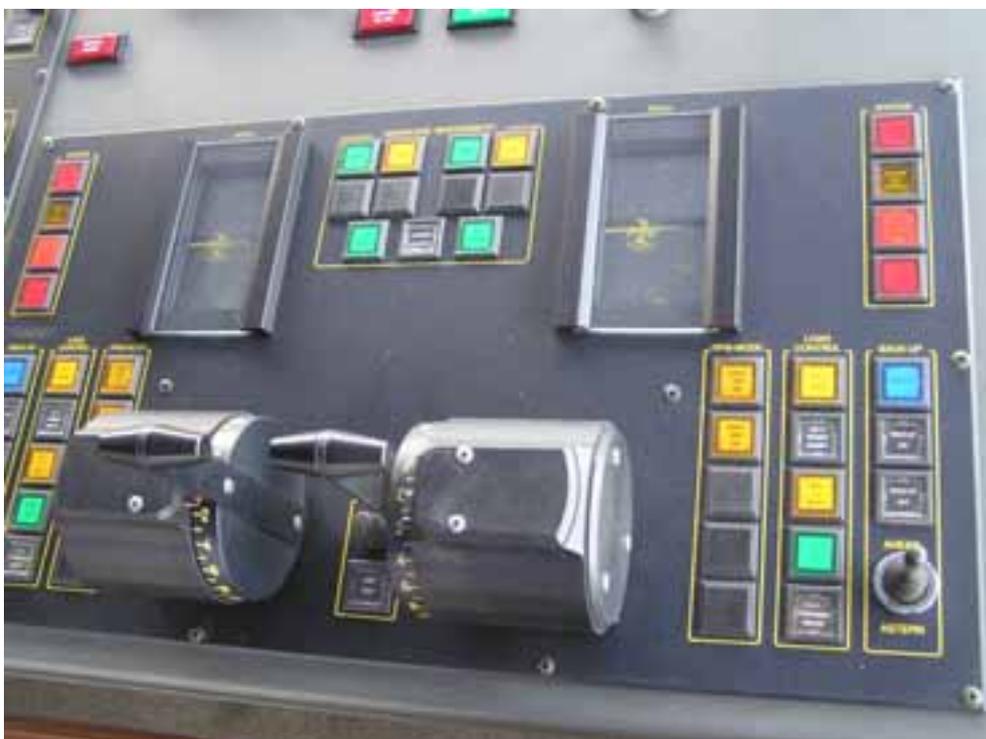
Figure 5. The control levers for the main propellers. The master used these.

The variable pitch propellers are manufactured by KaMeWa. Their control unit is presented in Figure 5. The levers work on the Follow Up principle. The sides of the console have emergency control levers functioning with the Non Follow Up principle.

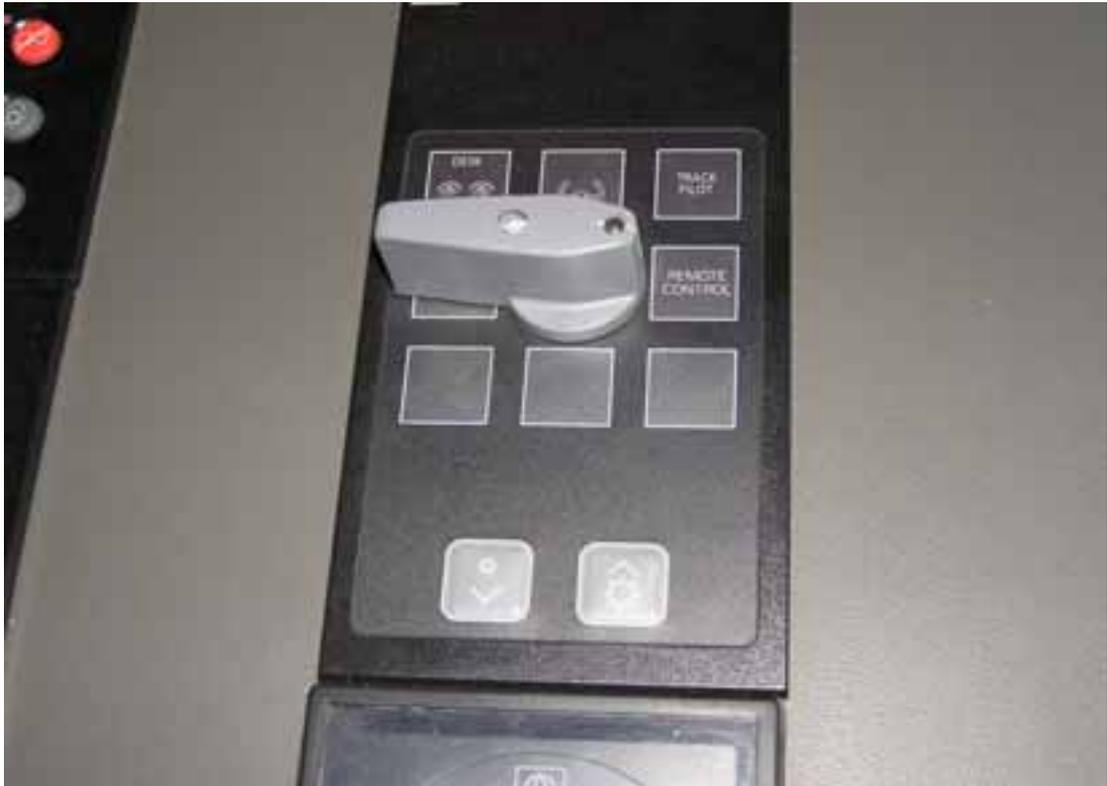
Figure 7. Selection of rudder control point in the console of the helmsman.

The place for rudder control is selected from the steering column with a mechanical switch (Figure 7). The figure of the helm means the control station of the helmsman. TRACK PILOT evidently means the Anschütz Nautopilot D autopilot in the centre console. DESK and REMOTE CONTROL mean the work station of the OOW in the centre console and the wings of the bridge.

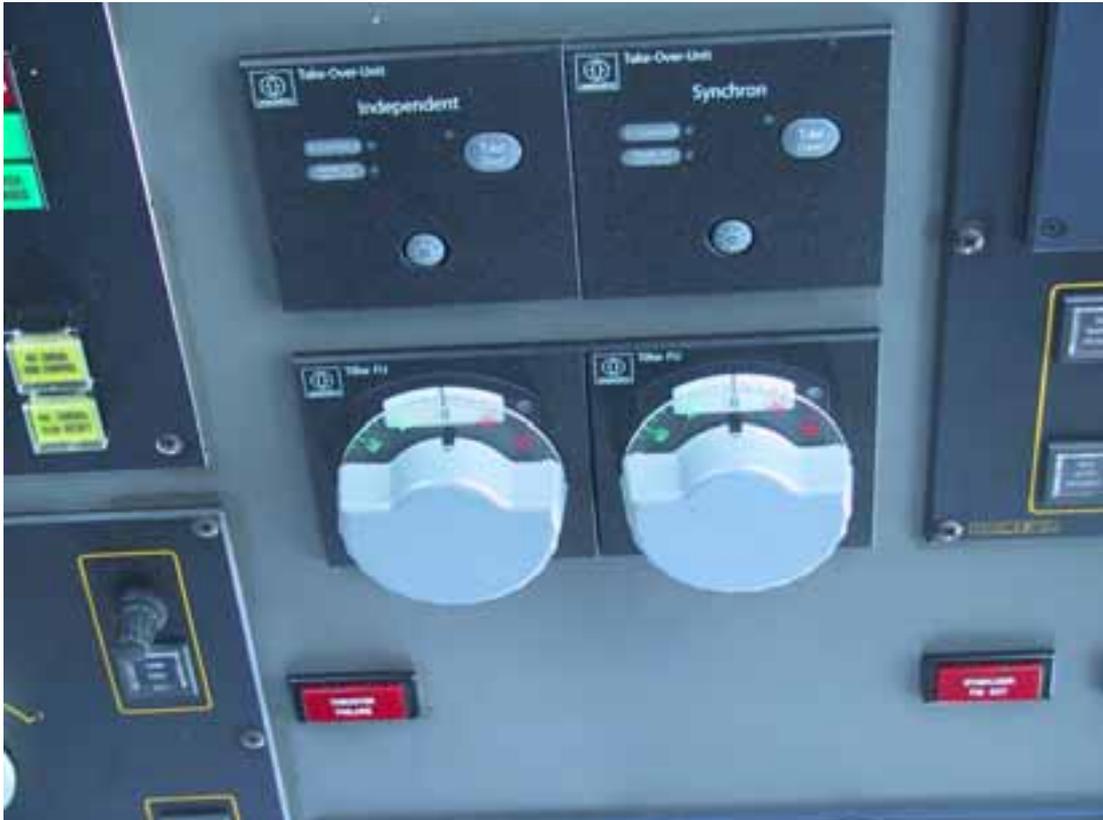
Figure 8. The Follow Up control of the rudders on the bridge wings.

When the front of the knob is turned to the left, the rudder turns left. The movement of the knob does not describe the actual direction of the rudder. If the rudder is thought of as a "lever", this gives the wrong picture of the movement of the rudder. Therefore it is important to check the direction of the rudder angle (i.e., the colour) at the front of the knobs.

The master could have had the opportunity himself to steer both rudders from the wings with follow-up steering. (Figure 8.) This manner of steering would have enhanced the operation of the rudders and the control of the stern, but the increase in control devices would have made it more difficult to concentrate on steering.

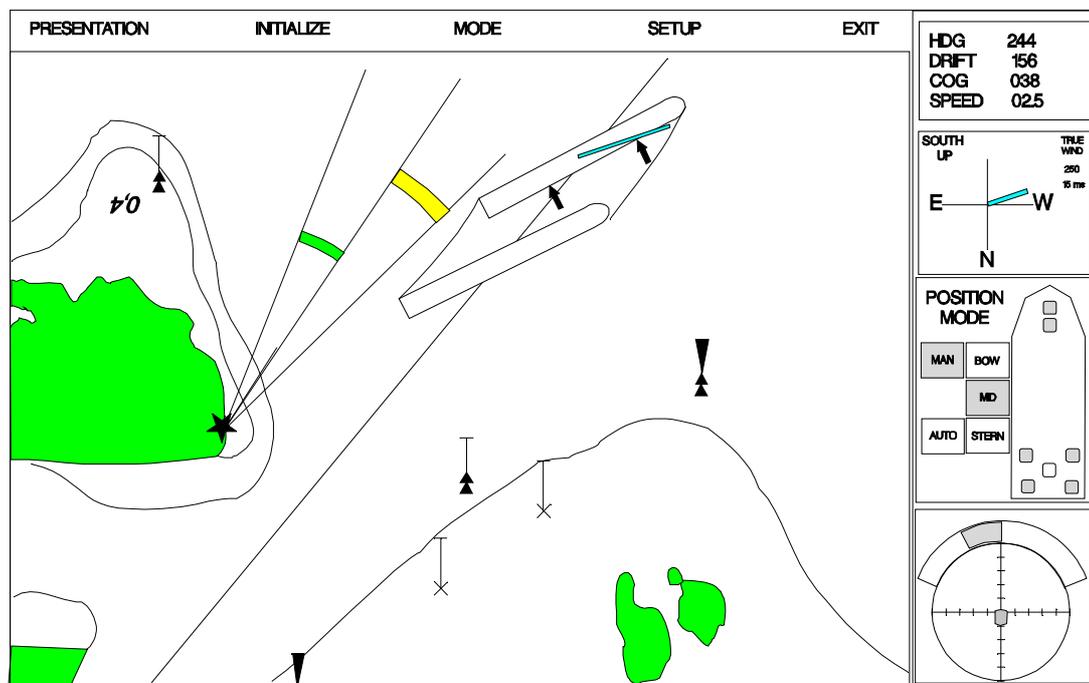
The vessel is reversing north-east and the future position of the vessel is indicated by the dotted line. The duration of the forecast can be selected. At slow speeds, a forecast of 45–60 seconds is normally used. The right-hand side of the display has the most important movement data on the vessel. Below it is the wind data for the moment and the orientation of the figure. The interval between the gusts is about 5 seconds, the force of the gusts is ± 5 m/s and the variation in direction is $\pm 20^\circ$. The gusts are varied in accordance with a random variable, within the limits given. The two lowest boxes show Joystick steering. The symbol of the vessel has indicator lights of the propellers and the
