Investigation report

C1/2006M

MS ESTRADEN and MT WOLGASTERN, collision in the Kiel-Canal on 2.2.2006

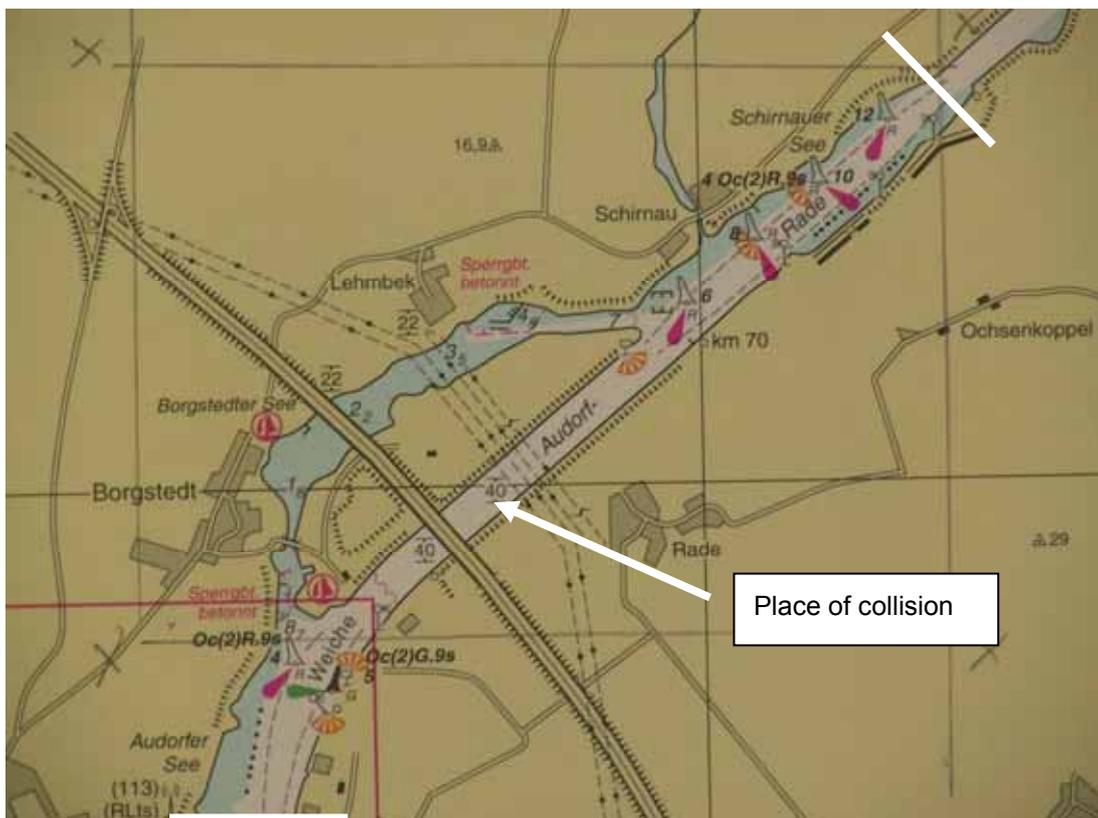
Figure 3 A map of the accident area. The limits of the siding area are shown with a white line (length 5.7km, endpoints at km 66,093 and 71,749). (© Bundesamt für Seeschifffahrt und Hydrographie, Hamburg-Rostock).

At the site of the accident (Audorf-Rade siding area) the width of the Canal bottom having the depth at least 10.5 m varies between 100–110 m outside the Schirnauer See (Figure 3) and inside it between 110–150 m. The widest area is between kilometres 70 and 71. At the nominal depth of 11 m the width is 10–40 m narrower than at depth of 10.5m⁷. The water depth varied both lengthwise and sidewise between 10.5 and 13.5 m, Figures 6 and 9. Figure 7 shows a cross-section of the point where there were three vessels side by side as the LENA was encountered. The map of the area is presented in Figure 3. The ESTRADEN and WOLGASTERN collided just before the end of the straight part of the Audorf-Rade siding area, near the bridge.

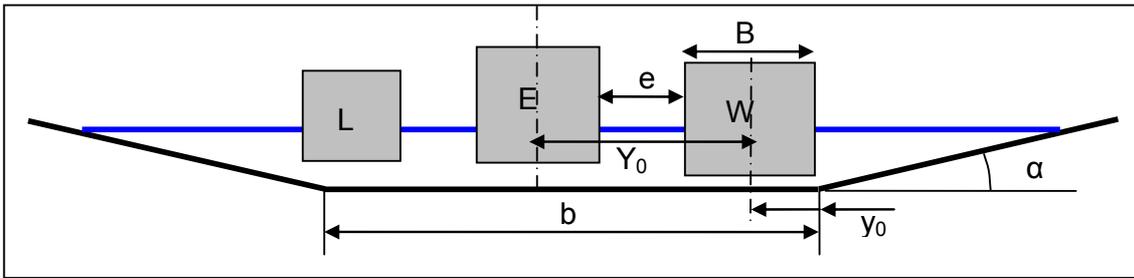
The parameters are defined in various ways in the references cited in this investigation. The investigators have tried to harmonize the results according to the definitions used in references 1–5. Some parameters are shown in figure 1, which correspond to the situation when LENA was encountering ESTRADEN and WOLGASTER. During the literature study it has been noted that comparisons between calculated and model test results are sometimes problematic; tests are sometimes old and not all information for the comparison was possible to reach. Moreover, the test methods and facilities differ. Shallow water test conditions might have some unknown scale effect, too²⁸.

Figure 1. Some parameters connected to the positions of the ships in the channel.

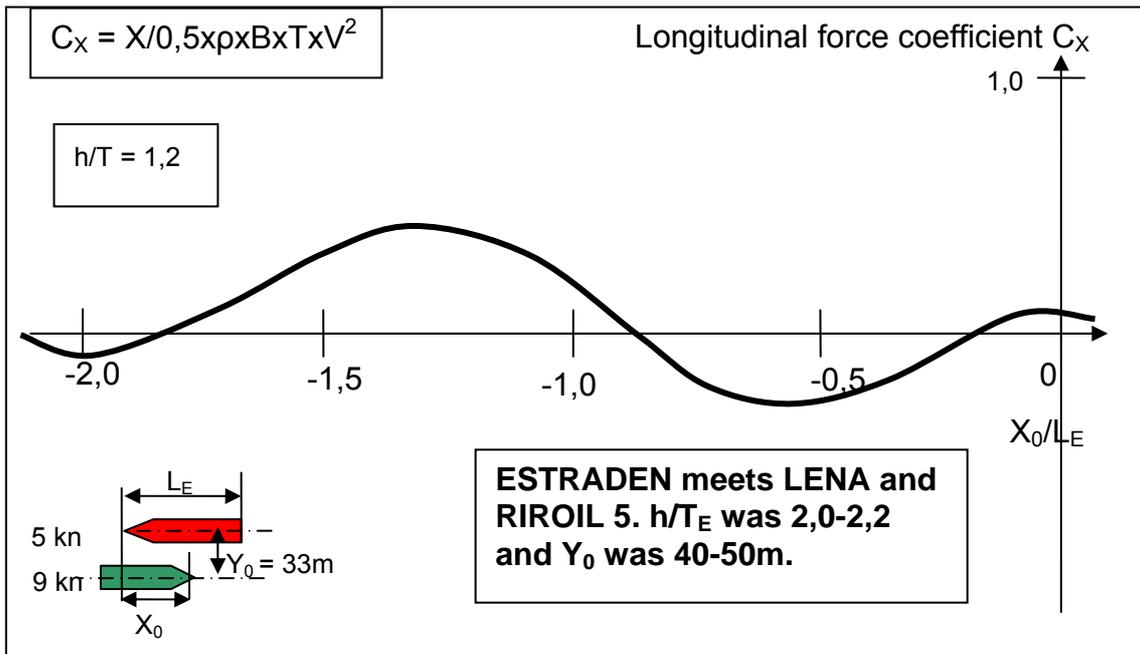
LENA or RIROIL 5 encountering ESTRADEN and WOLGASTERN. ESTRADEN met two times an encountering vessel: first LENA and later RIROIL 5. The following figures 12–14³⁴ show the interaction forces and moments acting on ESTRADEN in this situation, based on reference 4. The effects on the other vessel are opposite. Relative water depth and separation in the model tests deviated considerably from the actual. The separation between LENA or RIROIL 5 and ESTRADEN was 40–50m (distance between sides 20–25m, figures 2 and 6), not 33m as in model tests. The ratio h/T was for ESTRADEN about 2 and for LENA and RIROIL 5 about 1.5, when model test results are for the value 1.2. In general, however, these results correspond principally with the situation in Kiel Canal. According to the reference 5 the increase of water depth decreases forces and moments by two thirds and the increase of separation decreases them by 20 per cent. Both encounters lasted about one minute, and the interaction did not have time enough to fully develop. The opinion of investigators is that these encounters were not risky because of adequate water depth and moderate separation. However, dangerous situation developed because ESTRADEN was forced to proceed clearly too near to WOLGASTERN due to these encounters.

Figure 12. Longitudinal forces at head on encounter acting on bigger and slower ship.

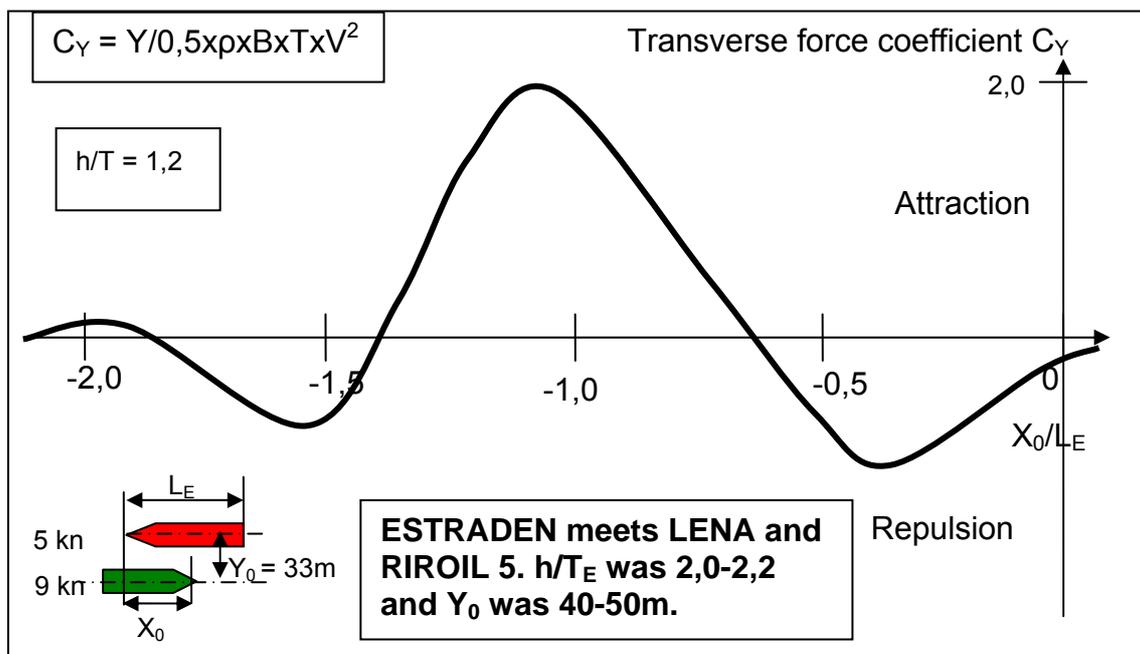
Figure 13. Transverse forces at head on encounter acting on bigger and slower ship.

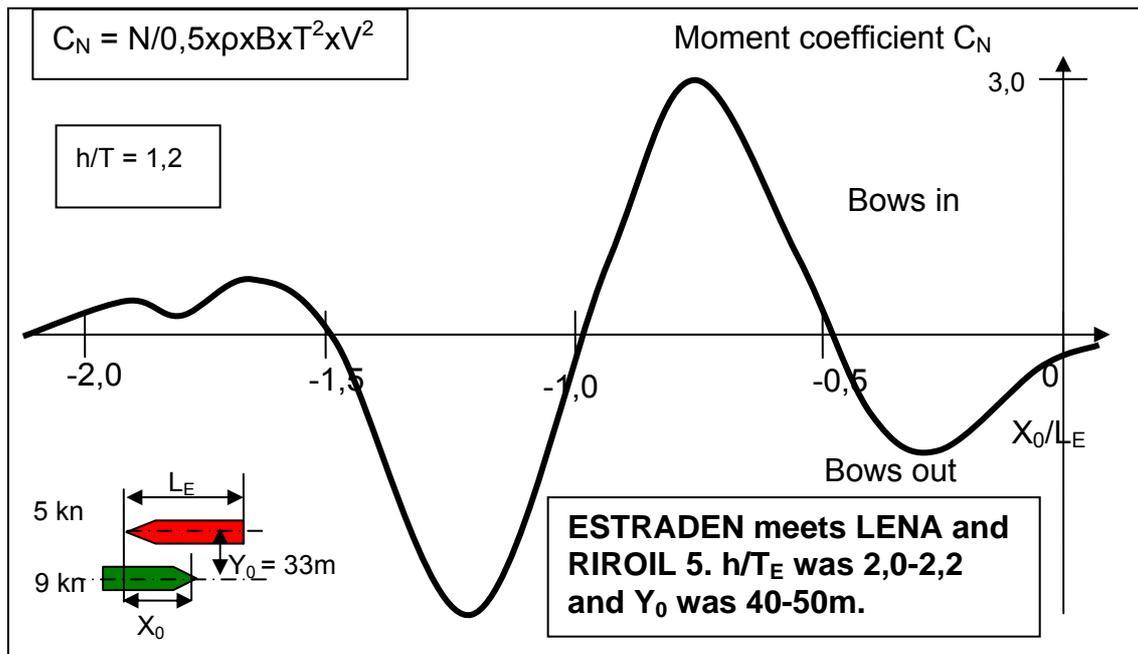
Figure 14. Turning moments at head on encounter acting on bigger and slower ship.
