Investigation report

C6/2006M

Passenger Vessel MS NORDLANDIA, Collision with Quay in Tallinn on 28.10.2006

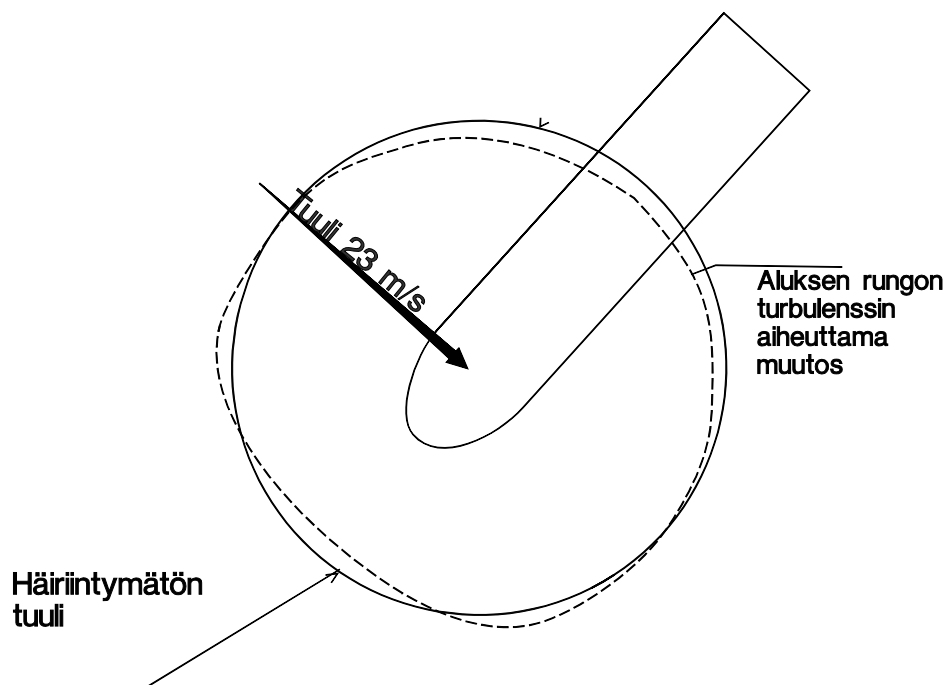
Figure 11. When the wind blew from the side or almost from the side, the NORDLANDIA's superstructure did not cause errors at the wind gauge.

By comparing the measured mean values of wind, one can conclude that the correction coefficient in the case of the NORDLANDIA, with wind blowing from the stern, was 0.96 when the wind blew 23.3 m/s. Figures 11 and 12.

The wind blew from the stern of the vessel when the NORDLANDIA approached the Port of Tallinn. The vessel structures formed wind vortices at the stern, and the wind speeds registered by the vessel were too low. The wind meter readings rose after the

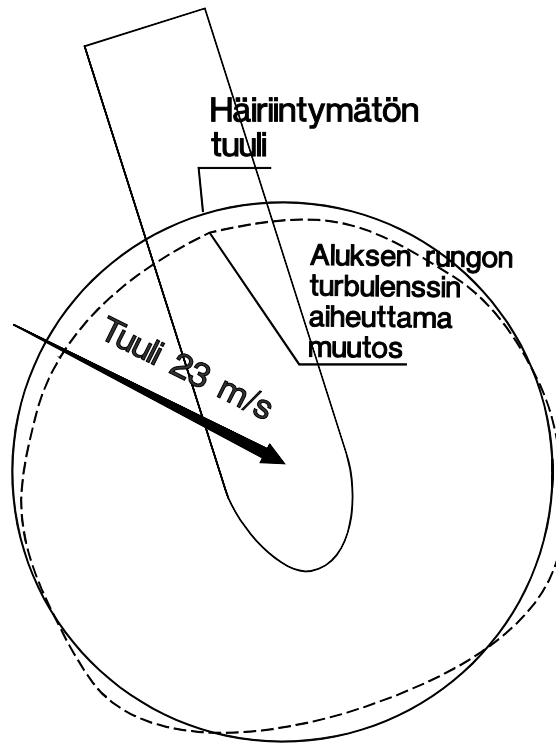
Figure 12. The superstructure of the NORDLANDIA decreased the speed of the wind blowing from the stern with a coefficient of 0.96, in which case the actual wind speed was 23 m/s.

Between where the vessel collided and where it was moored 20 register values were studied. Their mean value was only 18.3 m/s, i.e. 5 m/s lower than before the collision.

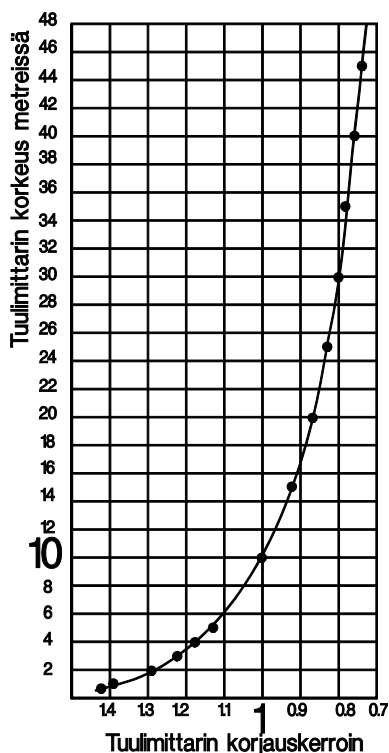
The biggest correction is the correction in the wind meter reading to the height corresponding with the weather forecast, i.e. 10 metres. The sensor of the NORDLANDIA's wind gauge was at the height of approximately 41 metres.

The wind speed was 23.3 m/s between the breakwater and the quay. The correction coefficient is taken from the curve in Figure 13. The height of the wind sensor 41 metres gives 0.75 as the correction coefficient, i.e. one gets the wind speed at the height of 10 metres. **This gives a wind speed of 17.5 m/s at the height of 10 metres.**

Figure 13. The coefficients to correct the wind meter reading so that it corresponds to the height of 10 meters, which can be compared with the weather forecast⁵.

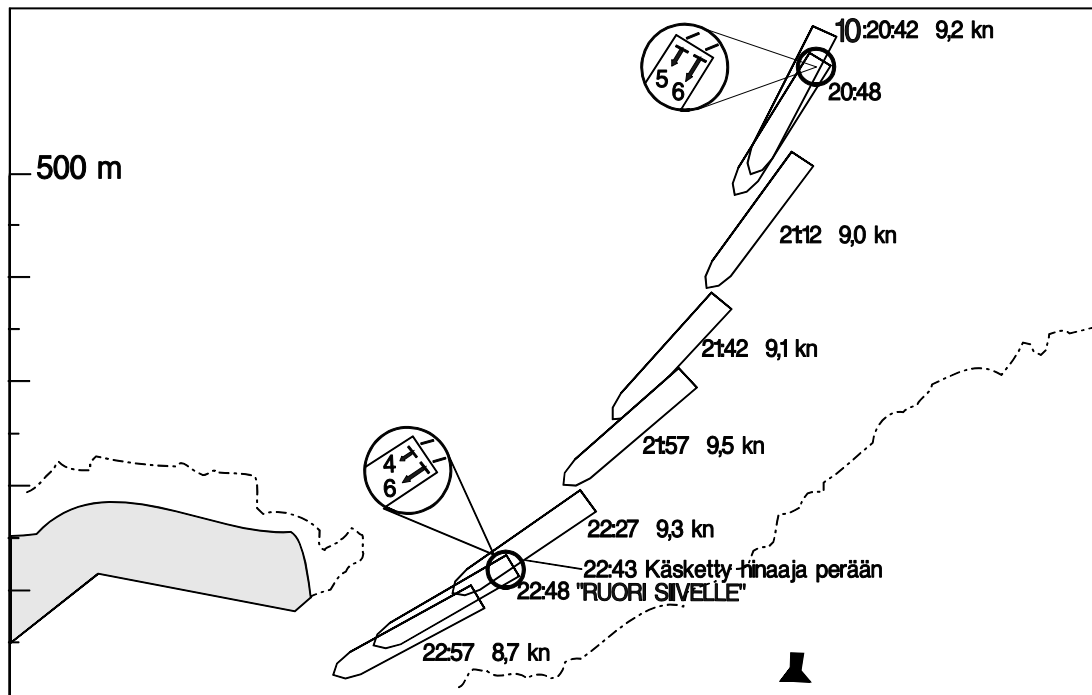
Figure 15. The turn towards the port. The settings of the rudders and propellers can be seen as the enlargements drawn in the circles. The exact values are presented in the table 9. The master took over the manoeuvrings to the bridge wing at the breakwater.

At 10:20:48 The rudders were turned to port so that the angular velocity would decrease. The engine order was still high.

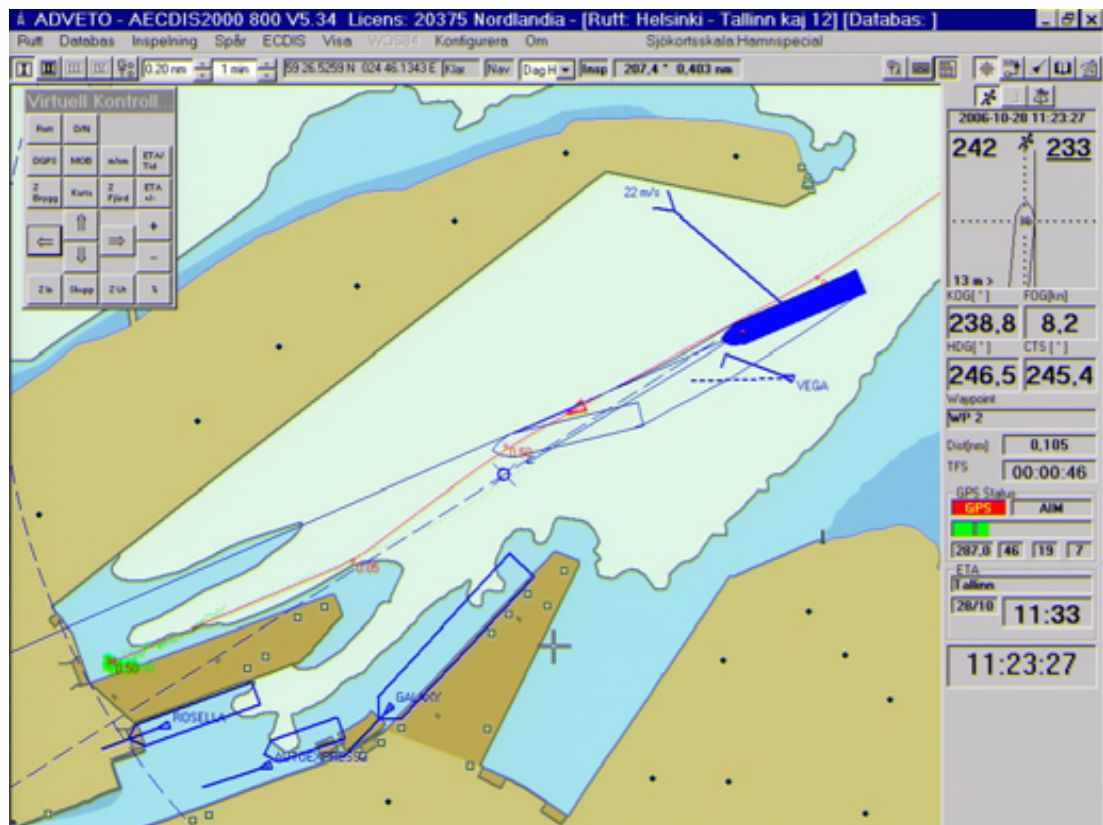
Figure 16. VDR-recorded picture from the electronic chart (ADVETO) 10:23:27.

The VDR saves the pictures from the electronic chart (ADVETO) at a time interval of 15 seconds. In the chart are also the position coordinates of the vessel. A recorded picture at 10:23:27 has been presented in Figure 16. The changes in the rudder and propeller effects have been registered and the positions of the vessel when these changes took place have been interpolated to be between the above-mentioned positions in Figures 15 and 17.

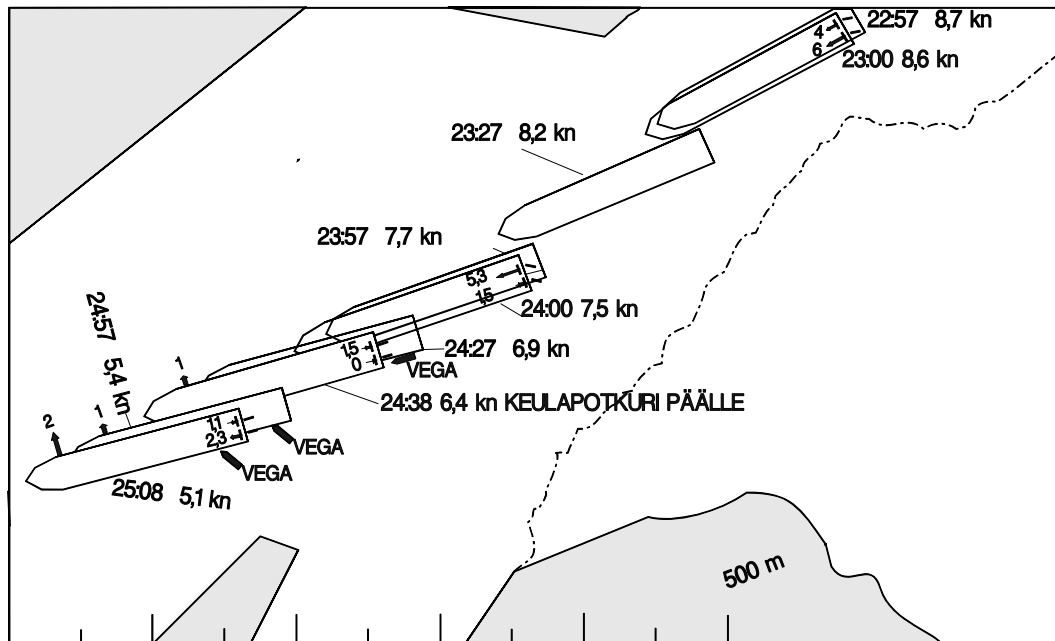
Figure 17. The setting of the propellers and rudders can be seen at the stern and the bow thruster setting 1-3 at the bow. Further details are available in Table 10. The VEGA starts pushing between 10:24:27 and 10:24:57. The data taken from the ADVETO-chart.

According to Figure 17 the manoeuvring orders given 10:23:00-10:24:57 were used to try to prevent the vessel from turning too much towards starboard and to decrease speed at the same time.

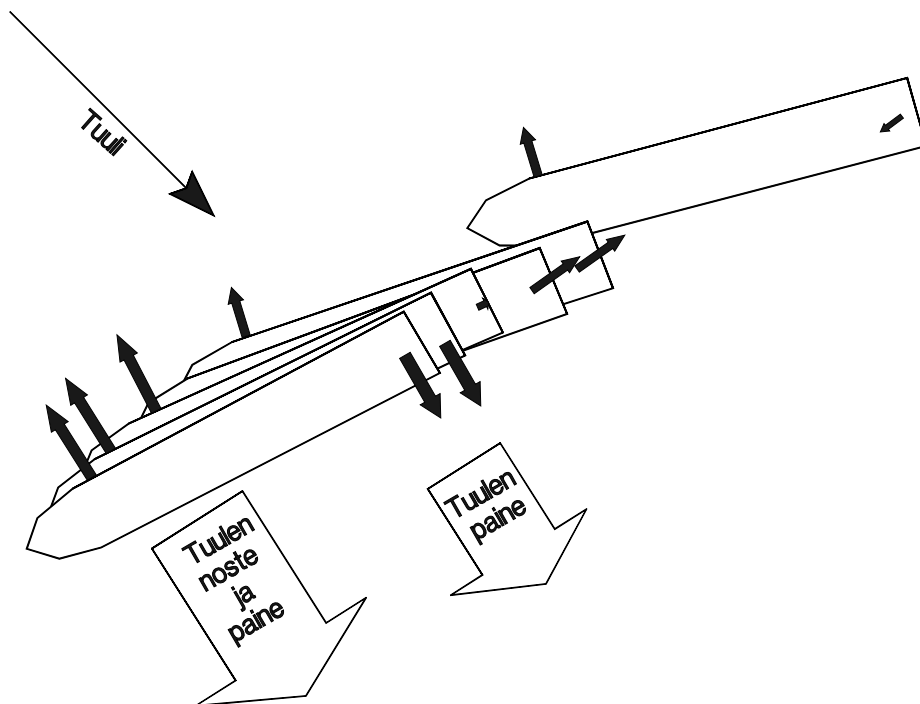
Figure 19. The settings of the vessel's rudders and propeller before the collision corresponding to figure 18 have been presented as approximate force vectors.

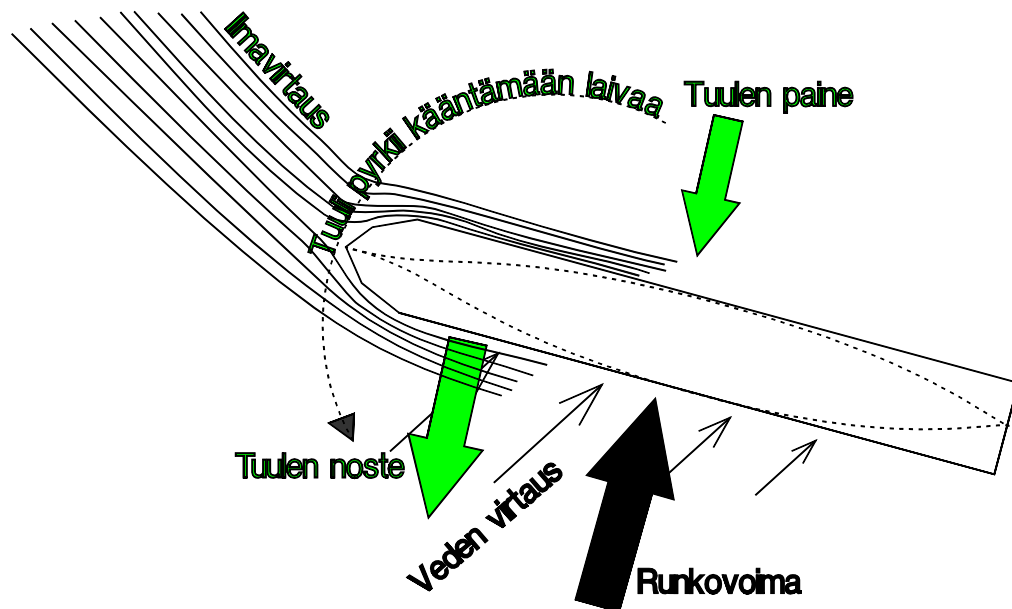
The large drift angle is used to compensate for the effects of the wind. The pressure of the water, i.e. hull effect, resists both the wind force and its turning effect on the vessel (Figure A1). The wind force has the tendency to turn the bow of the vessel to port. Gusty wind causes manoeuvring problems. Bow thrusters do not react to the gusts quickly enough. This reduces the wind limit. The speed of the vessel must not be too high. High speed multiplies manoeuvring errors' consequences and reduces the effect of the bow thrusters. Low speed is easy to correct.

Figure A1. The vessel is manoeuvred at a large drift angle in such a way that the effects (forces) of wind and water are equal. The wind has the tendency to turn the vessel.

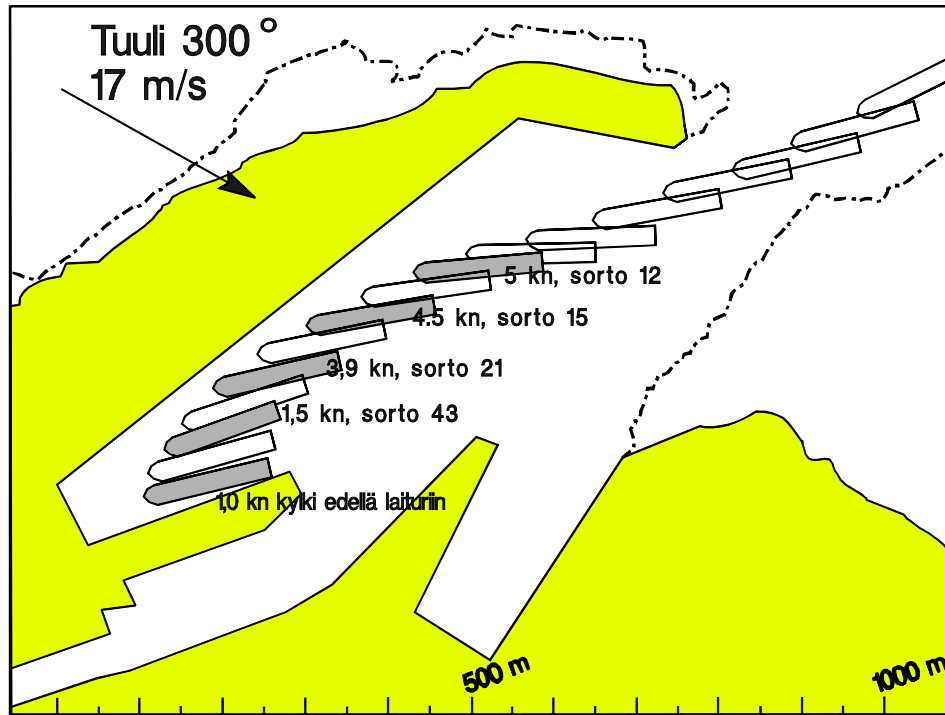
The model vessel did not reach the quay without damage when there were north-westerly (NW) winds of 17 m/s. If the quay is approached exactly in a parallel direction with the quay, a wind gust can "toss" the bow to port and the bow hits the quay constructions. The quay must be approached in such a way that the stern hits the quay first, but a too large angle in relation to the quay can lead the stern against the stone structure between the fenders.

Figure A2. The quay cannot be reached without damage when there are north-westerly (NW) winds of 17 m/s.

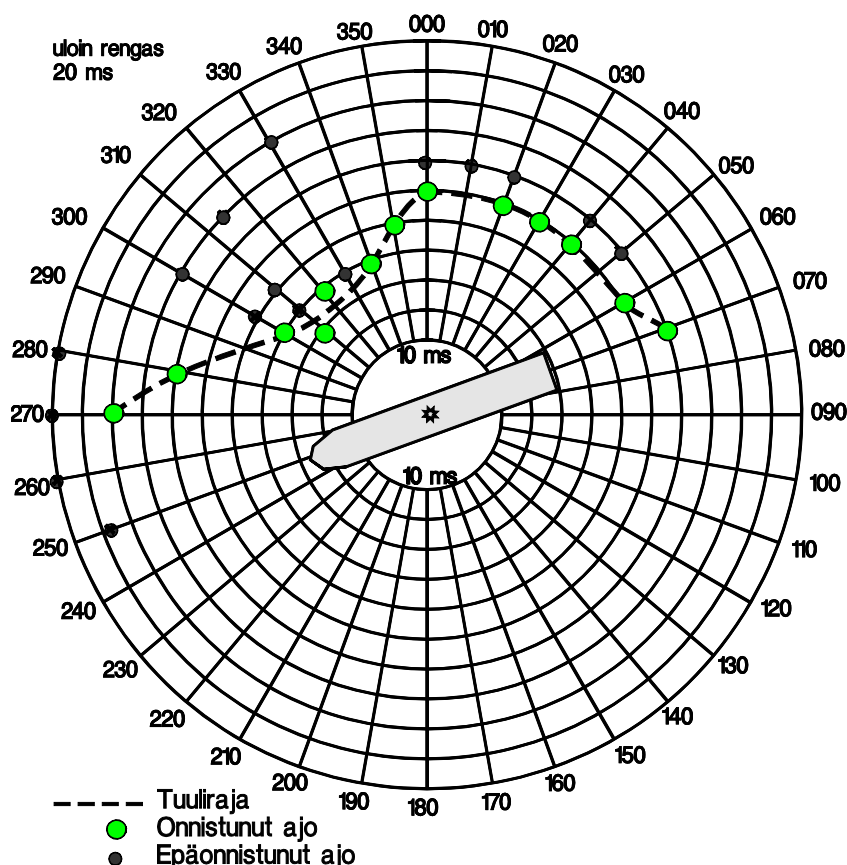
29 simulations were performed to determine the wind limit. The wind limit curve is presented in Figure A3. The wind affects the vessel most when the wind direction is 50°- 90° from the bow. When the wind turns to the aft side, the vessel can sustain more wind. The real wind limit of the NORDLANDIA is lower than the curve shown in the figure. In the mathematical model the bow thrusters were stronger. Therefore the wind limit must be defined 1-2 m/s lower than in Figure A3.

Figure A3. The wind limit determined with the help of simulation.

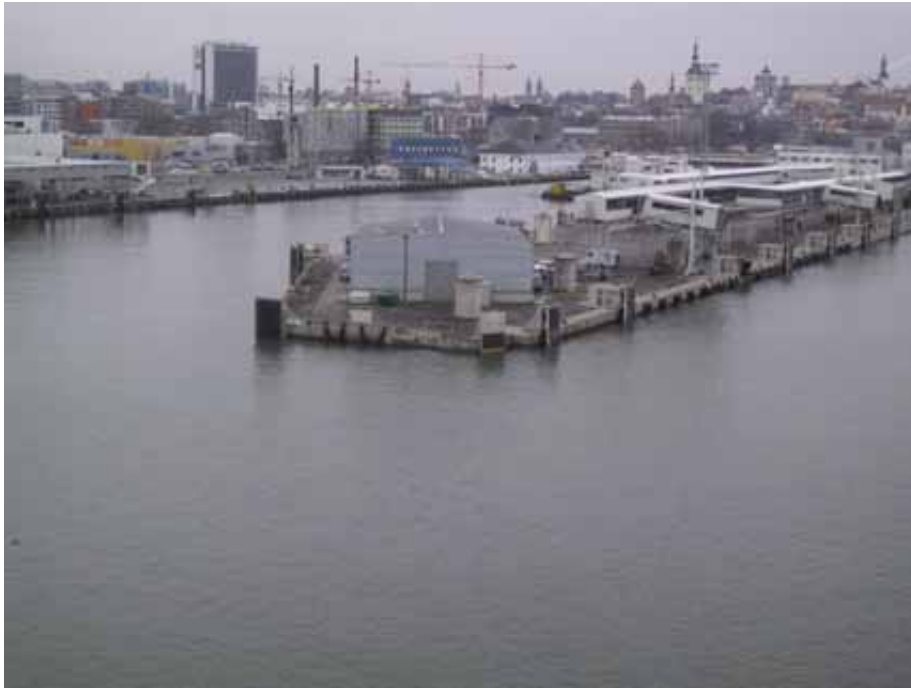
If the vessel is turned in the basin headwind and it leans against the corner of the quay, the wind limit can be increased. Figure A4 shows the corner of the quay used by the NORDLANDIA. A fender, which the vessel can lean against, has been built in the corner. The corner may not be sufficiently strengthened, but

Figure A4a. The quay used by NORDLANDIA.

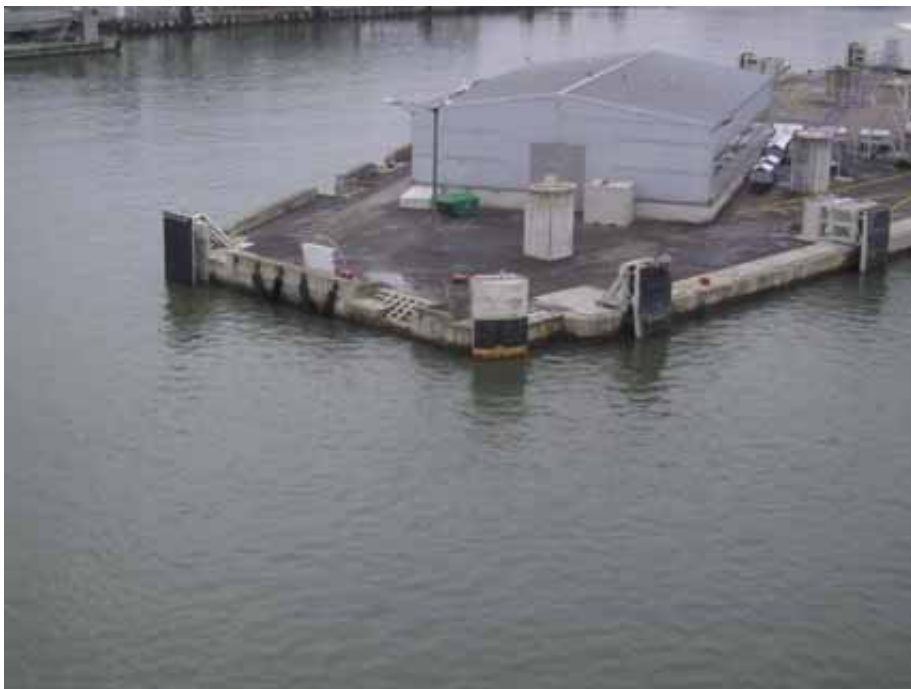
because a fender has been built there, this means that the corner can be leaned against when the vessel is turned towards the quay.

Figure A4b. There is a fender at the corner of the quay, and it can be used as support when the vessel is turned parallel with the quay.

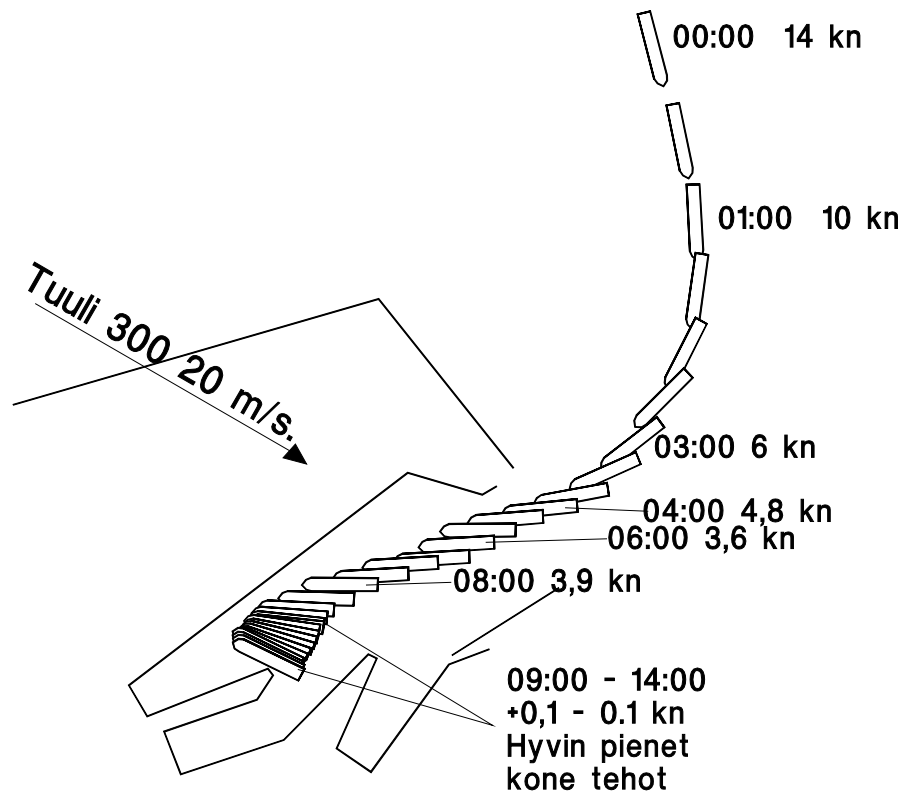
Figure A5. The last five minutes the vessel has to proceed slowly side first. Engine powers are very low. Using a tug is an important safety factor.

When the wind blows from between the directions 280°-030°, the vessel is turned against the wind in the port and then it proceeds sideways slowly to the corner of the quay. Figure A5 shows the track at a southwesterly wind of 20 m/s. This requires the use of a tug. How the vessel is manoeuvred is something that has to be agreed upon in advance with the tug. The length of the towing-line and where it is to be fastened are also factors which can be agreed on in advance. The towing-line should not be let go before the vessel is at the quay so that the cable does not foul the bow thruster. The language used when towing should be English and there should be an agreement on the terminology used in the communication.

In the simulation shown in Figure A5 the arrival to port took 14 minutes. During the last five minutes the vessel moves very slowly side first towards the quay. During the last minutes the vessel was almost still because the wind gusts almost pushed the vessel against the corner. A wind gust turns the vessel quickly in which case the vessel can be damaged. Therefore it is always safe to use a tug when a strong wind is blowing directly from the bow. In a way the vessel "hangs" on the towing-line in the wind. A tug reduces the effects of the gusts, and the bow thrusters are given time to fix the problem.

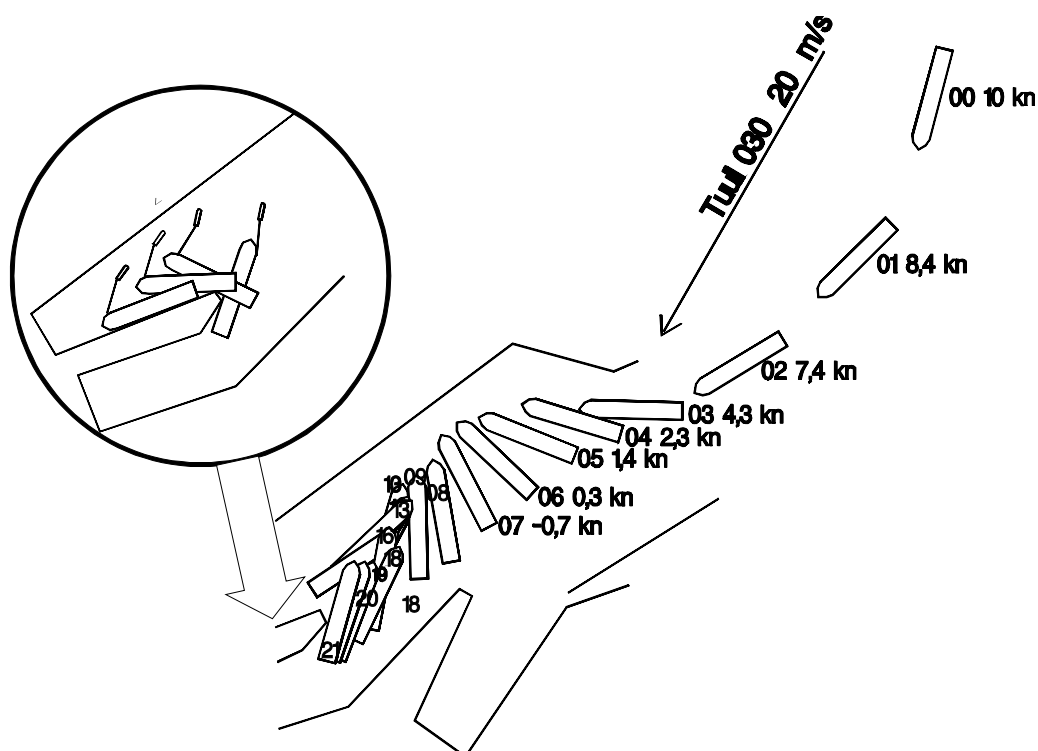
Figure A6. The vessel is turned against the wind. Without a tug it is difficult to keep the bow of the vessel in the wind. Between the times 09-19 in the simulation clock the vessel almost slipped out of the hands. A tug would keep the movements of the vessel steady. The tug helps the vessel around the corner of the quay.

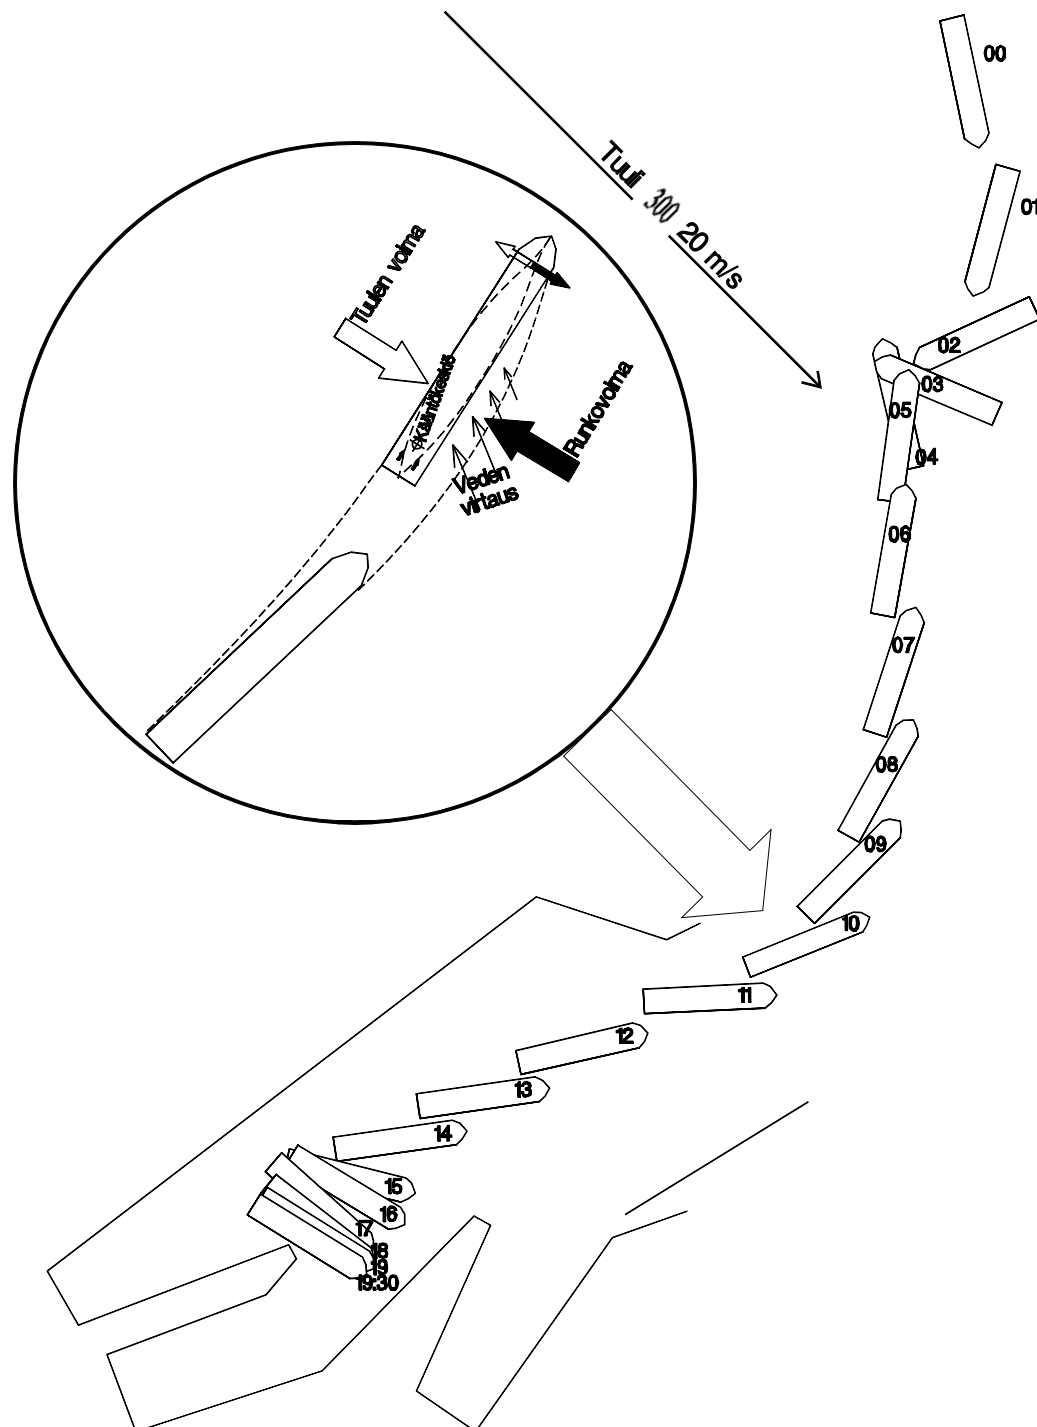
A wind blowing from the stern does not cause as strong wind force as a wind blowing diagonally from the bow. There are rails, gangways and other irregularities at the stern, and they cause whirlwind. When backing, the wind forces stay small. It is easier to manoeuvre the vessel in the basin in a wind blowing from the stern than in a wind blowing from the bow.

Figure A7. The vessel is first turned outside the port and then backed to the corner of the quay stern against the wind. From there the vessel is backed alongside the quay to the ramp.

The way of manoeuvring described above allows port entry when the wind blows 20 m/s from between the directions 270°-360°.

When proceeding bow first to Tallinn, one notices that strong winds come from the bow. If one does not want to use tug assistance, it is possible to back to the port. This also requires that the corner of the quay is used as support in the middle of port manoeuvring. Cars should be loaded from the bow in Helsinki and from the stern in Tallinn. The passenger gangway must be moved.

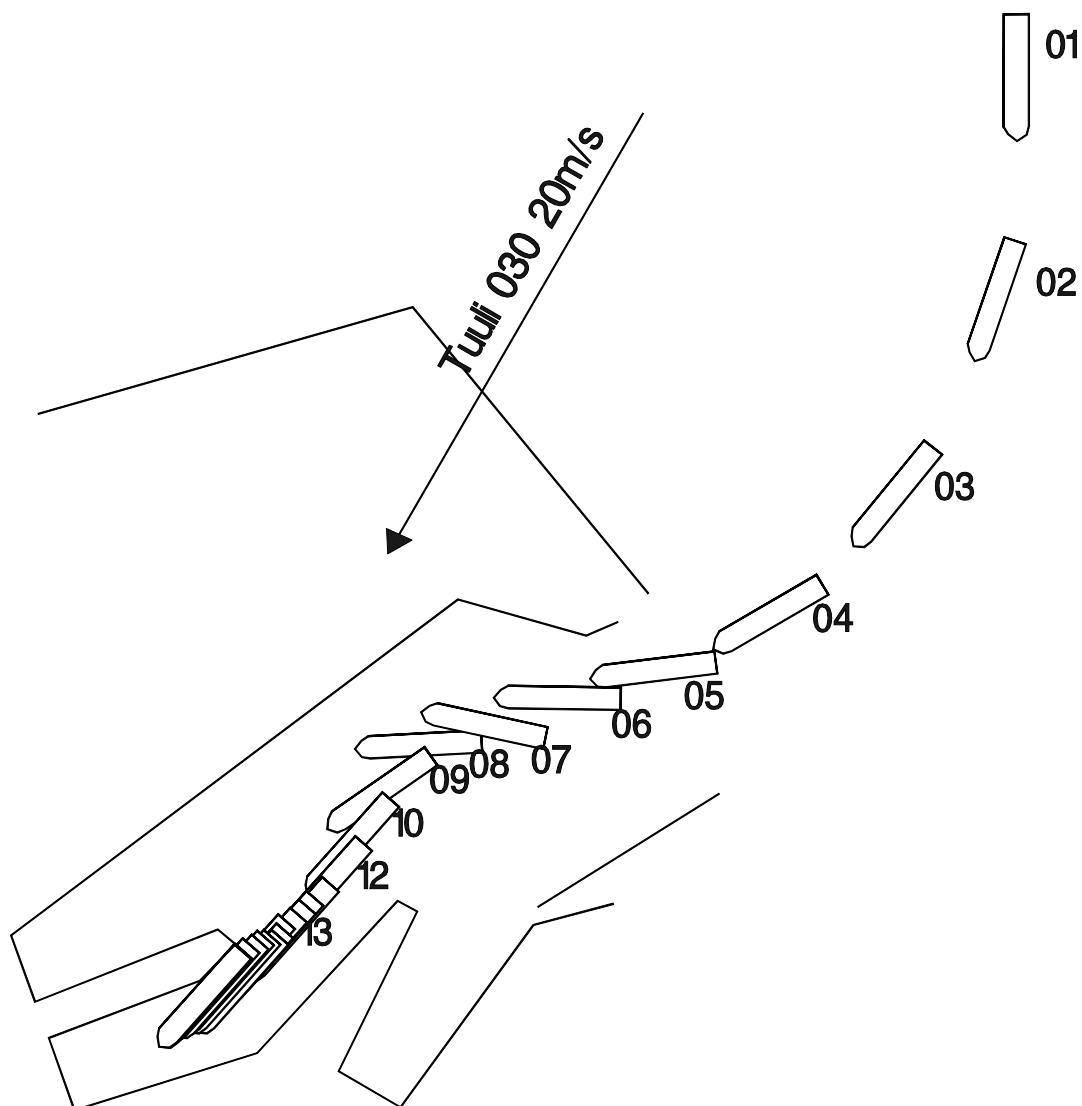
Figure A8. When the wind blows 030°, the vessel is turned in the port area in such a way that the corner of the quay is approached using the 210° counter direction of the wind.
