Investigation report

C2/2009M

M/T CRYSTAL PEARL, ramming of edge mark Lålättan on 26 January 2009

Translation of the original Finnish report

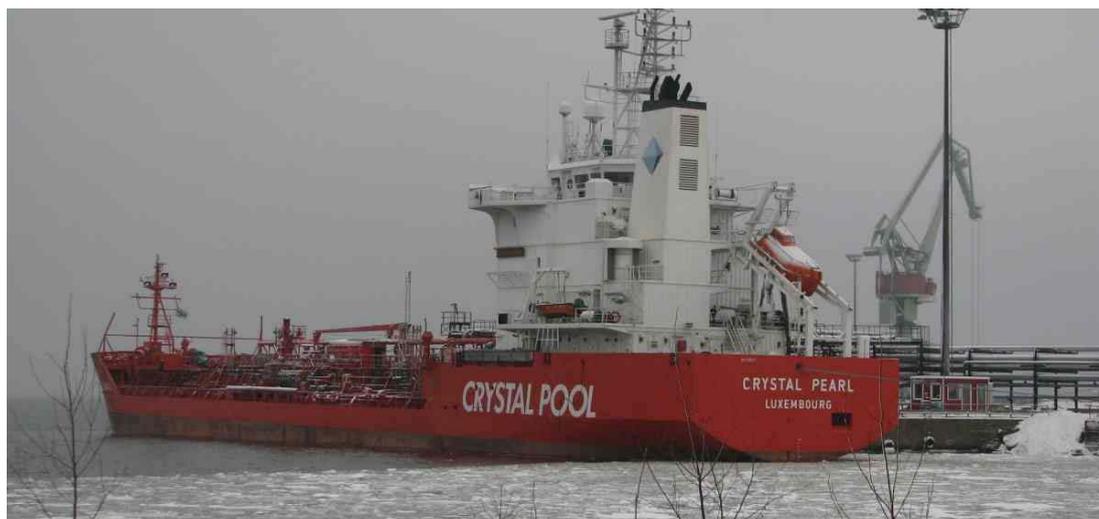
Picture 1. Picture taken in the port of Mussalo after the accident.

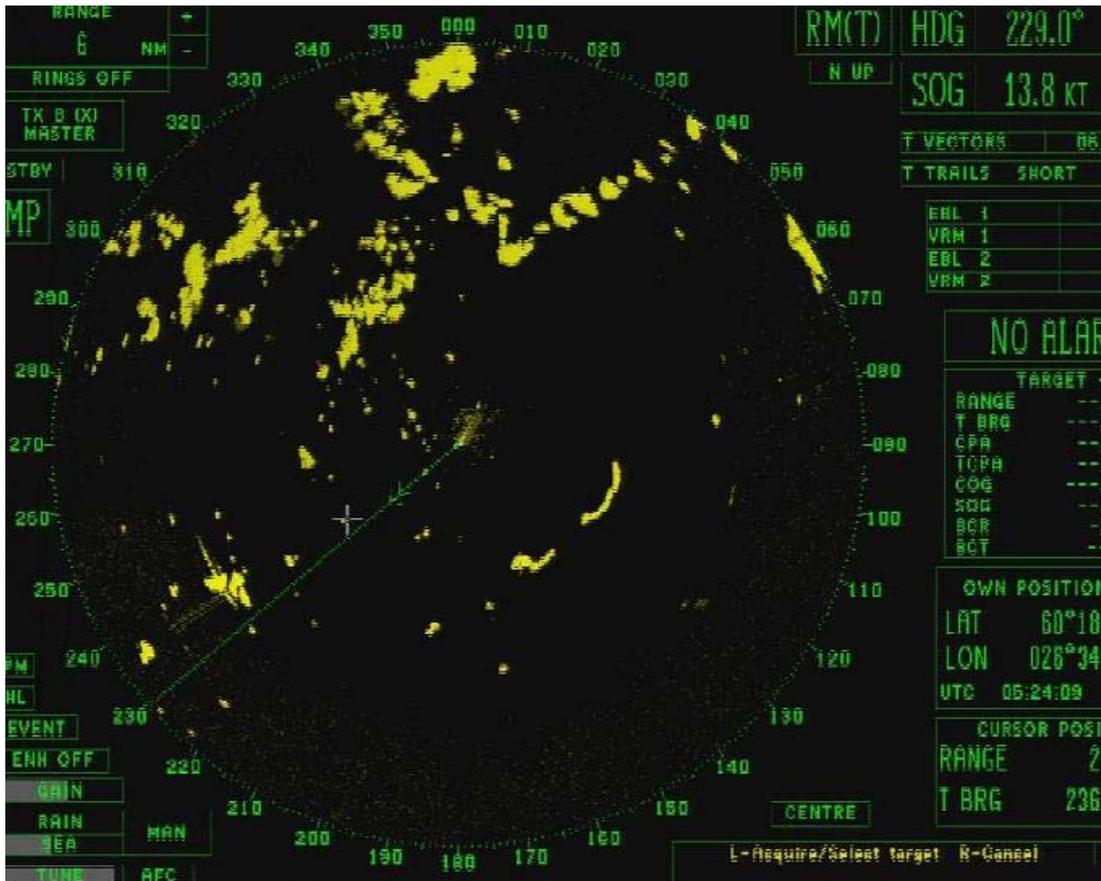
Picture 11. Radar picture in VDR storage at 07:24:09, range scale 6 nautical miles.

The tuning, adjustments or other actions with the radar and mentioned in the pilot's declaration could not be verified from the VDR recordings. For example the position check with the help of VRM (0,5 nm), mentioned by the pilot, when passing on Bisagrund cannot be observed from the recording. After the crash the range was switched to 3 nautical miles at 07.41 hours.

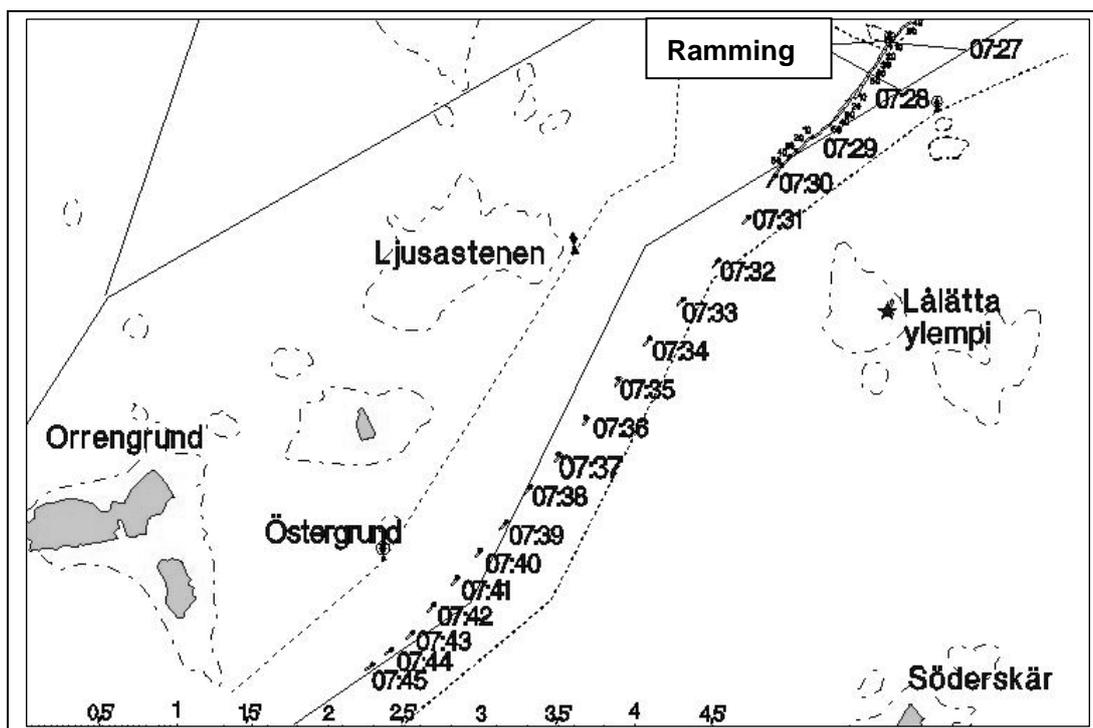
Picture 14. 10 minutes after the accident the speed of the vessel was 11 knots.

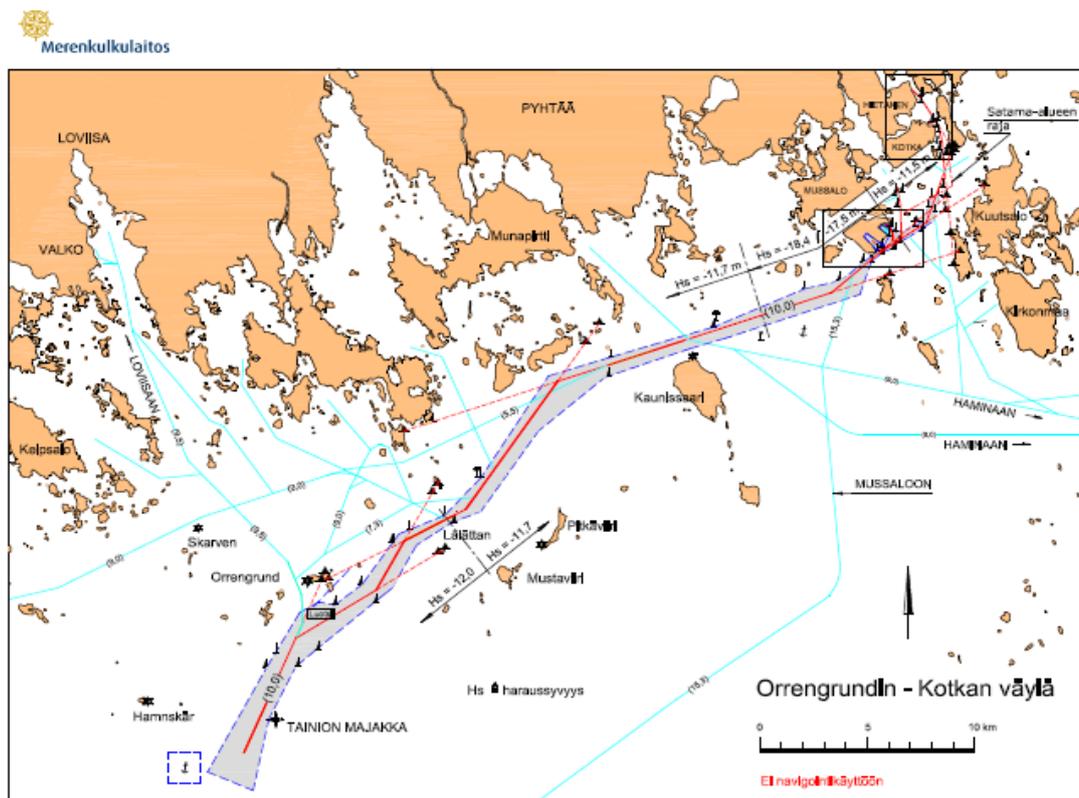
The Orregrund-Kotka fairway was completed year 1954. The general planning criterion of the fairway layout was made for optical navigation. The fairway legs were short and equipped with leading lights near to wheel over points causing the fairway to become very curvy. Thus the fairway allowed a better optical navigation environment even on reduced visibility conditions. Before radar assisted navigation the piloting service used a different set of navigational marks for daylight and for darkness. Later, the more common use of radars for navigation and position definition made it possible to use the same piloting method both on day and night time. The use of radar made it possible to cut across the turns and provided, together with very general piloting instructions, a favourable selection of the navigation lines to the pilots when planning their piloting.

Picture 16. The fairway description.¹³
