Investigation report

C3/2009M

M/Y NINAMARIA II and S/Y ILONA, collision to the north of Vänö on 27 June 2009

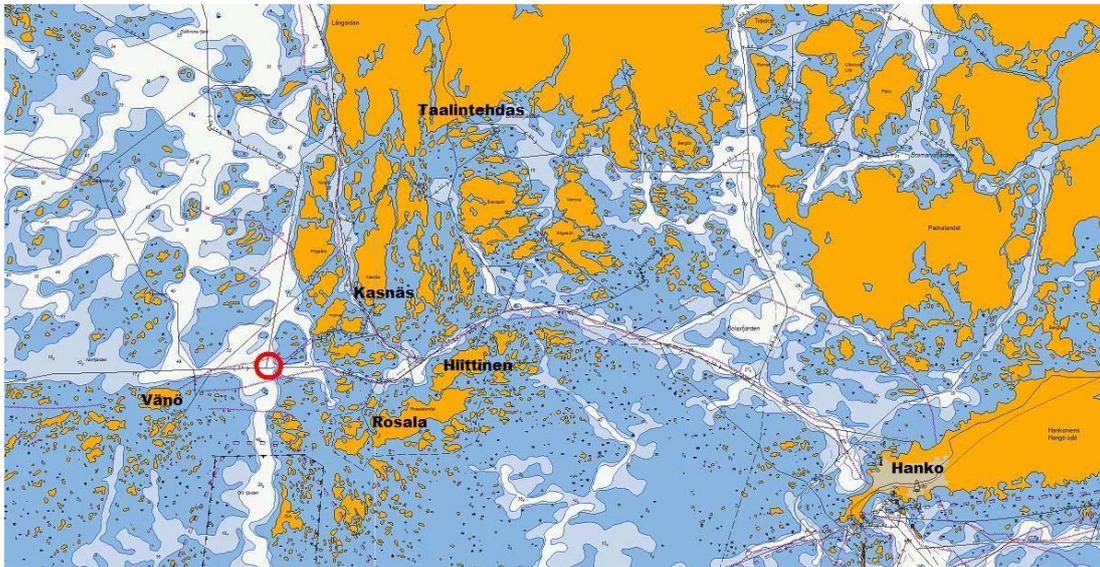
At the beginning of the situation leading to the incident, ILONA was further to the west and ahead of NINAMARIA II, having just passed the Vitgrund star buoys to the east of Vänö.

Figure 3. The red circle marks the scene of the accident.
(Chart: Finnish Transport Agency)

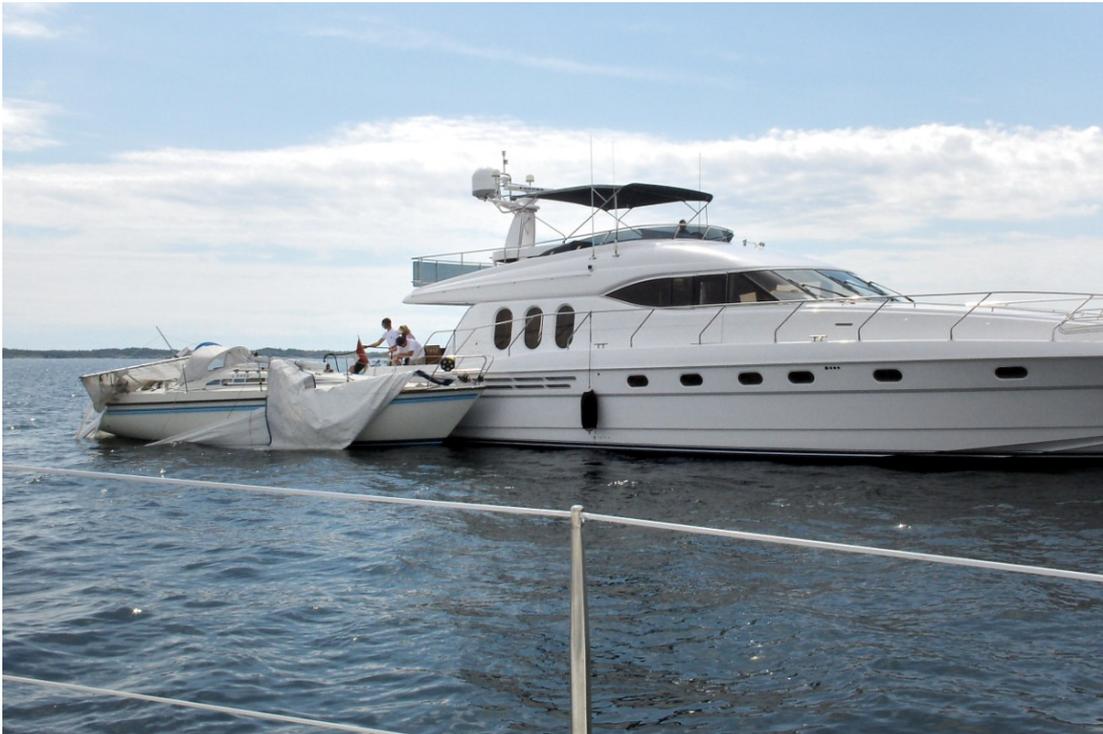
Figure 5. A photograph taken by an eye witness at the scene.

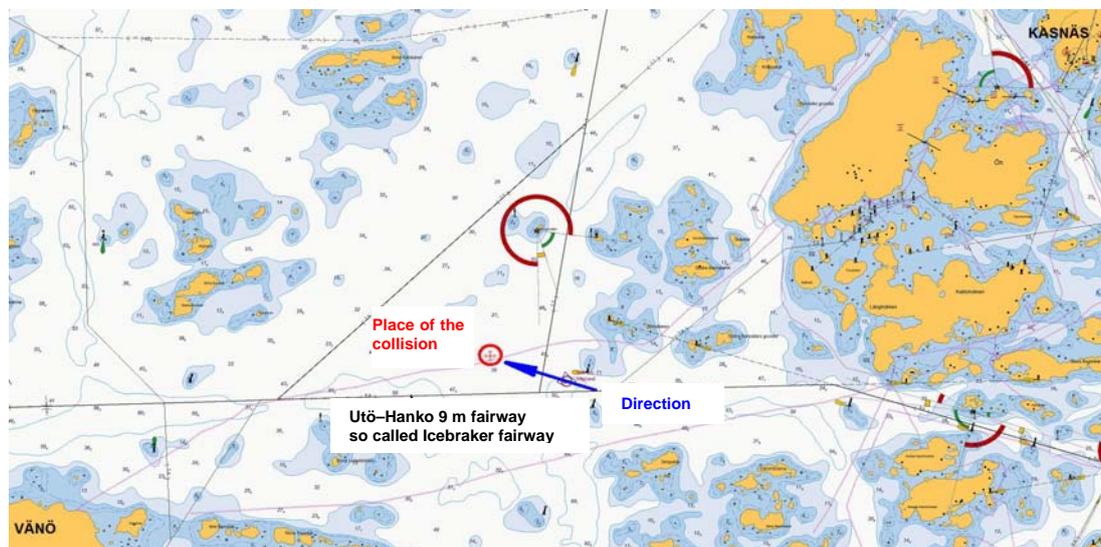
The location of the scene of the collision is slightly inaccurate. The position coordinates given in the emergency call presumably were slightly off the scene of the collision due to the boats drifting after the incident. The plotter trace on NINAMARIA II shows that the boat had turned right as a result of the collision and then travelled on for some distance before stopping and turning back. As the scene of the incident can be regarded the position where the trace in NINAMARIA II's plotter turns right.

NINAMARIA II was clearly approaching ILONA within the 135° stern sector specified in the rules of the road at sea, in which the approaching vessels is considered as the gaining one, and it has the duty to give way to the vessel it is gaining on.

Figure 10. The investigators' opinion of the site of collision. (Chart: Finnish Transport Agency)

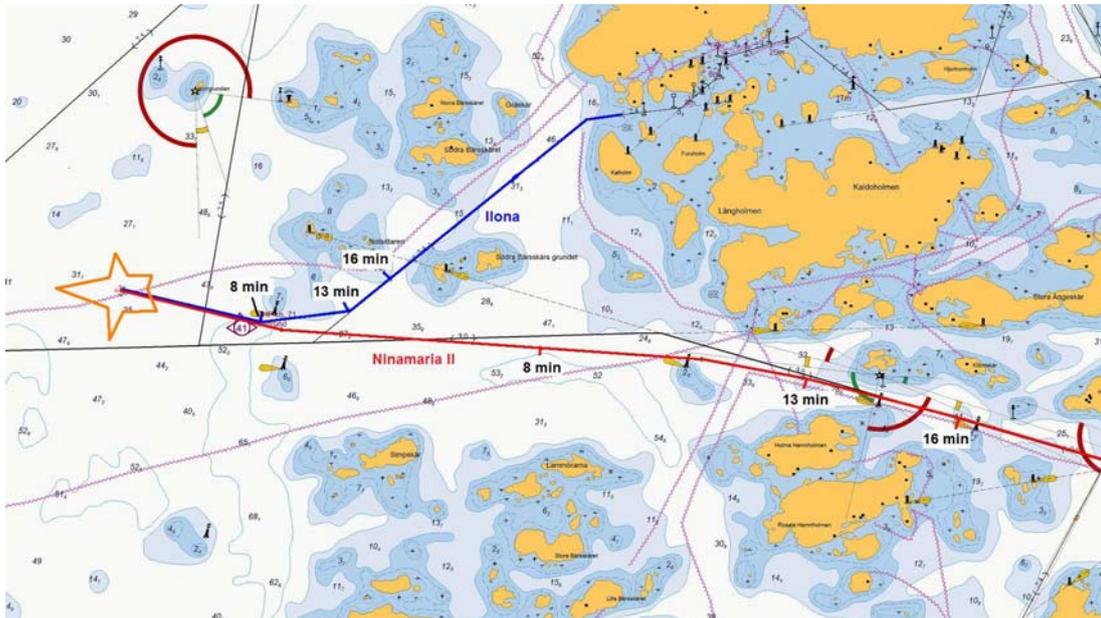
If we presume that ILONA's speed was 4 knots and NINAMARIA II's 12 knots, the mutual positions of the boats can be reconstructed as shown in the attached map. This examination is approximate, but accurate enough to clarify the fact that ILONA had been visible to NINAMARIA II for some quarter of an hour before the collision, and that in practice, ILONA was directly or nearly directly in front of NINAMARIA II's bow the entire time. In practice, ILONA had been visible even before this, as its sail could be seen across the islet of Södra Bärsskärsgrundet.

Figure 11. An approximate estimate of the boat's courses before the collision. ILONA was sailing from northeast and NINAMARIA II from east-southeast. The courses of the boats meet near the Vitgrund spar buoys. The Figure shows the positions of the boats 8, 13 and 16 minutes before the collision. This examination indicates that ILONA was visible to NINAMARIA II in the bow sector for at least quarter of an hour before the impact. (Chart: Finnish Transport Agency)

ILONA could not have appeared in front of NINAMARIA II suddenly and without warning. The fact that the sailing yacht in reality was only observed in the last moments in the situation shows that the Master of NINAMARIA II completely failed in his task of operating a motor boat in the Finnish archipelago. The Master's attitude to his task was irresponsible.
