## Investigation Report

C4/2009M

### **M/S SILJA EUROPA (FIN), Breaking of the Starboard Rudder Shaft in the Aland Archipelago on 22 November 2009**

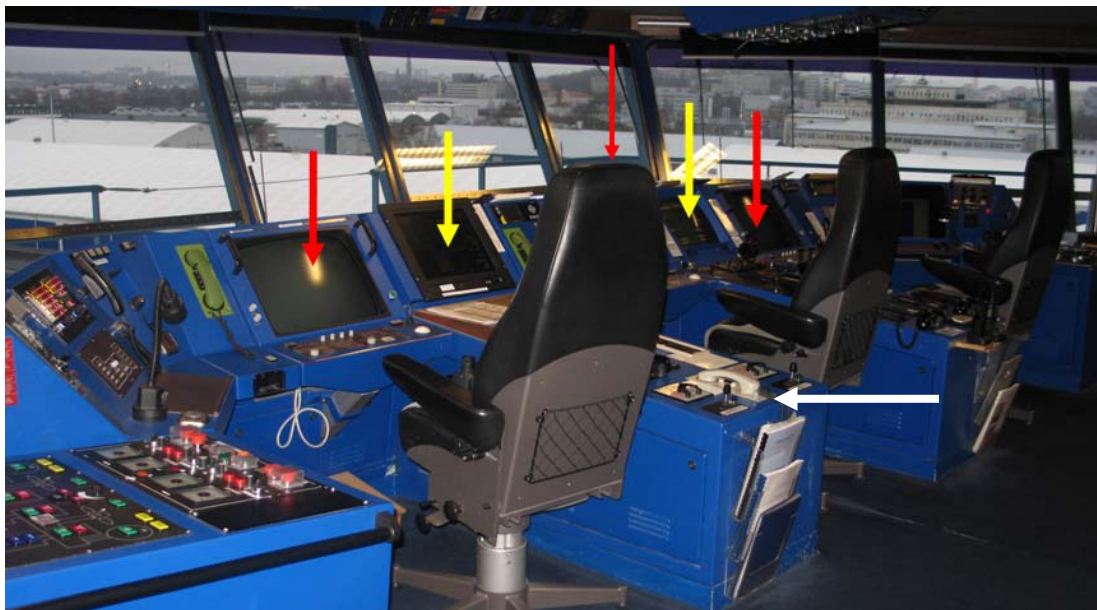
Figure 2. View from the navigating bridge, the vessel's steering positions. The picture was taken on 24 November 2009 in Turku. The red arrows point to the radar displays (one of them is hidden behind the chair) and the yellow arrows indicate the conning displays. The route pilot's chair (main steering) is in the middle, the OOW's chair (monitoring navigator) is to the right and to the left is the Master's chair. The white arrow indicates the control console of the hydraulic accumulators of the steering gear, the levers on the right and left side.

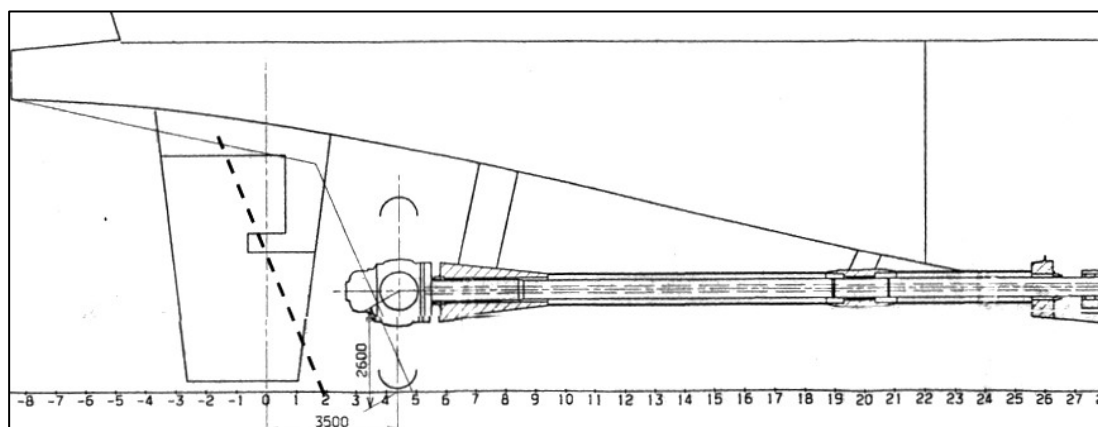
Figure 3a. The propeller-rudder arrangement of the SILJA EUROPA. The stern fin was extended already in the summer of 1993 (broken line). This assessment has been made on the basis of a photograph taken in Gdansk on 2 December 2009.

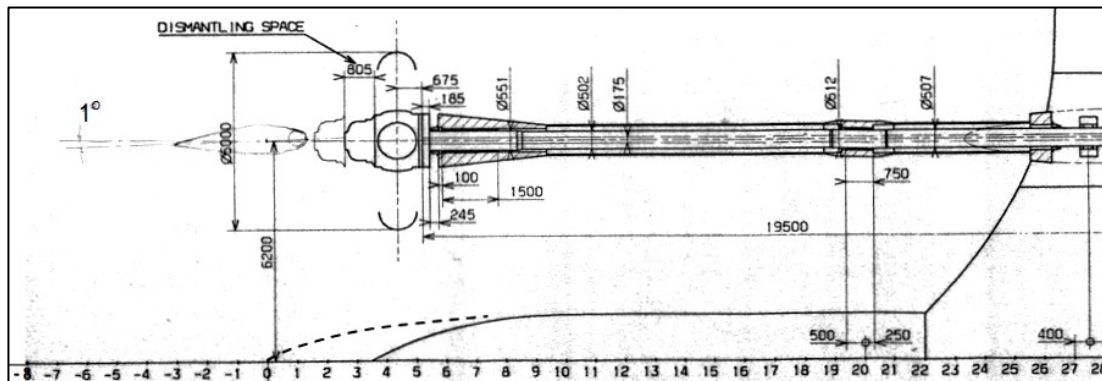
Figure 3b. The propeller-rudder arrangement of the SILJA EUROPA. The frame spacing is 800 mm.

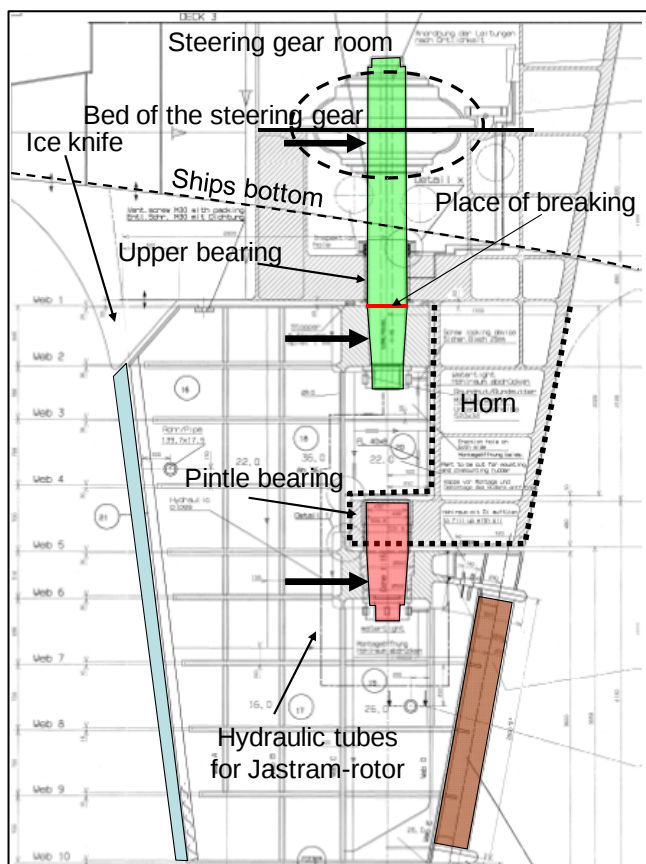
Figure 4. The rudder. The green colour indicates the rudder shaft, the red colour the lower shaft (pintle shaft, lower spindle), the brown colour the Jastram-rotor and the blue colour the extension of the rudder which was added already before the vessel was delivered. The thick arrows show the interference fits. The dotted line indicates the rudder horn, which joins closely the hull of the vessel through the streamlined intermediate structure. The steering gear has been circled with a broken line. Diagonal lines have been used to indicate the casting.

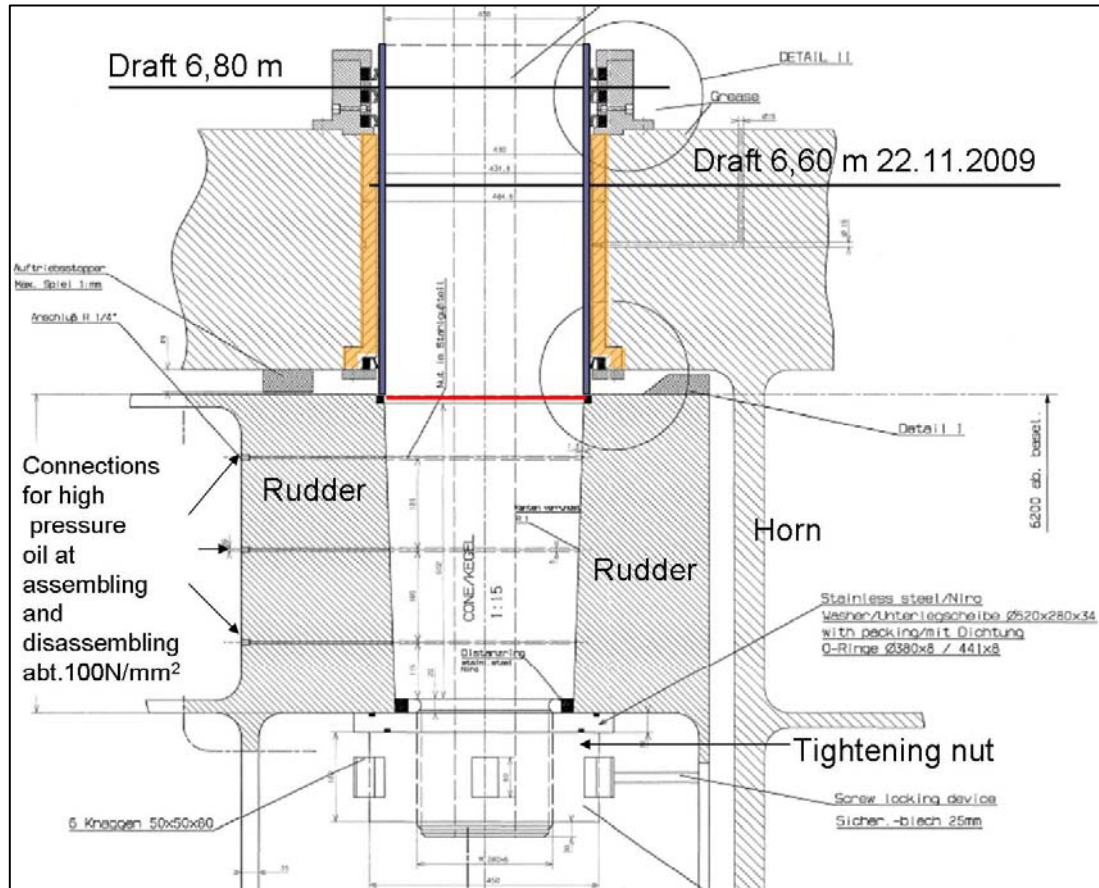
**Rudder bearings.** A tightening nut, connections for high pressure oil, the breaking point of the shaft and draughts have been marked in the picture showing the *upper bearing*. The materials are the same as in the pintle bearing, Figure 5b.

Figure 5a. A drawing of the upper bearing of the rudder. The taper connection of the rudder shaft to the rudder can be seen in the drawing. The bronze bush has been indicated with orange colour, the stainless steel liner with blue-grey. The bearing clearance is 1.8 mm (431.8–430.0). The breaking point of the SB rudder shaft has been indicated with red colour (at the point where the cone changes into a cylinder). Diagonal lines have been used to indicate the casting.

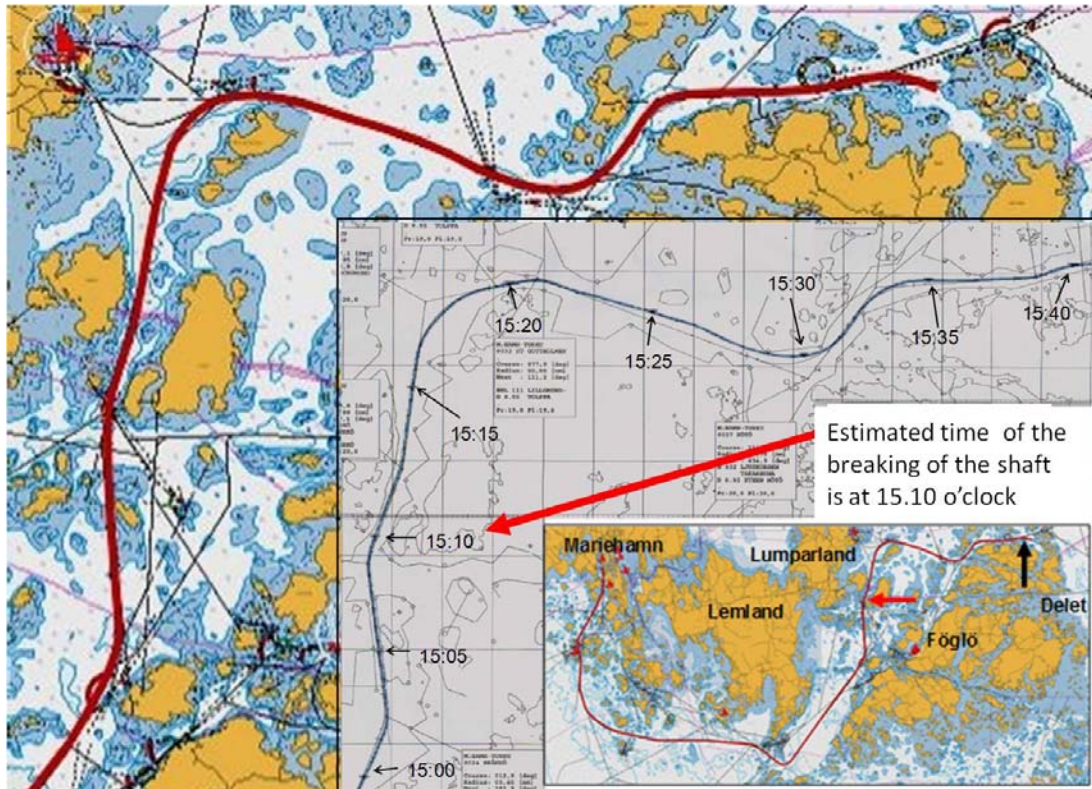
The chart drawing below (Figure 7) presents the route of the accident voyage near the Långnäs in the Aland Archipelago at the time when the rudder failure developed. It is presumed that the SB shaft broke in the position indicated by the red arrow. The black arrow points to the position where the vessel was stopped and steered off the channel, to "a pocket".

Figure 7. The accident voyage at Långnäs. It is presumed that the SB shaft broke at the point indicated by the red arrow. The vessel was stopped at the position indicated by the thick black arrow. The channel from Mariehamn to the open sea area at Teili includes several bends and narrow and shallow sections.

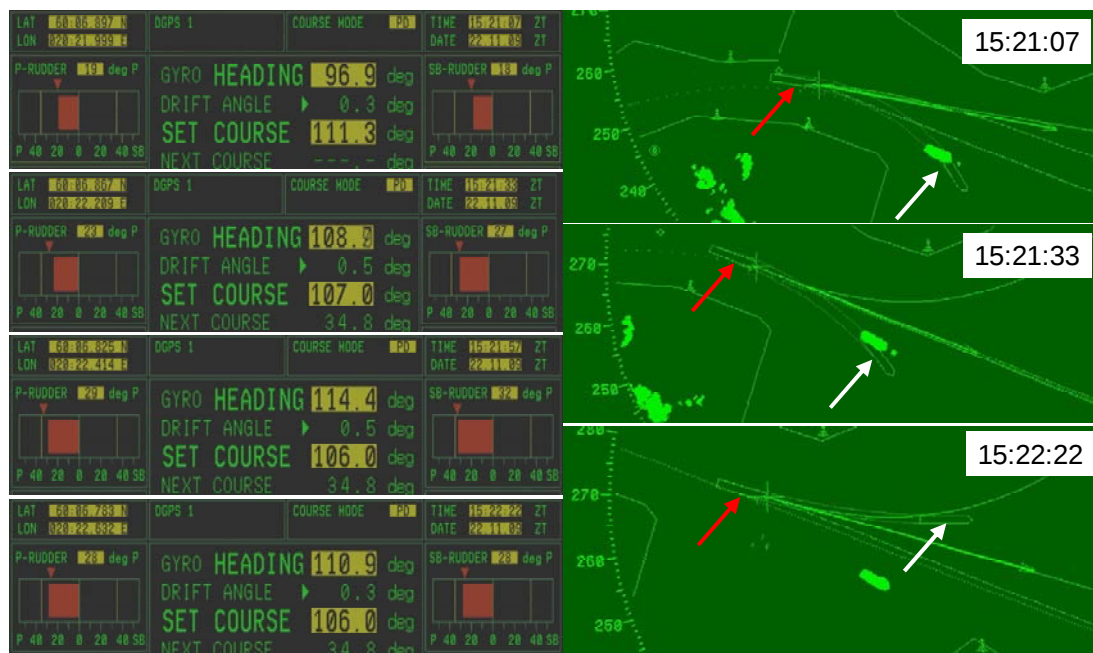
Figure 8. Large rudder angles used in the counter rudder after a turn to starboard commenced at 15:20 (Figure 7) shown on the conning-display (to the left) and corresponding picture of the radar display (to the right); the rudders are turned to port: BB rudder angle on the left and SB rudder angle on the right. In the radar pictures the position estimated by the predictor after a minute has been marked with a white arrow and the vessel's position at that particular moment with a red arrow. The green radar echo close to the white arrow is the M/S FJÄRDVÄGEN.

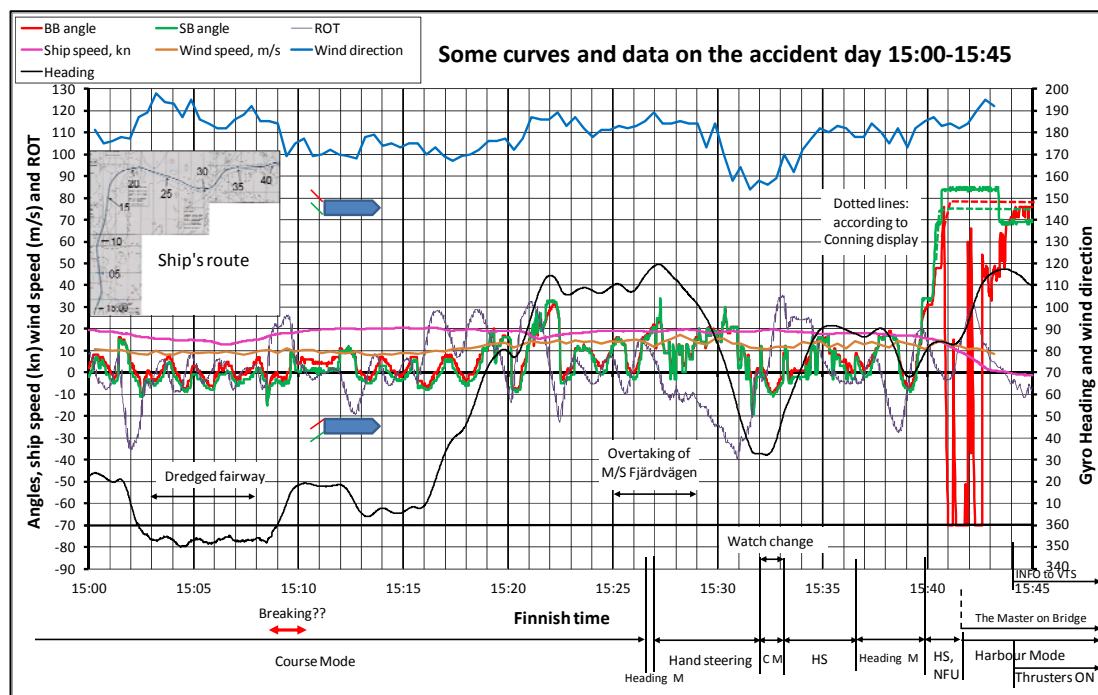
Figure 9. Information about the proceeding and steering of the vessel at the time of the accident. ROT stands for Rate Of Turn (the turning speed of the vessel, degrees per minute); Heading is the direction of the bow. After the breaking of the rudder shaft, SB-rudder angle equals to the angle of the angle indicator; the factual angle of the rudder remains unknown.

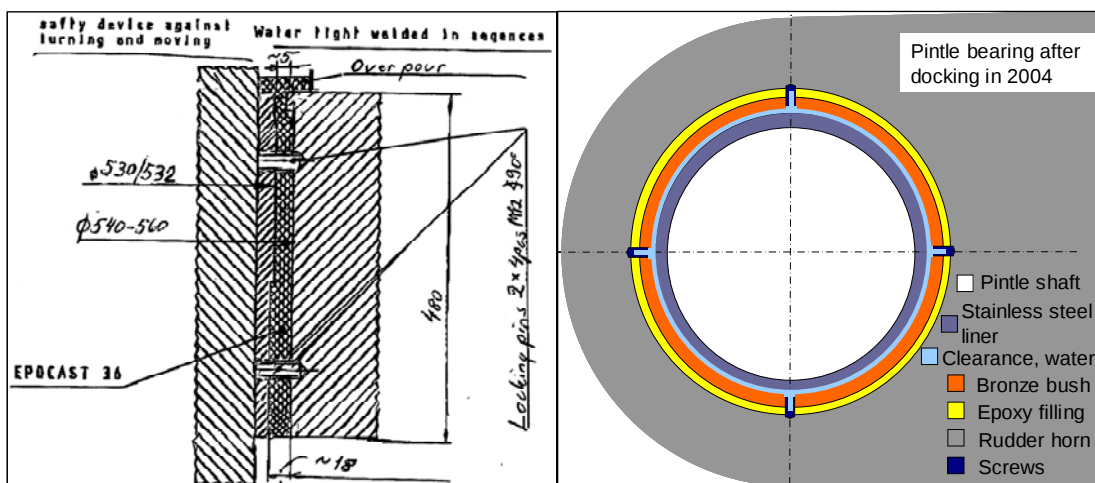
**Turku Repair Yard 30.8–8.9.2004.** The vessel had with her new slabs for the bronze bushes of the pintle bearing probably because of the increased clearances detected in the 2002 docking<sup>16</sup>. The bronze bushes of the pintle bearings of both rudders had dropped approx. 50 mm. All clamping screws from the upper edge had disappeared. It was discovered that the clearances had increased and that they now exceeded the limit allowed by the classification society. The clearance measurement was carried out in such a way that the wear on the pintle shaft and on (the inner surface of) the bronze bush were measured. The whole extent of corrosion was probably not detected in the clearance measurements. It was discovered by measuring the opening of the pintle bearing housing<sup>17</sup>. The opening proved to be too large for only the bush. The opening was not circular. Because of the short time reserved for the docking, such a solution was proposed to settle the matter which could be realised time-wise. A surface welding of the housing and reaming after that were not an option. It was decided that the corrosion was to be filled with Epocast-brand cast epoxy, which is commonly used when mounting machineries, Figures 14a and 14b. The repair shipyard had previously not used this repair method for vessels of SILJA EUROPA- size.

Figures 14a and b. Casting drawing of the epoxy mass (a, to the left) and a cross cutting of the pintle bearing (b, to the right) in the 2004 docking. The hex sockets of the screws have been drawn in the picture. The sockets filled with water.

Epoxy mass (Epocast 36<sup>18</sup>) was cast in the hole between the bronze bush and the housing from above in such a way that a brim was formed, Figures 14a and 14b and 5c. There was a counterpart at the bottom during the casting. For centring the bronze bush, hexagonal socket-head screws going through the bush and epoxy were used, see Figures 14a and 14b.

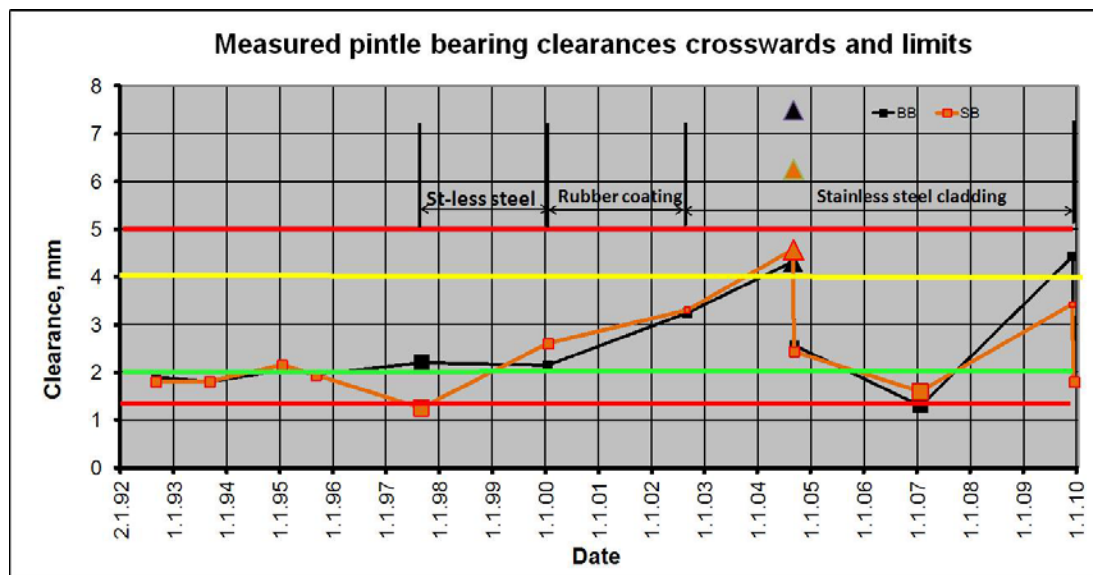
The measured pintle bearing clearances crosswise and some limit values for the clearance have been presented in Figure 15. It has not been possible to verify the comparability of the clearance measurements made at different points of time in the investigation. In practice the bronze bushes are replaced if the clearance clearly exceeds 2 mm.

Figure 15. Pintle clearance measurements, corresponds with Table 2. The measurements in which the rudder has been turned to the side are indicated with a larger square. The highest clearance measurement results have been obtained as the difference between the inside diameter of the bronze bush and the diameter of the pintle shaft, so they are the most accurate results. The green line presents a common, acceptable clearance of 2 mm, the yellow line the action limit of the classification society and the red line the absolute lower and upper limits for the dimensions corresponding to those of the SILJA EUROPAs rudder shaft. The time intervals for the different coatings have also been shown.

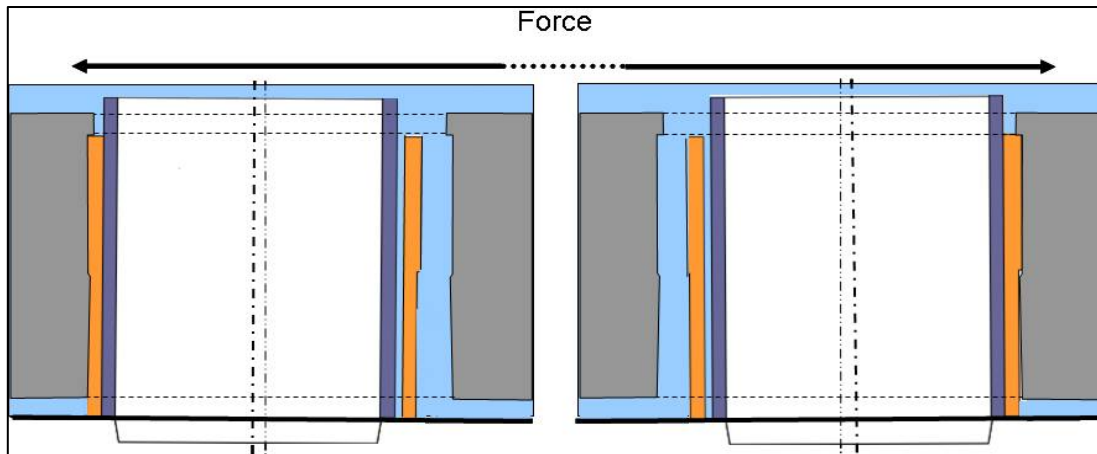
From the point of view of the bending of the rudder shaft, the corrosion of the pintle bearing had a crucial impact in the SILJA EUROPA case. The corrosion multiplied the deflection made possible by the clearance. The corrosion was caused by galvanic corrosion. The corrosion almost stopped after the 2004 reparations. In Figure 16 the corrosion has been presumed so extensive that the bush has dropped. The situation was like this when the vessel came to the dock in 2004. The theoretical amount of the pintle shaft to move horizontally is henceforth referred to as *free play*. It varies at the different height of the pintle bearing and at the different points on the bearing race. The pintle shaft moves crosswise approx. 8 times per second, which makes the water move in the clearance and in the corroded space (and after 2004 in the hex sockets of the screws) thus accelerating the corrosion.

Figure 16. The pintle bearing seen from astern. On the left the rudder shaft has bent to port and on the right to starboard. The pintle shaft and the dropped bush move  $\pm 15$  mm from one side to the other because of the corrosion of the housing. At the same time the rudder tilts. The height of the housing is 480 mm and the diameter of the bearing is 533 mm.

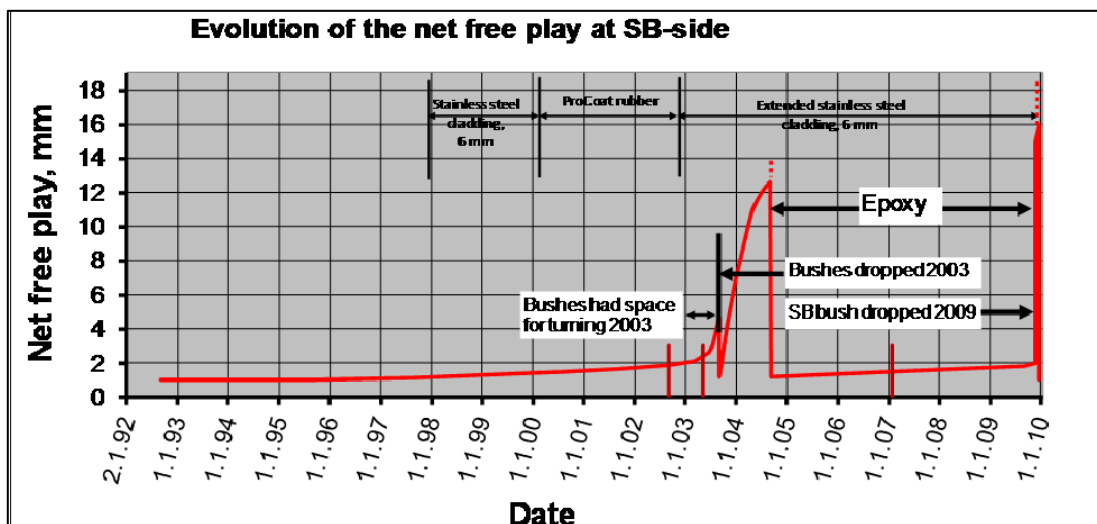
Figure 17a. An estimate on the evolution of the **net free play** of the SB pintle bearing. When the bush dropped in 2009, it is presumed that there was still epoxy left in its place. When the epoxy disappeared, the net free play increased erratically. The broken line shows the maximum estimate. The dockings in 2002, 2003 (clearances not controlled) and 2007 (the clearance measurement was not comparable) have been indicated with a brown vertical line.

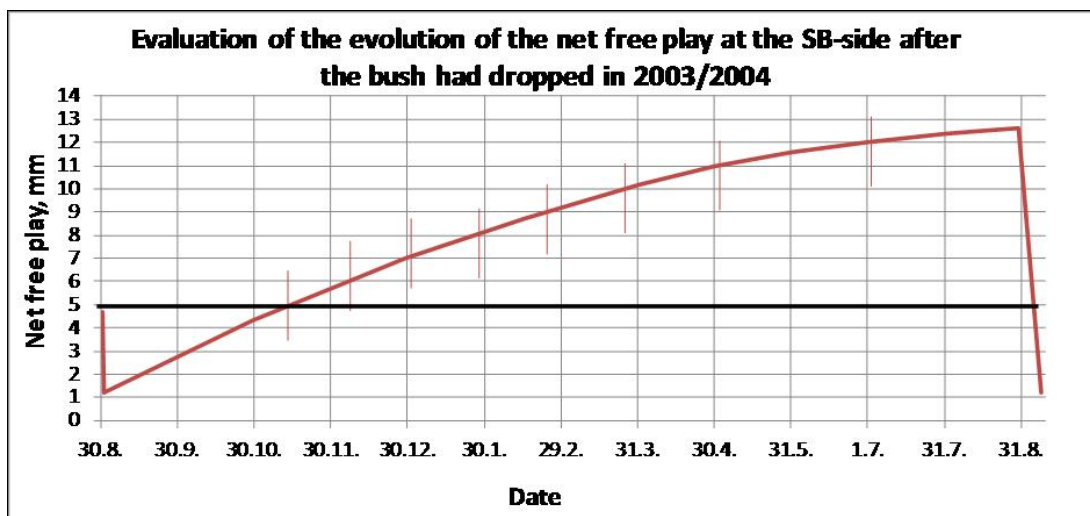
Figure 17b. An estimate on the development of **net free play** specified on the basis of Figure 17a. The vertical lines in the figure have been used to assess the duration of each net free play over 5 mm with the interval of one mm. It has been estimated in the investigation that the BB bush might have dropped a bit earlier.

Figure 17b presents also the approximate limit value of the net free play (about 5 mm) specified on the basis of fatigue calculations. Below this net free play limit the cyclic stress is at fatigue limit<sup>21</sup>.

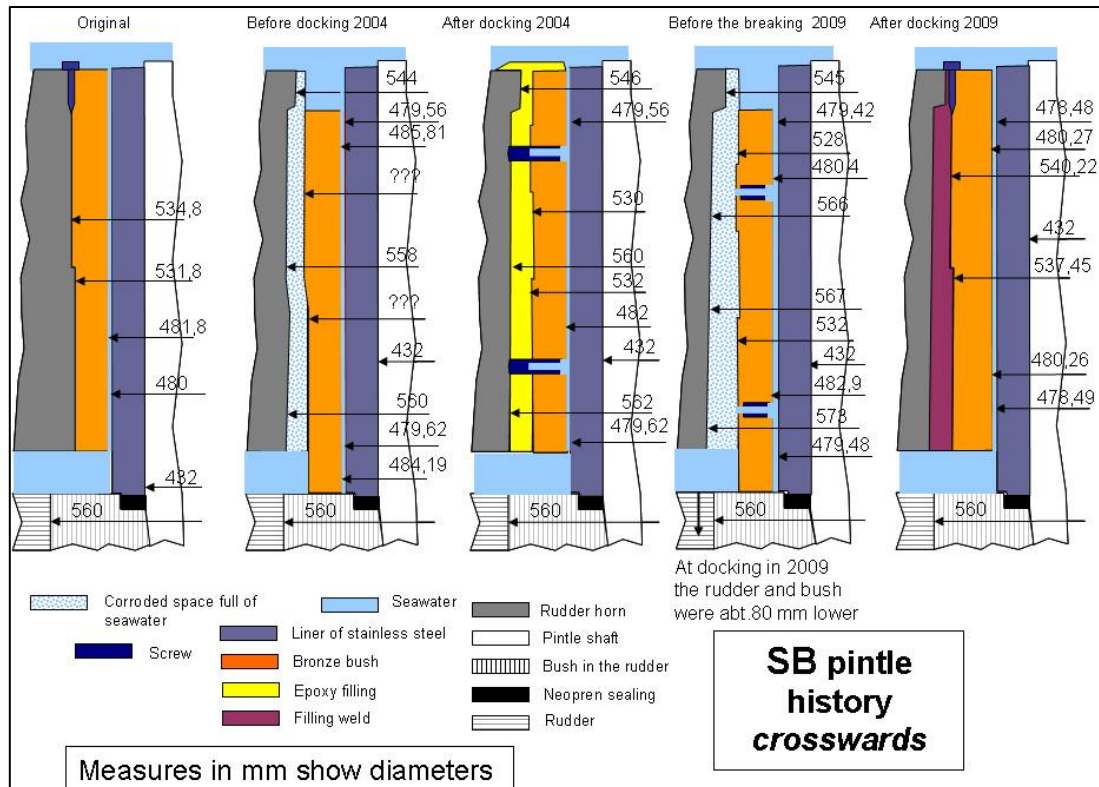
Figure 18. Some crosswise measurement results of the SB pintle bearing.

When compiling the picture it was presumed that the bend at the wall of the housing, which was caused by the notch of the bush, was grinded off in 2004 and the wall was made more even also elsewhere in which case approx. 1-2 mm of material was removed.

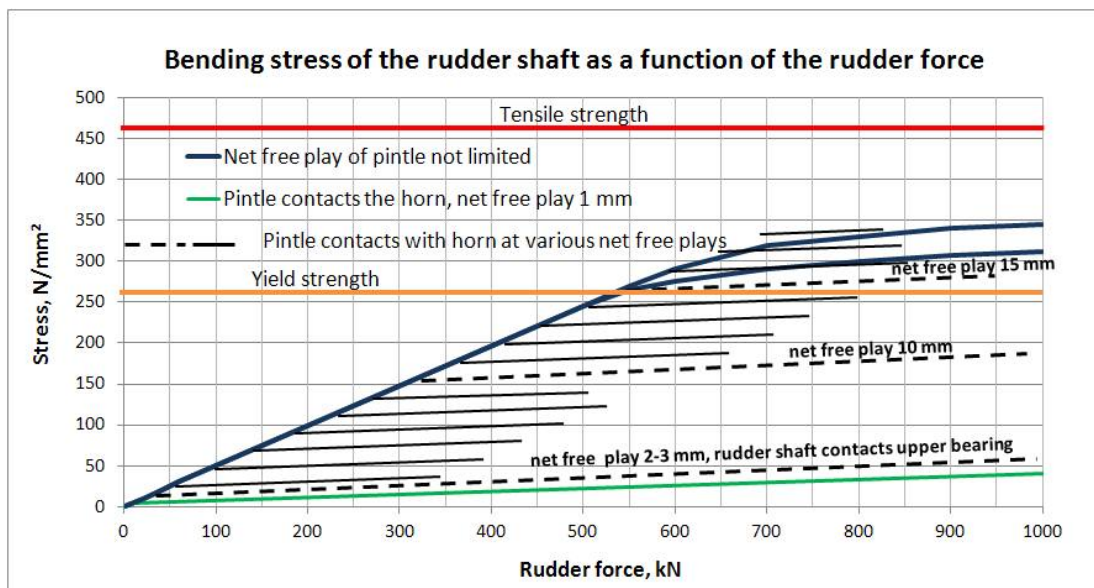
Figure 20 shows how the bending stress of the rudder shaft depends on the bending force. The blue, thick curve corresponds with the situation in which the beam formed by the rudder shaft and the rudder bends as a cantilever beam, without the support provided by the rudder horn. When the yield strength of the rudder is exceeded, the situation becomes approximate and therefore there are two limit curves in the figure<sup>22</sup>. The point in which the horn begins to support has also been marked in the figure with the interval of one millimetre of the net free play. The increase of the stress along with the increase of force slows down when the horn enters the picture.

Figure 20. The dependence of the **bending** stress of an **intact** rudder shaft on the rudder forces with different net free plays of the pintle bearing. The stress increases when the rudder force increases in accordance with the blue, thick curve until the pintle bearing leans on the horn. After that the stress increases slowly. After the stress exceeds the yield strength, the situation is so undefined that only estimated limit curves have been presented.

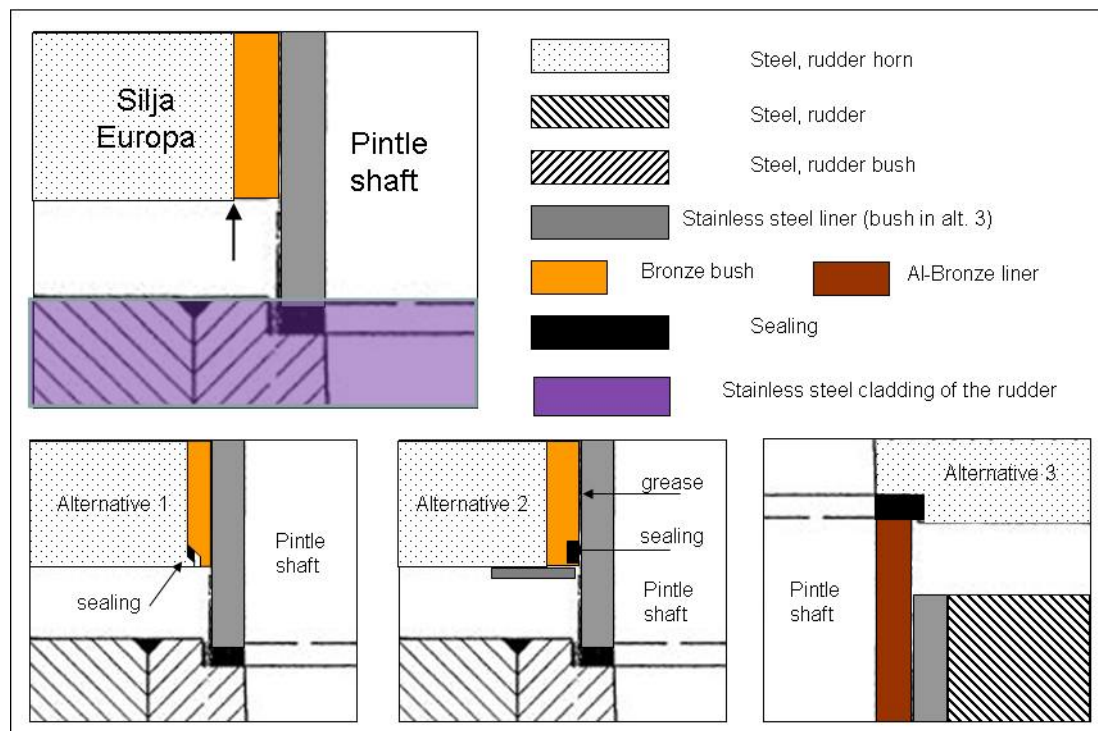
The structure of the vessel's pintle bearing is unfavourable considering the danger of galvanic corrosion, because bronze is unprotected in a seawater electrolyte in immediate contact with cast iron, Figures 5a, 5b and 25.

Only the lower edge of the pintle bearing is shown in the figure; the corresponding point on the upper edge on the SILJA EUROPA was unprotected but shown protected in the alternatives.

Figure 25. The structure of the lower edge of the pintle bearing of the SILJA EUROPA and alternative structures used on other vessels. The extent of the coating of the SILJA EUROPA's rudder has been presented in Figure 12. Alternative 1 is the one most commonly used, for instance on the SILJA SERENADE and the SILJA SYMPHONY.

**A sharp, 0.3-mm-deep notch** (Figure 22) in the SB shaft significantly reduced the fatigue endurance of the shaft and was the most important factor leading to its breaking. The notch in the rudder shaft had for unknown reason been left sharp. **Galvanic corrosion in the pintle bearing** (Figure 25) is, in the investigators' view, another main factor leading to the failure. However, galvanic corrosion alone would not have been sufficient to cause the prolonged fatigue process of the rudder shaft. The simultaneousness of these factors caused **the durability of the shaft to be weaker than presumed and its stresses exceeded the rated values in two stages**. These factors differed entirely from the normal ship building practice.

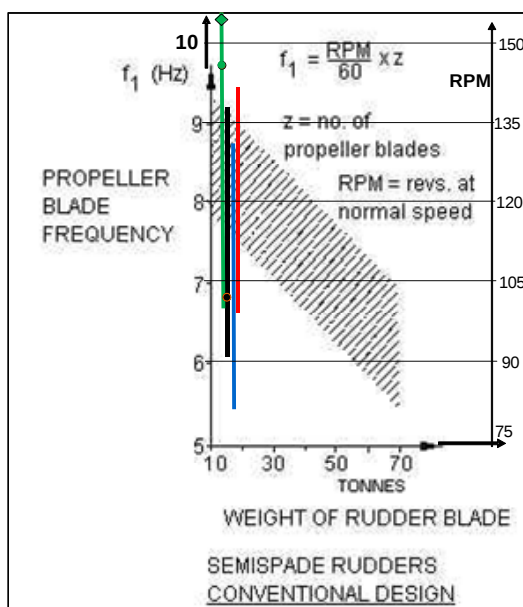
Figure 26. The natural frequency of an intact horn rudder as the function of the weight of the rudder blade. The RPM range of the SILJA EUROPA's propeller has been marked with red. The figure also shows the situation on three other vessels. The diamond indicates the RPM of the propeller when the shaft generator is in use. The circles show the most commonly used RPM. The dangerous RPM range has been indicated with lines. The original picture by Det Norske Veritas has been modified ("Semispade rudder of conventional design" is same as horn rudder).

The increase in the transverse movement of the rudder increases the stresses directed to the rudder shaft. The dangerous range of the propeller revolutions for a horn rudder has been shown in Figure 26<sup>28</sup>. The propeller blade frequency range of the SILJA EUROPA has been marked with red colour. The information on three similar vessels has been added in the picture. The normal range of propeller revolutions varies between 100–143 1/min.

**Resonance phenomenon and the vibration of rudders.** The structure of rudders on this type of car passenger ferries and the optimal propeller revolutions range lead to the fact that blade frequency resonance cannot be avoided altogether. Of the vessels compared (Figure 26), the SILJA EUROPA was most badly in the dangerous zone. The resonance vibration of the rudder accelerated the effect of the notch and corrosion.

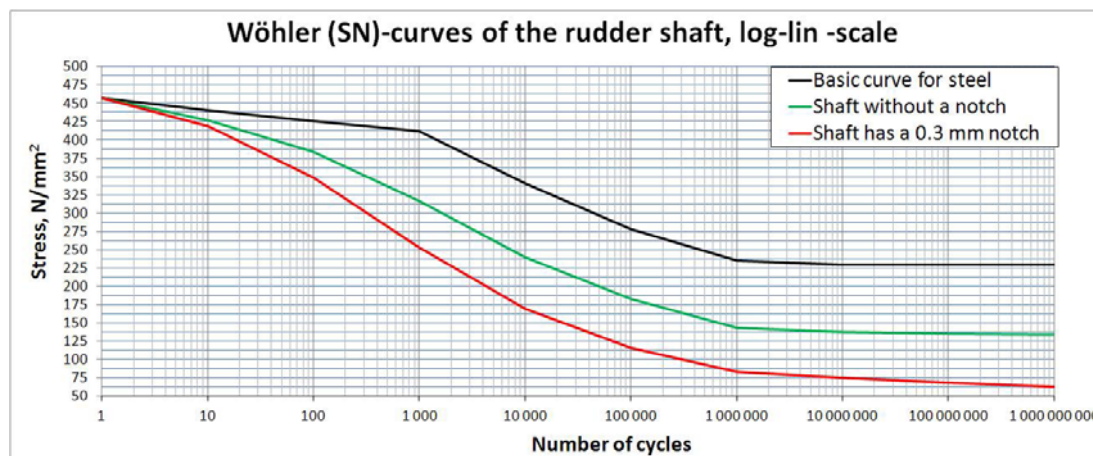
Assessing the fatigue endurance of the rudder shaft is based on the Wöhler curve, Figure 29. The curve illustrates how many cyclic stress (more than ca 1,000) or strain/compression changes (under ca 1,000) of a certain magnitude the material endures. The estimated basic curve of the rudder shaft, black, is the starting point. Normal corrections caused by the quality of the surface and the size of the object have been made to it and the result is the green curve. If there is a notch, cracks or similar in the object under stress, the fatigue endurance decreases. The effect of the notch can be taken into account e.g. by using the so-called effective notch fatigue concentration factor. When the effect of the 0.3 mm sharp notch in the SB shaft is taken into consideration, the outcome is the red curve.

Figure 29. The basic curve of the fatigue endurance of steel (black) and the estimated fatigue endurance curves of the rudder shafts, Wöhler i.e. SN curves when the mean stress is zero. The horizontal scale is logarithmic.

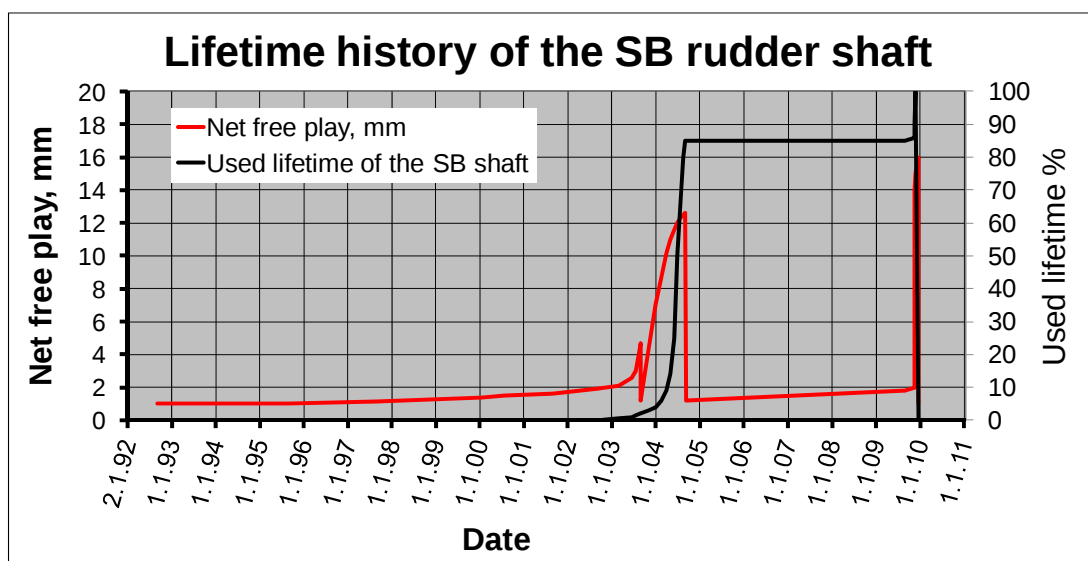
The chronological progress of the fatigue failure process with reference to the SB rudder shaft of the SILJA EUROPA has been illustrated in Figure 32. It is worth noticing the accelerating speed of the growth of the breakage once it started, which is characteristic of a fatigue phenomenon. When considering similar cases, this leads to a need to consider carefully the time span between the dockings.

Figure 32. The development of the free play of the SB shaft and the shortening of the service life. The moment the service life starts to become shorter and the level, on which it stops after the epoxy casting, are estimates. The figure illustrates the fundamentals of the events.

The typical development trends of the net free play and shortening of the service life presented in Figure 32 are correct in the investigators' opinion. Instead, the numerical values indicating moments of time and especially the shortening of service life are uncertain.

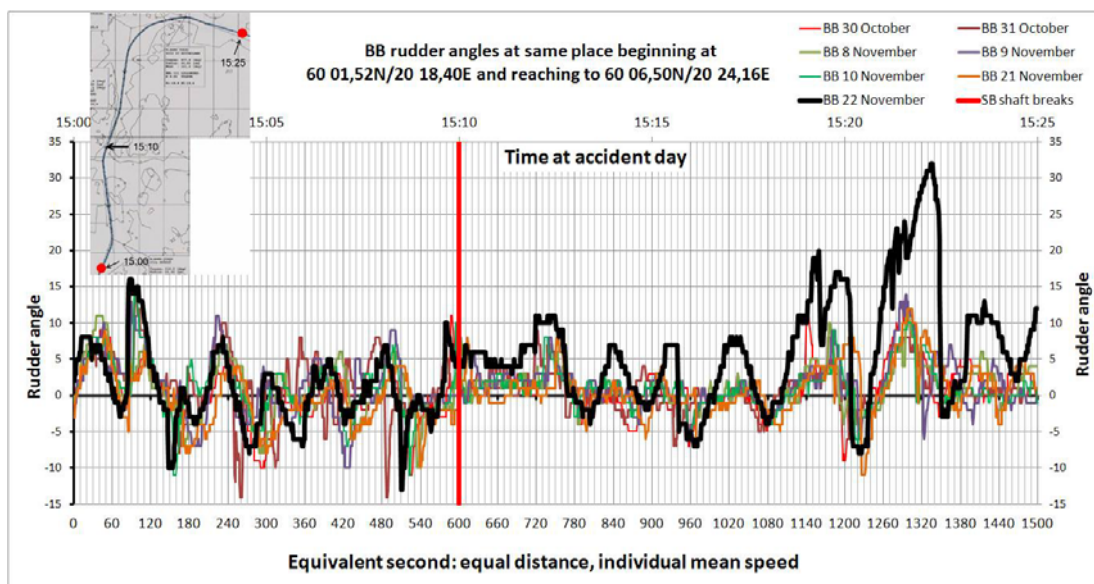
The investigators have estimated the time of the breaking of the rudder shaft on the basis of a comparison of rudder angle curves from seven different days. The curves have been constructed so that the rudder angles are shown on each day at the same place (Figure 34). In addition to this, a statistical analysis of the rudder angles in Figure 34 (the mean value  $\pm$  two times the mean deviation was drawn) and the information on the heading for those days were used. On the basis of these pictures, the rudder angles of the accident day started to differ from the angles of other days after 15:10.

Figure 34. Curves of BB rudder angles on different days transferred to start and end at same place. The curve of the accident day has been marked with black. The start and end points have been indicated in the ship's route by using red circles.

On the basis of the study of the fracture surface of the rudder shaft, it can be concluded that the shaft has broken while it bended outwards (in other words when the rudders were turned to port). This was possible during the turn, at approx. 15:10 (then the turn to starboard was stopped by using counter rudder to port).
