Investigation report

C5/2009M

M/V EMSRUNNER, grounding off Kalajoki on 11.12.2009

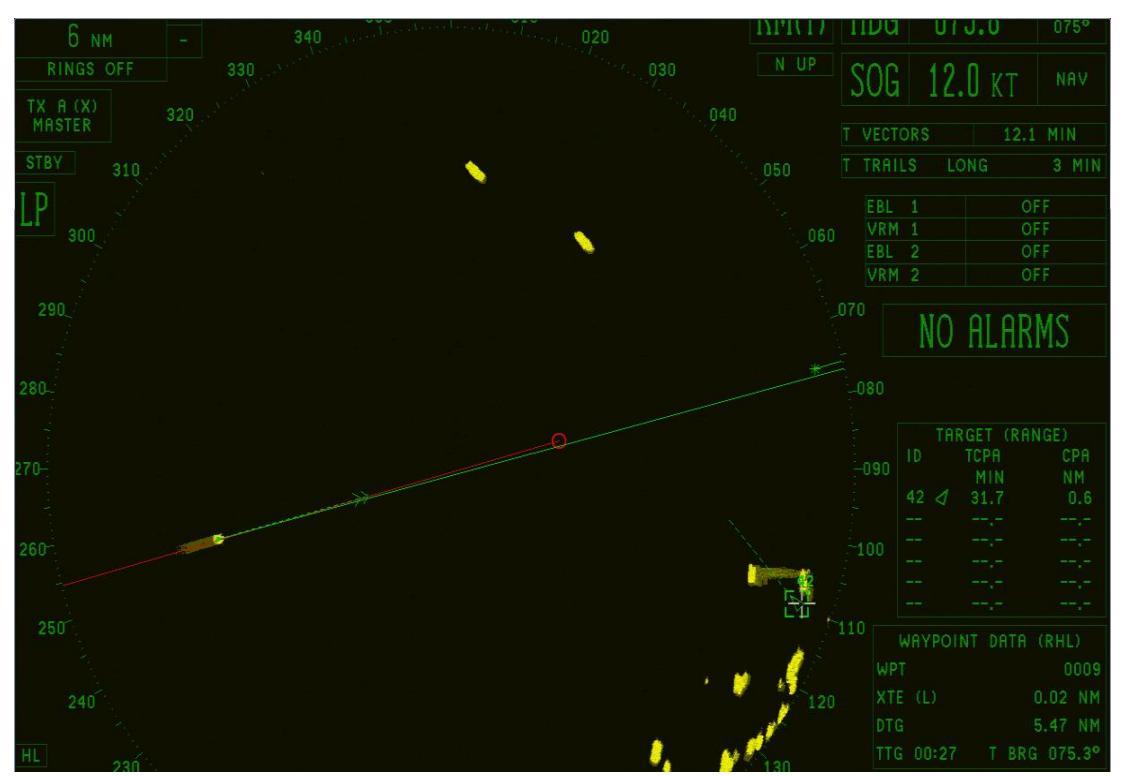
Picture 2. At 7.33 a.m. the EMSRUNNER with heading 075.3°, directly towards the pilot boarding place, which is 5.47 nm away. The cutter as an ARPA target (42) near the Äijänkallio RACON.

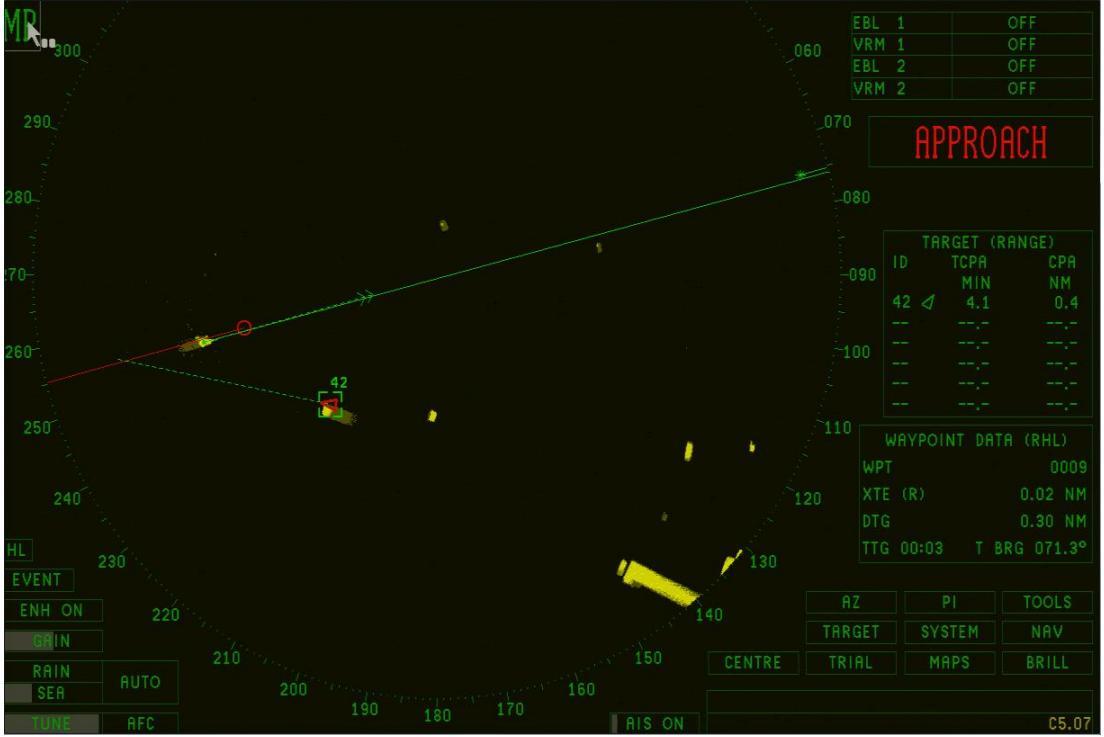
Picture 3. At 8.00 a.m. the ship is 0.3 nm from the pilot boarding place; WAYPOINT APPROACH ALARM. The cutter in the front to the right, ARPA target 42. The Äijänkallio RACON in SE.

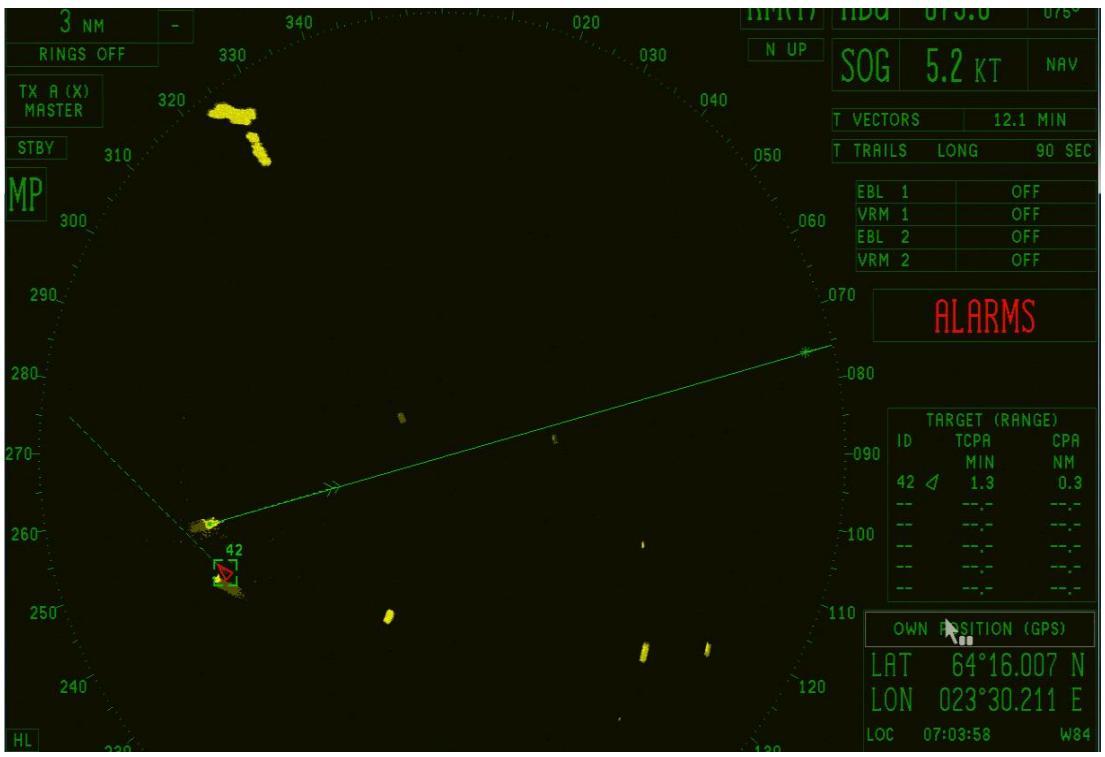
Picture 4. At 8.04 a.m. the cutter is approaching the ship on the right side of the aft of the ship; heading 168.3°, distance: 0.37 nm. Heading of the ship: 075.6°, speed 5.2 knots.

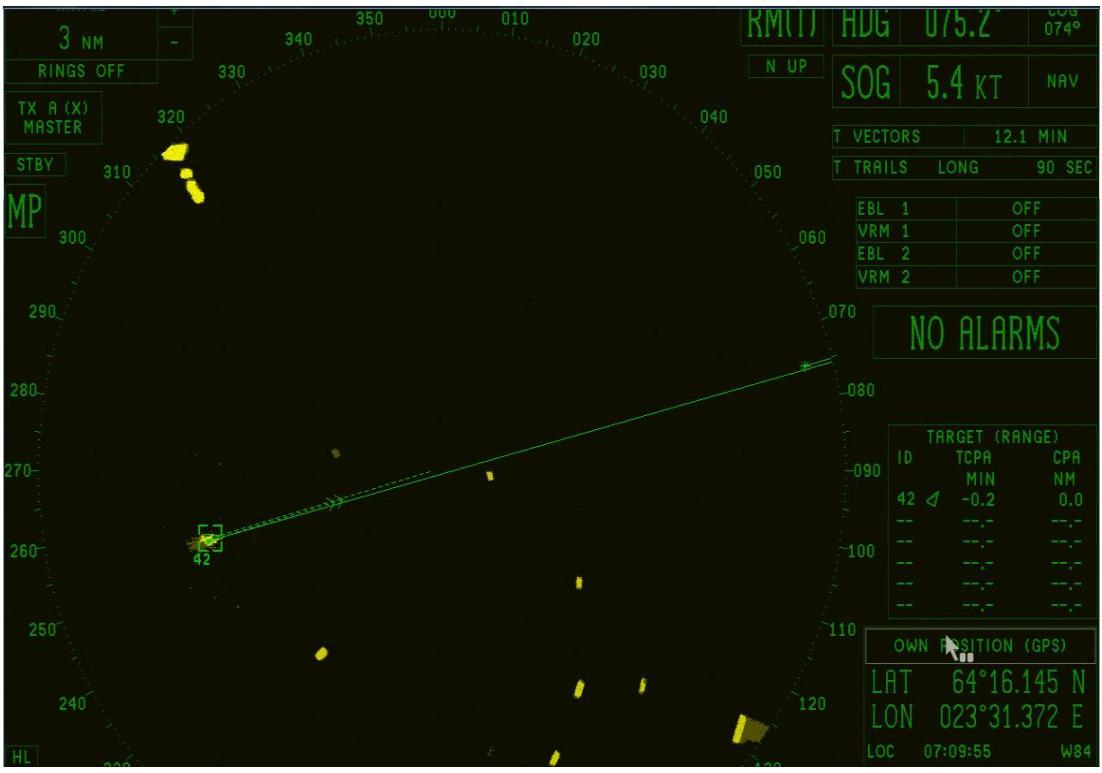
Picture 5. At 8.10 a.m. the pilot is boarding the ship on the left side. The radar echoes to the north of the ship are from the Maakalla and Ulkokalla islands.

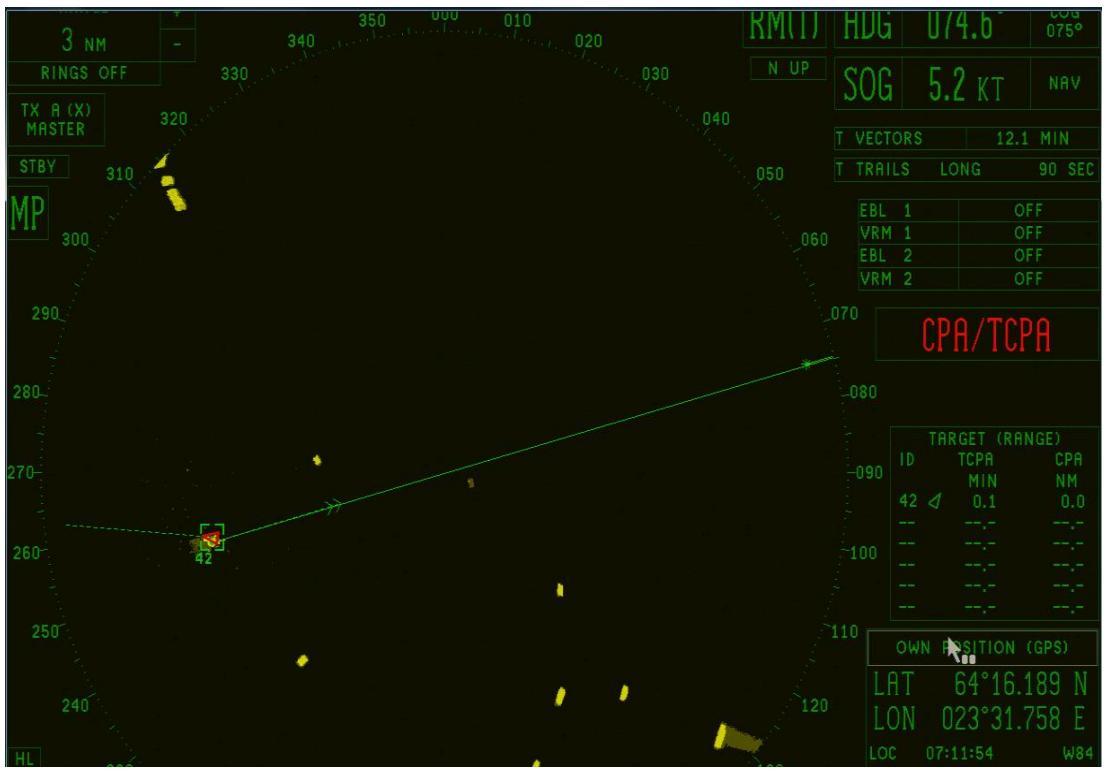
Picture 6. At 8.12.11 a.m. the pilot arrives to the bridge, greets the Master, and ensures the location of the ship in relation to the radar target on the front left from the radar. He then confirms the speed to the Master ("Full ahead"), and gives 080 degrees as the heading. At 8.12.45 The pilot asks for the draught of the ship, which the Master confirms as four metres.

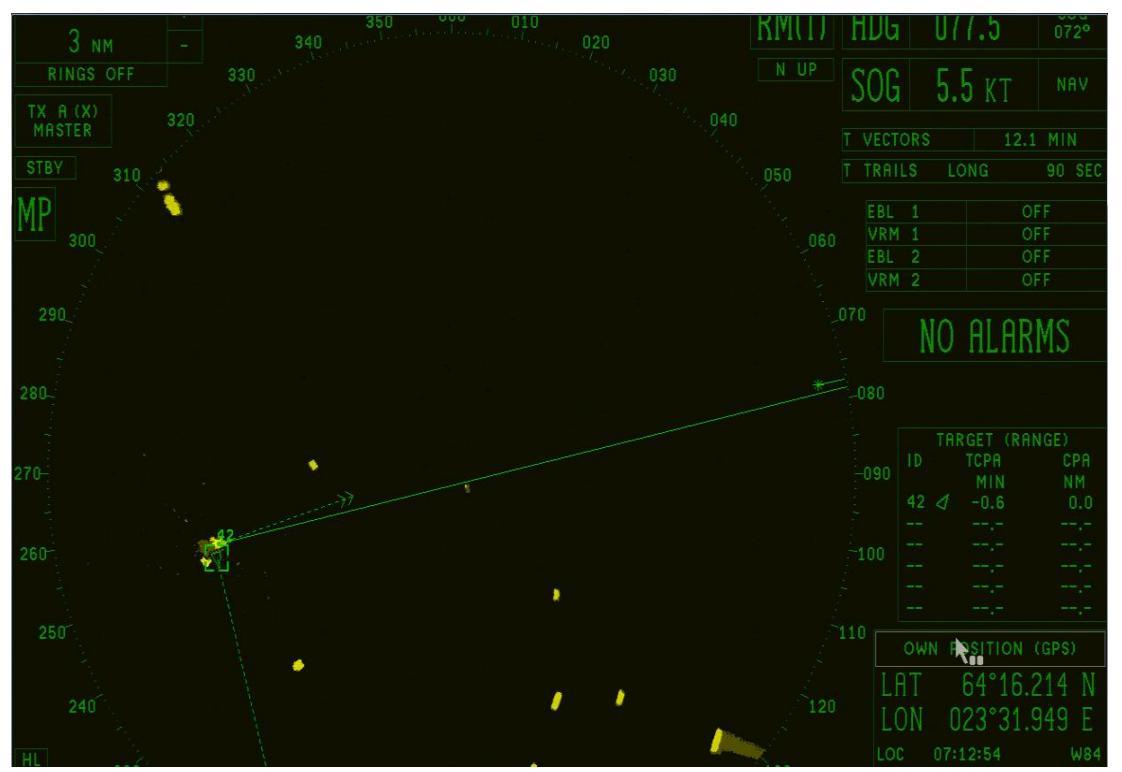
Picture 7. At 8.13.27 the pilot confirms his previous assumption of the location of the ship from the radar. He asks the Master for the maximum speed of the ship, the Master confirms this as 12 knots.

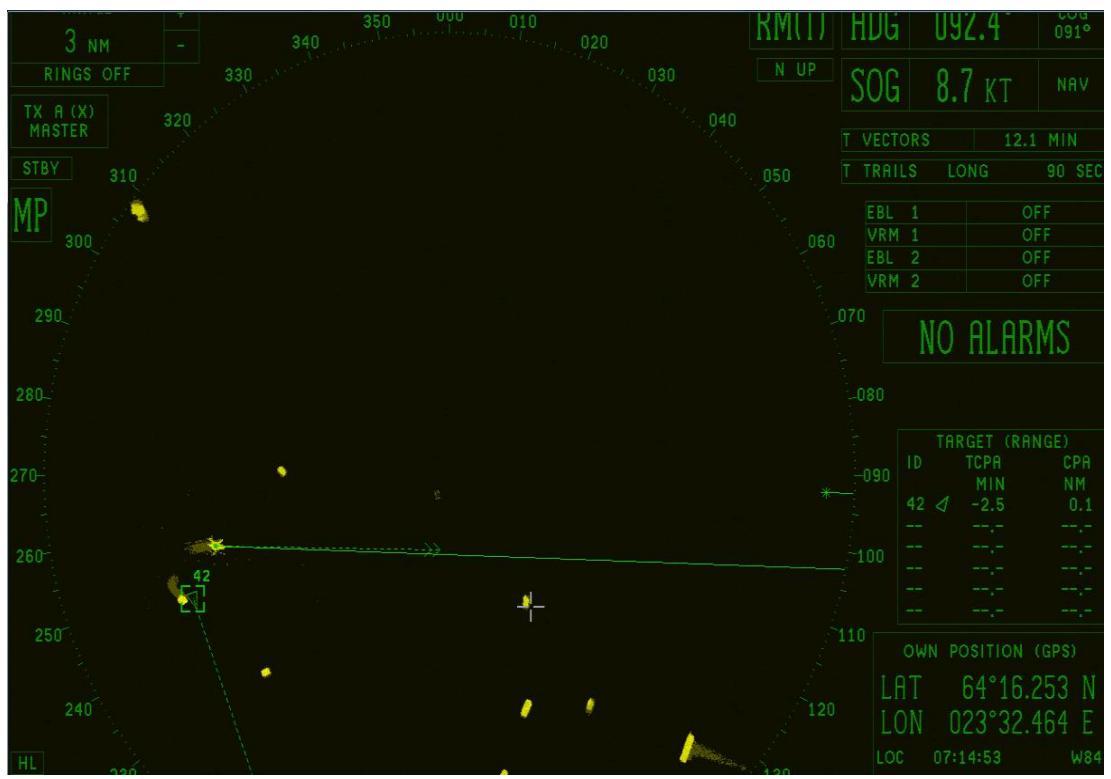
Picture 9. At 8.15 a.m. discussion on the manoeuvring, engines, etc., as well as the weather.

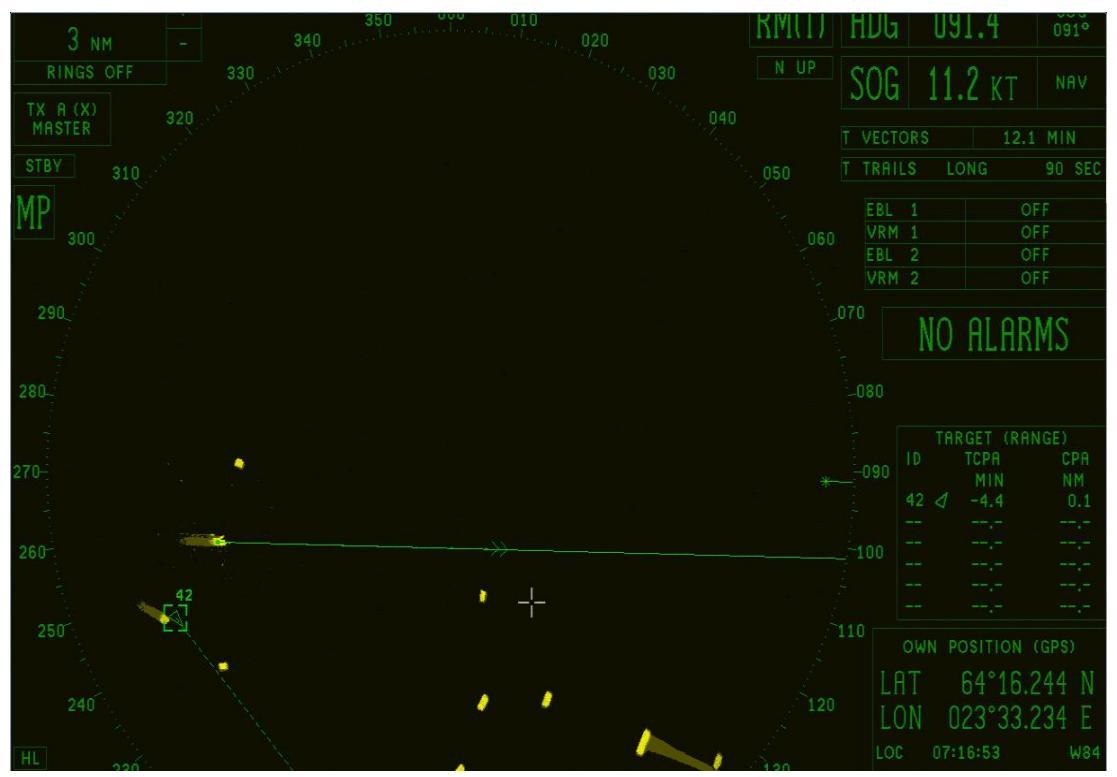
Picture 10. At 8.17.34 the pilot's phone rings. The colleague calls from the pilot station, saying that the EMSRUNNER is heading towards Välimatala.

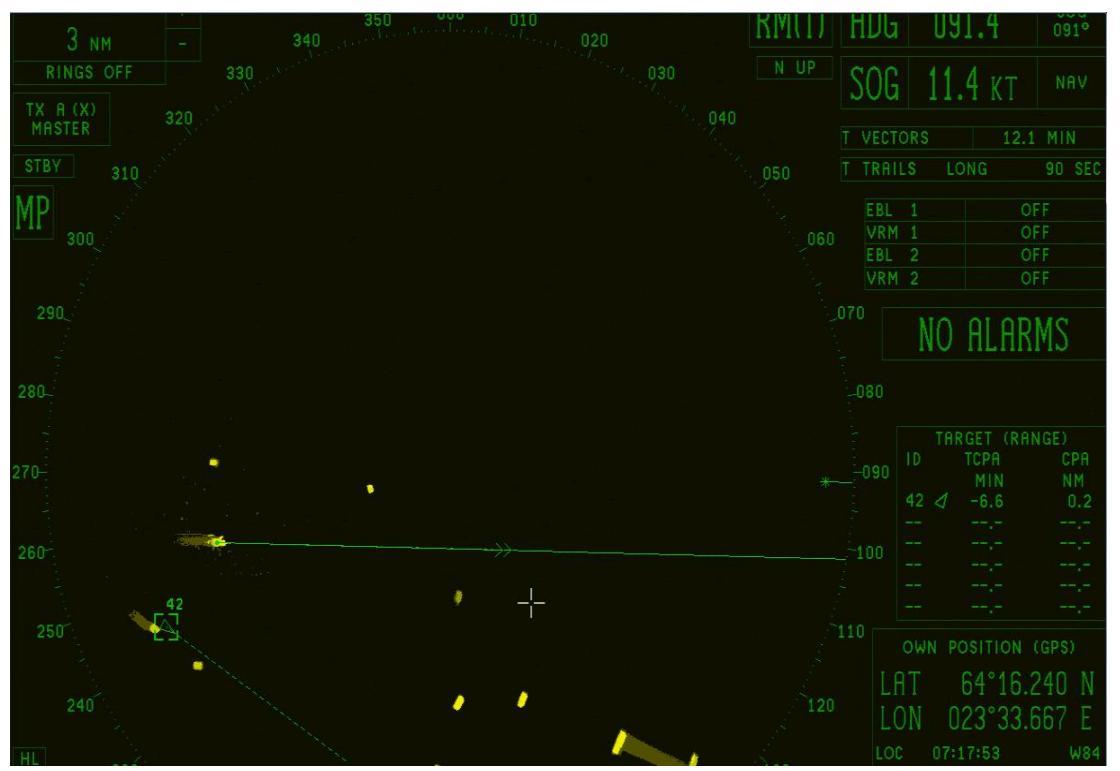
Picture 11. At 8.18 a.m. the pilot states on the phone that the Kaarlo ice buoy is on the port side of the ship, doubts the colleague's observation, thanks him, and finishes the call.

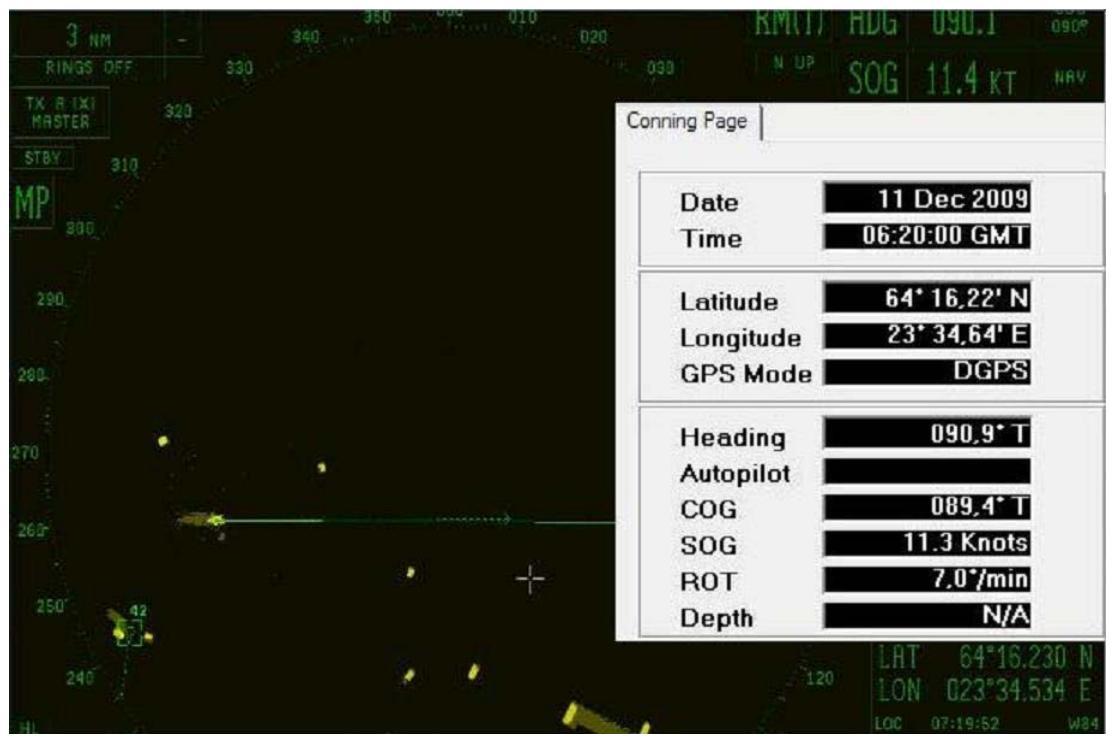
Picture 12. At 8.20.51 a.m. the pilot calls the cutter operator and confirms the ship's location in relation to the Kaarlo ice buoy. The cutter approaches the Kaarlo ice buoy.
