Investigation report

B2/2011M

M/V AMAZON (BHS) and F/V FLORENCE (FIN), collision resulting in the sinking of the fishing vessel in the Gulf of Finland on 23 October, 2011

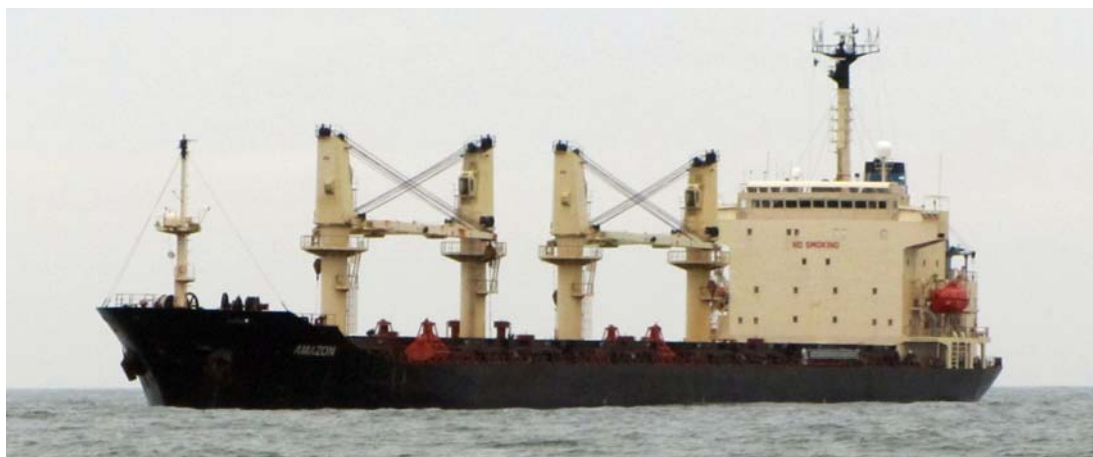
Image 1. The AMAZON off Hanko after the collision.

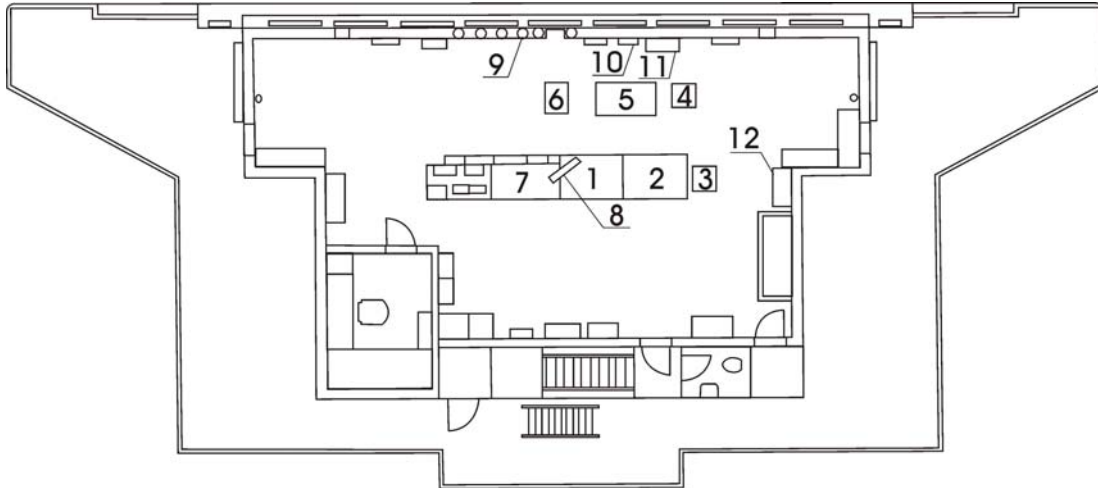
The layout of the AMAZON's bridge is traditional and the wings of the bridge are open (image 4). The OOW's chair is located by the steering console slightly on the starboard side of the vessel (image 4, number 5). The chart table is located behind the OOW's chair (image 5).

Image 4. The AMAZON bridge and the positions of equipment relevant to the case.

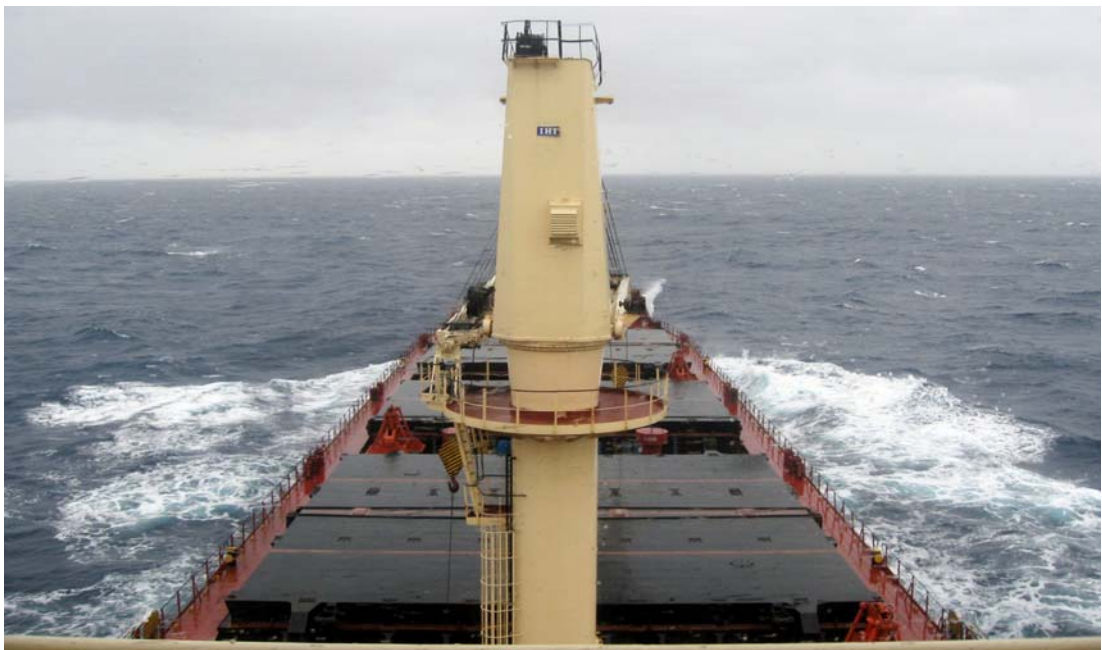
The four cranes on the AMAZON obstruct the view from a certain angle on the bridge (image 6).

Image 6. View forward from the AMAZON bridge. (Picture taken by the master of the vessel.)

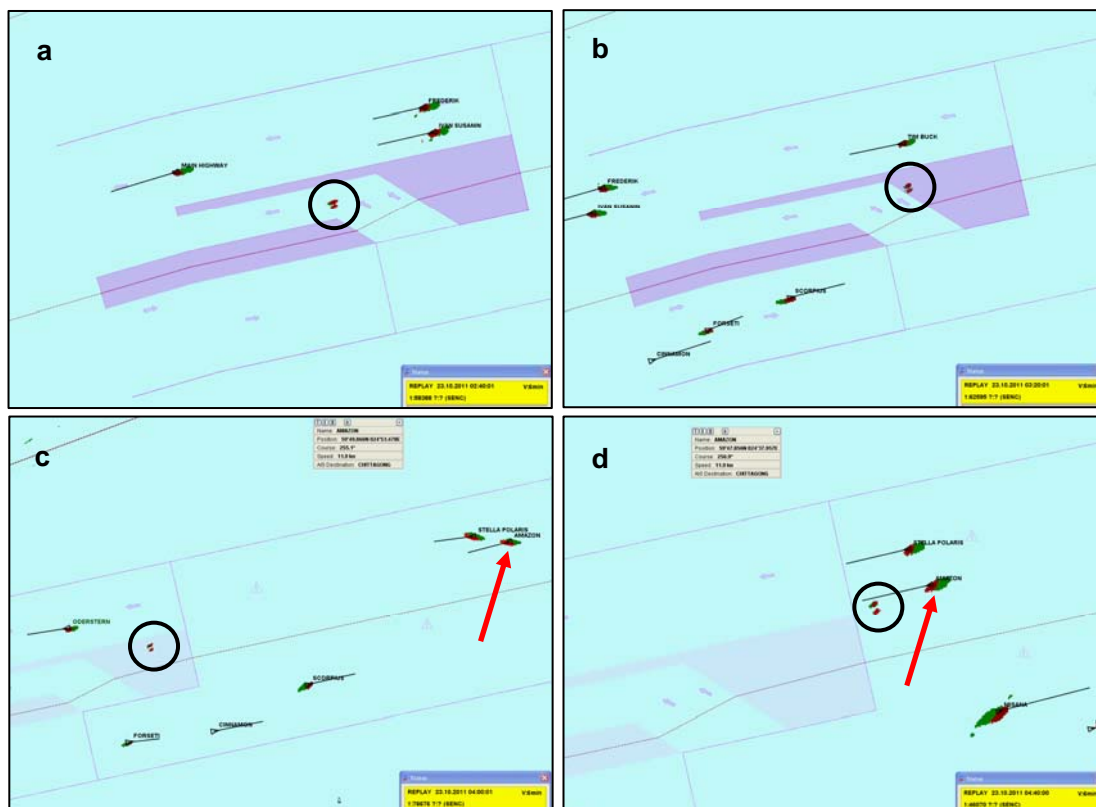
According to the masters, the vessels drifted into fog at around 04:30, after having trawled for approximately two hours. The thick fog made visual observing difficult and they had to rely on the radar alone. At the same time, the fishing vessels moved out of the TSS traffic separation zone and into the precautionary area (image 10 d). The pair trawling vessels were moving eastwards.

Image 10. Progression of the trawling. The pair-trawling vessels have been marked with a black circle and the AMAZON with a red arrow.
(© Finnish Transport Agency)

- a At 02:40: the vessels have started trawling a moment before.
- b At 03:20: the fishing vessels have been trawling for approximately 50 minutes and they have moved to the traffic separation zone between the lanes.
- c At 04:00: the fishing vessels are approaching the eastern border of the traffic separation zone. The AMAZON is approaching from the east.
- d At 04:40: the fishing vessels have proceeded on the same course, moving out of the traffic separation zone and into the precautionary area. The moment of collision is approximately four minutes away. The AMAZON has not changed course to give way to the fishing vessels (the vector of the vessel is pointing forwards).

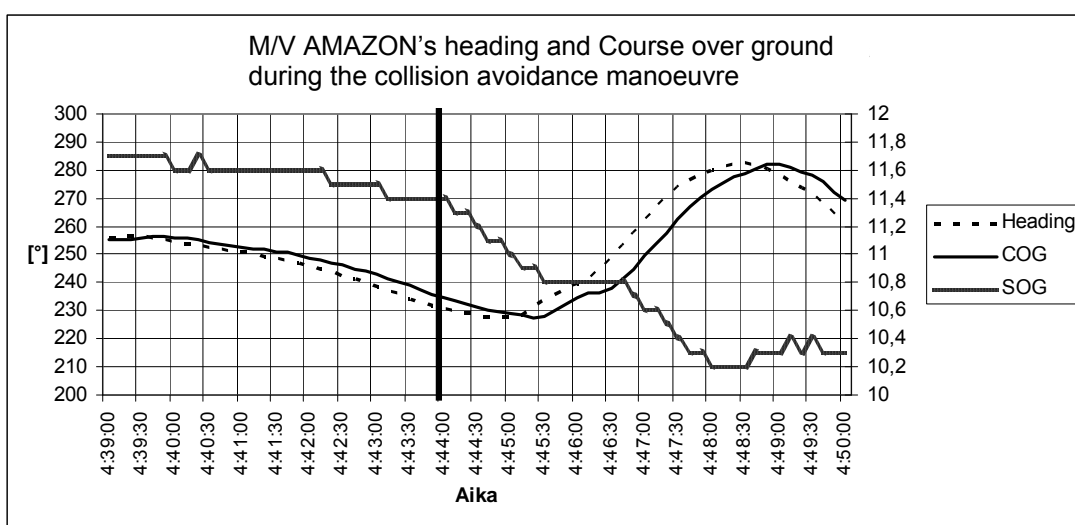
Image 13. Graphs of the AMAZON's course, heading and speed before and after the accident based on the vessel's S-VDR data. The moment of collision has been marked on the chart with a thick black vertical line.
Legend:

The OOW of the AMAZON changed the course of the vessel a little less than 30 degrees to the port on autopilot (image 13). Collision with the MENHADEN was avoided, but the AMAZON proceeded directly at the FLORENCE.

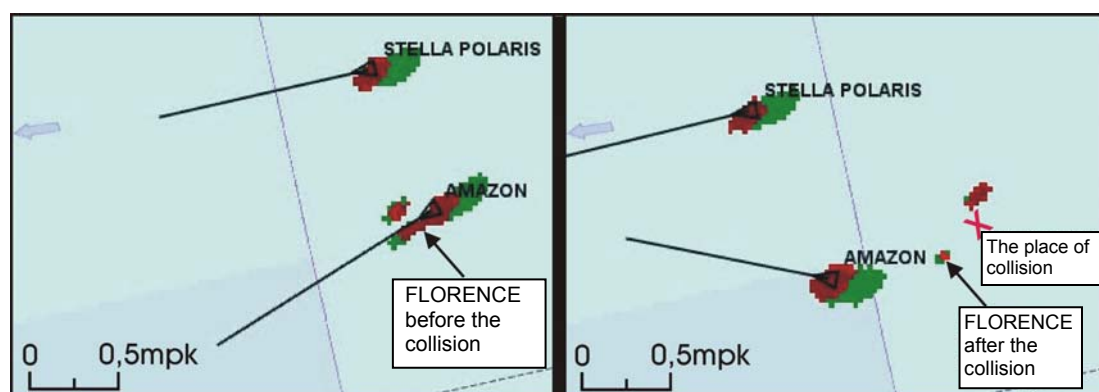
After the collision, the FLORENCE was dragged along¹⁷ with the AMAZON for about $\frac{1}{3}$ of a mile before disengaging (image 14). According to the VTS recording, the collision occurred at 04:44.

Image 14. At the collision the FLORENCE was moved approximately $\frac{1}{3}$ of a nautical mile against her original direction. (© Finnish Transport Agency)

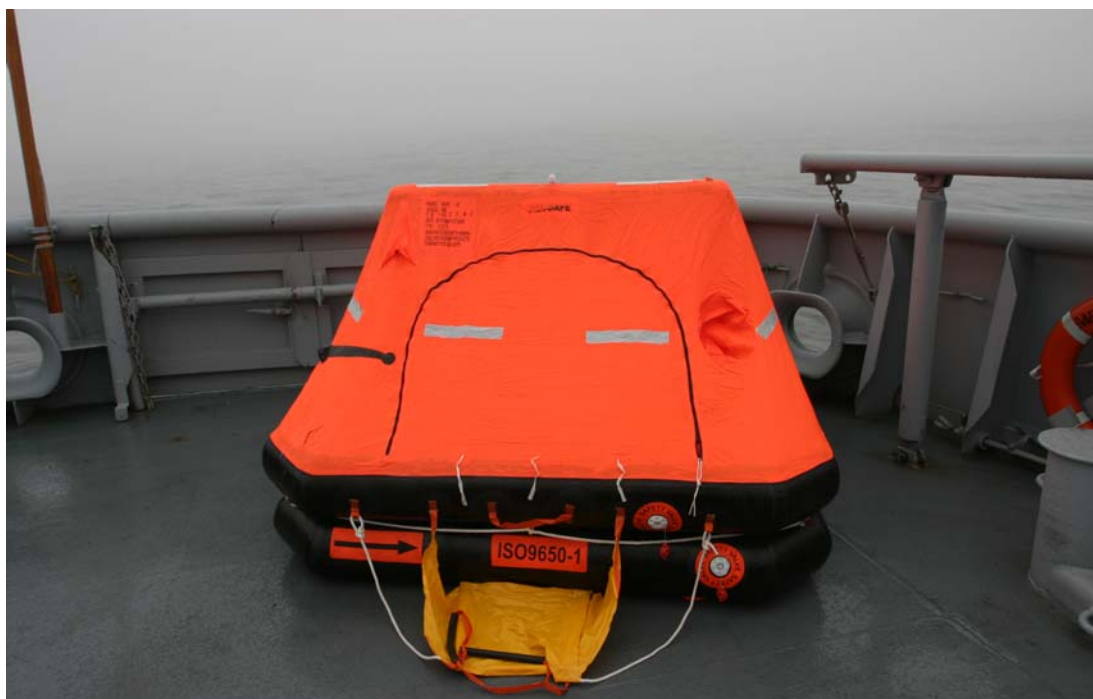
The FLORENCE had a six-person Sea-Safe KHY-6 liferaft (image 23). It is a rubber-made liferaft that will automatically turn right way up in the water. The liferaft was stored in a fibre glass case outside the vessel's deckhouse (image 16). The raft is deployed by pulling the release cord.

The raft had been purchased in Estonia in 2010, circa one year before the accident. The raft had been recently inspected and worked faultlessly during the accident.

Image 23 The liferaft of the FLORENCE on the deck of the MERIKARHU after the crew was rescued. The image also illustrates the visibility near the site of the accident.
(© Finnish Border Guard)

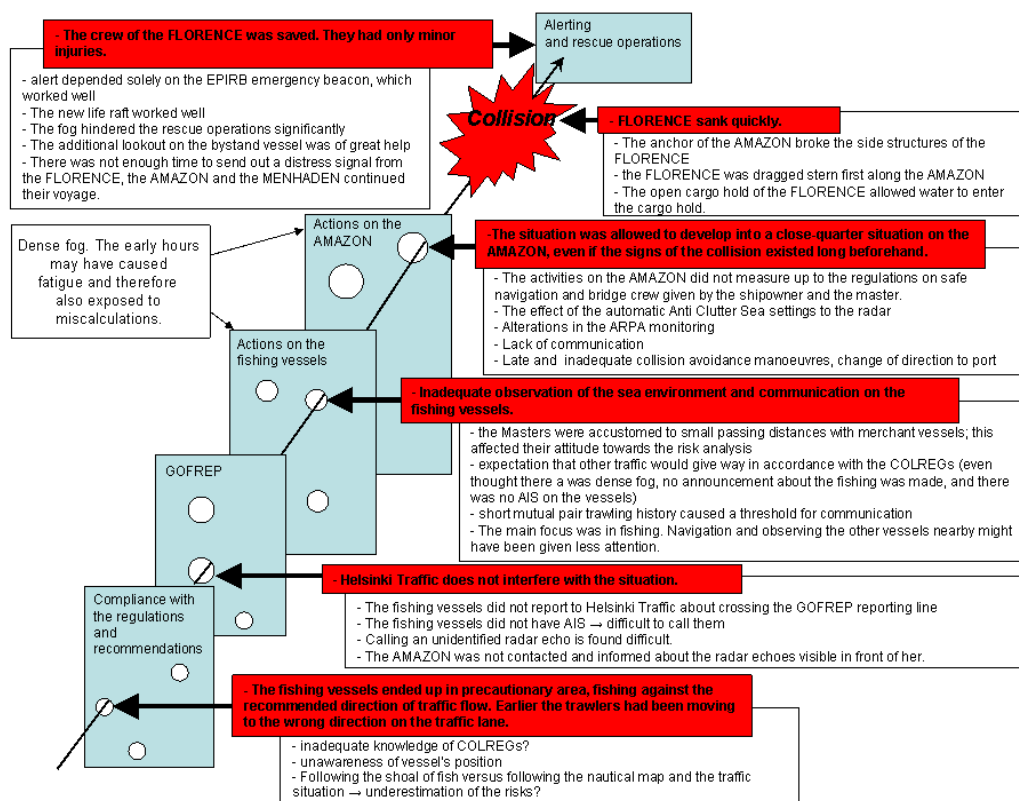
The incident consists of a chain of events that could have been interrupted at numerous occasions. However, this was never accomplished, which led to the collision and the sinking of the FLORENCE. The applied Reason model³⁹ in image 24 illustrates this. The analysis text is based on this image.

Image 24 The events leading up to the accident illustrated through a applied Reason model.

³⁹ The image shows four barriers (light blue rectangles), each of which could have intercepted the chain of events. The reasons for why the barriers did not work and the event was able to progress a step forward (a hole in the barrier) are written in the red boxes. The factors behind a barrier's flaws are further explained underneath.

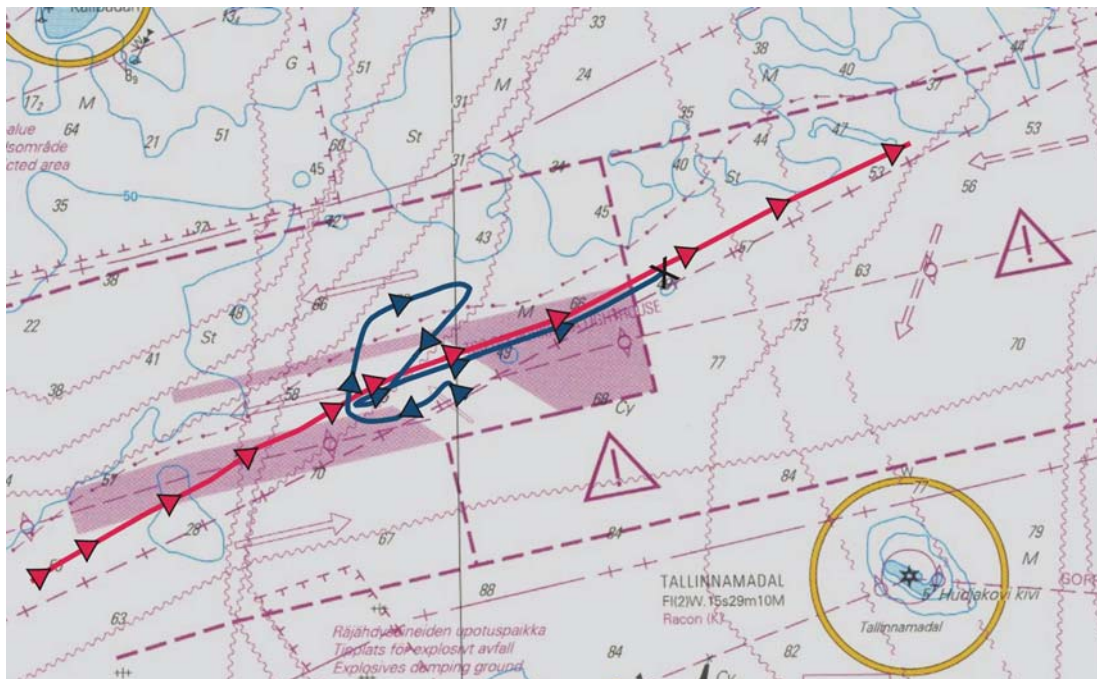
The fishing vessels started trawling as a pair on a TSS lane that is used by traffic from Tallinn when joining the lane that leads westwards. The trawling progressed to the traffic separation zone and through it to the precautionary area. The progression of the trawling is shown in image 25.

Image 25. The fishing vessels' routes before and during the trawling according to the VTS recording. The route of the FLORENCE is marked in blue and the MENHADEN's in red. (© Finnish Transport Agency)

Trawling in the traffic separation zone is allowed in the COLREGs, but impeding the passage of a vessel using the lane is not (section 1.5.4).

The aim of the precautionary area is to control the intersecting traffic flows. The dashed outlined arrows represent the recommended direction of traffic flow. In this area the arrows therefore indicate the primary directions of traffic flow (image 25); slight deviations from them are allowed. Failing to comply with the arrows indicating the direction of traffic flow is against good seamanship.

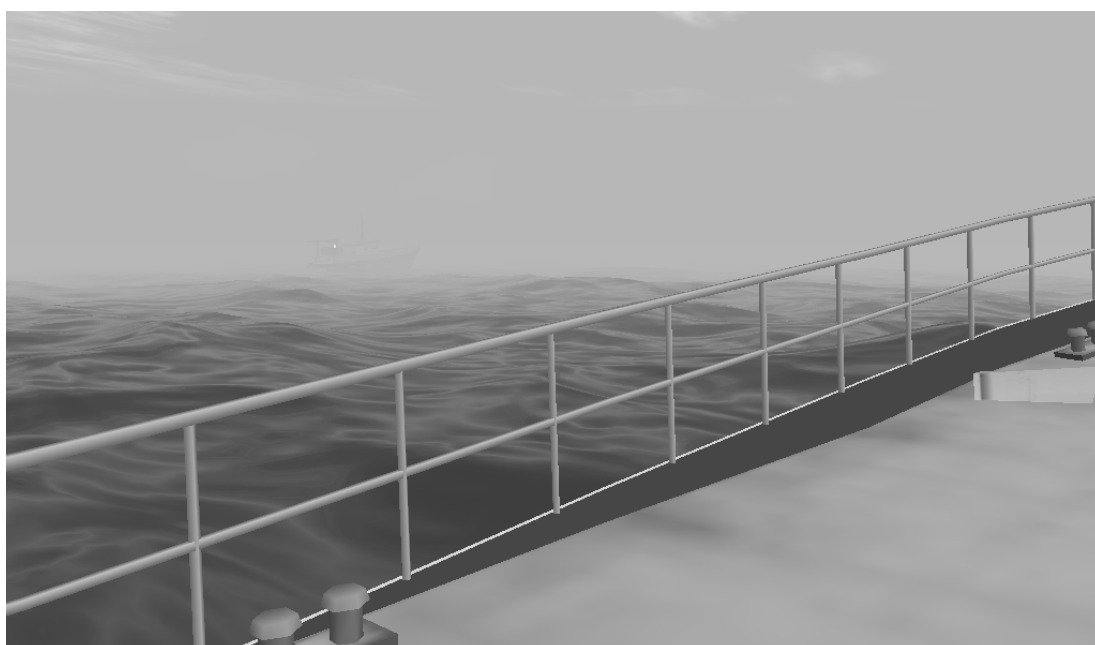
However, a dense fog hindered the visibility of navigation and fishing lights, changing the situation crucially. This was not completely acknowledged on the fishing vessels. Image 26 illustrates the visibility just before the accident in a photograph taken on a simulation run.

Image 26 Image of the simulation⁴¹. View from the FLORENCE towards MENHADEN when visibility in the fog was 200 m. To better demonstrate the circumstances, the picture shows daylight. The silhouette of the MENHADEN and its SB navigation light are barely visible.

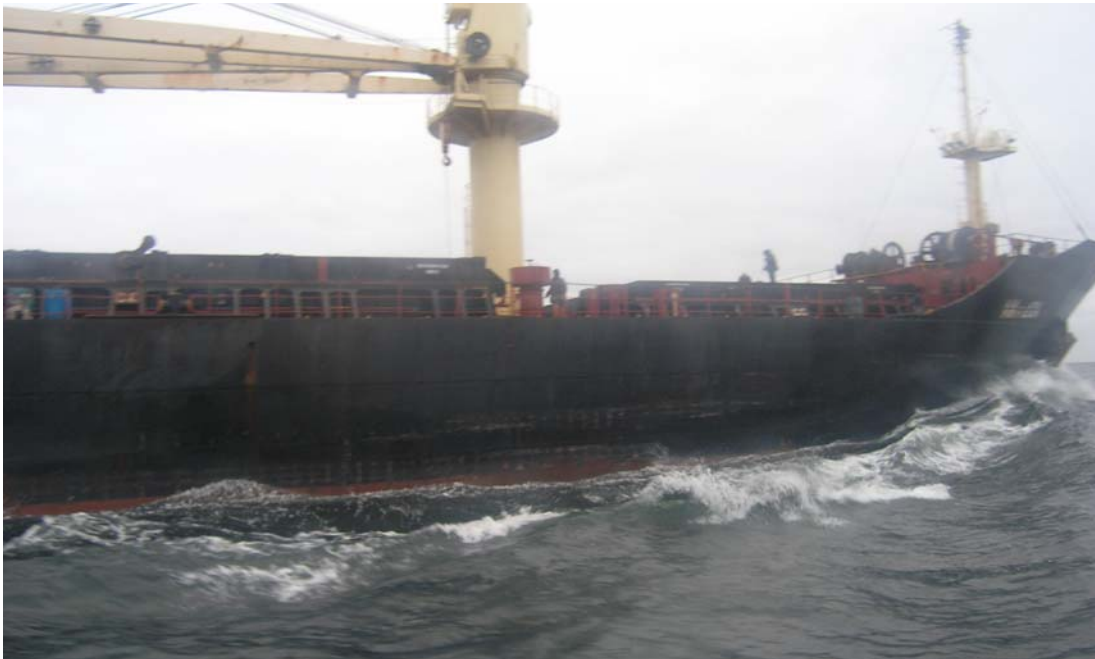
The bow wave of the AMAZON raises the water level (image 27). The FLORENCE rose higher by the side of the AMAZON near her bow. This was one of the factors contributing to the height at which the AMAZON's anchor hit the side of the FLORENCE. The blue paint mark (image 17) visible on the front side of the anchor in the bow of the AMAZON is probably caused by the steel structure on the FLORENCE's stern.

Image 27. The AMAZON moving in loaded condition. The water level rises due to the bow wave. The picture is taken on the day of the accident on 23 October, 2011, so the draught is the same as it was during the accident.

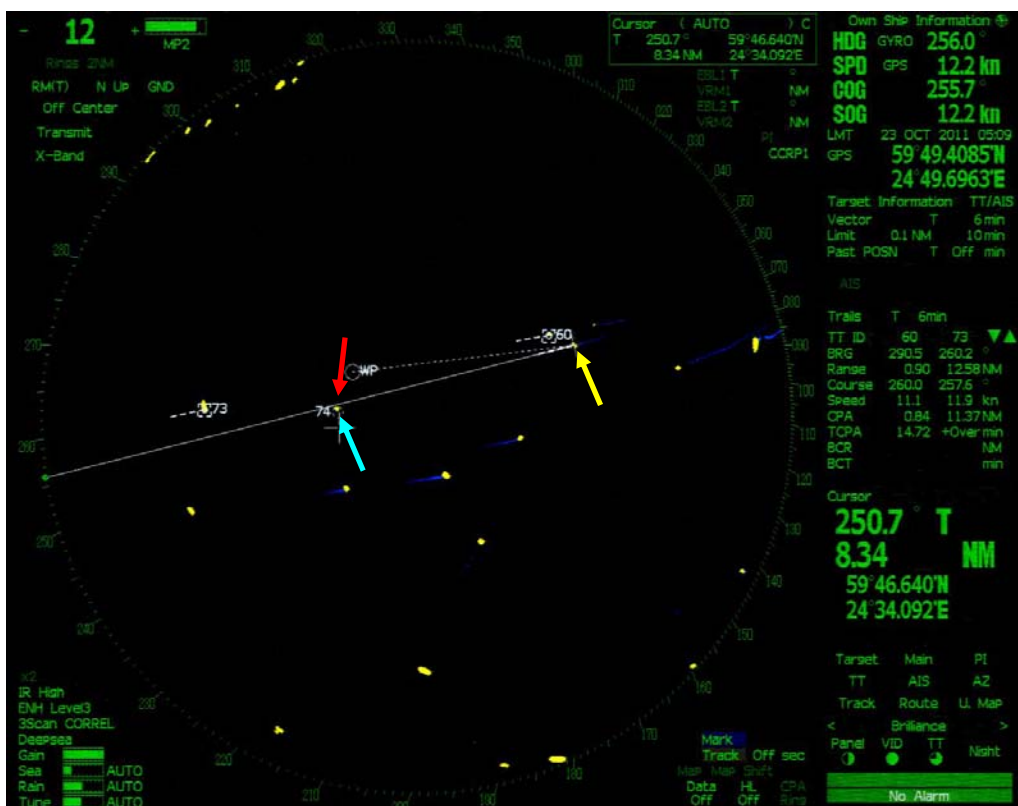
Image 2. At 04:09:34, approximately 34 minutes before the collision. The radar range is 12 miles. The OOW of the AMAZON has just begun the ARPA monitoring of the fishing vessels (number 74 on the screen) so the additional radar information is not displayed on the radar screen yet. The course of the AMAZON is 255.7° with a speed of 12.2 knots.

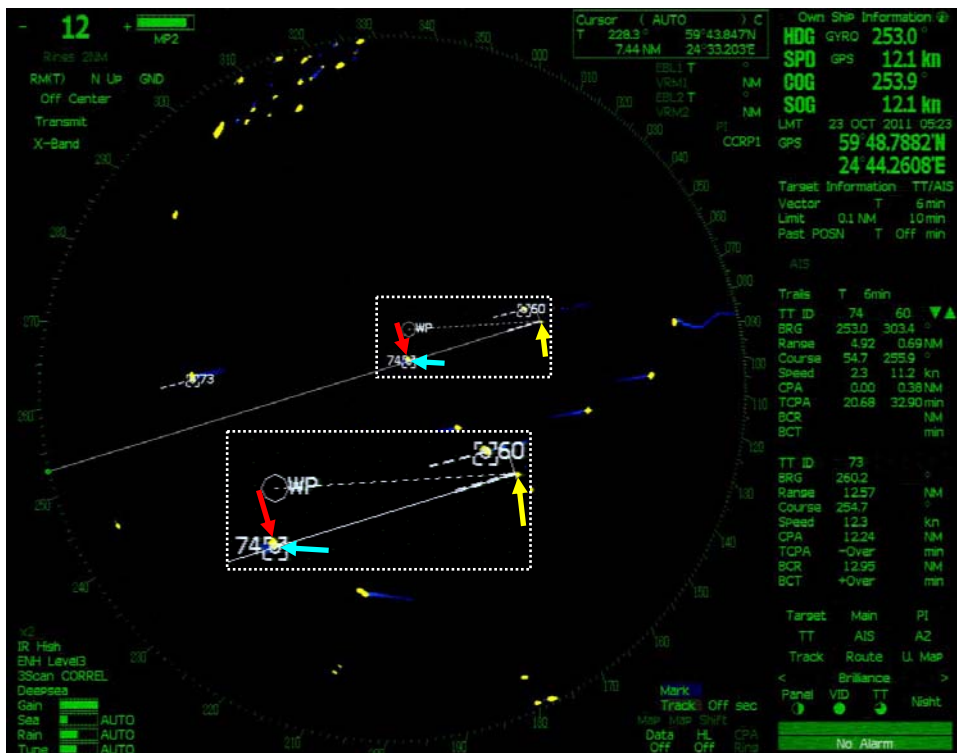
Image 5. At 04:23:42, approximately 20 minutes before the collision. The fishing vessels are within 4.92 miles of the AMAZON in a heading of 253°. The course of the fishing vessels is 55°, and the speed 2.3 knots. The fishing vessels are directly underneath the AMAZON's vector that indicates the course (CPA 0 miles). TCPA 20.68 minutes. The course of the AMAZON is 253.9° with a speed of 12.1 knots.

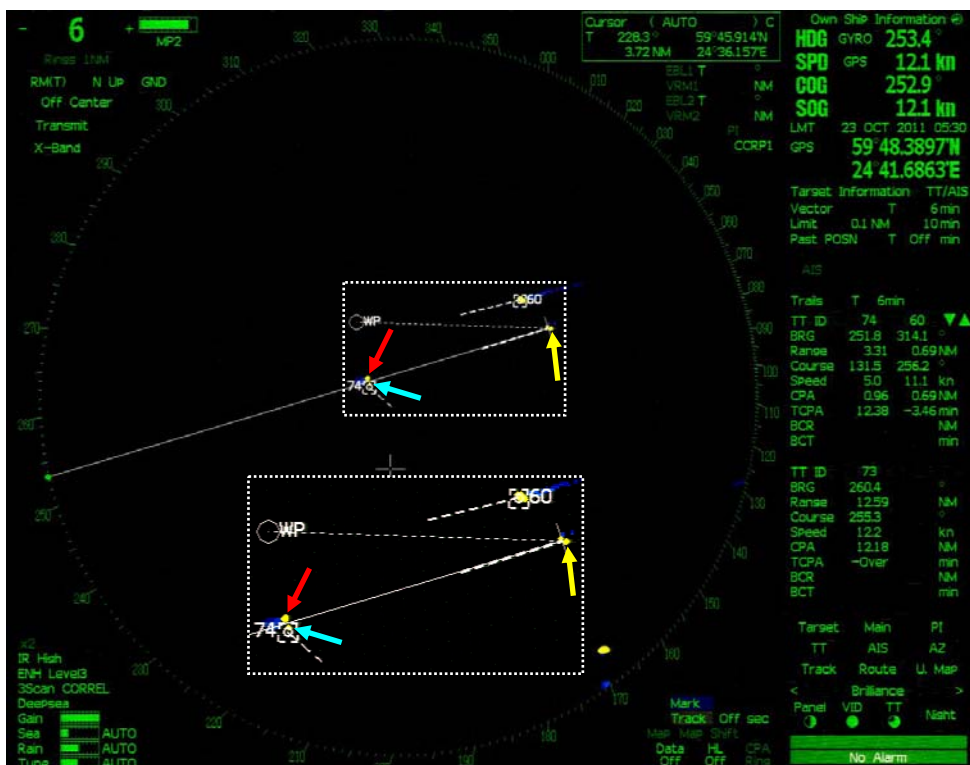
The S-VDR recording of the AMAZON (appendix 1, image 6) reveals that there are two echoes near each other on the port side of the heading within 3.3 nautical miles. The scale of the X-band radar was 6 nautical miles. When approaching further, the echoes of the vessels weaken significantly, and the echo of the FLORENCE occasionally disappears from the radar (appendix 1, image 7).

Image 6. At 04:30:13, approximately 13.5 minutes before the collision. The radar range has been changed to 6 miles, and there are two distinguishable echoes on the radar by the fishing vessels. The vector of the lower echo points inaccurately to the south-east. The fishing vessels are within 3.31 miles of the AMAZON in a heading of 252°. The CPA is 0.96 nautical miles, and the TCPA is 12.18 minutes. The course of the AMAZON is 252.9° with a speed of 12.1 knots.

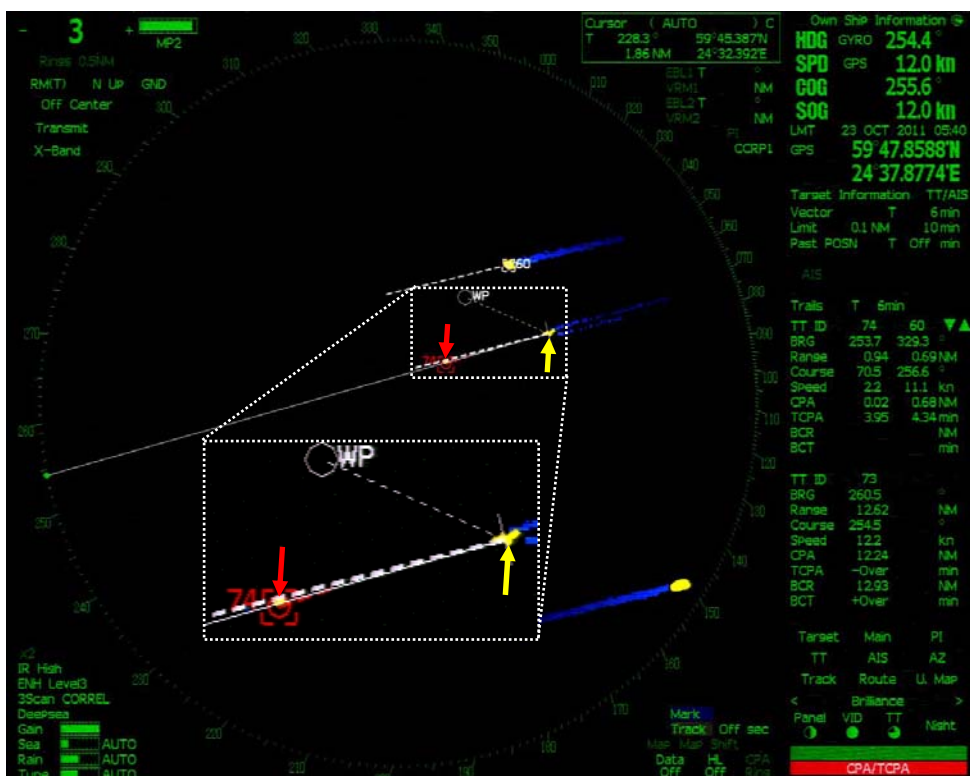
Image 9. At 04:40:12, approximately 3.5 minutes before the collision. The radar range has been changed to 3 miles. The course of the AMAZON is 255.6° with the speed of 12 knots, thus the course and the speed have not changed during the 4 minutes since the last image. The fishing vessels are within 0.94 miles of the AMAZON in the heading of 254°. The CPA is 0.02 nautical miles, and the TCPA is 3.95 minutes. The FLORENCE's radar echo is not displayed on the radar (the turquoise arrow is missing).

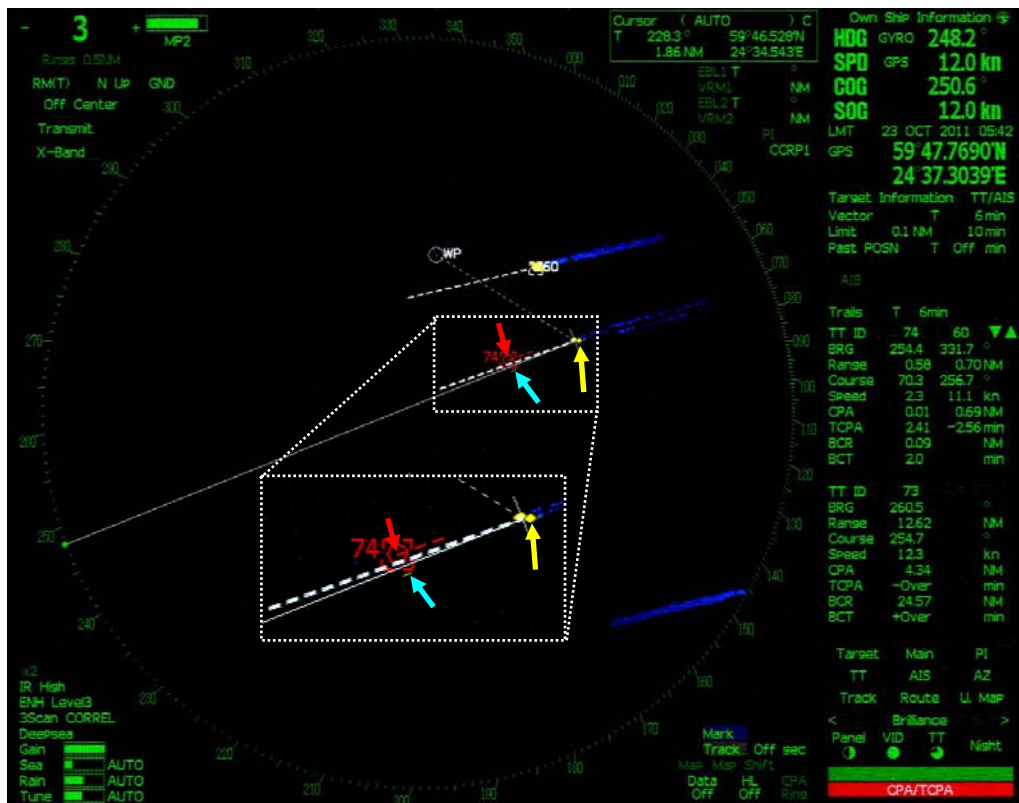
Image 10. At 04:41:41, approximately 3 minutes before the collision. The AMAZON has started to change heading (course 250.6°, speed 12 knots) to the port. The ARPA monitoring of the MENHADEN, the FLORENCE gives a weak echo below it.

The first run simulated the occurred accident. The circumstances had been created as authentic as possible in regard to the time of the accident. It was dark, and there was a dense fog (visibility 200 metres). The simulation conducted the change of the course to the port in order to avoid the MENHADEN, and collided with the FLORENCE. The change of the course was started within 0.58 miles of the fishing vessels, similar to the actions of the AMAZON (appendix 1, image 10).

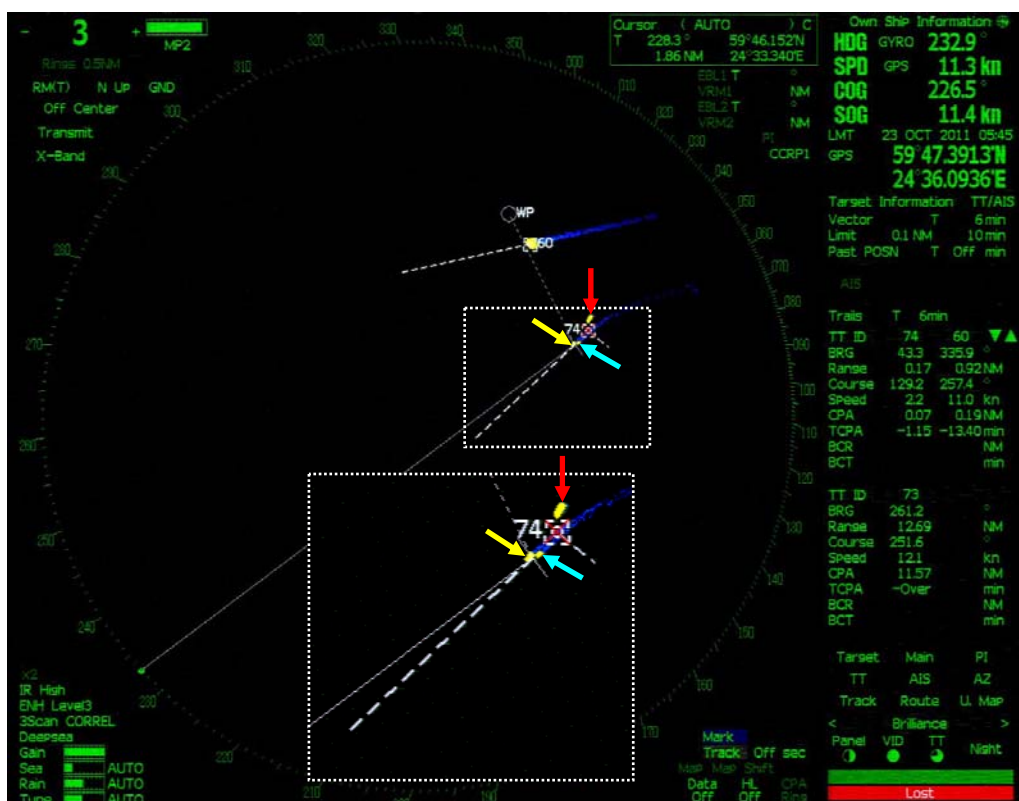
Image 15. At 04:45:25, approximately 1.5 minutes after the collision. The AMAZON has started to turn back to the starboard, and the ARPA monitoring of the FLORENCE has been lost (red tick). The course of the AMAZON is 226.5°, with a speed of 11.4 knots.

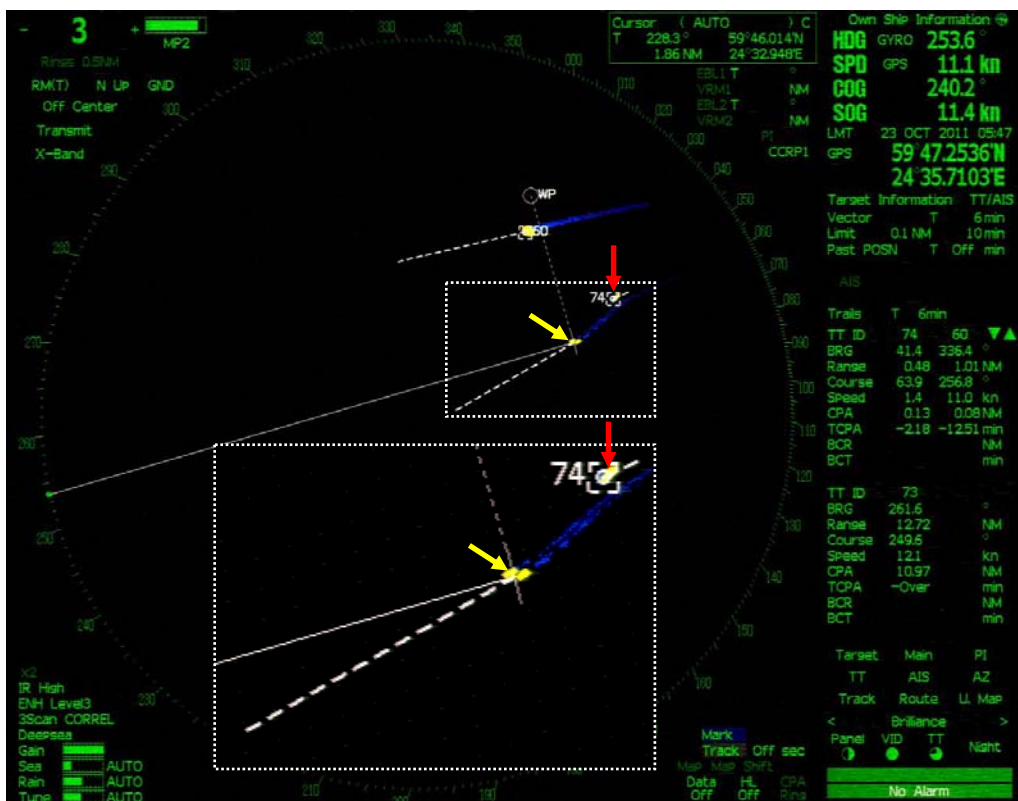
Image 17. At 04:46:42, approximately 3 minutes after the collision. The echo of the FLORENCE is not displayed on the radar, and the ARPA monitoring has changed over to the MENHADEN. The course of the AMAZON is 240.2°, with a speed of 11.4 knots.

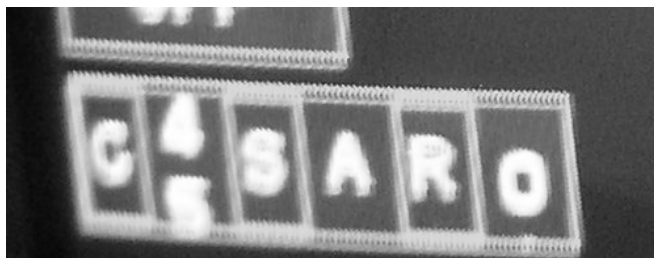
Image 1. The radar range adjustments of six nautical miles during the time of the accident, starting at the left: G=Gain (sensitive control of the received radar signal, 4.5), S=SeaClutter (anti-clutter sea control, A=automation, which deletes the sea clutter completely), and R=RainClutter (anti-clutter rain control, value 0).

Both of the radars had the anti-clutter sea control on automation. All distractions and weaker echoes cannot be distinguished on these adjustments when a vessel is approaching.

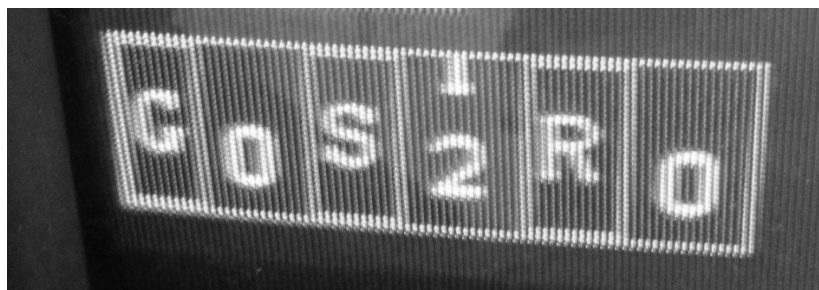
Image 5. The radar adjustments when the PV-161 approaches the vessel for the second time.

Sea clutter was somewhat visible with the changed settings (image 5 above), but not to a distracting extent. These settings ensure that also the weaker echoes are distinguishable all the way to a close-quarte situation. The adjustments are radar specific, thus they should not be considered universal.

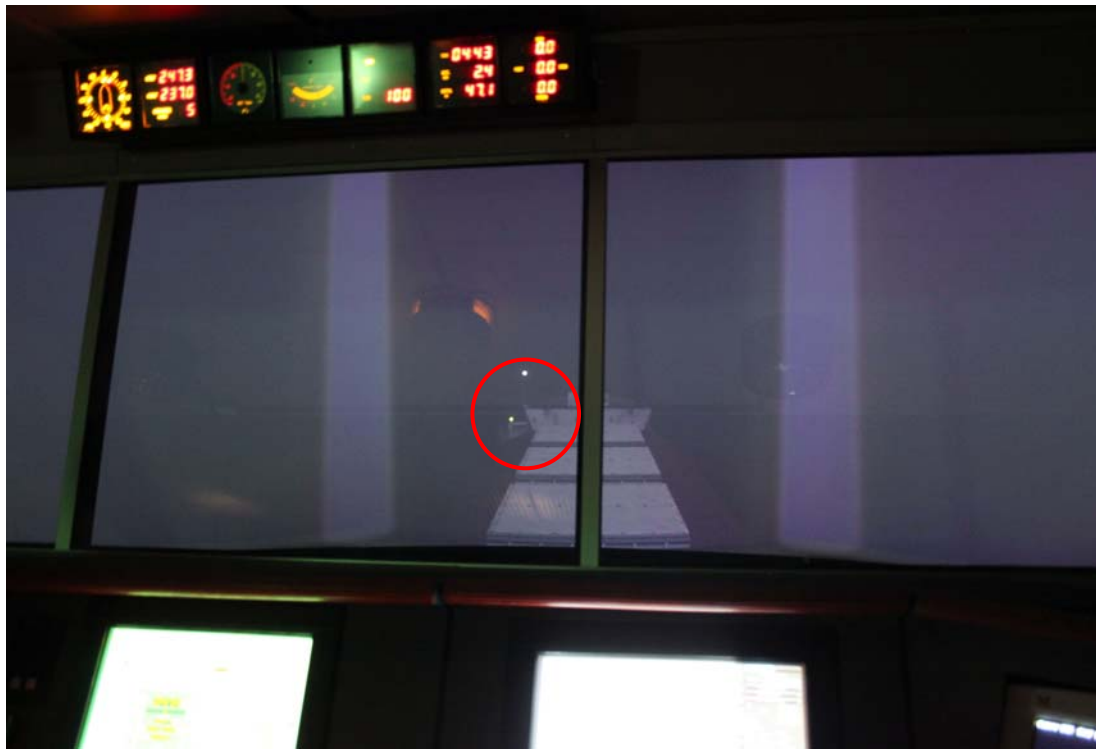
While the anti-clutter sea controls were on automation, the fishing vessels disappeared off the screen as they were approaching. The lights of the fishing vessels appeared only shortly before the collision (image 2). When the lights appeared, there was nothing to be done to prevent the collision. Shortly before the collision, the lights of the FLORENCE disappeared behind the forecastle of the AMAZON. The MENHADEN was slightly ahead of the AMAZON's starboard wing during the accident, and its navigation lights were visible from the bridge of the AMAZON.

Image 2. The simulated collision is just about to happen in the fog (visibility 200m) and darkness. The FLORENCE is marked with a red circle. Its navigation lights have appeared a moment earlier. The fishing vessel's white mast-head light, green navigation light, and some of its deckhouse are visible. (During the actual accident, the vessel's cranes have probably hindered the visibility especially when looking out from the starboard side of the bridge. In that case it is possible that also the fishing vessel lights have been in a blind spot.)

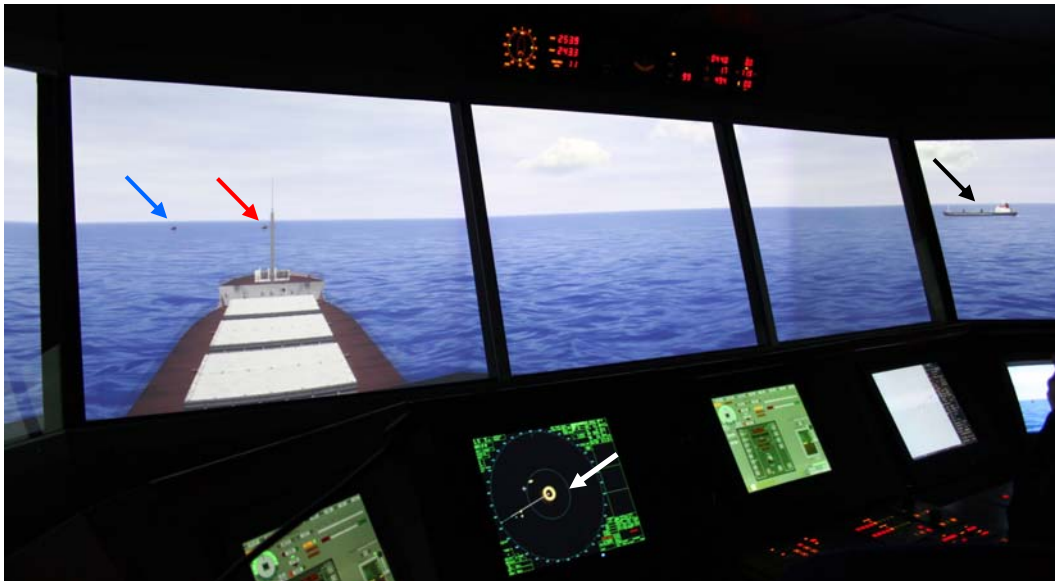
The **second run** simulated the accident in daylight without the fog in order to be able to monitor the progress of the situation visually through the bridge windows. The change of the direction was initiated based on radar observations only. The simulation conducted the change of course to the port in order to avoid the MENHADEN, and collided with the FLORENCE.

Image 3. The initiation of the change of direction is approaching. The FLORENCE is marked with a blue arrow, the MENHADEN with a red arrow, and the STELLA POLARIS with a black arrow. The VRM⁴⁸ ring on the radar that is seen in the foreground of the image is set to 0.58 miles (white arrow). The change of the course is initiated when the ring hits the displayed radar echoes of the fishing vessels. The distance to the fishing vessels in the image is approximately 0.8 miles.

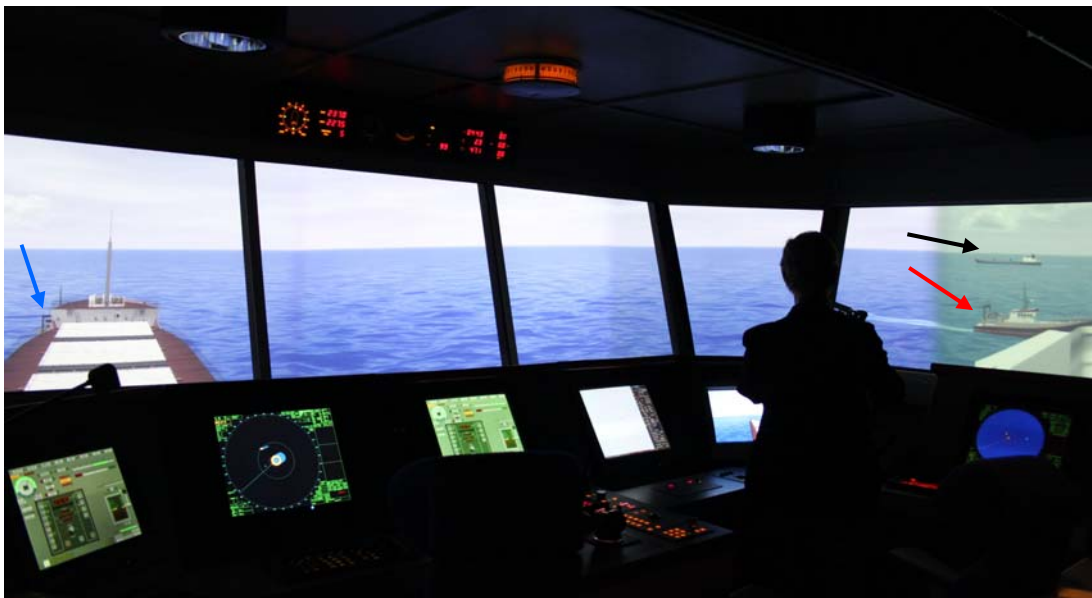
Image 4. The simulated collision has just taken place. The corner of the FLORENCE's deckhouse is visible behind the AMAZON's forecastle (blue arrow). The MENHADEN, which is by the starboard wing, is marked with a red arrow. The STELLA POLARIS (black arrow) can be seen further at the starboard.

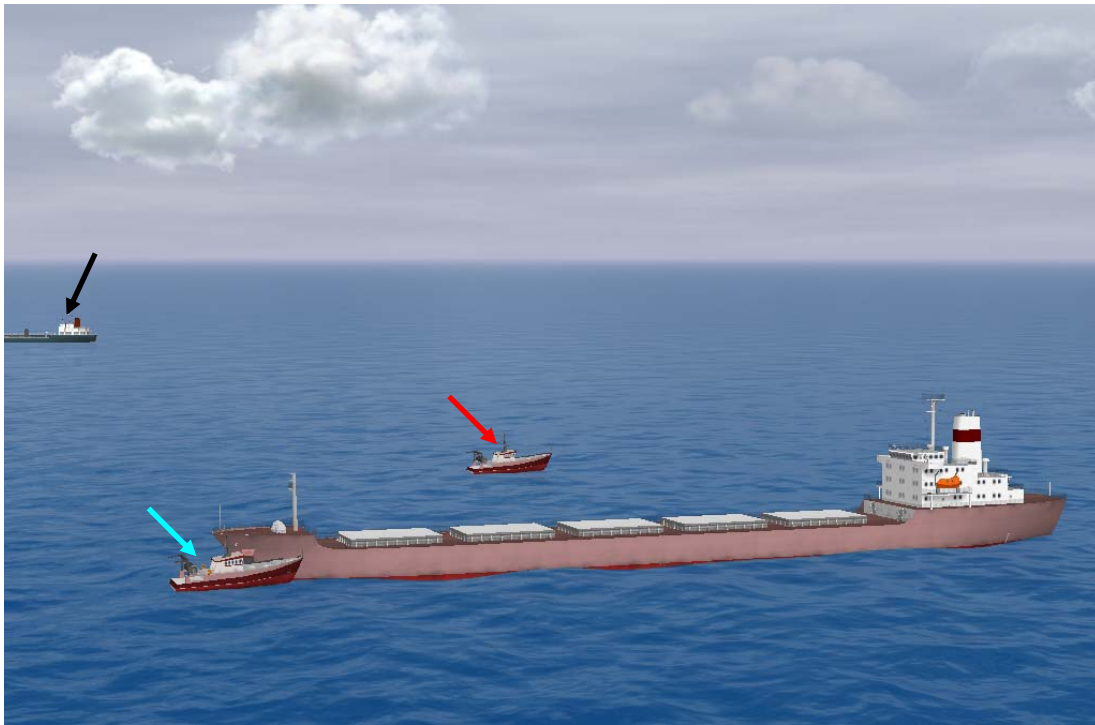
Image 5. An aerial view of the time of the accident. The FLORENCE is the blue arrow, the MENHADEN is the red arrow, and the STELLA POLARIS is the black arrow.

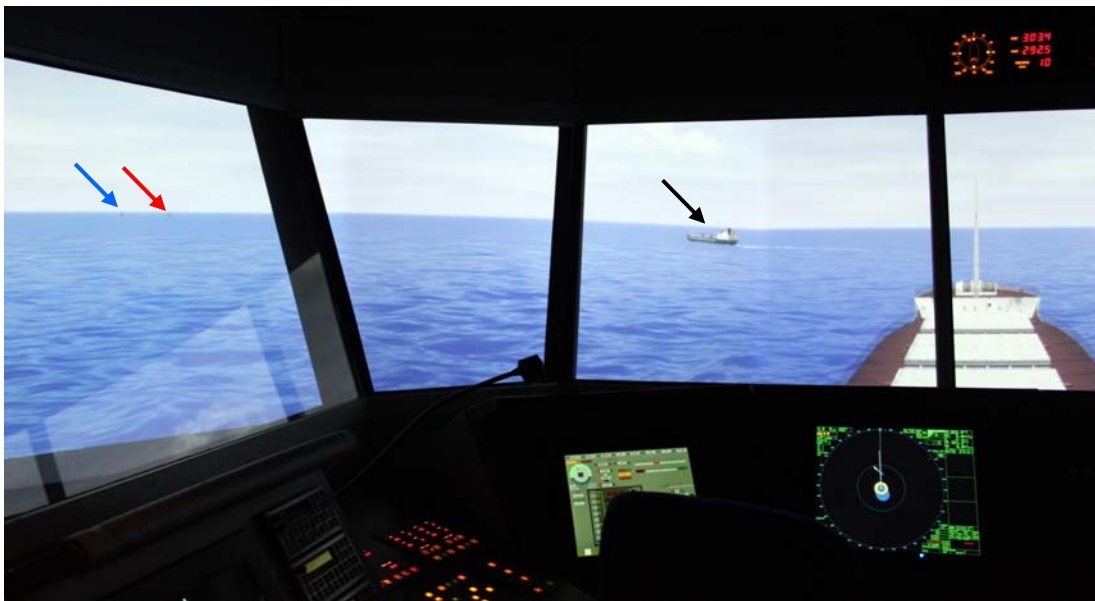
The change was initiated in good time before the close-quarters situation with the fishing vessels while passing the STELLA POLARIS. Speed was not reduced (image 6). After the change of direction the simulation continued to north of the STELLA POLARIS.

Image 6. The FLORENCE is marked with a blue arrow, the MENHADEN with a red arrow, and the STELLA POLARIS with a black arrow. Despite the turn initiated during the passing, no close-quarters situation with the STELLA POLARIS is developed because the distance to it grows during the turn.

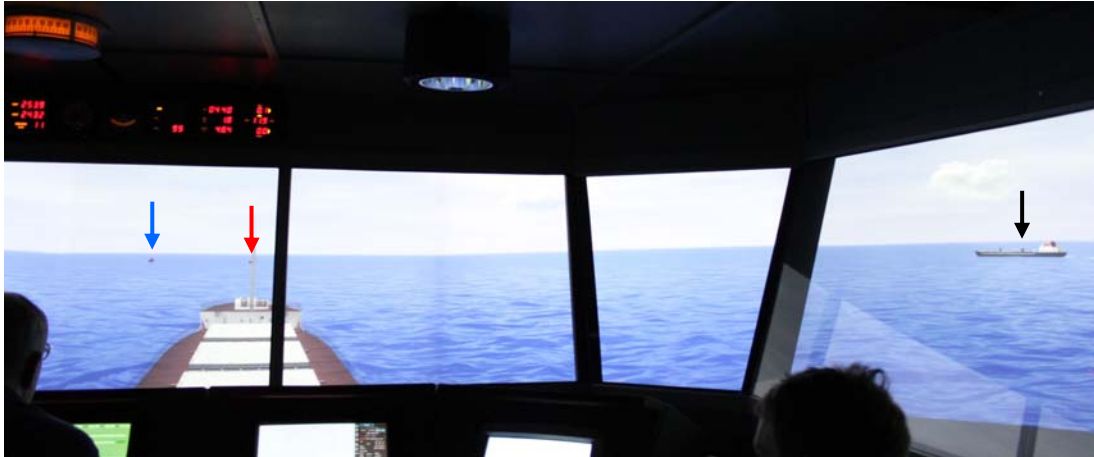
The fourth run consisted of the change of direction to the starboard in daylight without fog in order to monitor the change of direction visually. The initiation of the change was based on radar observations only, and it was conducted when the distance to the fishing vessels on the radar was 0.58 miles (the same distance as in the actual situation before initiating the change). After the change was done, the vessel was driven between the fishing vessels and the STELLA POLARIS. Speed was not reduced.

Image 7. The change of direction to the starboard starts with the rudder command “hard to starboard”. The distance to the fishing vessels is 0.58 miles. The FLORENCE is marked with a blue arrow, the MENHADEN with a red arrow, and the STELLA POLARIS with a black arrow.

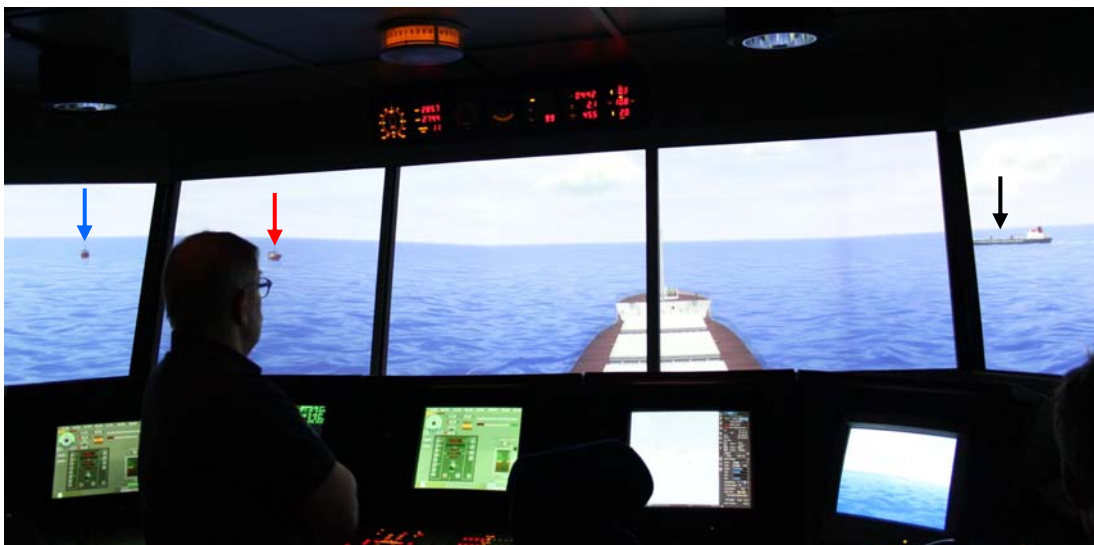
Image 8. The change of direction to the starboard is approximately half-way through. The FLORENCE is marked with a blue arrow, the MENHADEN with a red arrow, and the STELLA POLARIS with a black arrow.

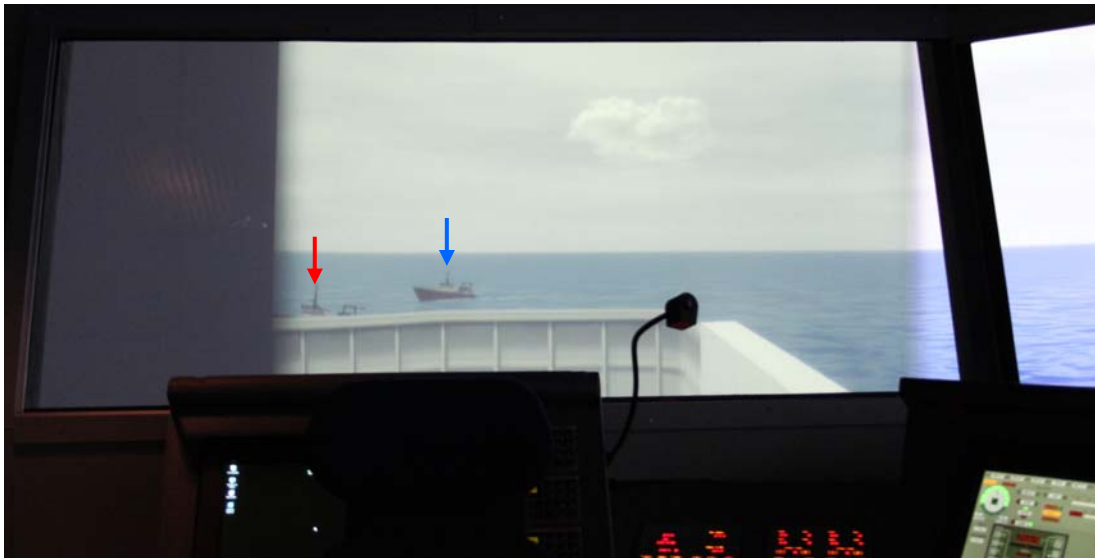
Image 9. The change of direction to the starboard is ready. The fishing vessels pass from the port side. Distance to the nearest fishing vessel is 0.1 miles. The FLORENCE is marked with a blue arrow, and the MENHADEN is marked with a red arrow.
