Investigation report

B2/2011M

M/V AMAZON (BHS) and F/V FLORENCE (FIN), collision resulting in the sinking of the fishing vessel in the Gulf of Finland on 23 October, 2011

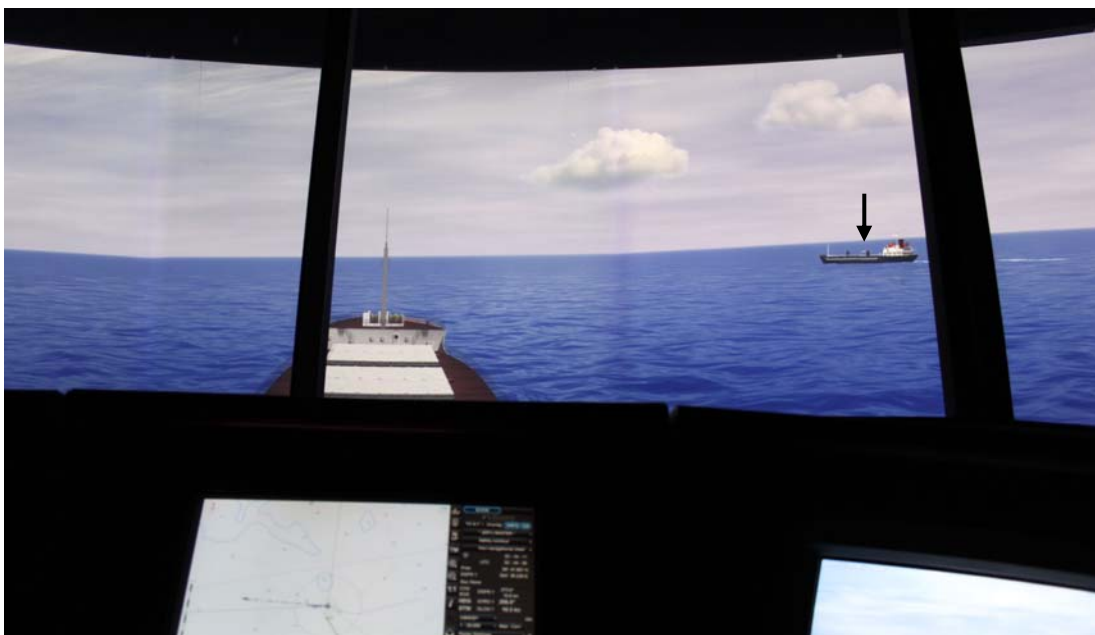
Image 10. The change of direction to the starboard is ready, and the change of direction back to the original course has been initiated a moment earlier. The fishing vessels pass from the port side, and the distance to the STELLA POLARIS (black arrow) is approximately 0.4 miles.

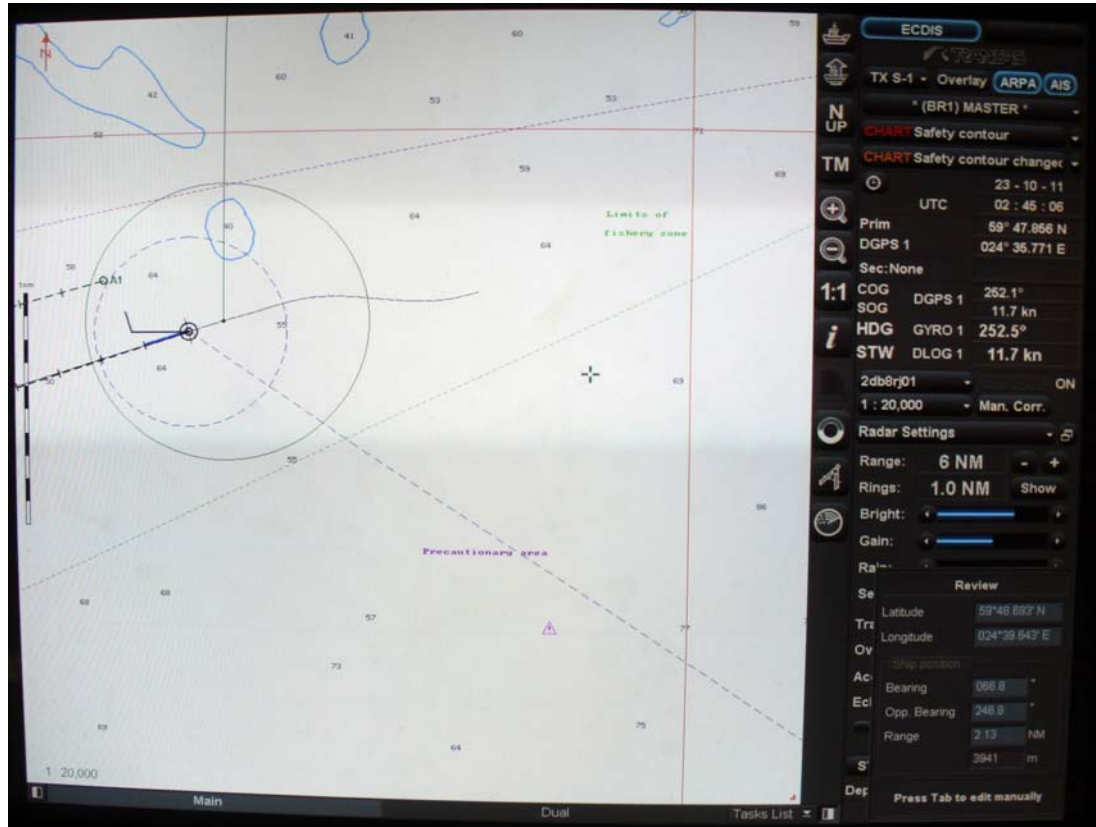
During the fifth run, which was conducted in darkness and fog, the engine speed was reduced (engine order: dead slow ahead), after which the engine speed was gained (in order to increase the rudder flow), and the change of direction was conducted with the command “hard to starboard”. The engine speed was reduced significantly before the development of the close-quarters situation. The timing of the manoeuvres was based on radar observations only.

Image 11. Image of the vessel's course on the ECDIS after the successful collision avoidance action. The eventual distance to the MENHADEN was 0.2 miles. The STELLA POLARIS got a small lead before the change of the course. After the manoeuvre, the distance to it was approximately 0.8 miles.
