Investigation report#

C2/2011M

F/V WILLEMPJE HOEKSTRA UK 33 (NLD) and M/V BIRKA TRANSPORTER (FIN), Collision off the Netherlands on 14 February 2011

**Onnettomuustutkintakeskus
Olycksutredningscentralen
Safety Investigation Authority, Finland**

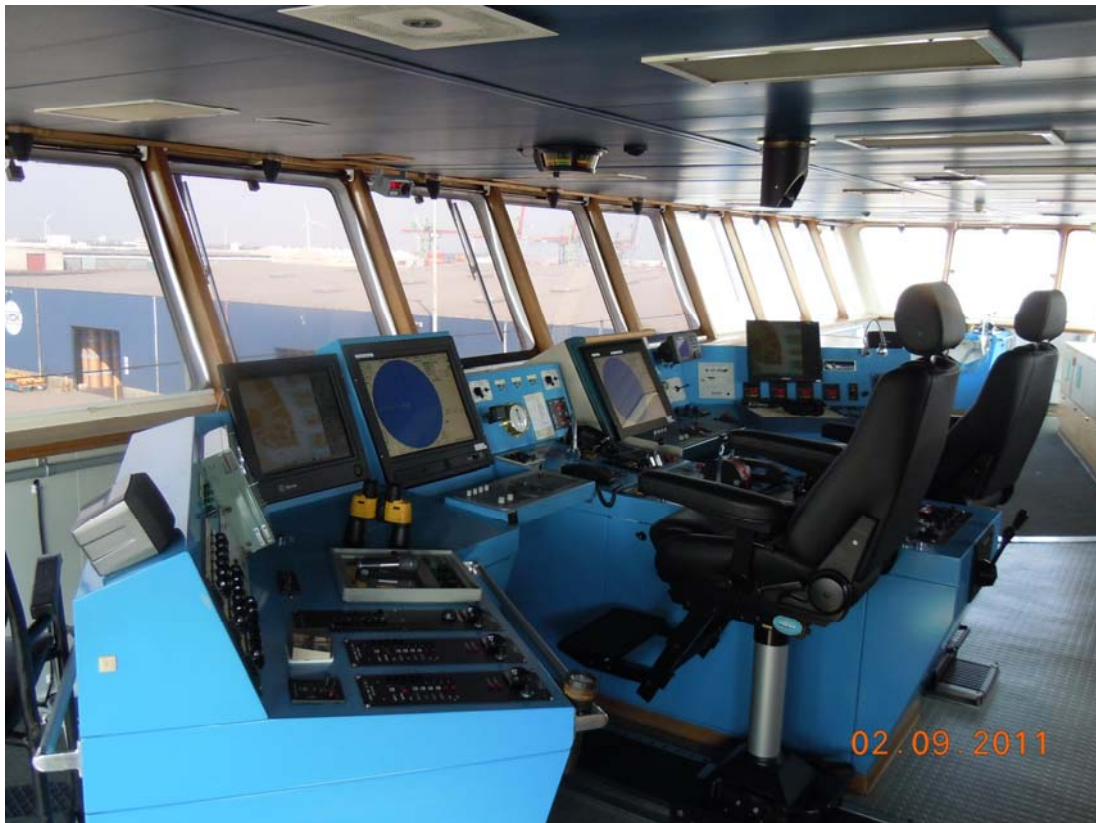
Figure 3. *The wheelhouse on BIRKA TRANSPORTER. The further chair was the conning position prior to the collision.*

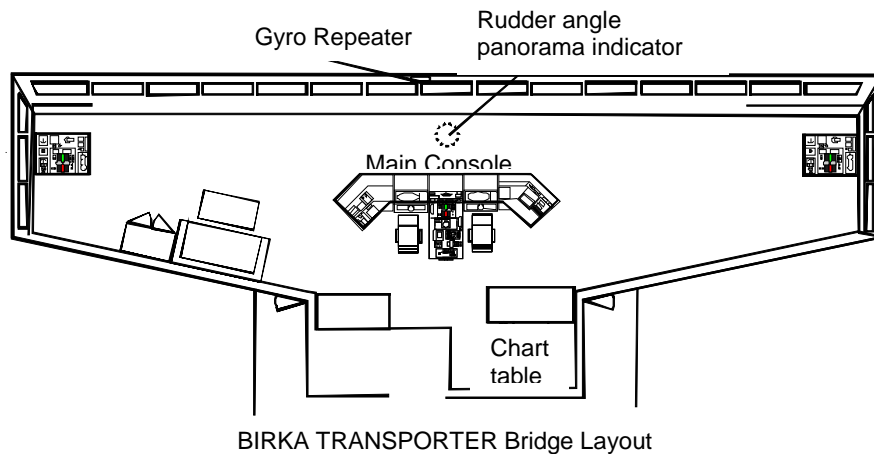
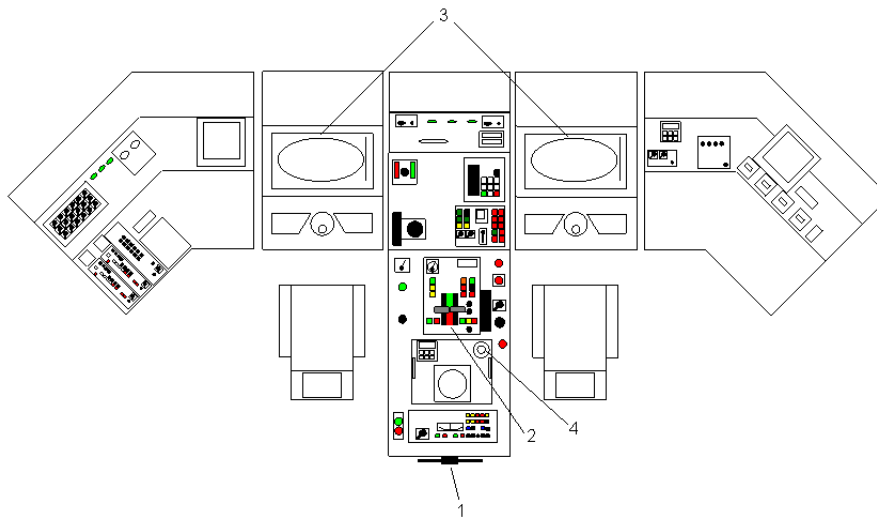
Figure 4. Wheelhouse and main console on BIRKA TRANSPORTER. Only navigation equipment relevant to this accident is displayed. The OOW was using the right conning position.

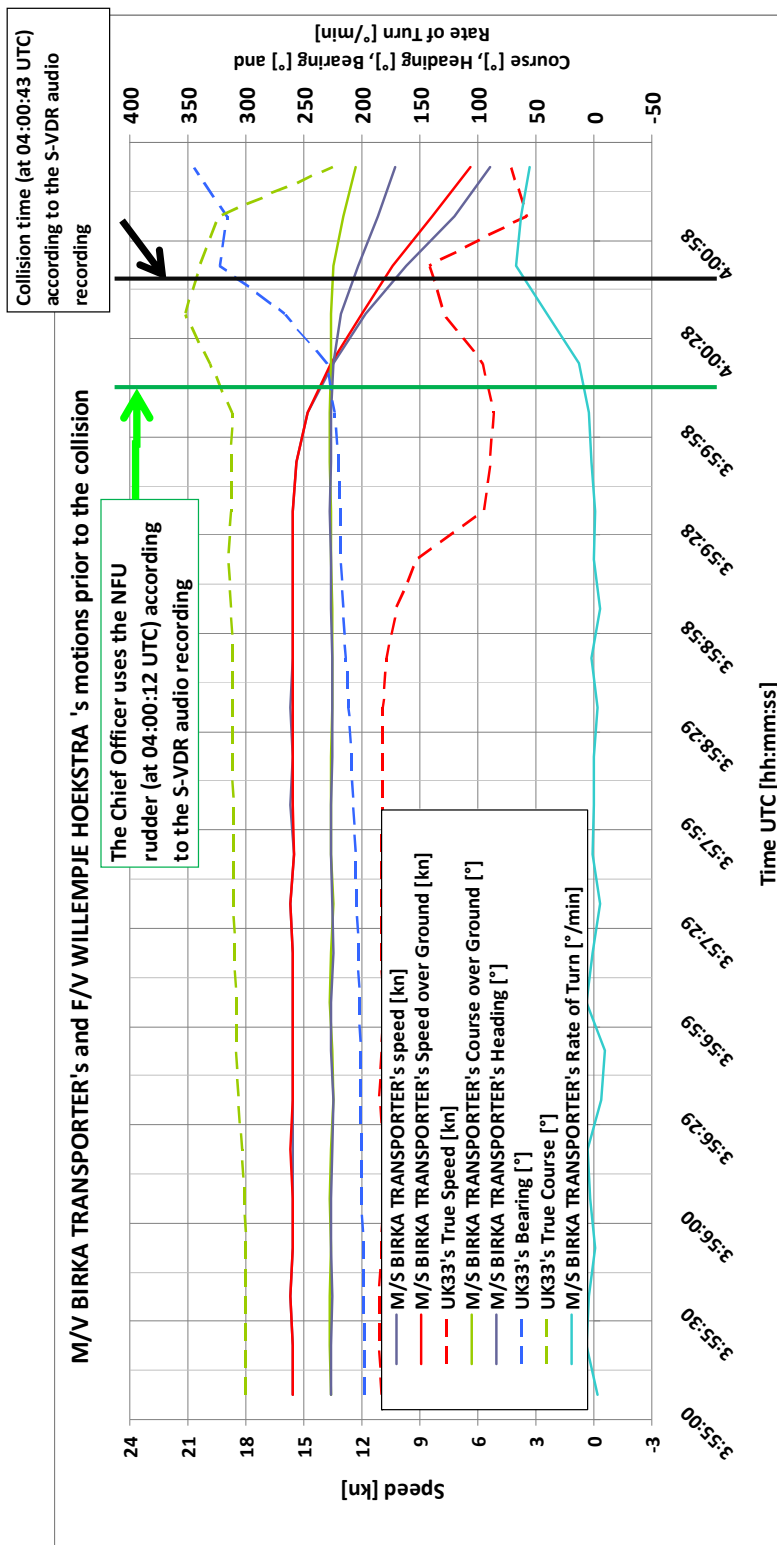
In the figure 12 there are curves illustrating the motion data of both vessels until the accident.

Figure 12. BIRKA TRANSPORTER's and WILLEMPJE HOEKSTRA's motion data prior to the accident based on recorded S-VDR data.

- WILLEMPJE HOEKSTRA performed a slight course alteration to starboard prior to the collision. At this point, the distance between the vessels was some 1.4 NM. According to Figures 12 and 14, a sharper turn to starboard may have taken place just before the collision. However, at this point the fishing vessel was already so close to the radar antenna that the accuracy of the ARPA information was probably compromised.

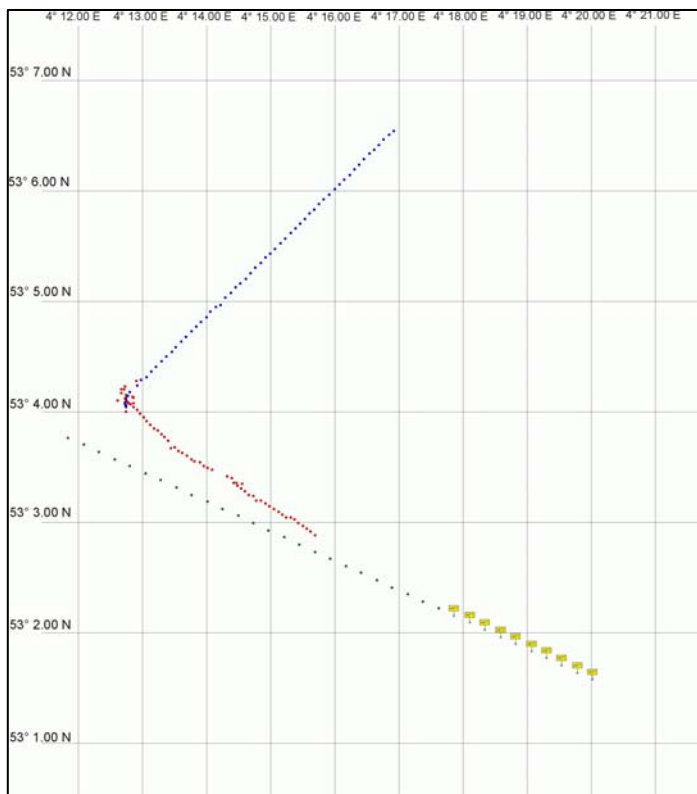
Figure 14. Vessel tracks derived from BIRKA TRANSPORTER's S-VDR. BIRKA TRANSPORTER's track is shown as blue dots (data from the S-VDR recording). WILLEMPJE HOEKSTRA's track is shown as red dots (data from S-VDR's ARPA data). The yellow marked track is WILLEMPJE HOEKSTRA's track from the beginning of the situation (based on the radar plot). The track is extrapolated by dead reckoning until it crosses the track of BIRKA TRANSPORTER (marked as green dots).

- According to the S-VDR-recording, the collision took place in position 53°04.178N, 004°12.797E at 4:00:43 UTC. The exact collision time was concluded based on the S-VDR audio; the collision noise as well as the OOW's reaction. In Figure 14. the collision site has slightly different coordinates. This can also be explained by the closeness of the fishing vessel.

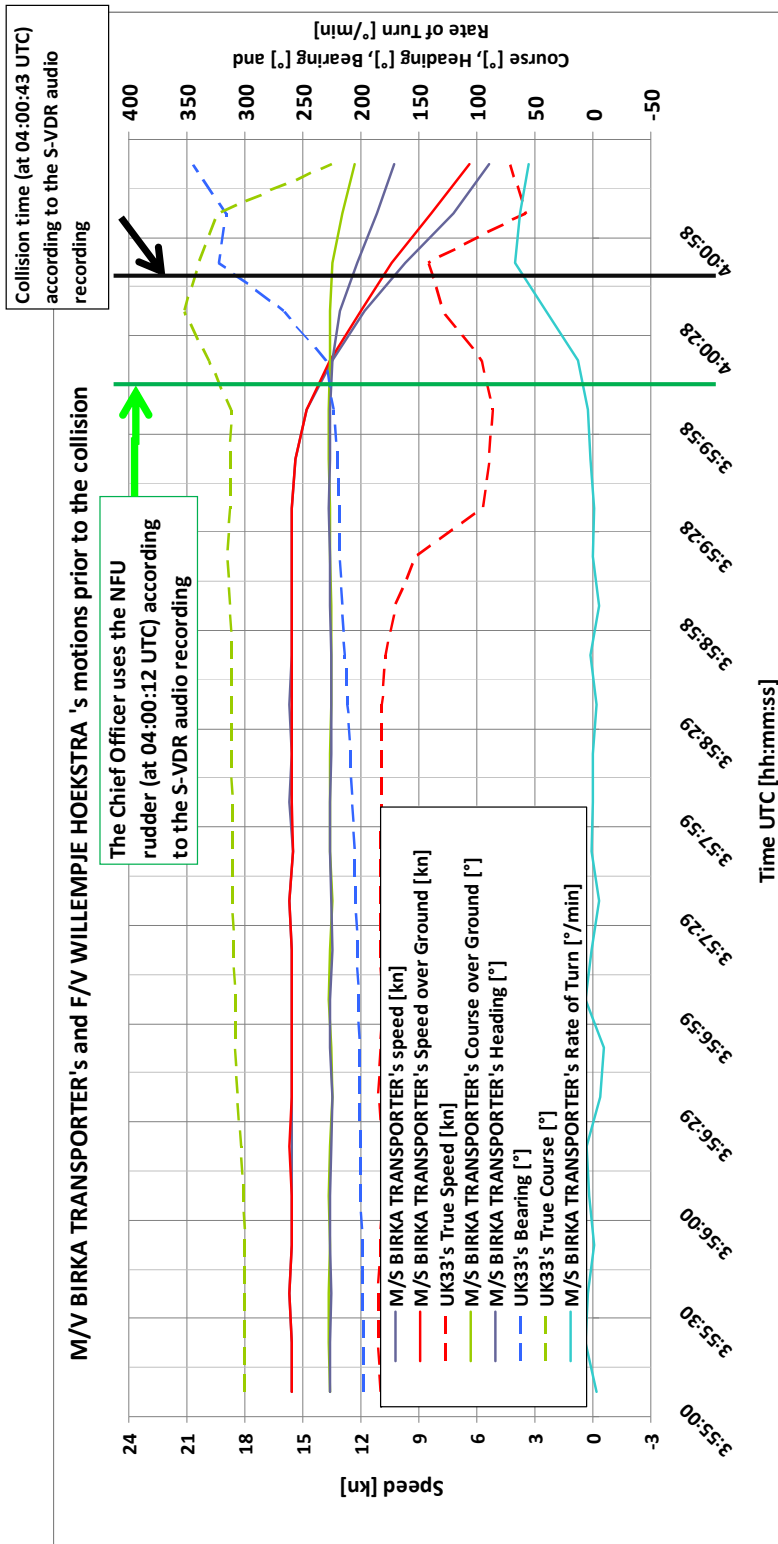
The graph in Figure 1 was drawn based on the S-VDR data. Because the ARPA target data in the radar extracts is the only recorded information on the fishing vessel, the radar extracts were also used as a data source for BIRKA TRANSPORTER's curves in order to enable a comparison between the two vessels. The time interval in the graph is thus 15 seconds.

Figure 1. BIRKA TRANSPORTER's and WILLEMPJE HOEKSTRA's movements prior to the accident based on recorded S-VDR data.

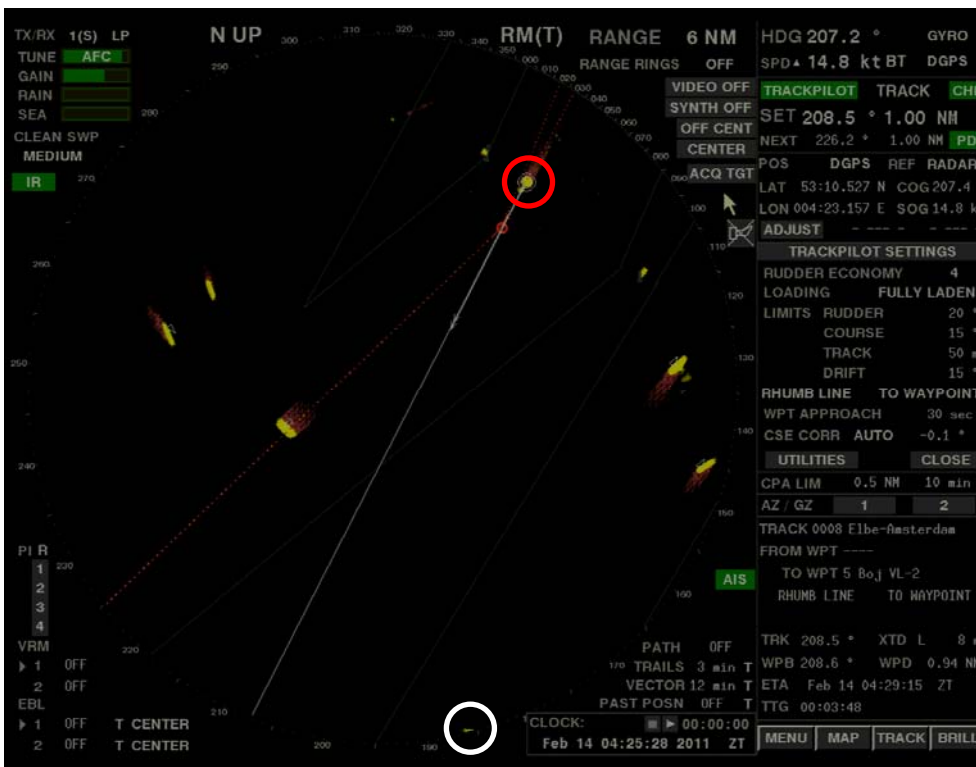
Figure 2. At 3:25:28. WILLEMPJE HOEKSTRA (white circle) is in sight on the radar screen for the first time. BIRKA TRANSPORTER is marked as a red circle. Time to the collision is circa 35 minutes.

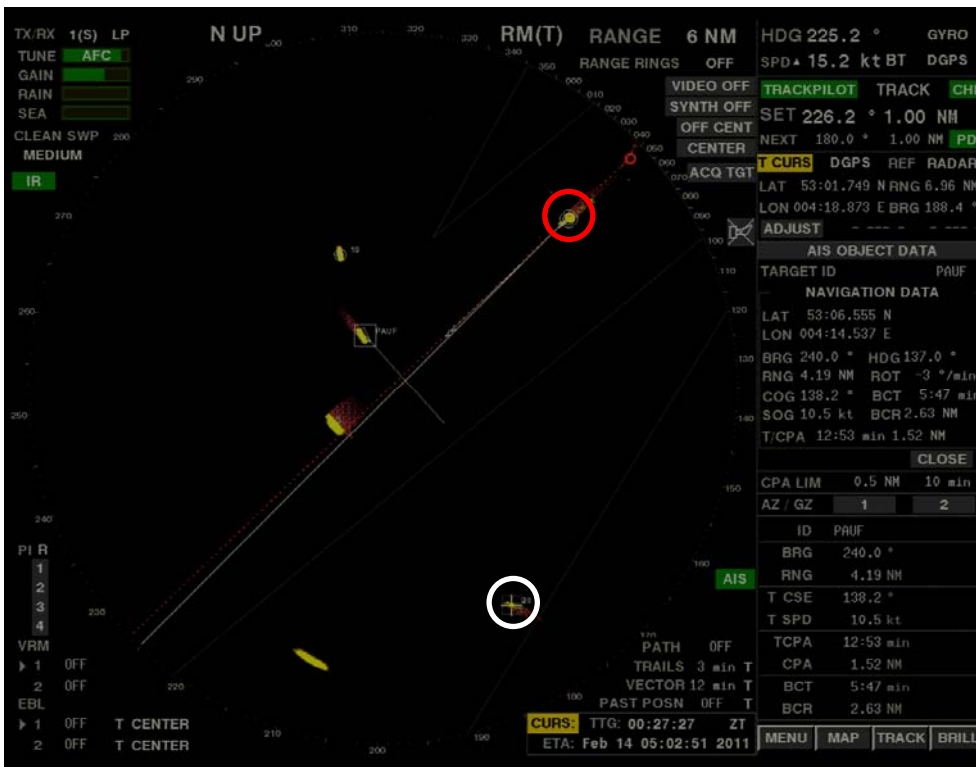
Figure 3 At 3:35:23. WILLEMPJE HOEKSTRA (white circle) is plotted on BIRKA TRANSPORTER's ARPA radar. BIRKA TRANSPORTER is marked as a red circle. Time to collision is circa 25 minutes.

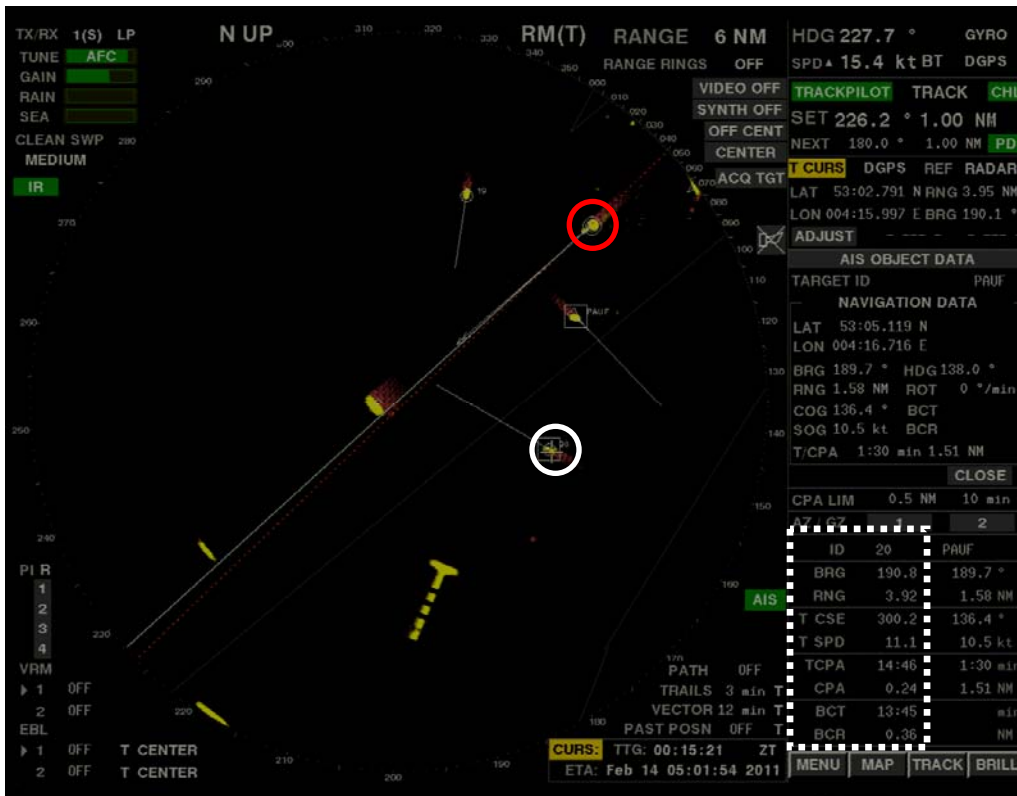
Figure 4. At 3:46:34. WILLEMPJE HOEKSTRA's (white circle) ARPA data (rectangle in white dash line) is activated on BIRKA TRANSPORTER's (red circle) radar. Time to the collision is circa 14 minutes. CPA is 0.24 miles and TCPA 14.46 minutes.

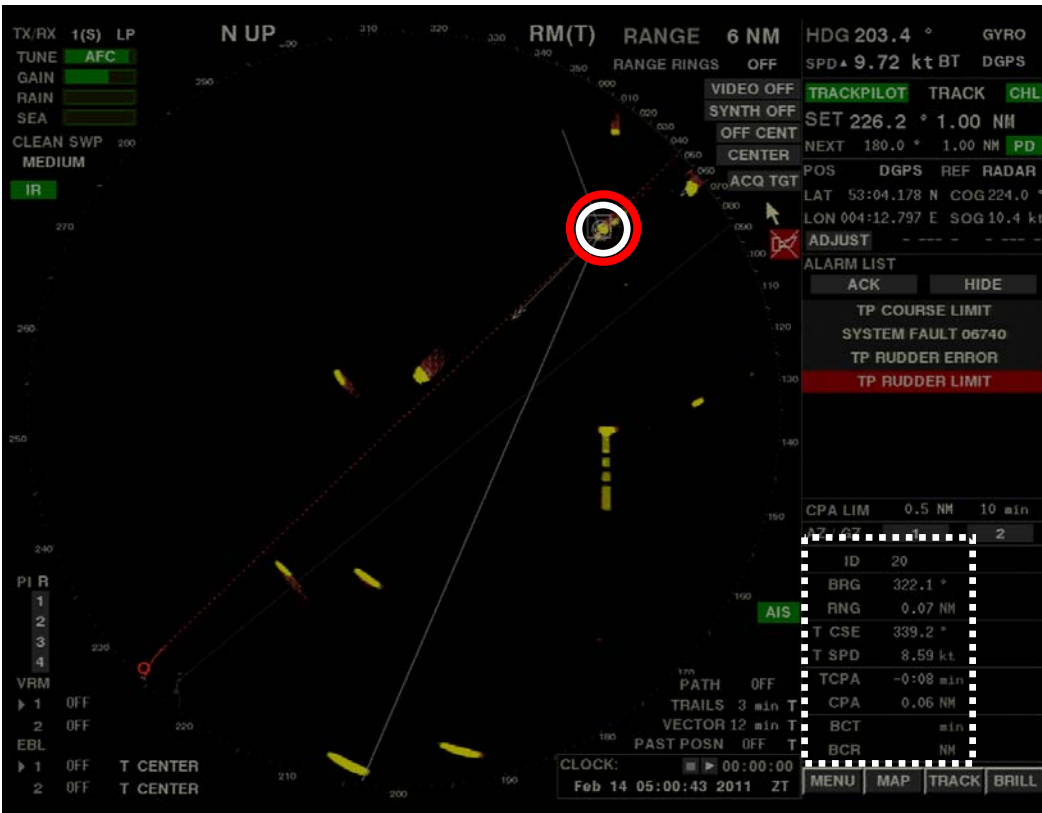
Figure 7 At 4:00:43. The collision occurs according to the S-VDR audio.

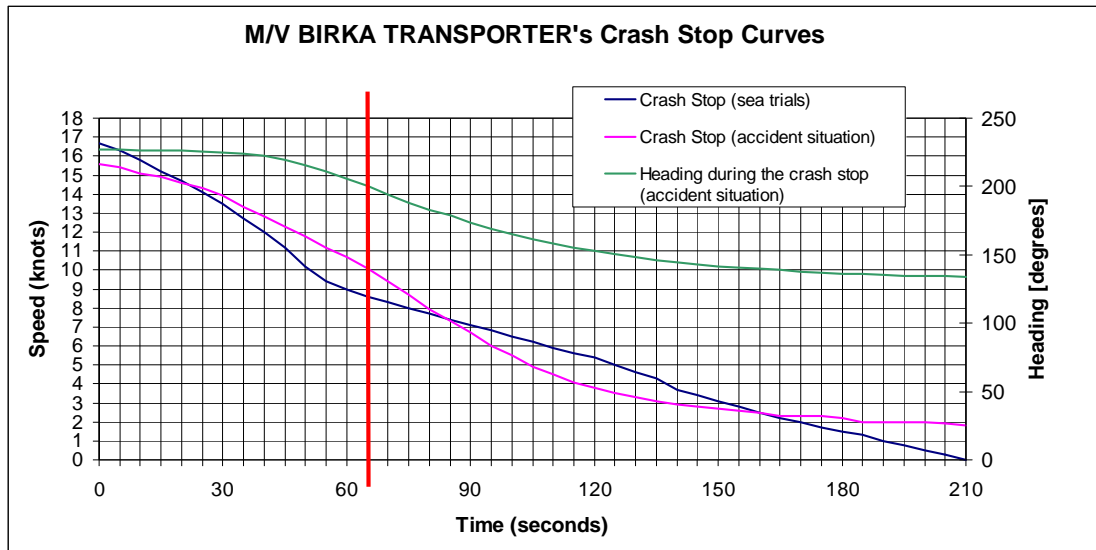
Figure 9 illustrates BIRKA TRANSPORTER's speed during the crash stop test and during the accident. The heading during the accident crash stop is also shown on the graph. The speed curve in the picture begins with a slope which is not as steep as the corresponding one from the crash stop test. This is due to slowly setting the propeller pitch to zero in 30 seconds.

BIRKA TRANSPORTER had almost stopped abt. two minutes after the collision when her heading was 135 degrees and speed slightly under two knots.

Figure 9. Crash stop manoeuvre of BIRKA TRANSPORTER at sea trials (blue line) and in the accident (red line). The green line illustrates the heading during the accident crash stop and the red vertical line the accident time. Sources: S-VDR data and BIRKA TRANSPORTER's crash stop test poster.

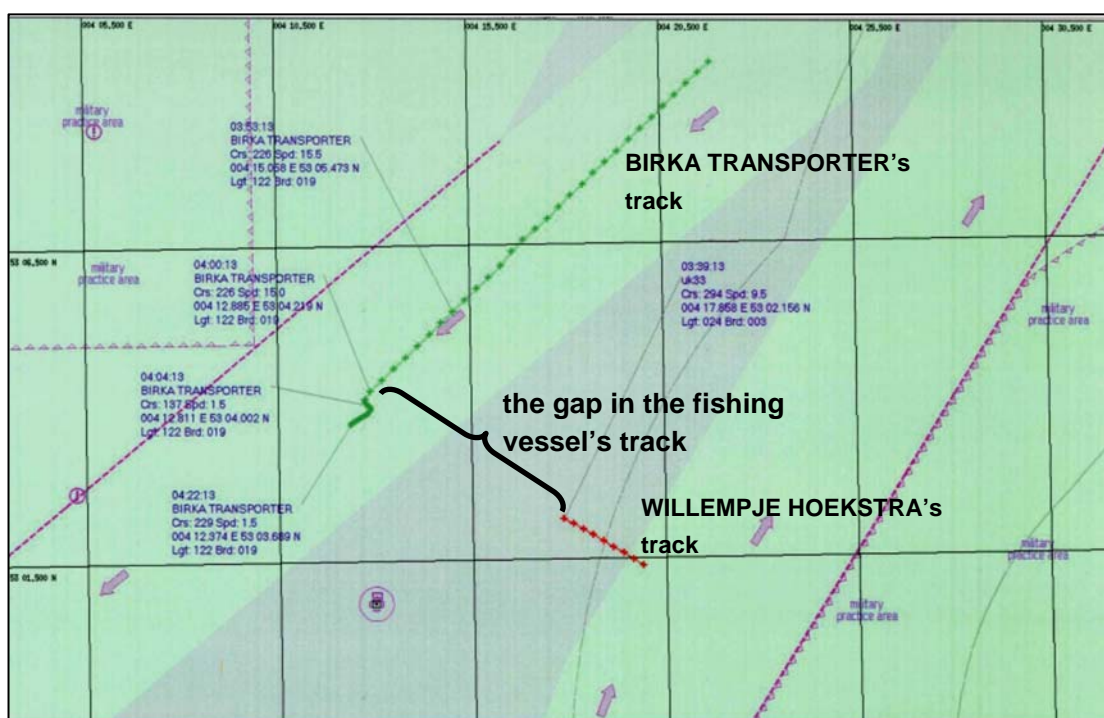
The accident investigation commission was provided with an incident log including a few radar plots by the Netherlands Coastguard Service. According to the radar plot in Figure 1 BIRKA TRANSPORTER maintained a steady course until 4:00:13, at which time the vessel started to turn to port. Figure 1 shows that WILLEMPE HOEKSTRA also maintained a steady course in the beginning of the situation. For some reason, there is a gap of approximately 15 minutes in the track of the fishing vessel in the radar plot.

Figure 1. An overall picture of the situation provided by the Netherlands Coastguard Service. The Figure shows the tracks of both sides, BIRKA TRANSPORTER's in green and WILLEMPE HOEKSTRA's in red. There is a gap of approximately 15 minutes in the track of the fishing vessel prior to the collision.

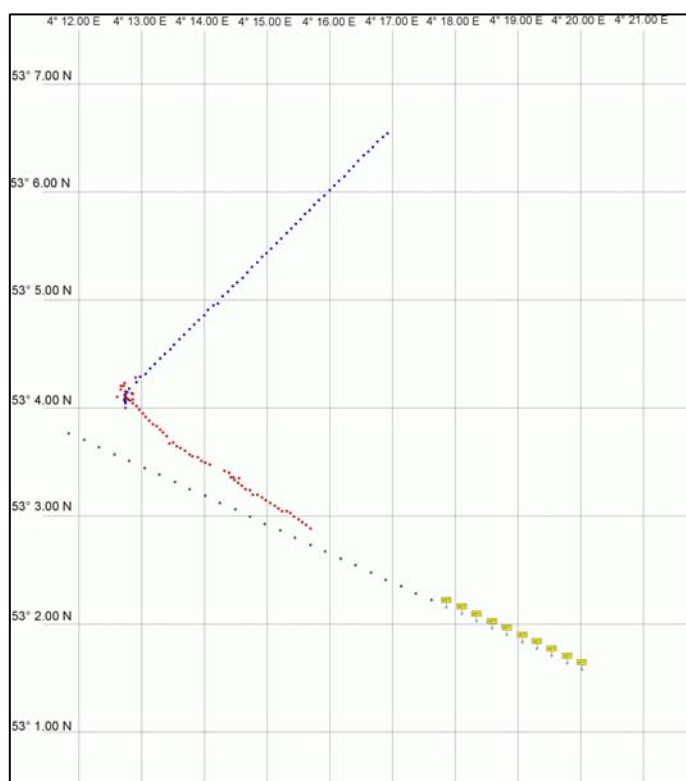
Based on the S-VDR recording, in reality the fishing vessel slightly altered its course to starboard, and BIRKA TRANSPORTER, because of the crash stop manoeuvre, turned to port prior to the collision. The situation is illustrated in Figures 2 (large scale) and 3 (small scale). In Figure 2, an attempt was made to fill in the gap in the fishing vessel's track between the end of radar recording and the beginning of S-VDR recording by using dead reckoning.

Figure 2. Vessel tracks derived from BIRKA TRANSPORTER's S-VDR. BIRKA TRANSPORTER's track is shown as blue dots (data from the S-VDR recording). WILLEMPJE HOEKSTRA's track is shown as red dots, and it is based on dead reckoning (data from S-VDR's ARPA data). The yellow signs are from the radar system, and dead reckoning calculations are marked as green dots.

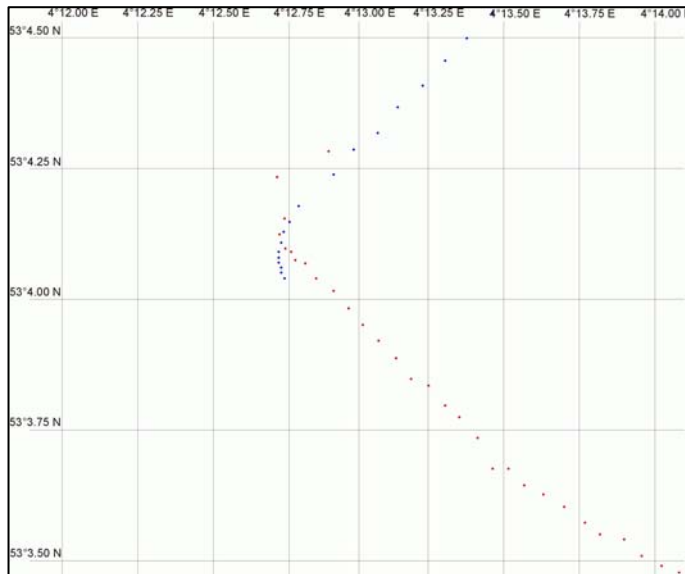
Figure 3. Enlargement of vessel tracks derived from BIRKA TRANSPORTER's S-VDR. BIRKA TRANSPORTER's track is shown as with blue dots and WILLEMPJE HOEKSTRA's track as red dots.

- WILLEMPJE HOEKSTRA performed a slight course alteration to starboard prior to the collision. At this point, the distance between the vessels was some 1.4 NM. According to Figure 3, a sharper turn to starboard may have taken place just before the collision. However, at this point the fishing vessel was already so close to the radar antenna that the accuracy of the ARPA information was probably compromised. This can be seen in Figure 3, where the last two spots are presumably misplaced.

- According to the S-VDR-recording, the collision took place in position 53°04.178N, 004°12.797E at 4:00:43 UTC. The exact collision time was concluded based on the S-VDR audio; the collision noise as well as the OOW's reaction. In Figure 3. the collision site has slightly different coordinates. This can also be explained by the closeness of the fishing vessel.

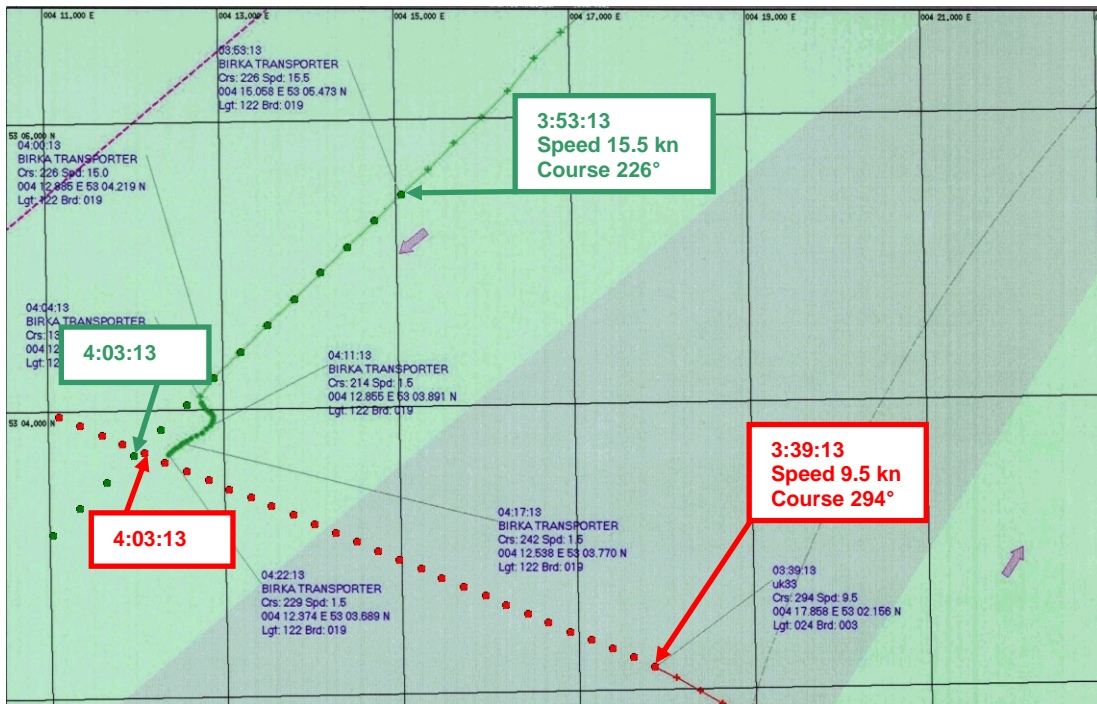
An attempt was made to calculate what the situation could presumably have been like if no course or speed alterations had been made by either of the vessels (Figure 4). The last positions, speeds and courses recorded by the radar system were used as starting values for dead reckoning.

According to Figure 4, it seems that instead of a collision, the situation could have been a near miss if no course and/or speed alterations had been made by the vessels.

Figure 4. Vessel tracks calculated by means of dead reckoning. The Figure illustrates what the situation could have been like if no course or speed alterations had been made by the vessels. WILLEMPJE HOEKSTRA's track is shown as red dots and BIRKA TRANSPORTER's as green dots. The time interval between each spot is one minute. As starting values for calculations were used the last positions, speeds and courses recorded by the radar system.

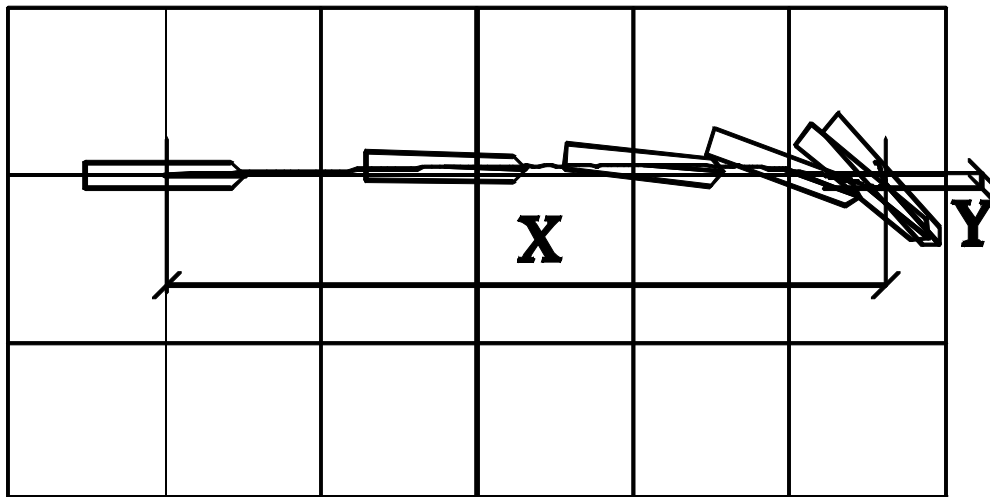
According to the IMO, a vessel in a crash stop test should stop within the distance of 15 vessel lengths (X denoting advance in Figure 1). BIRKA TRANSPORTER's advance in the crash stop test was approximately 5.8 vessel lengths.

Figure 1. An illustration of a crash stop test. X = advance, Y = lateral.

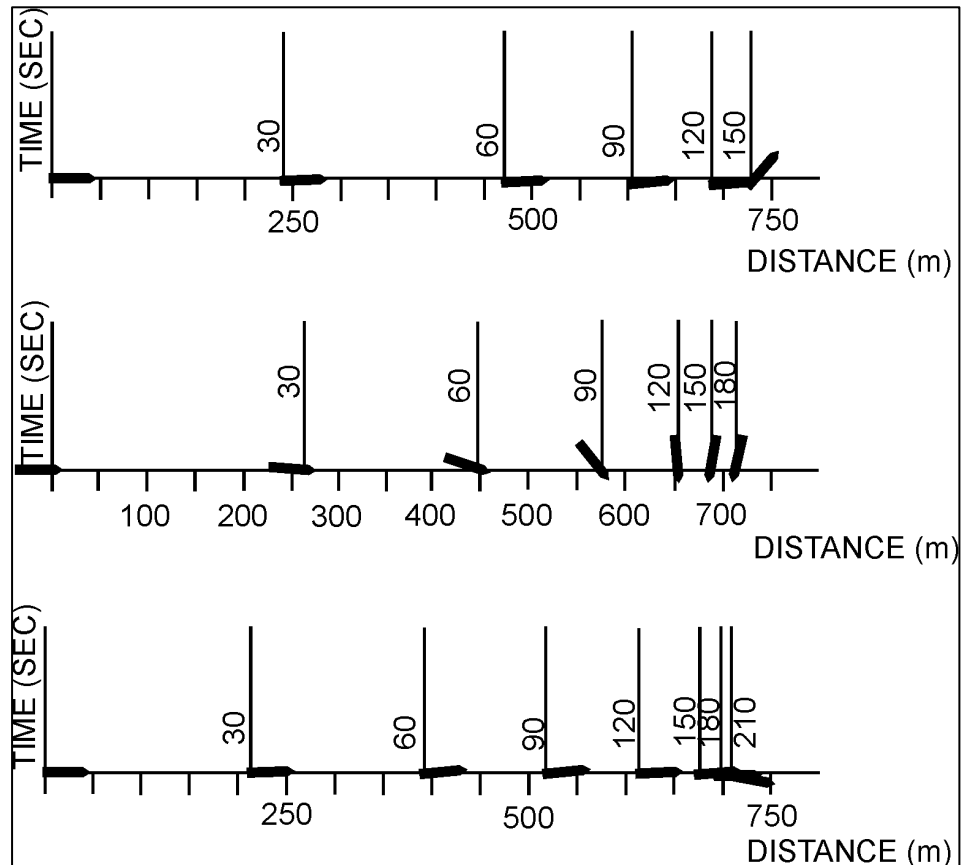
As mentioned previously, BIRKA TRANSPORTER has 5 sister ships. The investigators were able to get a crash stop poster from two of these vessels, M/S BIRKA EXPORTER (ex M/S GRANÖ) and M/S BIRKA SHIPPER (ex M/S STYRSÖ). When comparing these posters, it was noted that even though the vessels are similar, they turned to opposite directions during crash stop trials. This is illustrated in Figure 3.

Figure 3. Differences in behaviour between sister ships in crash stop tests.

As Figure 3 above illustrates, the turning direction of a ship in a crash stop may vary between sister ships, even though their hulls, rudders etc. are similar to each other.
