### Investigation report

M2012-02

### M/S PHOENIX J (ATG) grounding off Rauma 18.4.2012

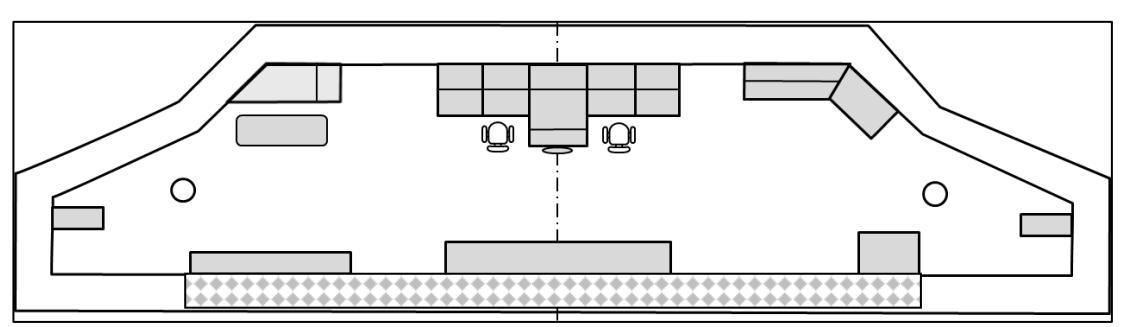
Figure 2. General arrangement of the navigating bridge of the PHOENIX J. The dotted areas offer no visibility aftwards (Figure 3).

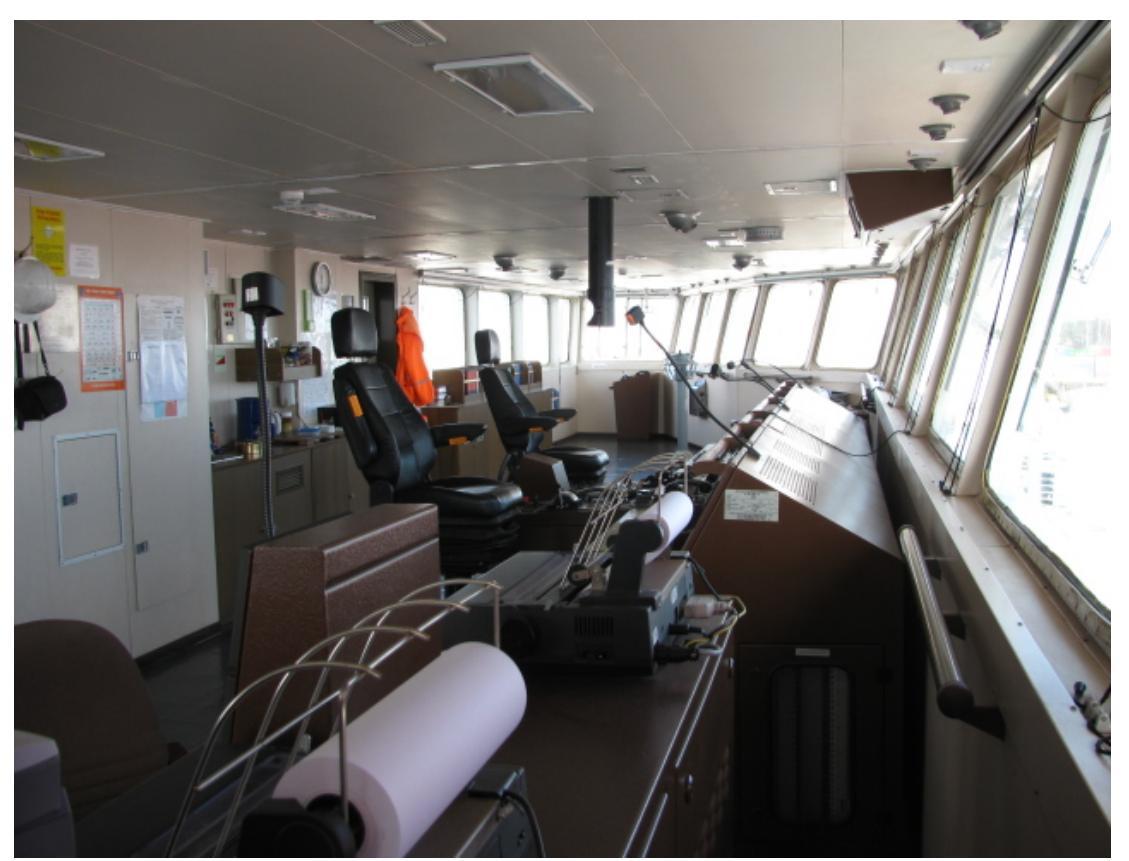
*Figure 3.* The navigating bridge desks photographed from the starboard side on 27 April.

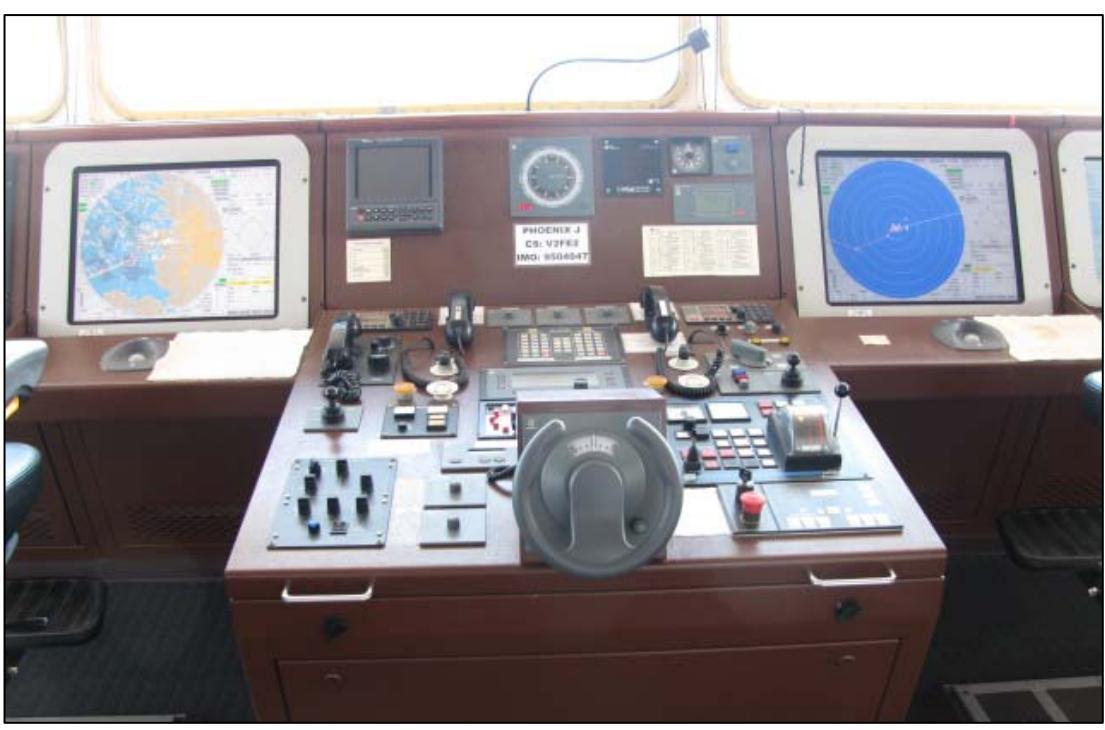
Figure 4a. The middle console and the manual rudder in the steering column. The master was steering the vessel when she ran aground.

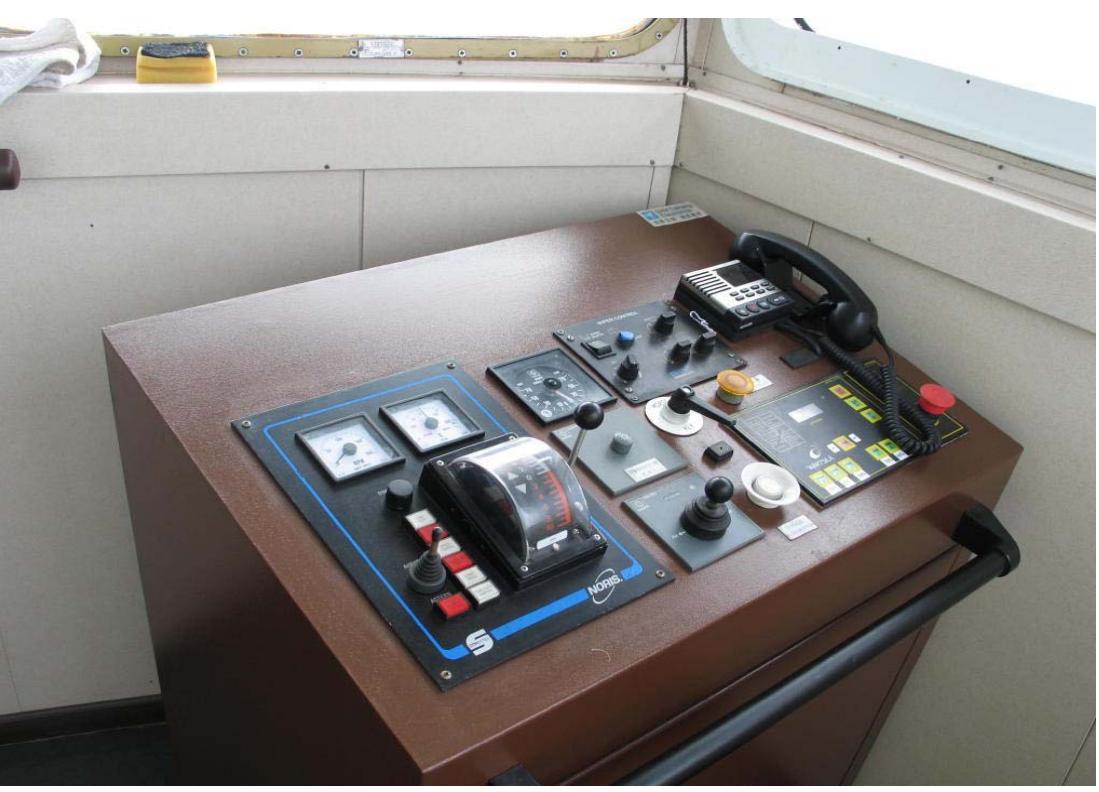
Figure 5. The starboard bridge wing desk and its steering console. The Master steered the vessel from here when the pilot was disembarking the vessel. An identical desk can be found on the port bridge wing.

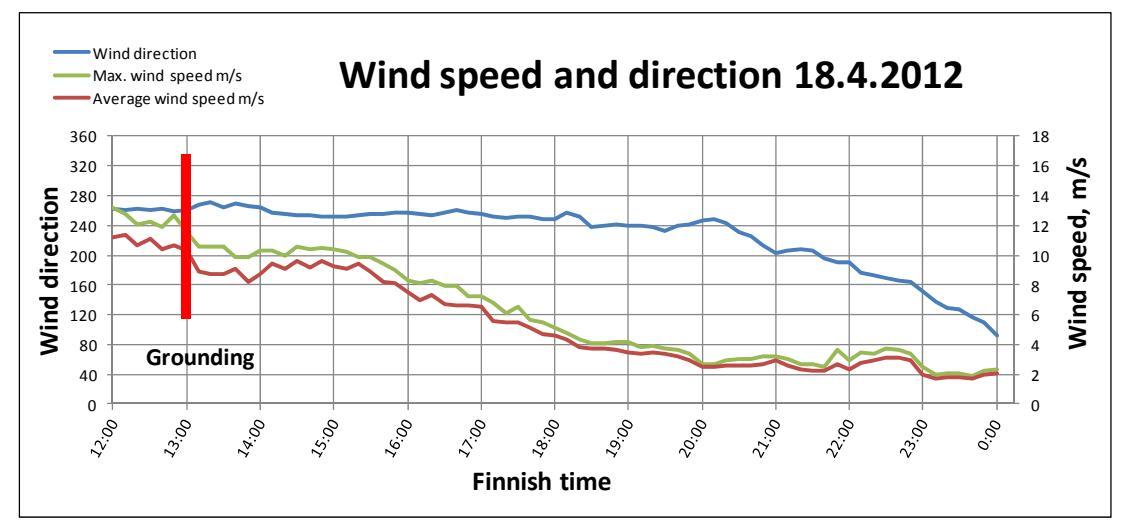
The Finnish Meteorological Institute has provided the weather, wave and water height information for the time of the accident and the rescue activities<sup>2</sup>. At the time of the accident, the wind was blowing from west with the speed of approx. 10-12 m/s (Figure 6). There was slight sea, the significant wave height was approx. 1 m. The visibility was good.

Figure 6. Wind condition in Kylmäpihlaja during the grounding, the red vertical line.

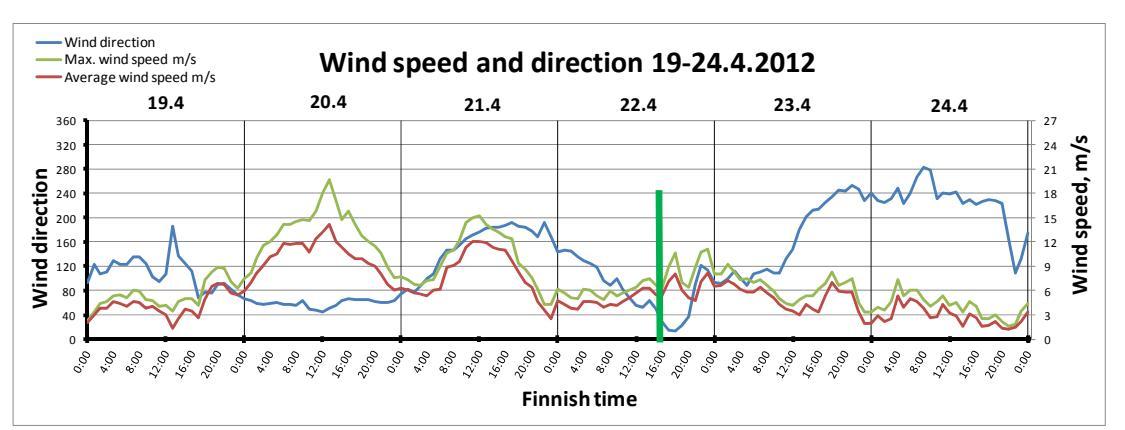
The salvage company brought tugboats and salvage equipment to the scene. On 20 April pumps were installed on the vessel and pneumatic appliances in the leaking tanks. Tightening and patching work was continued on 21 April when an attempt was made to refloat the vessel. The attempt was interrupted because of a strong wind, Figure 14. The sea level during the rescue operations is shown in Figure 15.

Figure 14. Wind conditions during the rescue operations in Kylmäpihlaja. The green line indicates the time of refloating.

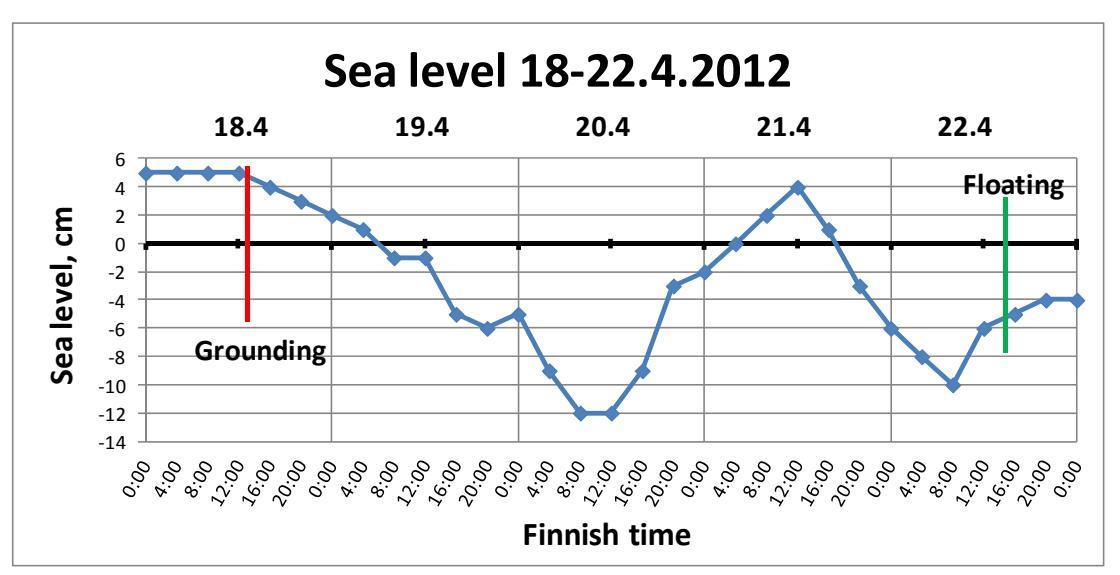
Figure 15. Sea level in Rauma at the time of the accident and rescue operations.

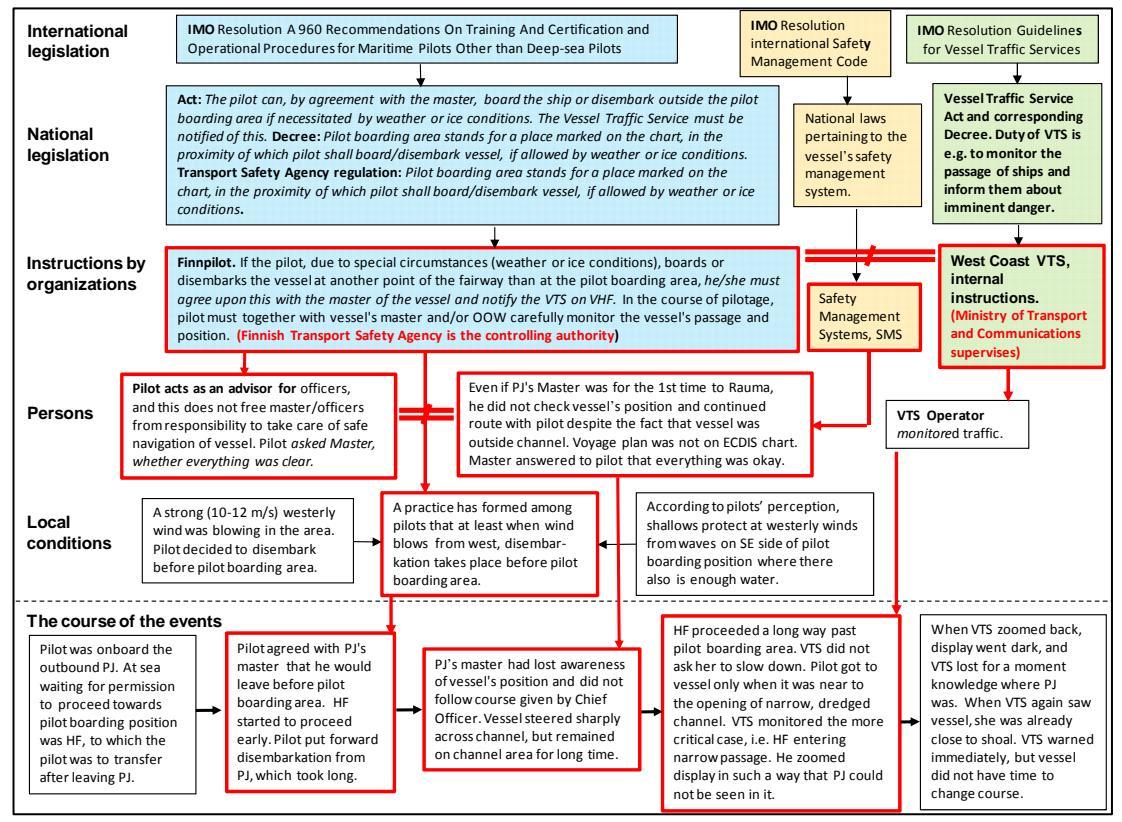
Figure 17. The organizations involved in the accident and the course of events. PJ stands for M/S PHOENIX J, HF for M/S HARBOUR FOUNTAIN and VTS for VTS operator.

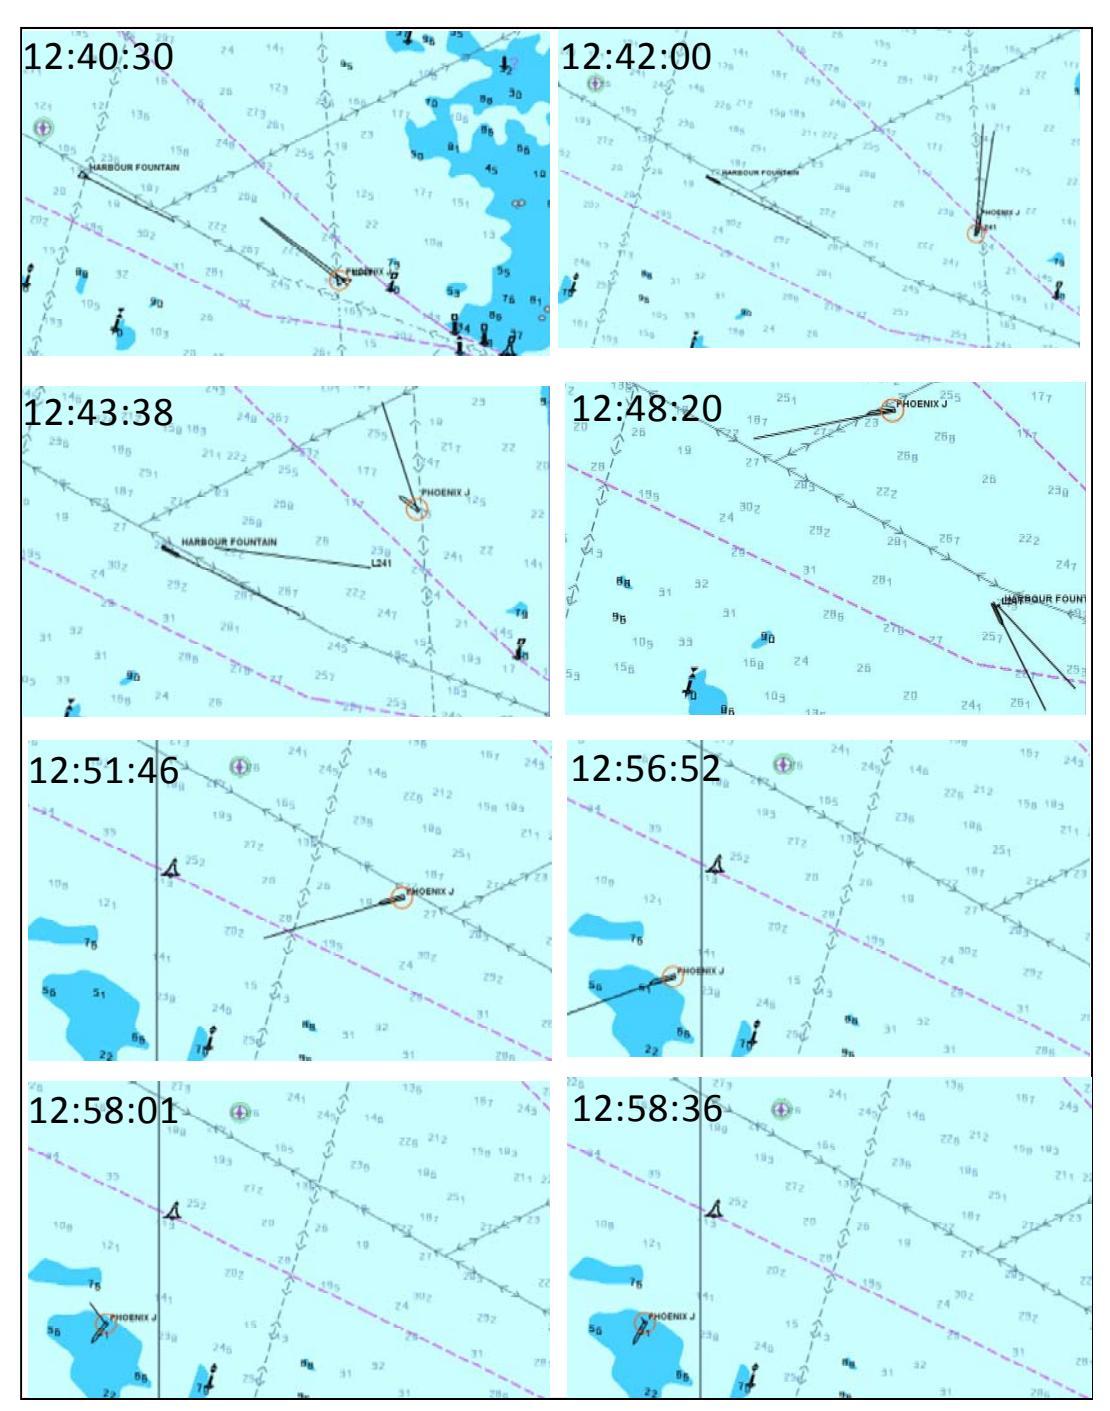
POSITIONS OF VESSELS AT 12.40–12.59 ACCORDING TO THE VTS-RECORDING.

The PHOENIX J approaching the shoal based on screen prints from VTSrecording. At 12.42 the pilot boat leaves the side of the PHOENIX J. At 12.48.20 the pilot boat leaves the side of the HARBOUR FOUNTAIN. The grounding and of the PHOENIX J happened approximately at 12.58 when the vessel stopped.
