MARINE ACCIDENT REPORT

RAMONA
Collision with railway bridge 28 March 2012

This marine accident report is issued on 24 September 2012

Case number: 201204183

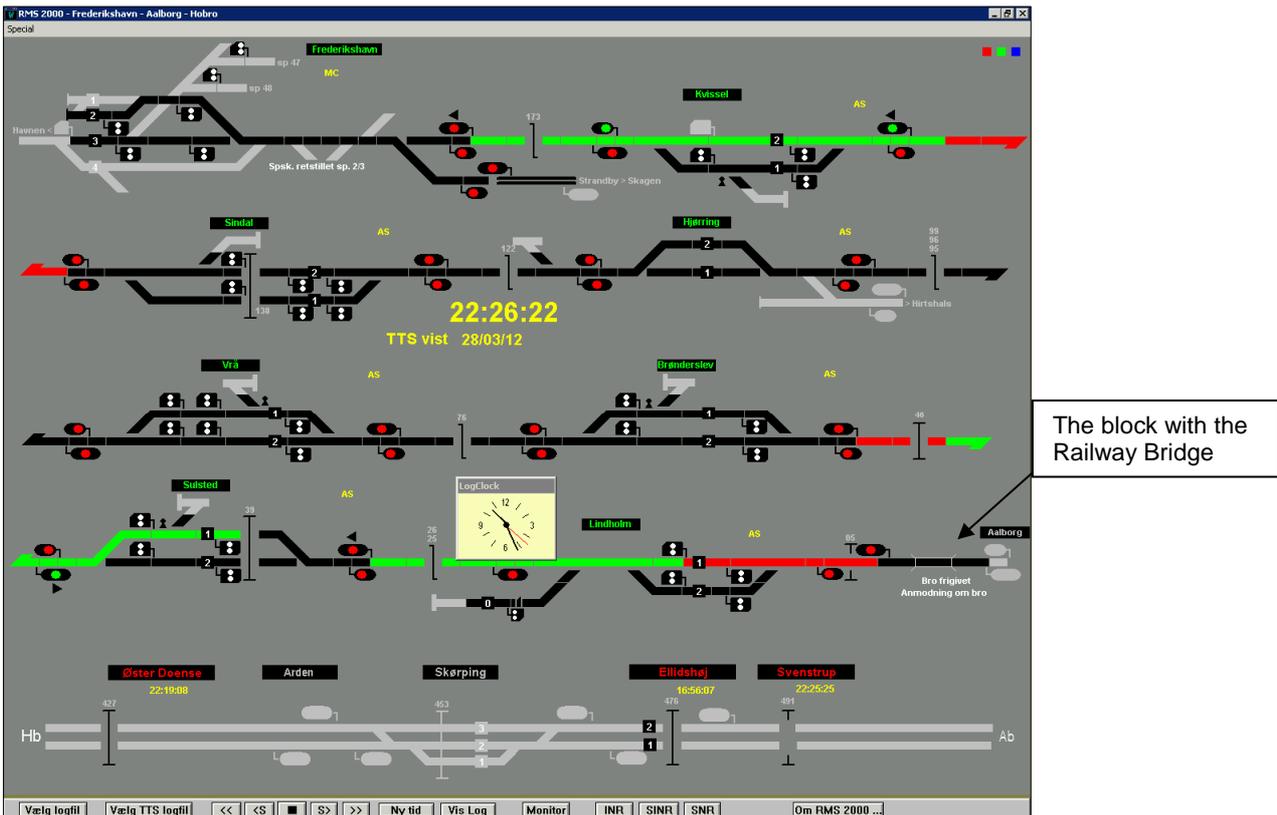
Figure 17: Extract from Rail Net Denmark's railway signal log
Source: Rail Net Denmark

- 22:26:12 The train had passed the "I-signal" for Lindholm.
- 22:26:15 The bridge keeper made a "request for bridge".
- 22:26:22 The Railway Bridge was made available to the bridge keeper, see figure 17 below.
