M2014-01

M/V SYLT (AG), ground touching off Rauma on 11 October 2014

Investigation report 5/2015

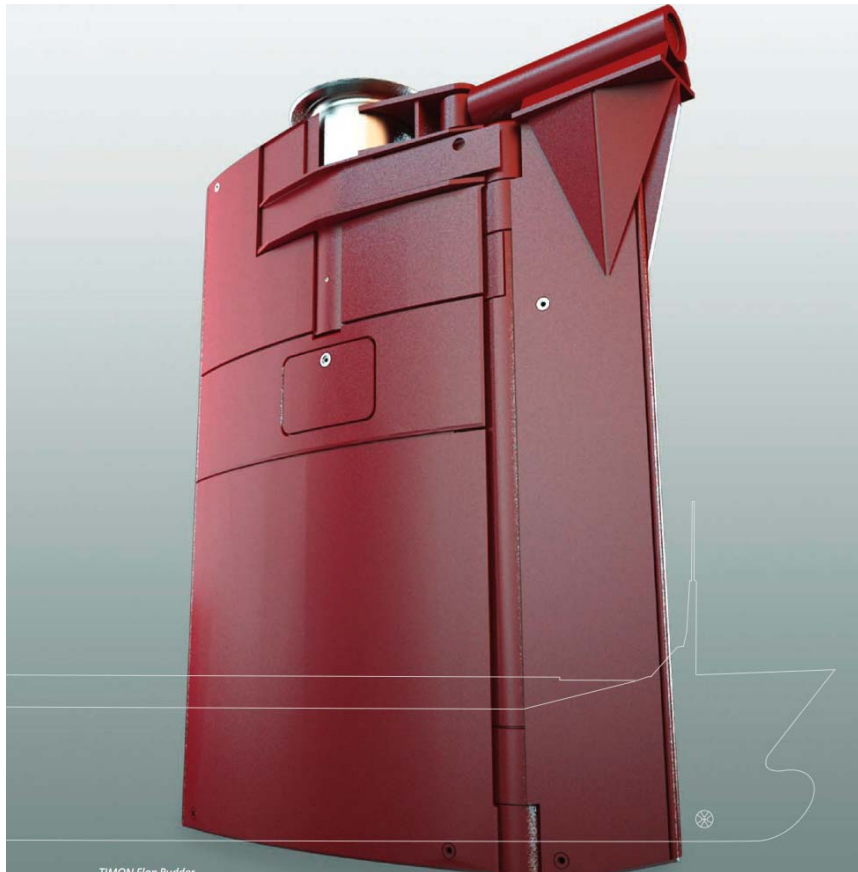
Figure 3. The TIMON rudder (Photo: van der Velden Marine Systems B.V)

The operating principle of a flap rudder is to increase the manoeuvring capacity of the rudder with the help of an asymmetrical wing profile. A turning flap has been installed on the rear edge of the main rudder blade. It is hinged from its leading edge to the main rudder blade. With the help of the shaft interlinked behind the rudder stock it is possible to make the flap turn into a larger angle than the main rudder blade. When the rudder turns, it forms a curved profile together with the flap. The manoeuvring capacity of a

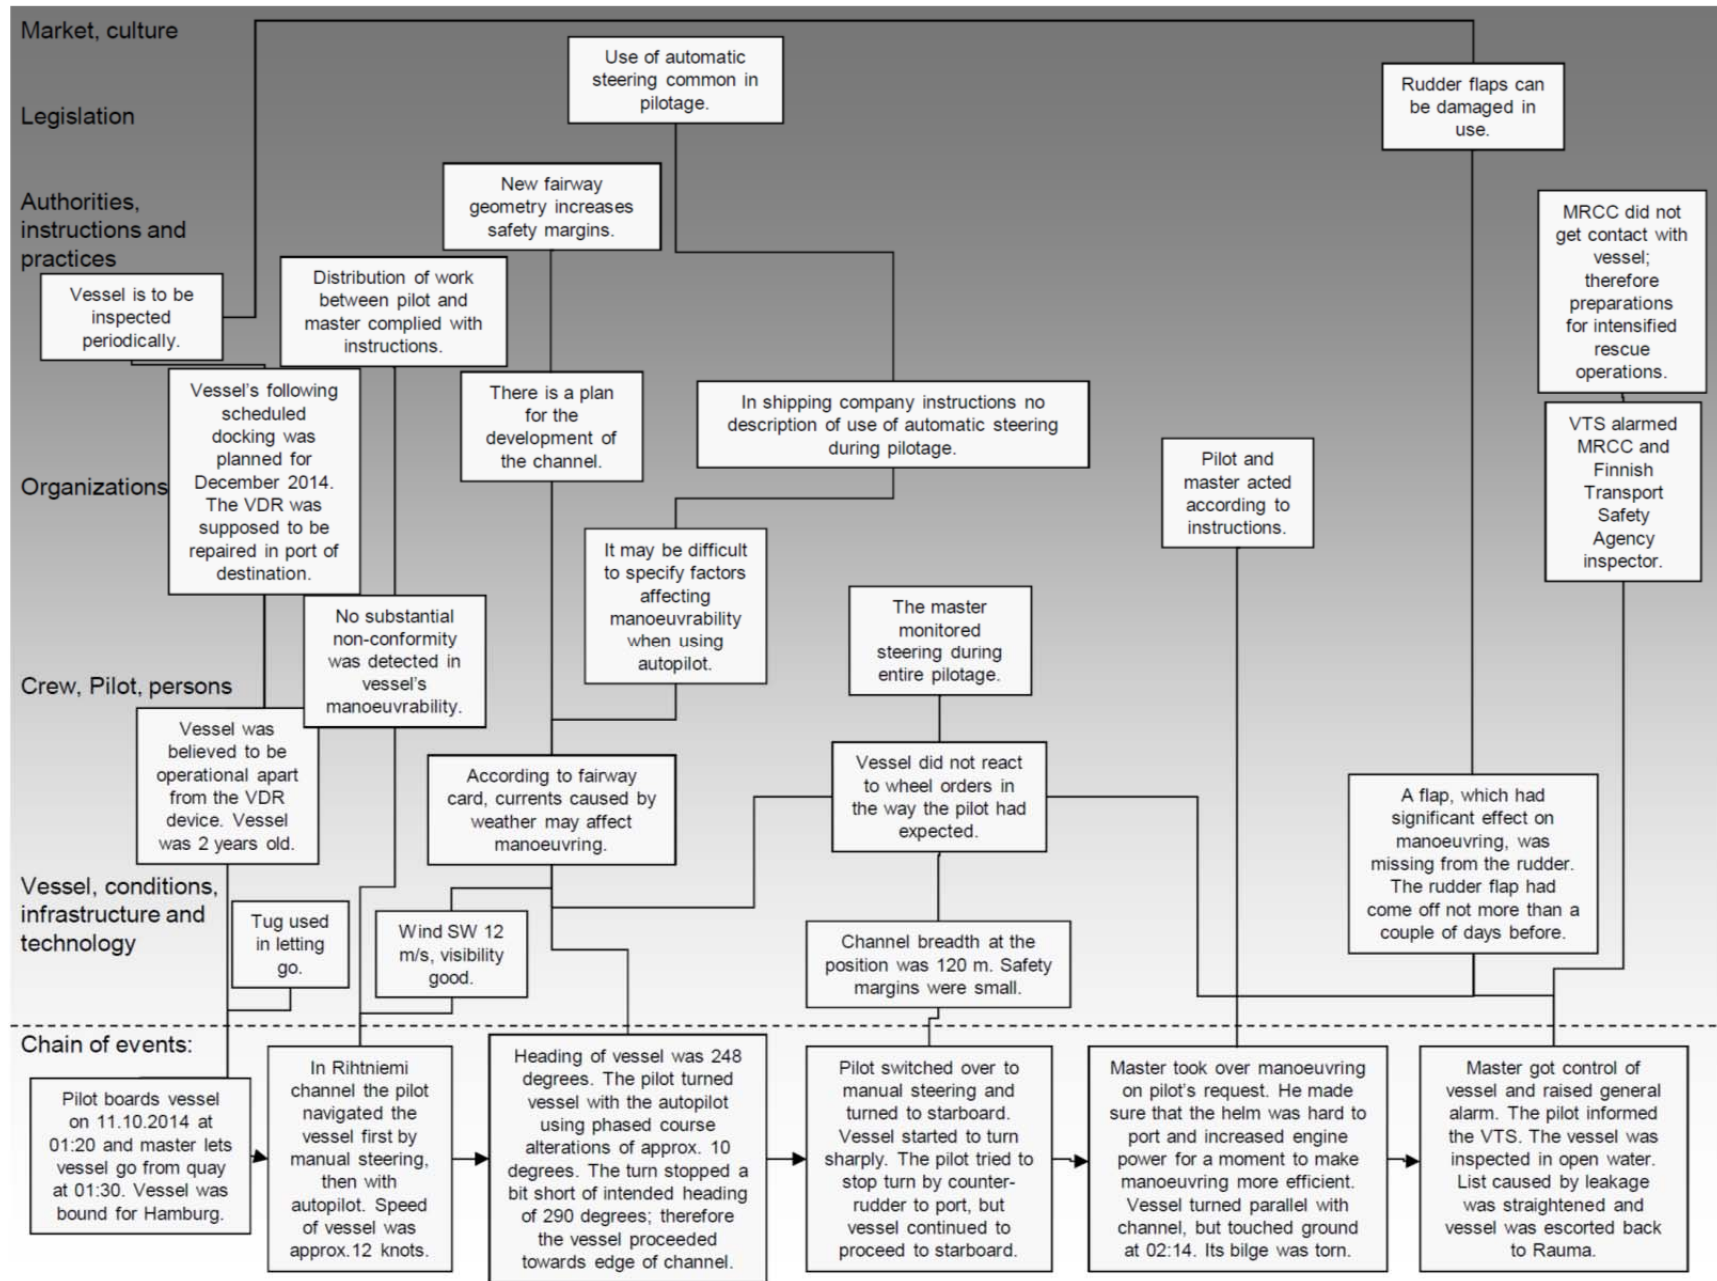
Figure 15. The Accimap diagram
