Drifting of container ship MV Priamos (AG) into shallows off Kotka on 12 September 2018

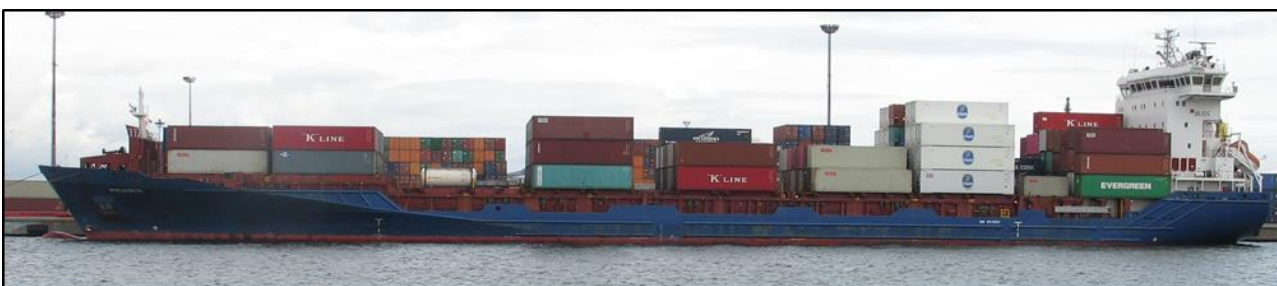
Picture 3. MV Priamos on 15 September. Its cargo situation is the same as during the accident. The combined wind area of the vessel and its cargo was around 2,100 m². (Photo: SIA)

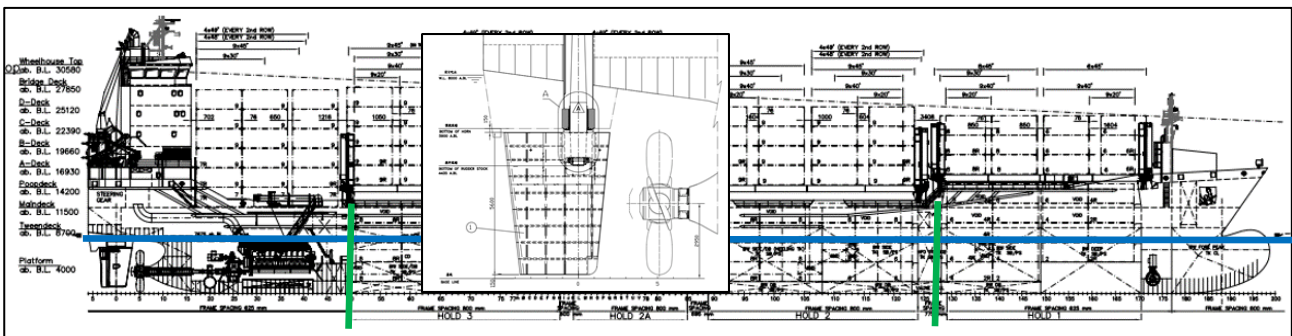
Picture 5. Container ship MV Priamos. The rudder is seen in the small photo. (Picture: MV Priamos)

In Picture 5, the green vertical lines on the sides of the vessel indicate the allowed area for a tugboat's pushing, between side frames 50 and 128. The maximum allowed distance of a tugboat's pushing point from the vessel's midships is around 33 m. The water line at the time of the accident is indicated with a blue line in the picture.

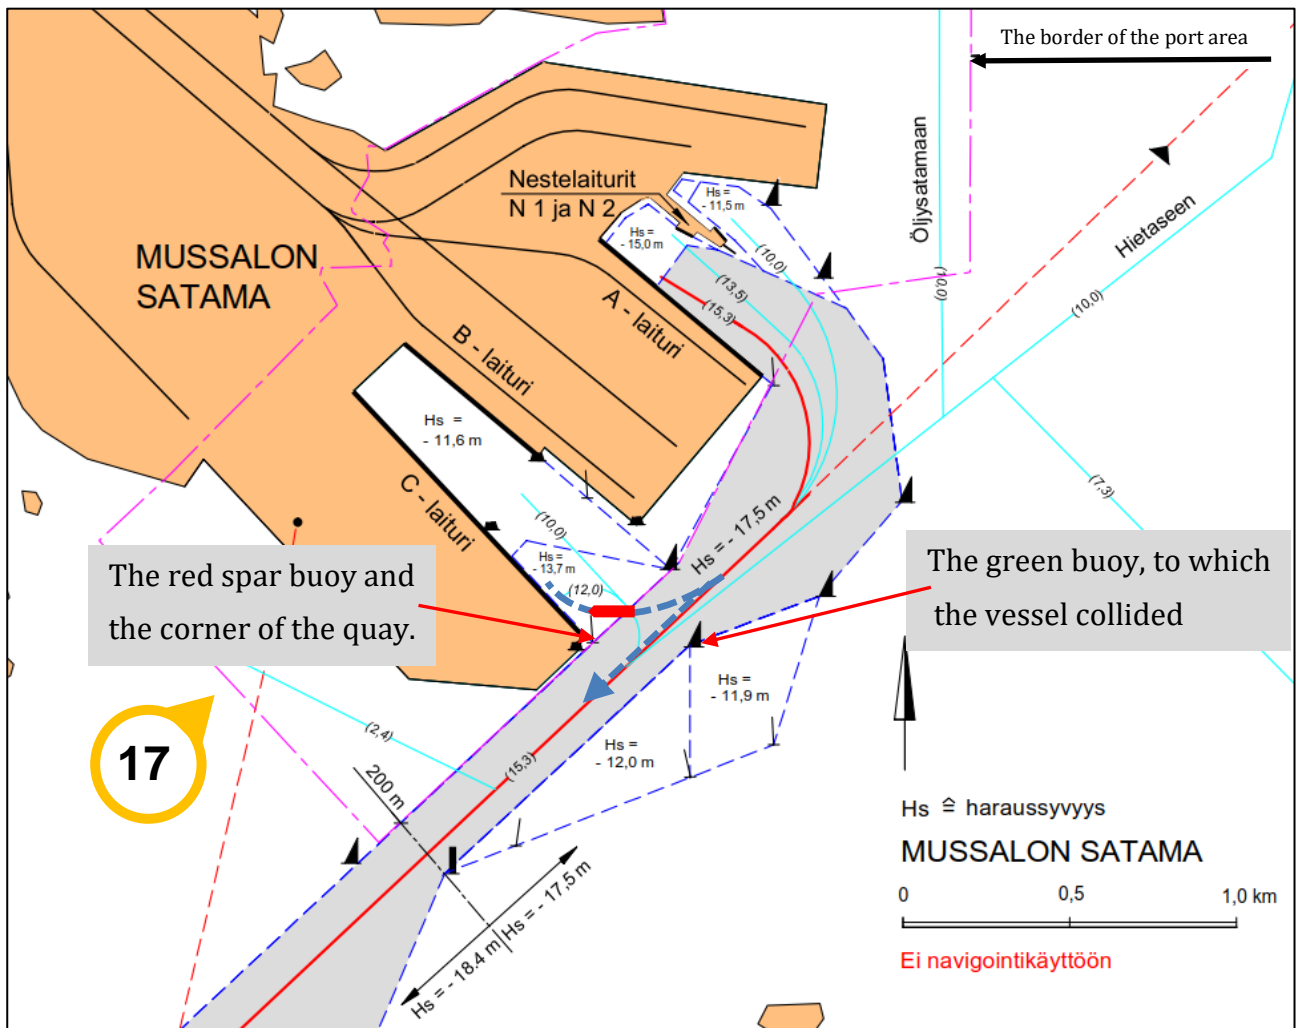
Picture 8. The Mussalo port area. MV Priamos indicated with a red, and its optimal route with a blue dashed-line arrows. The direction of quay C is 317° . The wind direction 230° is indicated with the arrow in an orange circle, strong breeze. The wind speed in m/s used in the simulation calculations is shown in the circle. The pile shows the border of the area administrated by the port. (Picture template: The Finnish Transport Infrastructure Agency, additions: SIA)

Moving a vessel in the port from quay C directly to the fairway requires a tight turn (Picture 8). Vessels usually come into dock bow first, with the stern towards the fairway, due to which they are reversed out of the quay area. The ice buoys indicating the fairway area of the deep water route limit the free manoeuvring of vessels off the dock. The usual procedure is to turn the vessel to the deep water route area and, upon departure, reverse the vessel between the buoys. The location of the green buoy particularly restricts the turning space of the vessels. There is scant time for errors of judgement or steering mistakes, because there is not a lot of room to operate.

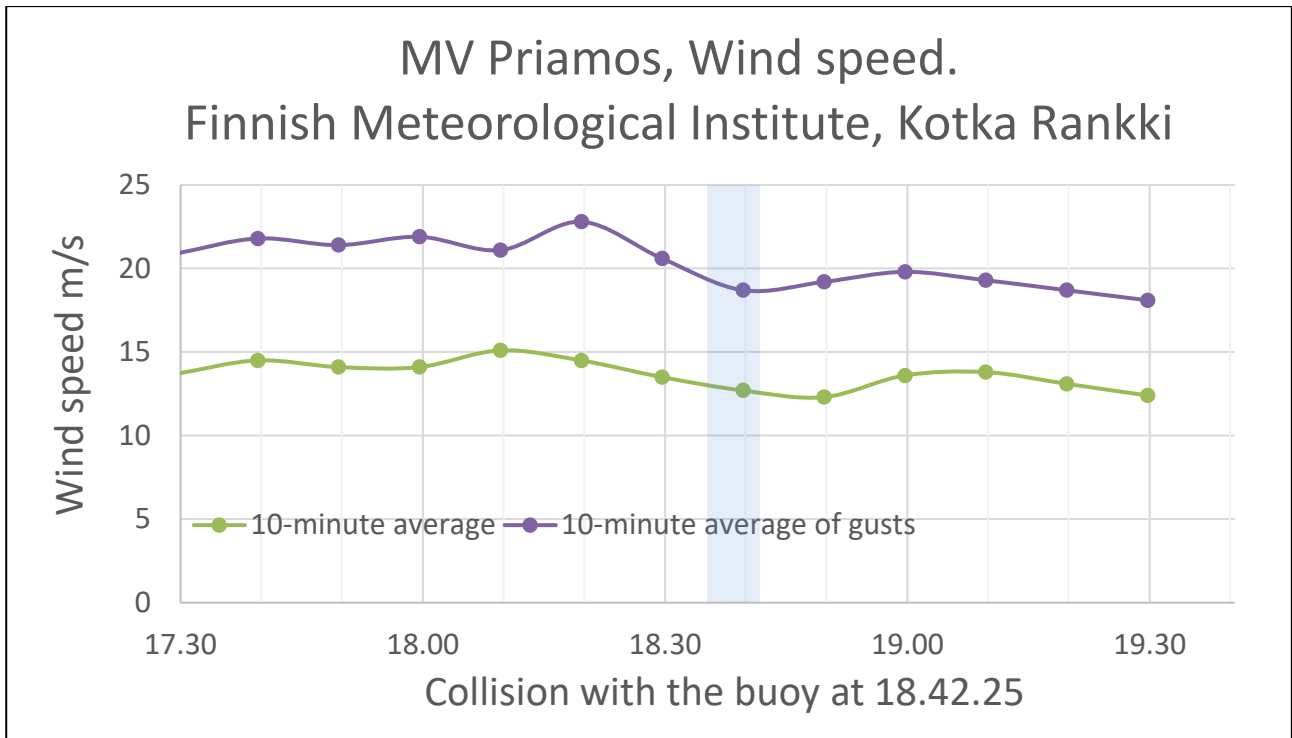
According to data from the Kotka Rankki weather station of the Finnish Meteorological Institute, the wind direction was 230–240 degrees (from west-southwest) during the accident. Rankki is located at a distance of around 6 km south-southeast of Mussalo. After the vessel departed at 18:35hrs, the constant wind speed was 12–13 m/s, with gusts up to 18–20 m/s (Figure 10). According to the vessel's entries, the wind speed was 13–19 m/s (7–8 Beaufort), direction SW. According to the vessel's officers and the pilots accounts, at around 18:40hrs a strong gust hit the vessel, making it more difficult to steer. There were no islands in the area that would have shielded the vessel from the gust.

Picture 10. Wind speeds on 12 September at 17:30–19:30hrs. The time range from departure to hitting the buoy is marked in grey. (Picture: SIA from data provided by the Finnish Meteorological Institute)

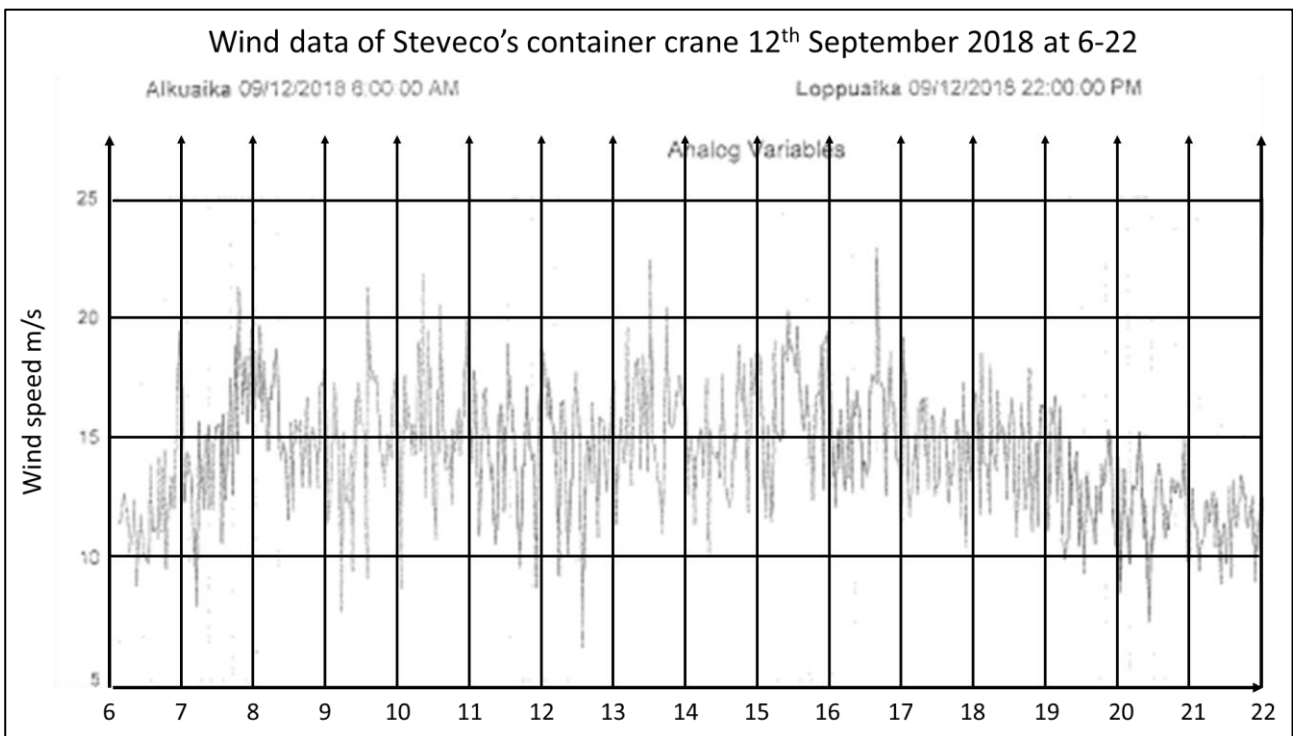
Picture 11. Steveco's wind speed data from 12 September from 06:00hrs to 22:00 hrs. (Picture: SIA on Steveco's template)

The port operator Steveco has an anemometer in its crane at a height of 56 m from the quay surface. Loading is automatically interrupted if wind speed exceeds 25 m/s. See Figure 11 for Steveco's wind speed graph. The wind speed at the time of the vessel's departure matches the

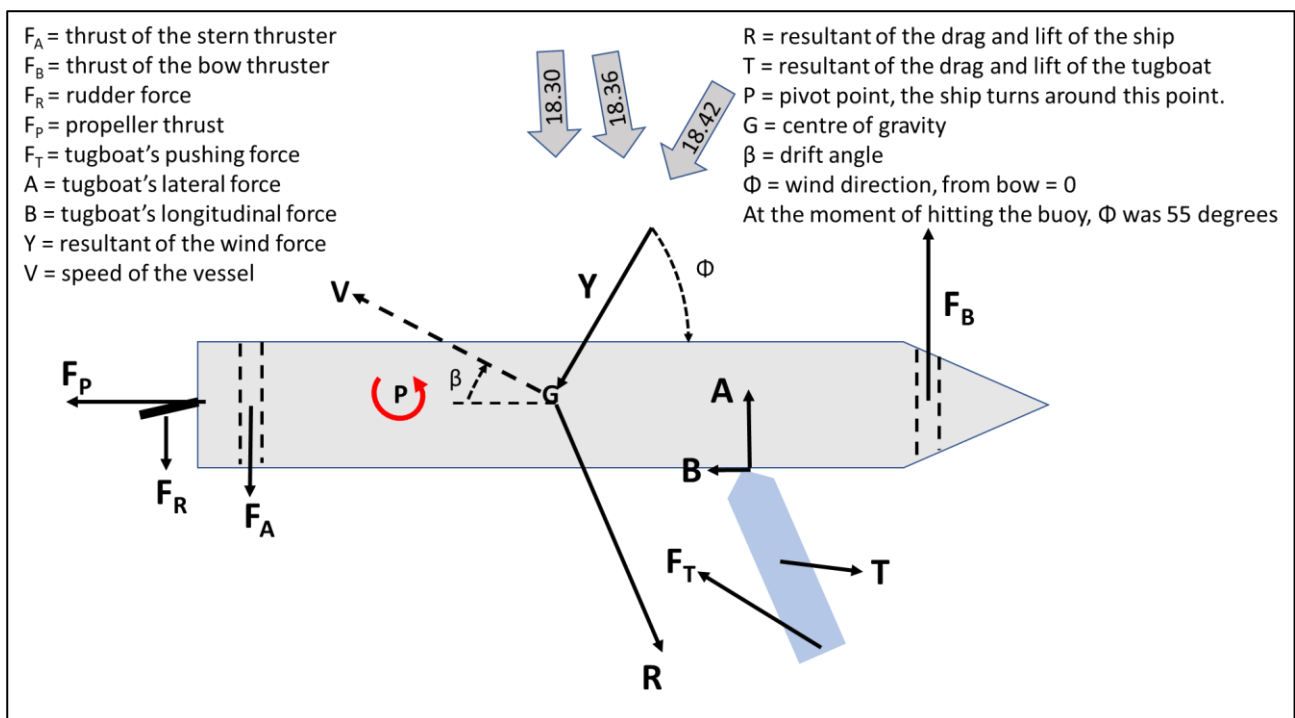
The tugboat's pushing point against the side of the vessel affects the turning moment achieved: in order to produce maximum moment, the tugboat should be as close to the bow as possible. However, the shapes of the vessel's bow and stern sections, the strength of the structures and the structure of the tugboat's bow place limitations to the possible pushing points. In the case of MV Priamos, the allowed pushing area reached from side frame 50 frame 128 (Figure 5). Because MV Priamos was reversing, the tugboat had to direct its pushing to the side in order to balance the drag and lift of the tugboat's hull. For this reason, MV Priamos was subjected to force A, which was at most half of the tugboat's pushing power (SBP), while force B increasing the reversing speed of MV Priamos was also generated.

Picture 16. The resultant of the wind force, the resultant of the hull's drag and lift, and the forces of the propeller and the steering systems that affected MV Priamos. The tugboat's pushing generated forces A and B affecting MV Priamos. The thick arrows indicate the wind direction relative to the vessel at three points in time. (Picture: SIA)

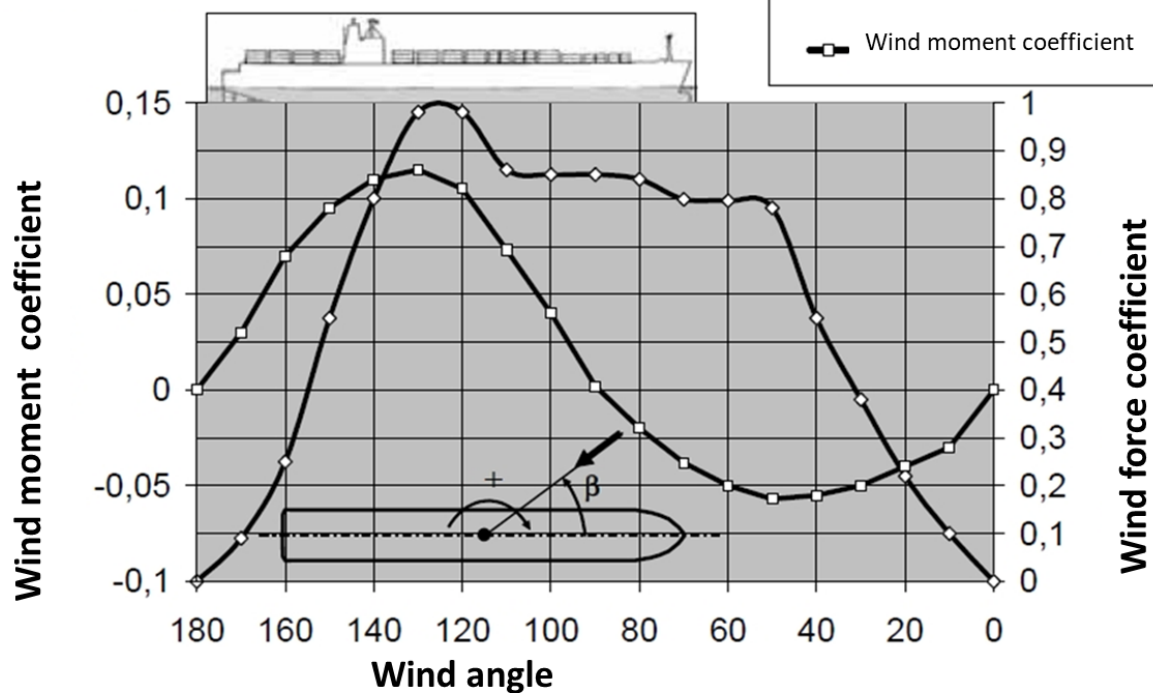
Picture 17. A schematic of the wind's effect on the container ship. (Picture: SIA¹⁵)

Figure 17 describes the principle of the wind's effect. The basic shapes of the curves describing the wind's effect are the same for the vessels. Vessel type and the positioning of cargo on deck cause vessel-specific differences. Crosswind has the strongest effect at an angle of attack from around 50 to 140 degrees. The turning moment is lowest when the wind comes almost directly from the side. Wind coming obliquely from the aft (110 to 160 degrees) has the strongest turning effect on container ships. In the case presented in the figure, a crosswind from the bow (30 to 50 degrees) has half the effect.

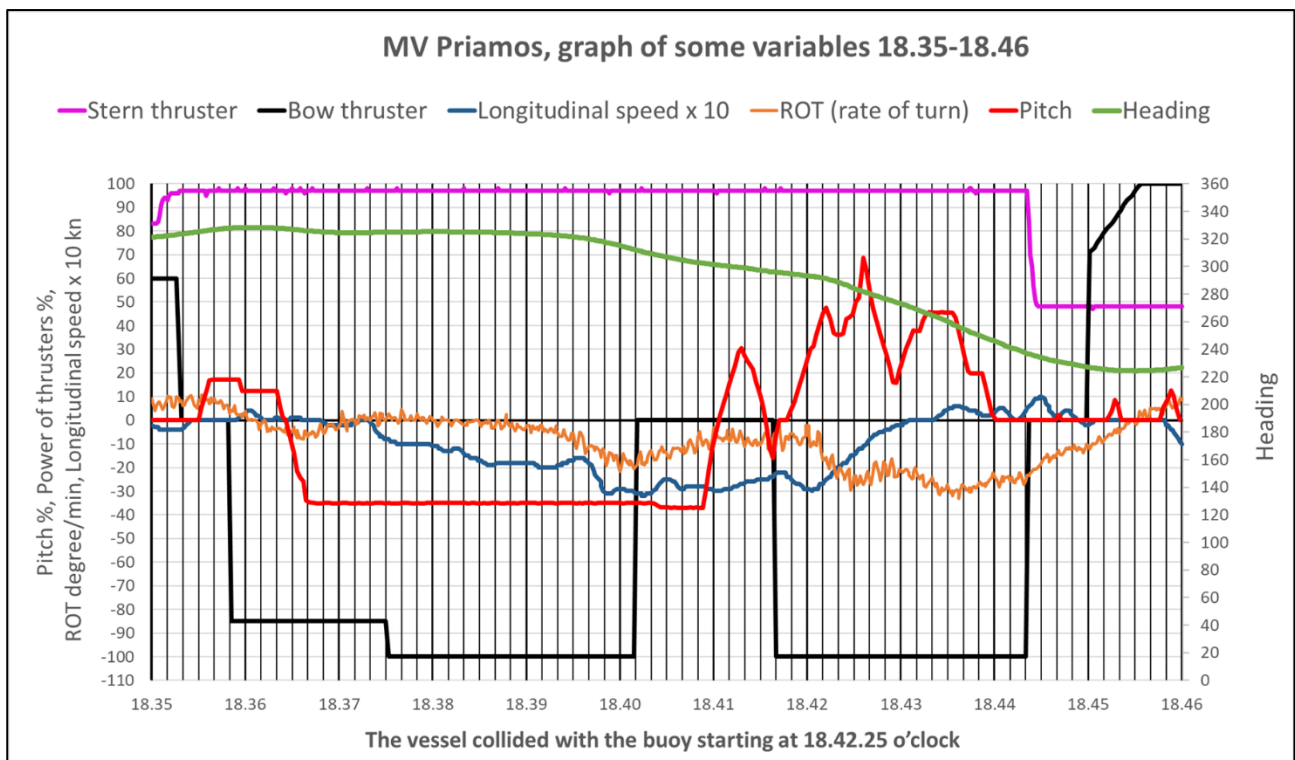
With respect to the bow thruster, there were differences in the numerical VDR values and the values shown on the display of the VDR software. With respect to the manoeuvring thrusters, the values read from the display were logical: the thrusts of the stern and bow thrusters were in opposite directions, due to which the value read from the display of the VDR software is presented in Figure 18.

Figure 18 indicates that after 18:39hrs, the tugboat's pushing started to have an effect as an addition to the bow thruster, and the vessel started to slowly turn to the left (the ROT and Heading curves). The stopping of the bow thruster at 18:40.20hrs is visible as the slowing down of the rate of turn.

Picture 18. Variabels of MV Priamos's state of motion from the VDR data. (Picture: SIA)

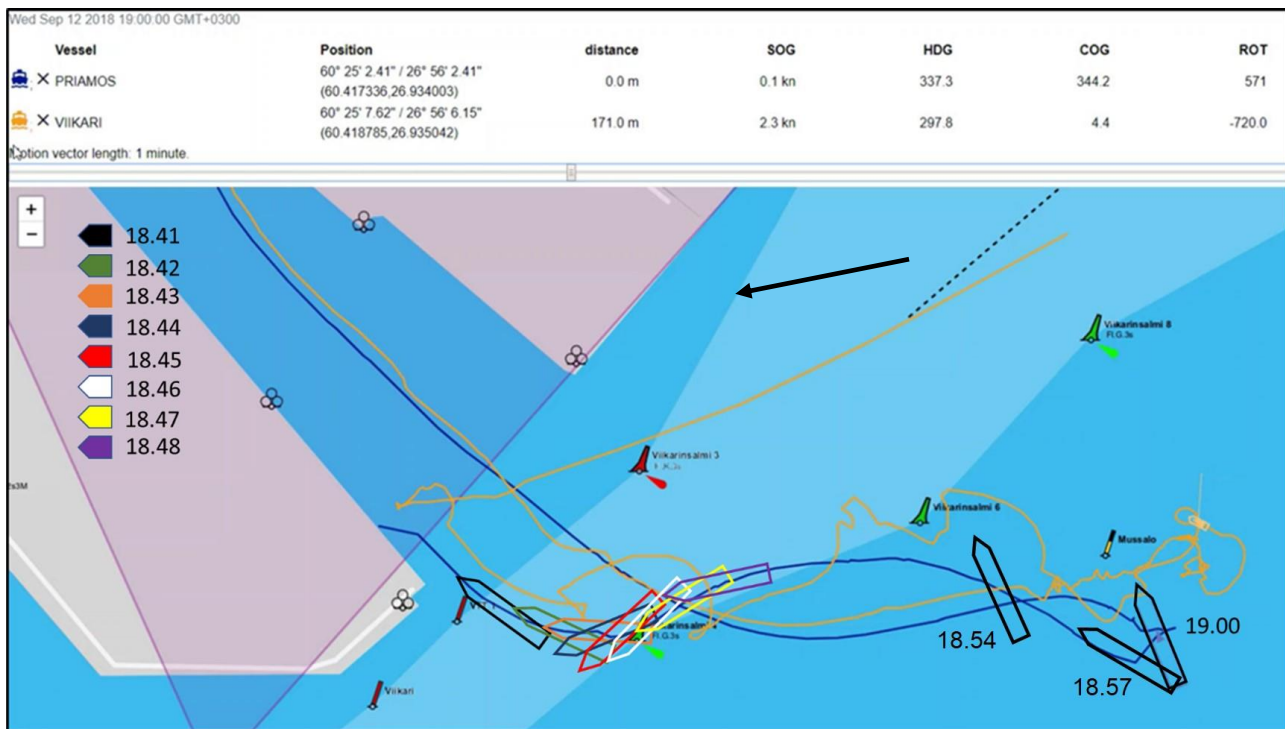
Picture 20. MV Priamos's movements at one-minute intervals from 18:41hrs to 18:48hrs. MV Priamos was at a 100 m distance from the buoy at 18:41hrs. Order to drop anchor at 18:54hrs. Anchor began to hold at 18:57hrs. Vessel stopped in the shallows at 19:00hrs. The movement path of MV Priamos's centre point in blue, the movement path of tugboat Viikari in orange. The pile shows the outer border of the area administered by the port. (Screen capture: Finnpilot's AISLab- video at 19:00hrs)

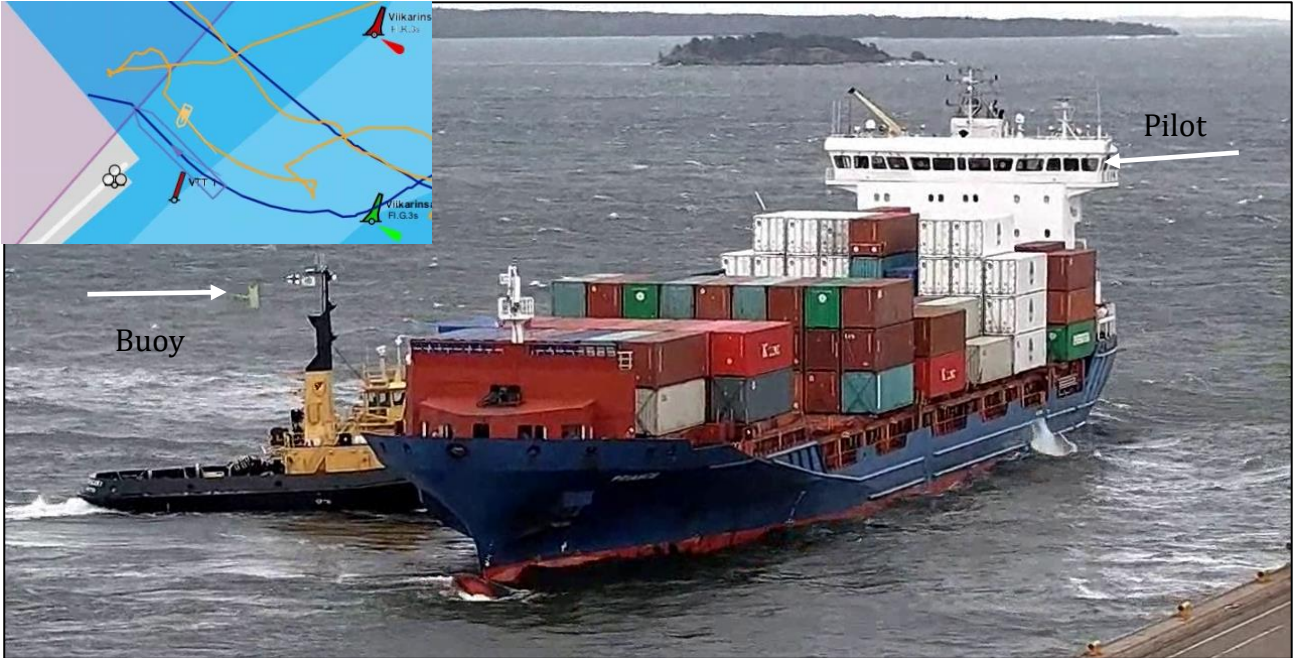
Picture 21. Tugboat Viikari pushing MV Priamos at 18:39.50hrs. (Screen capture from a video: HaminaKotka Port). The small image shows Viikari's position. (Screen capture from a video: Finnpiilot AISLap)

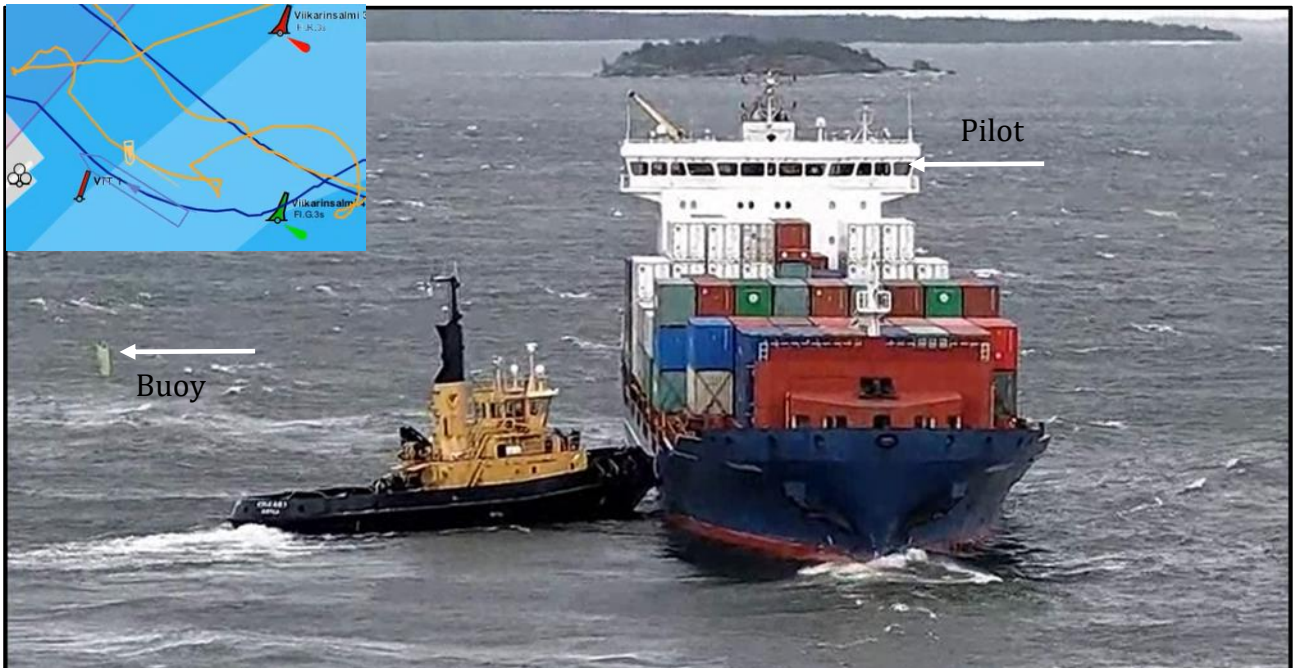
Picture 22. Tugboat Viikari pushing MV Priamos at 18:41hrs. (Screen capture from a video: HaminaKotka Port). The small image shows Viikari's position. The distance between the vessel's stern and the buoy is 100 m. (Screen capture from a video: Finnpiilot AISLap)

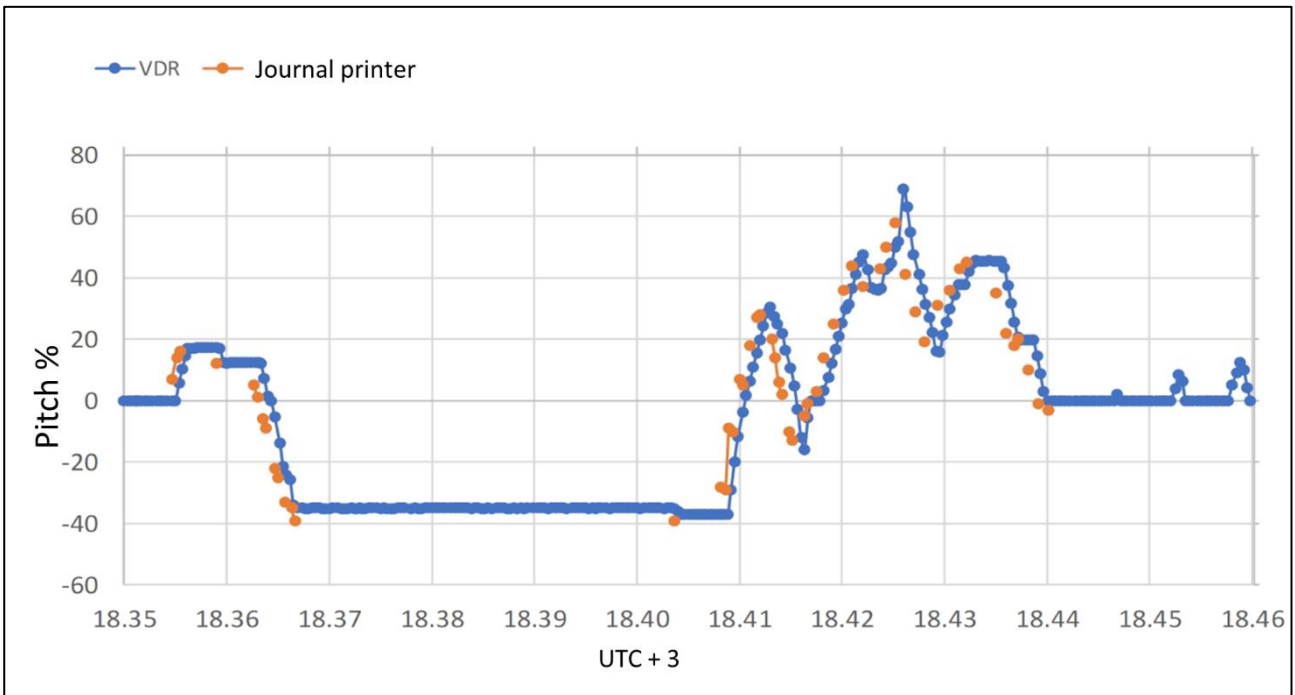
Picture 24. The propeller pitch data from the journal printer and the VDR could be made to match each other by changing the times of the journal printer 13 minutes earlier. (Picture: SIA)

A journal printer printout was obtained from MV Priamos for the time period from 18:17hrs to 19:01hrs. The engine orders given to the vessel's main engine and propeller pitch were examined from it. A comparison of the journal printer's timestamps to the VDR timestamps with respect to propeller pitch (Figure 24) revealed a time difference of around 13 minutes

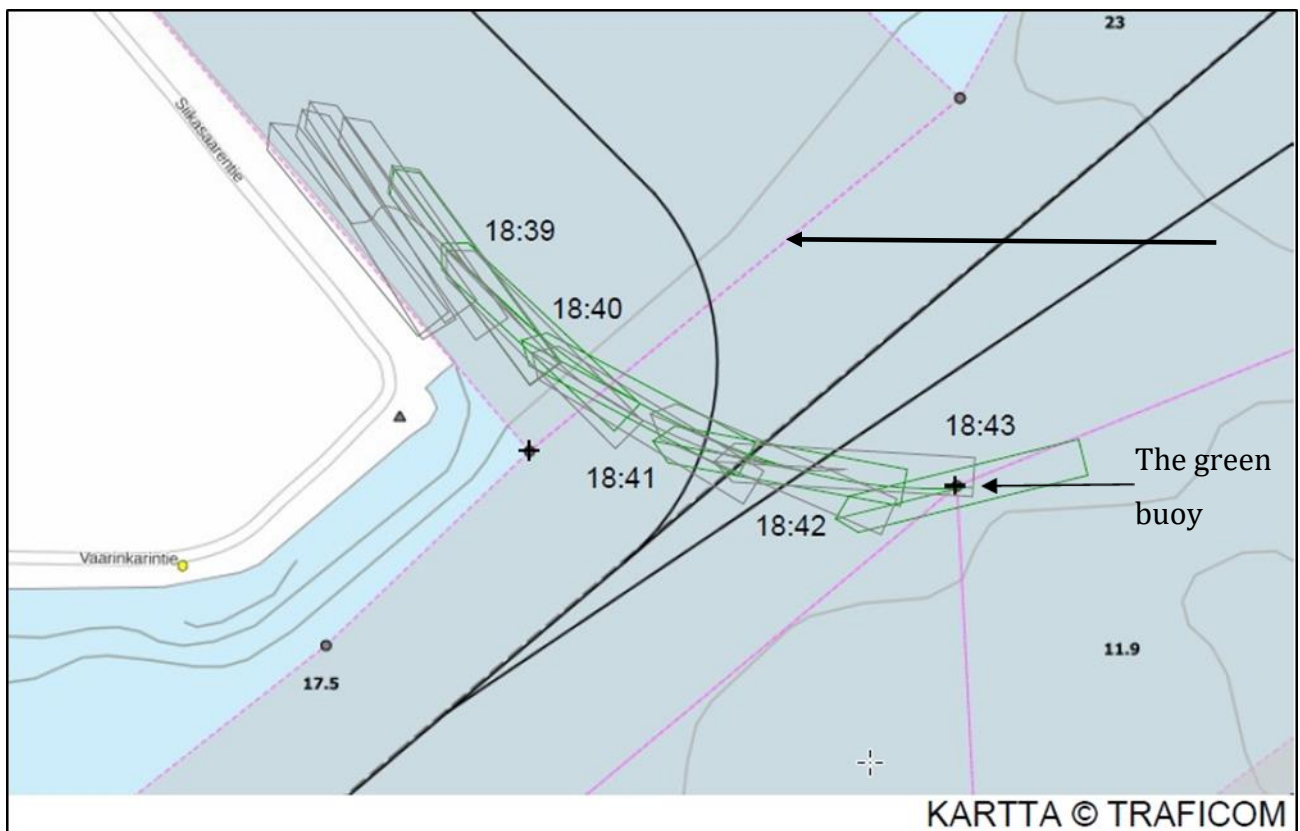
Picture 26 shows the vessel's actual passage that led into a collision (grey) and the nearly identical passage of the simulated vessel (green). This shows that the parameters used in the simulation are sufficiently correct and that the results of the simulation can be considered to be in the right direction for the needs of the investigation.

Picture 26. The vessel's simulated (green) and actual (grey) passage. The pile shows the outer border of the area administered by the port. (Picture: Simulco Oy)

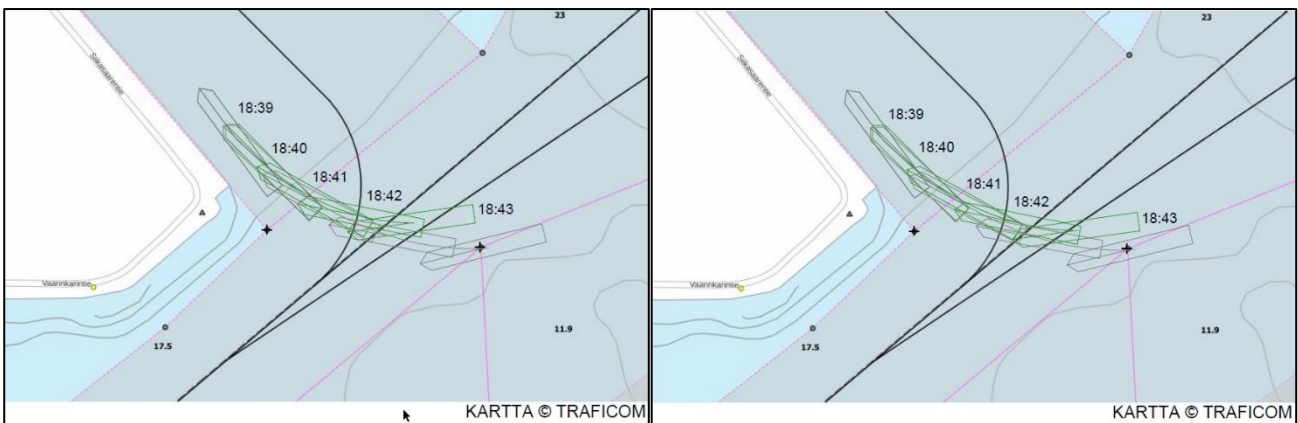
The effect of the main engine and the propeller pitch was examined in a simulation by giving the engine order "stop" and adjusting the propeller pitch to zero at 18:39hrs, 18:40hrs and 18:41hrs. In the simulation, pitch adjustment took place in a couple of seconds. The vessel's bow thruster was constantly engaged, turning the bow to the left. Figure 27 presents engine stops at 18:40hrs and 18:41hrs. In the simulation, engine stop at 18:39hrs led the vessel to the fairway at 18:43hrs at a clearly tighter turn than an engine stop at 18:40hrs. An engine stop at 18:41 resulted in the vessel ending up very close to the buoy.

Picture 27. The simulated comparison movement paths in green. The effect of adjusting propeller pitch to zero on the movement path. On the left, the propeller pitch is adjusted to zero at 18:40hrs, on the right at 18:41hrs. In both alternatives, the vessel's bow thruster is constantly engaged, turning the bow to the left. (Pictures: Simulco Oy)

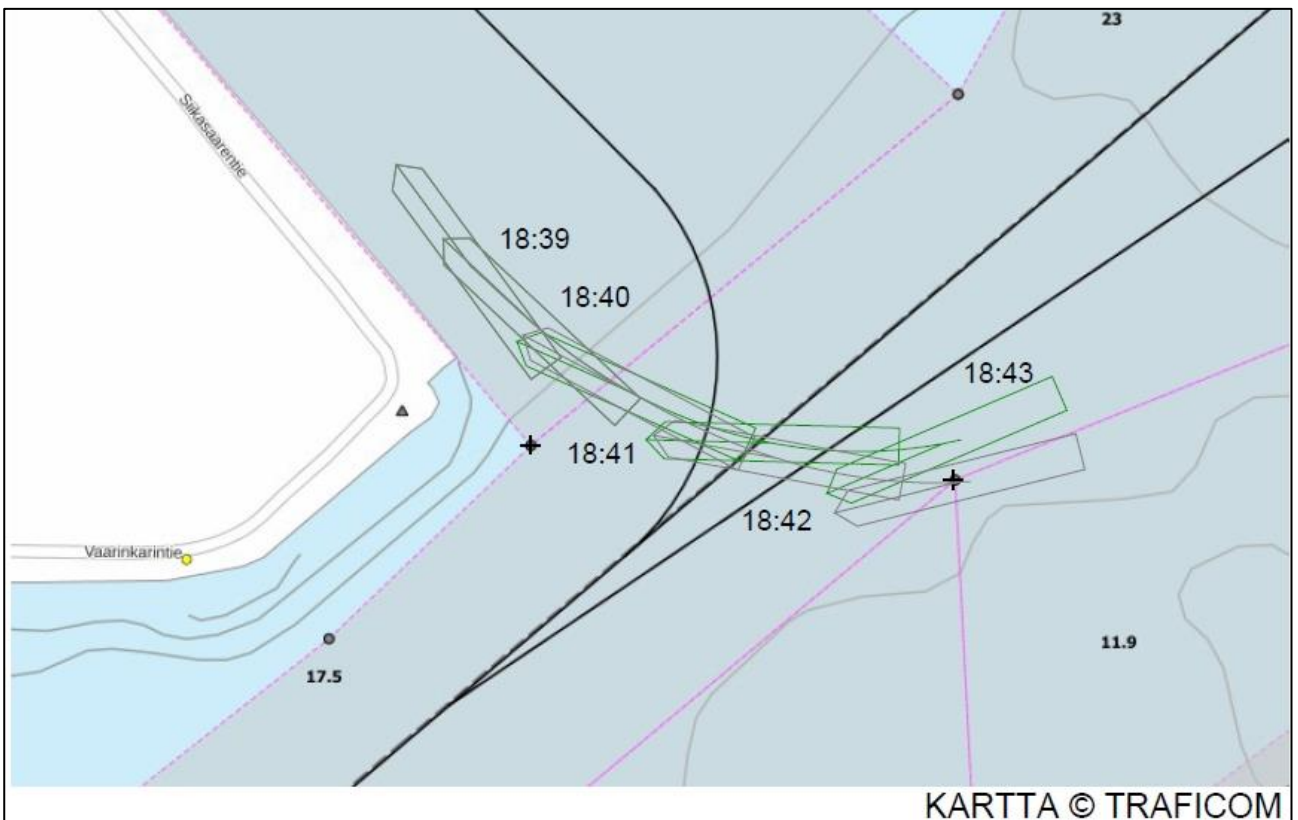
Picture 28. Simulated comparison movement path in green, with the bow thruster in constant operation. (Picture: Simulco Oy)

Only the bow thruster's effect was simulated, because the stern thruster had no effect on turning the vessel. The effect of the constant operation of the bow thruster to the vessel's turning to the fairway is presented in Figure 28. The stern of the vessel would have not hit the buoy. If the vessel had been reversed further, the buoy would have likely been overrun by its bow.

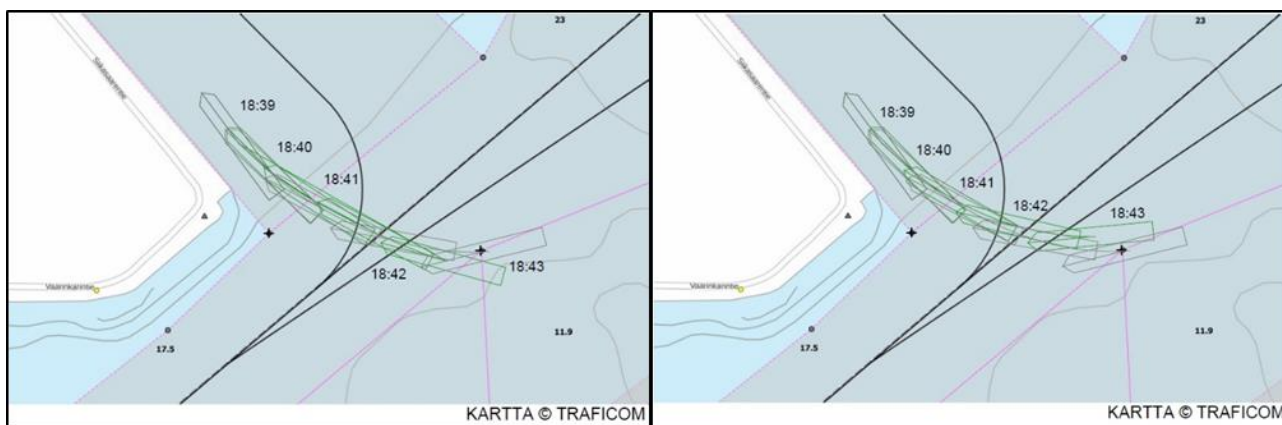
The tugboat's pushing force is the largest uncertainty factor in the simulation. Due to the vessel's longitudinal speed accelerating backwards, the pushing force varied and was non-existent at times. Due to the uncertainty related to the pushing force, the pushing force was simulated additionally at around 25% of the static bollard pull (Picture 29).

Picture 29. The simulated movement paths in green. On the left, the simulated movement path with the tugboat's pushing force at 25% of the SBP and the bow thruster stopped for 1.5 minutes. On the right, the simulated movement path with the tugboat's pushing force at 25% of the SBP and the bow thruster operating all the time. (Pictures: Simulco Oy)

The green movement paths in Figure 29 show the effect of the bow thruster being stopped for 1.5 minutes when the tugboat's pushing force is 25% of the SBP.

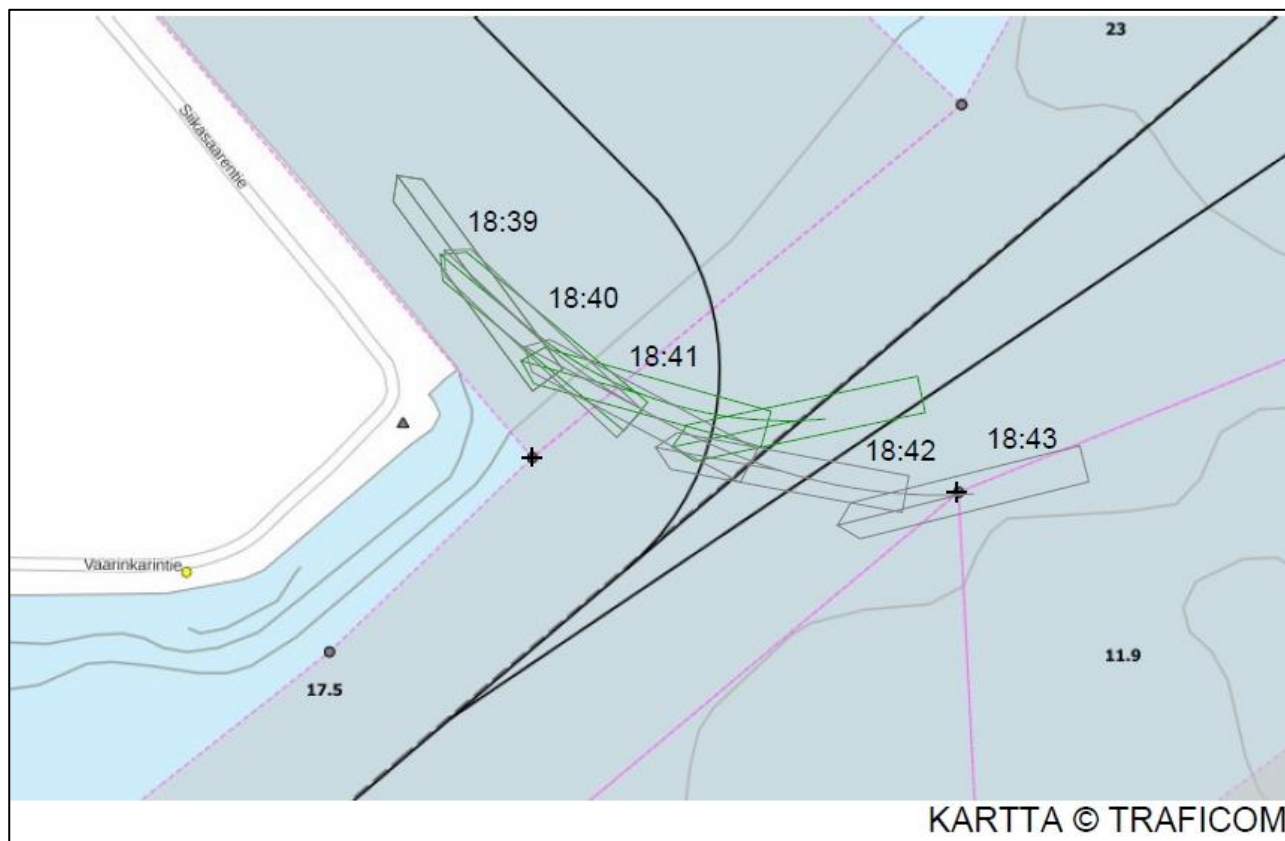
The effect of the tugboat's pushing location was examined in simulation by placing the tugboat to push at a point 20 m further towards the bow, 45 m from midships. The collision with the buoy would have been clearly avoided then (Figure 30). In reality, however, the tugboat could not have been so far from midships. The 25 m from midships used in the simulation is nearly the maximum distance.

Picture 30. Simulated comparison movement path in green, when the tugboat is pushing at a point 45 m from midships towards the bow with the bow thruster in constant operation. The tugboat's power is around 50% of SBP. (Picture: Simulco Oy)

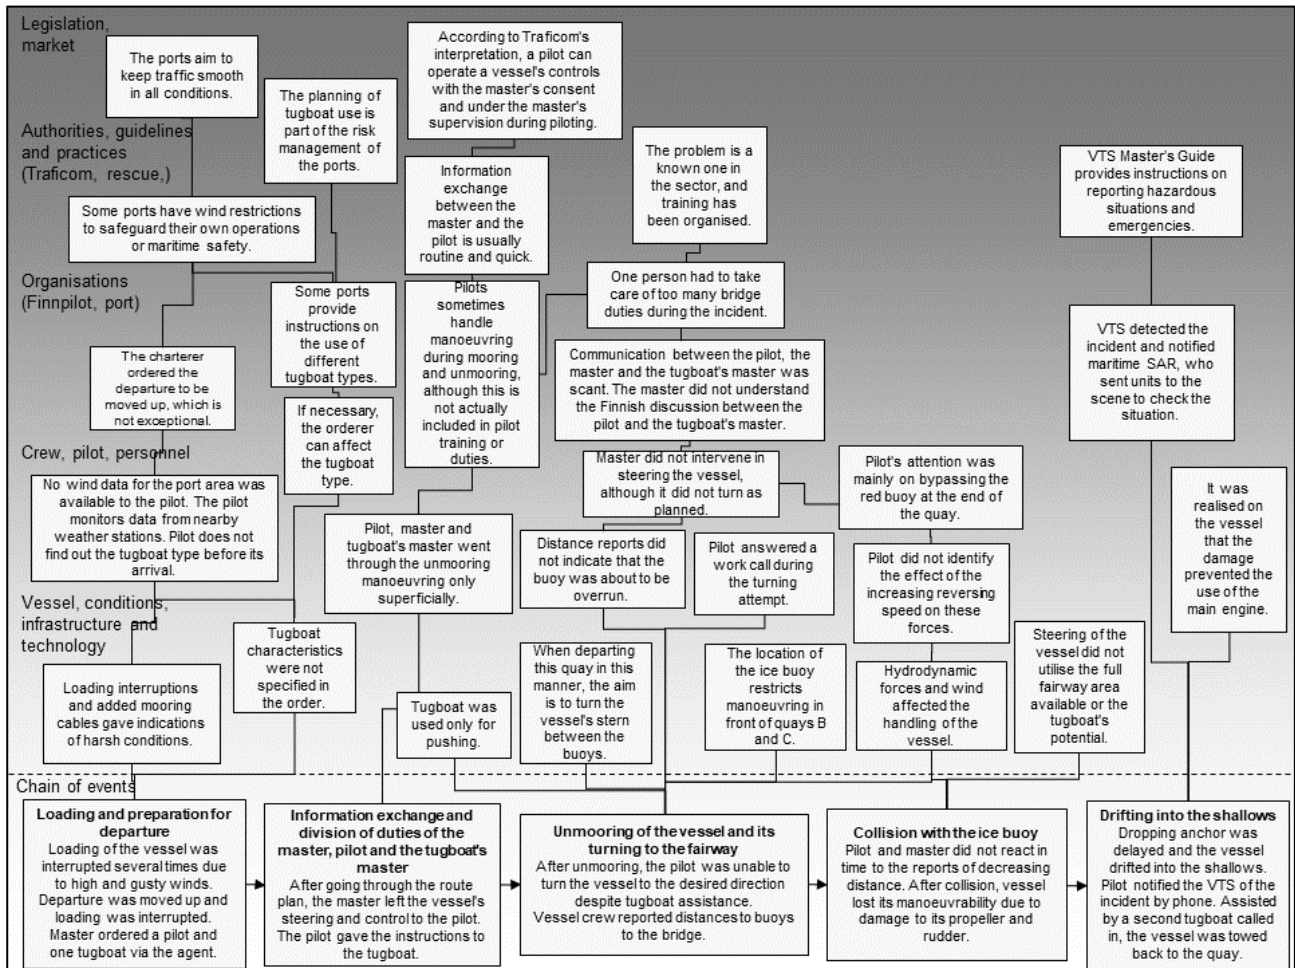
The analysis of the incident used the Accimap³⁶ method further developed by the Safety Investigation Authority. The breakdown of the analysis text is based on the Accimap diagram drawn up during the investigation. The accident is described as a chain of events in the lower part of the diagram. Factors revealed in the background of the chain of events are broken down in the diagram at different levels of analysis.

Picture 31. The Accimap diagram prepared during the investigation
