Landing gear failure during landing run at Oulu Airport on 3 October 2016

Investigation number: L2016-02

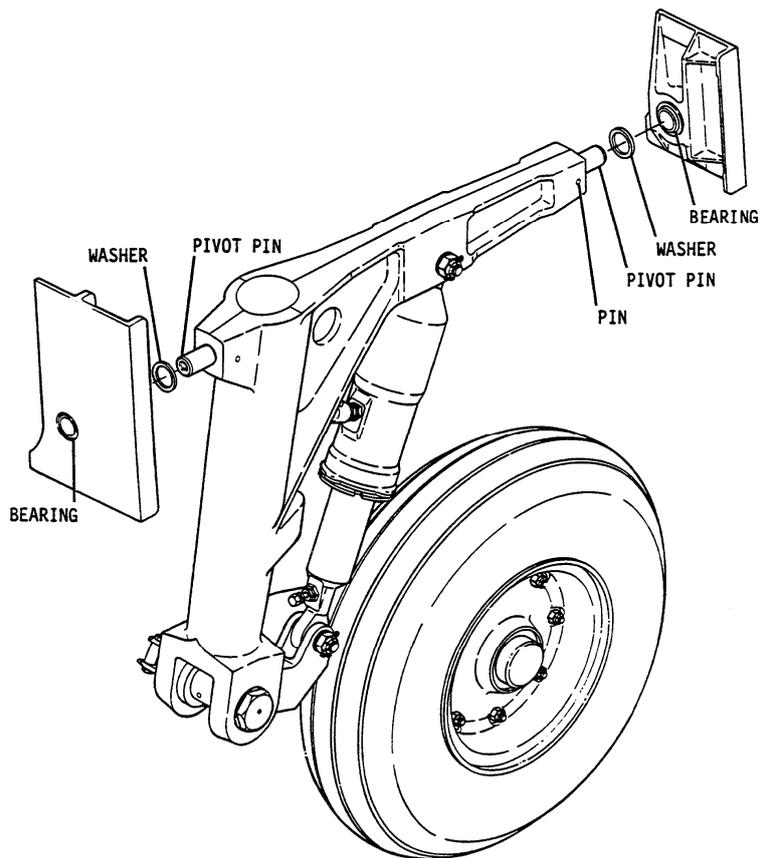
Kuva 1. Main landing gear. Picture: ASI Aviation

As the front attachment of the right main landing gear failed, the landing gear leg was pivoted down and back, held only by the aft attachment. The dislocated gear damaged the inner wing flap and the landing gear door. The wheel was clamped between the runway and the wing flap, and its tyre was abraded through. The engine nacelle, wing skin plates, fairings and their brackets were also cracked and deformed in various places.

In this context it must be noted that the downlock and its status indicator switch are mounted on the relevant actuator. As long as the actuator is in the locked position, the system indicates that the individual landing gear is down and locked. This is a rather typical feature.
