MV Estonia Accident Investigation. Stability calculations.

Technical Report VALC177.

VTT Manufacturing Technology. Espoo 1996.

Espoo, May 1996

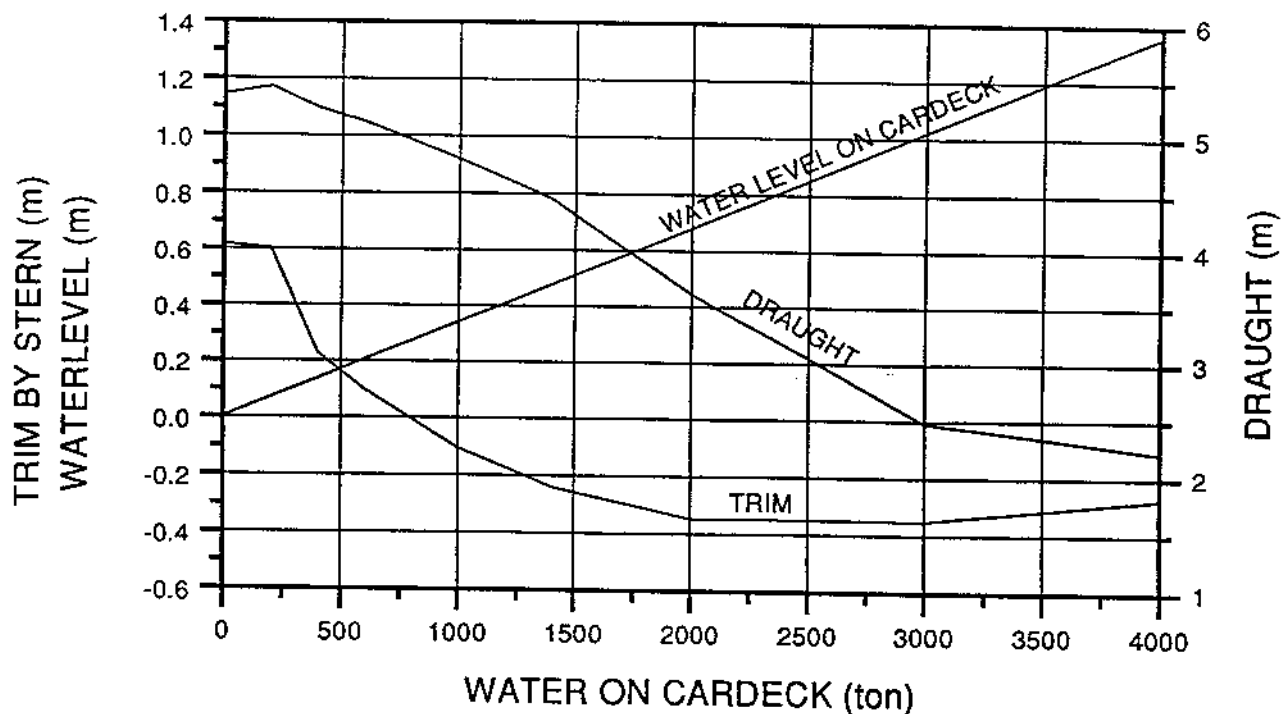
Figure 4.3 The water level on the cardeck, draught and trim as functions of water amount on the cardeck, side included.

The static and dynamic stability for the case with side above the 4th deck included were calculated with 0, 200, 400, 600, 1000, 1400, 2000, 3000 and 4000 tons of water on cardeck. The draught and trim of the ship and the water level on the cardeck assuming neither heel nor trim angle, are shown in Figure 4.3 as functions of water amount on the cardeck. The effect of cargo on water level was not taken into account. Draught is defined at midships as in Figure 4.1. Trim is the difference of draughts at after and fore perpendiculars. In Figure 4.4 the static (solid line) and dynamic heel angles are shown as functions of water amount on cardeck. The actual values of ship main particulars excluding the visor were used. The h_ϕ and e_ϕ values as functions of heel angle are shown in Figures 4.5 and 4.6, respectively. The static heel angle and the flooded water for four cases is visualised in Figure 4.7 corresponding 1000, 2000, 3000 and 4000 ton water on cardeck. The frames drawn in each case are #6, #80.5 and #156 with x-coordinates of 3.6, 69.0 and 134.8 m from AP, respectively. These drawings as well as the h_ϕ and e_ϕ values were calculated using the actual values with the visor but the influence of the visor on the results is insignificant.

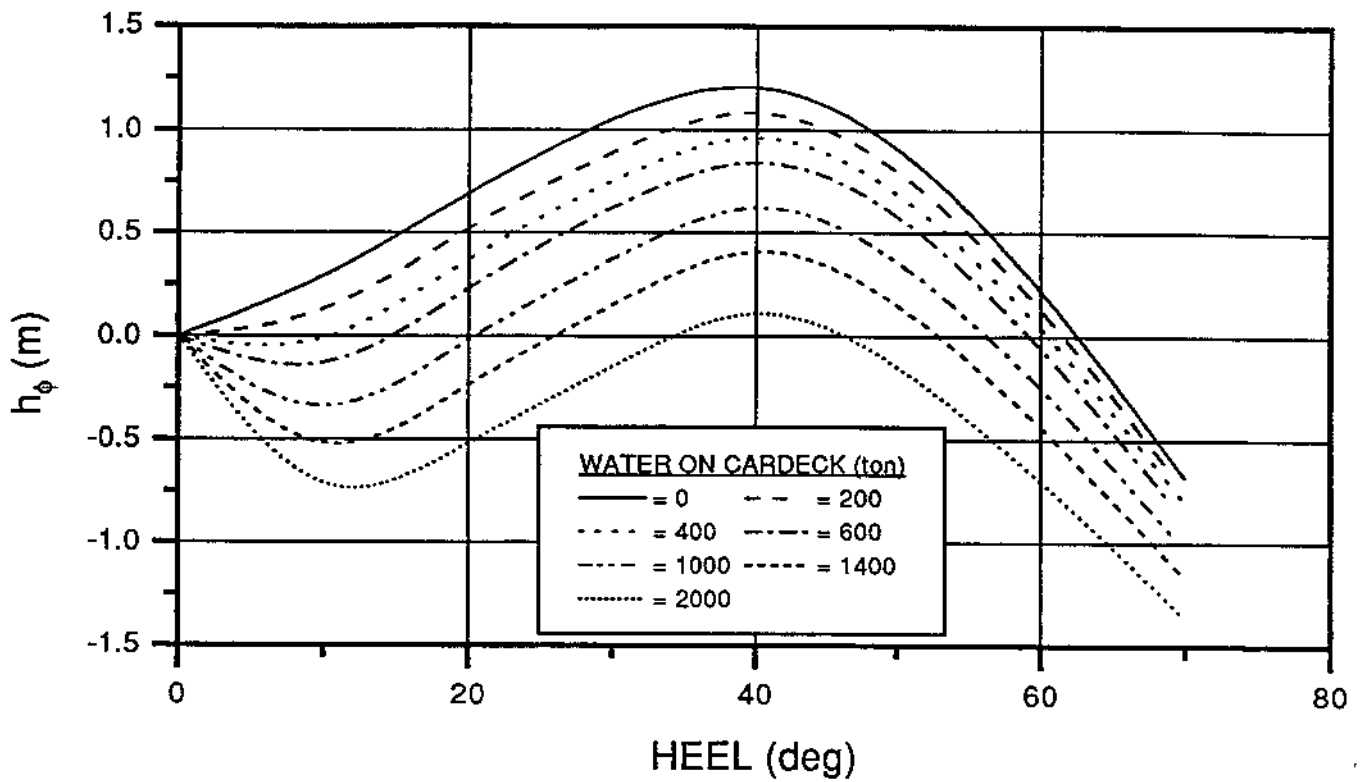
Figure 4.8 Static stability curves. Side above 4th deck not included, preliminary load condition.

The stability for the case with side above the 4th deck not included was calculated with 0, 200, 400, 600, 1000, 1400 and 2000 tons of water on cardeck. The h_ϕ and e_ϕ values as functions of heel angle are presented in Figures 4.8 and 4.9, respectively. The static and dynamic heel angles as functions of water amount on cardeck are shown in Figure 4.10 where the last dynamic heel angle corresponding to 1350 ton water is interpolated using the adjacent values. The preliminary values of ship main particulars were used.

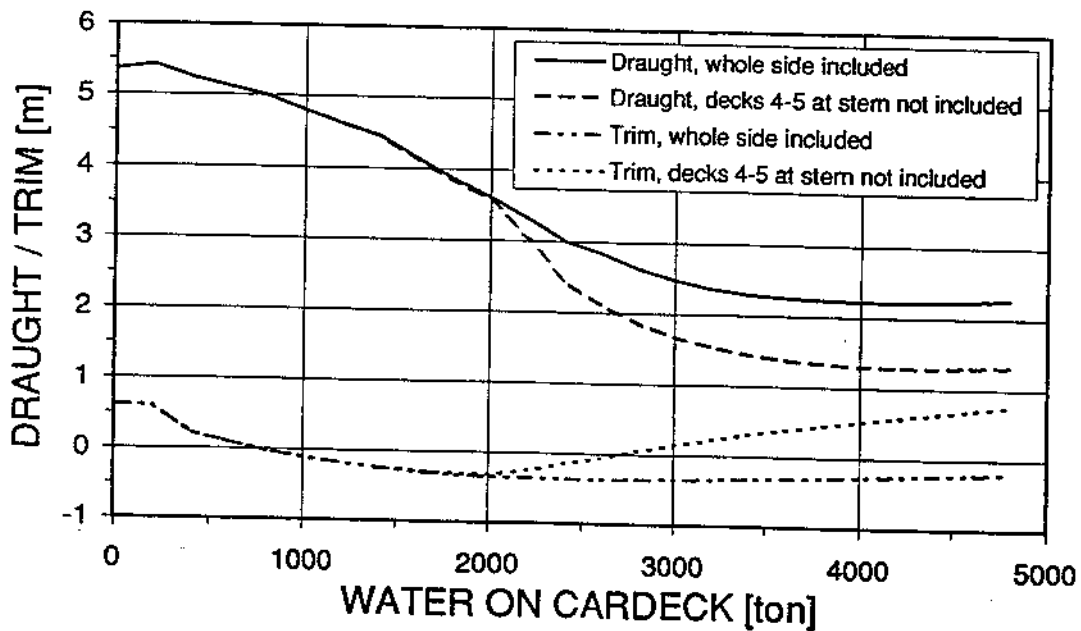
Figure 4.11 Draught and trim, whole side included and decks 4-5 at stern not included, actual load condition without the visor.

Assuming that some of the large windows on the 4th and 5th deck broke being the first openings through which the water flooded on these decks, a damage case where a large space between the 4th and 6th deck in the aft part of the ship was excluded from the watertight hull volume was also analysed. On the 4th deck, the hull volume from the aft bulkhead to the cabin department, i.e. to the frame no. 44, was disregarded. On the 5th deck, the disregarded space extended from the aft bulkhead to the frame V just aft from the main stairway. The static heel angle in the case when these spaces do not contribute any more to the stability is shown in Figure 4.4 (dotted line). The draught and trim compared to the

intact hull case are shown in Figure 4.11. These calculations were done using the actual values of ship main particulars but without the visor.

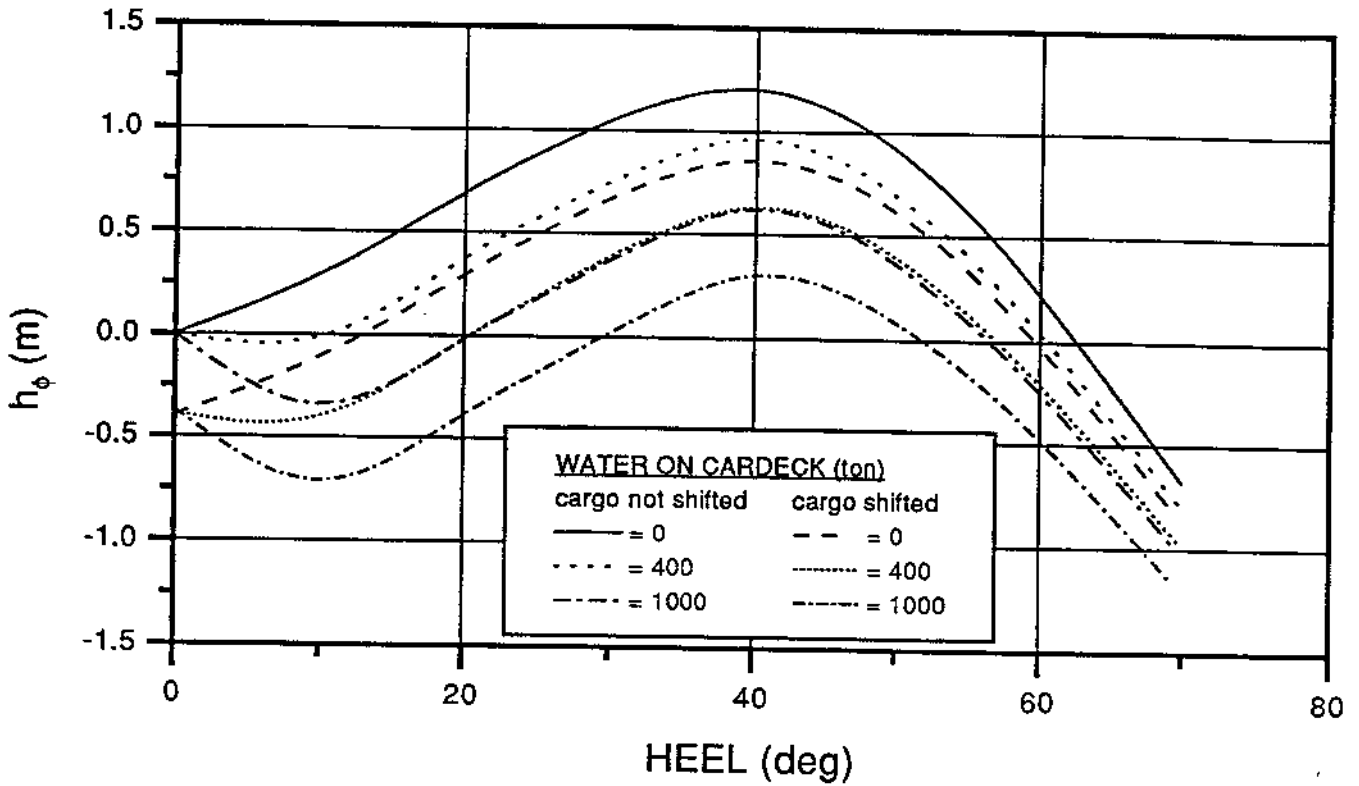
Figure 4.13 Static stability curves, effect of cargo shift. Side above 4th deck not included, preliminary load condition.

The h_{ϕ} and e_{ϕ} values for the case where the cargo on the cardeck was assumed to be shifted were calculated in cases with 0, 400 and 1000 tons water on the cardeck. The side above the cardeck was not included in the righting moment calculations. The weight of cargo in both sides of the cardeck was 300 tons. The transverse locations of the centre of gravity for shifted cargo were conservatively estimated as 11.0 m on starboard side and -3.0 m on port side measured from ship centreline. These values are somewhat conservative because in reality the cargo could not move that much. It has been estimated that during the MV Estonia accident the cargo was able to move only about 1 m sideways. The static and dynamic heel angles are shown in Figure 4.12. The h_{ϕ} and e_{ϕ} values together with the corresponding results of unshifted case are presented as functions of heel angle in Figures 4.13 and 4.14, respectively. The preliminary values of ship main particulars were used.

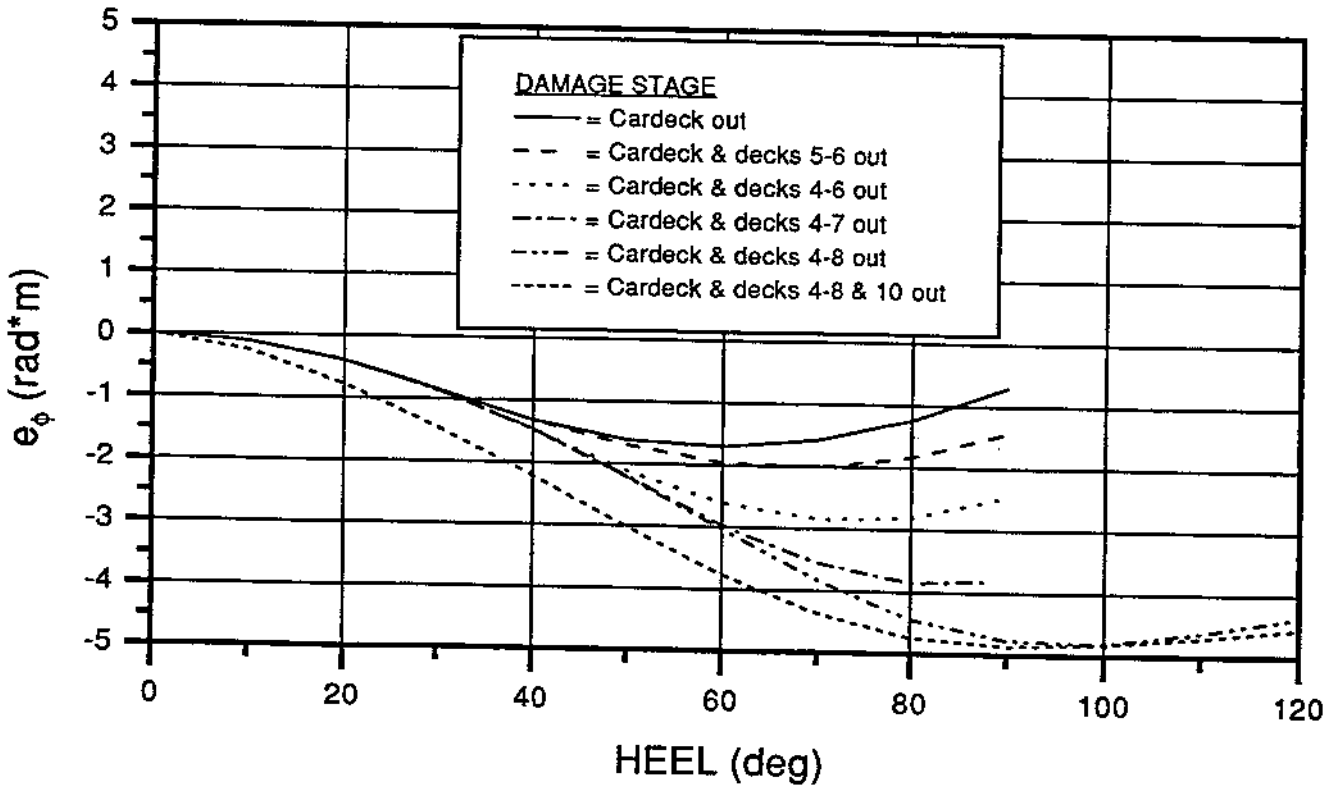
Figure 4.17 Dynamic stability curves, effect of damage stage, 3200 ton water on cardeck.

Though it is impossible to predict how the flooding of the vessel hull and the superstructure developed, some simplified flooding cases have been analysed. The h_{ϕ} and e_{ϕ} values as functions of heel angle for different damage stages are presented in Figures 4.16 and 4.17, respectively. The static stability was calculated for cases where watertight hull volume above the cardeck gradually decreases as the ship heels and more water flows inside through openings. The notation of first damage stage 'cardeck out' in the figures means that water can flood in to the cardeck through the lower corner of the opened bow
