Tutkintaselostus

D14/2008M

Kahden henkilön tajunnan menetys lastitankissa 4.11.2008 säiliöaluksella

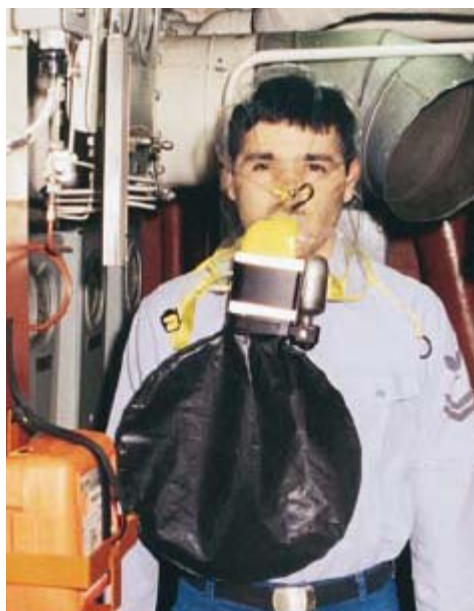
Moottorimies oli yrittänyt laittaa tankissa hätäpoistumishengityslaitteet, "pakopulot", (EEBD) kummallekin kansimiehelle siinä kuitenkaan onnistumatta. Pakopullon suukappale on "snorkkeli mallinen" joka pitää laittoa suuhun ja puristaa hampailla yhteen eli tajuuttomina olleet kansimiehet eivät voineet tehdä tätä. Hän sai kuitenkin pullo auki ja oman kertomuksen mukaan kansimiehet saivat "ainakin jonkin verran ilmaa" pakopulloista.

Kuva 2. Pakopullo (EEBD) Ocenco M-20.2 puettuna (kuva on valmistajan www-sivuilta)

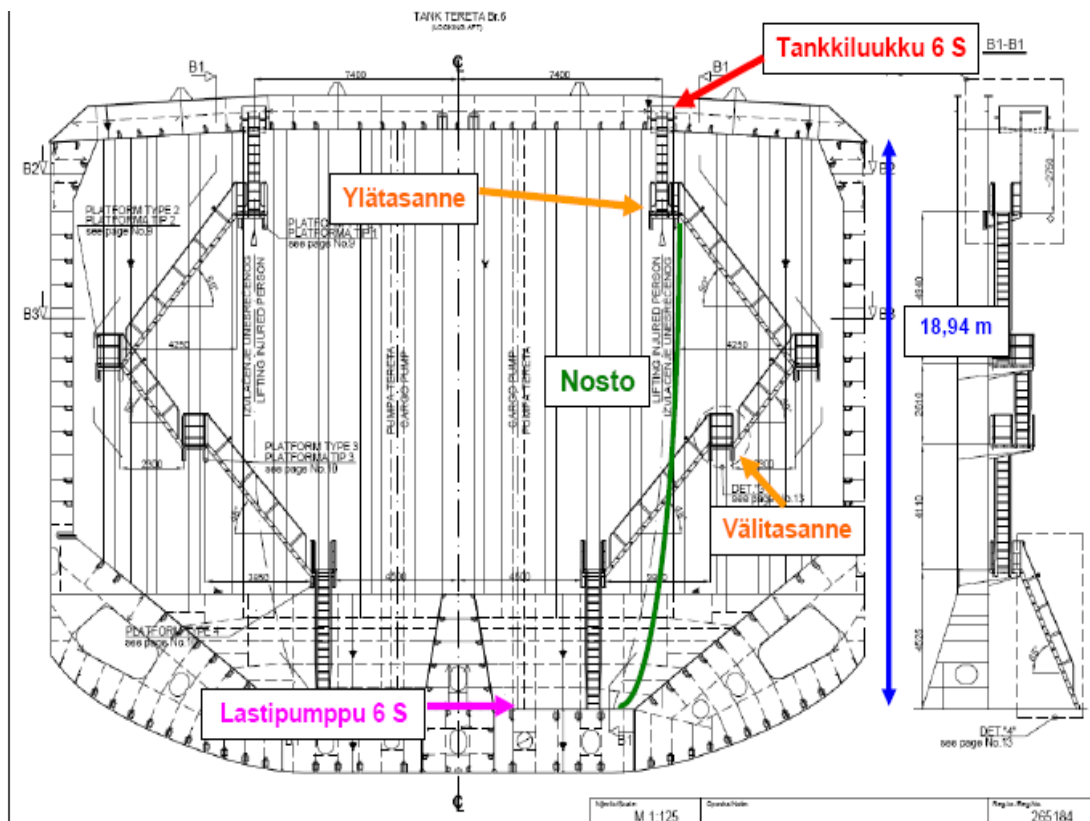
Kansimies MM putoamissuojainvaljaat kiinnitettiin ensin putoamisen estämiseen tarkoitettuun turvatarrainen vaijeriin (jojo). Tämä kuitenkin huomattiin nopeasti ja vaihdettiin varsinaiseen nostoon tarkoitettuun vaijeriin. Haastattelujen perusteella tässä meni ylimääräistä aikaa "jokunen minuutti". Moottorimiehen paineilmalaitte hälytti ja hän poistui tankista. Moottorimies antoi paineilmalaitteen korjausmiehelle, joka pullojen vaihdon jälkeen siirtyi välitasanteelle auttamaan nostossa. Kansimies MM saatiin kannelle klo 10:38. Varsinainen nosto alhaalta ylös kesti noin 5 minuuttia.

Kuva 3. Tankista nostaminen.

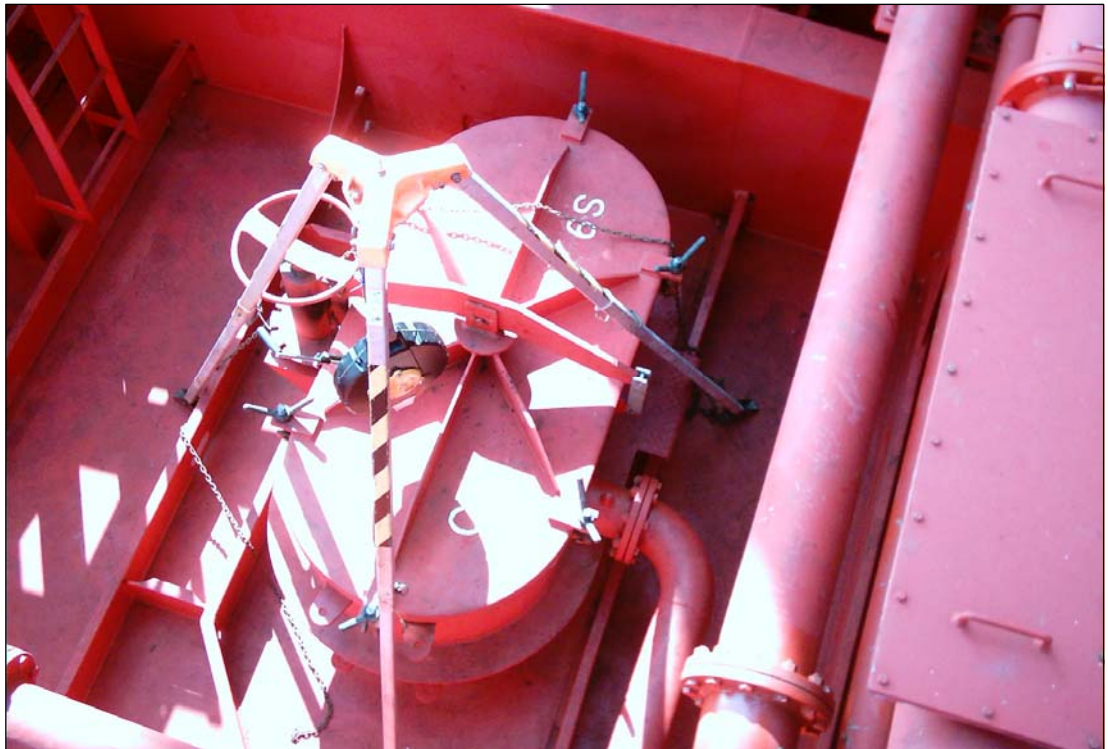
Kuva 4. Kolmijalka ja vinssi lastitankki 6 S tankkiluukulla

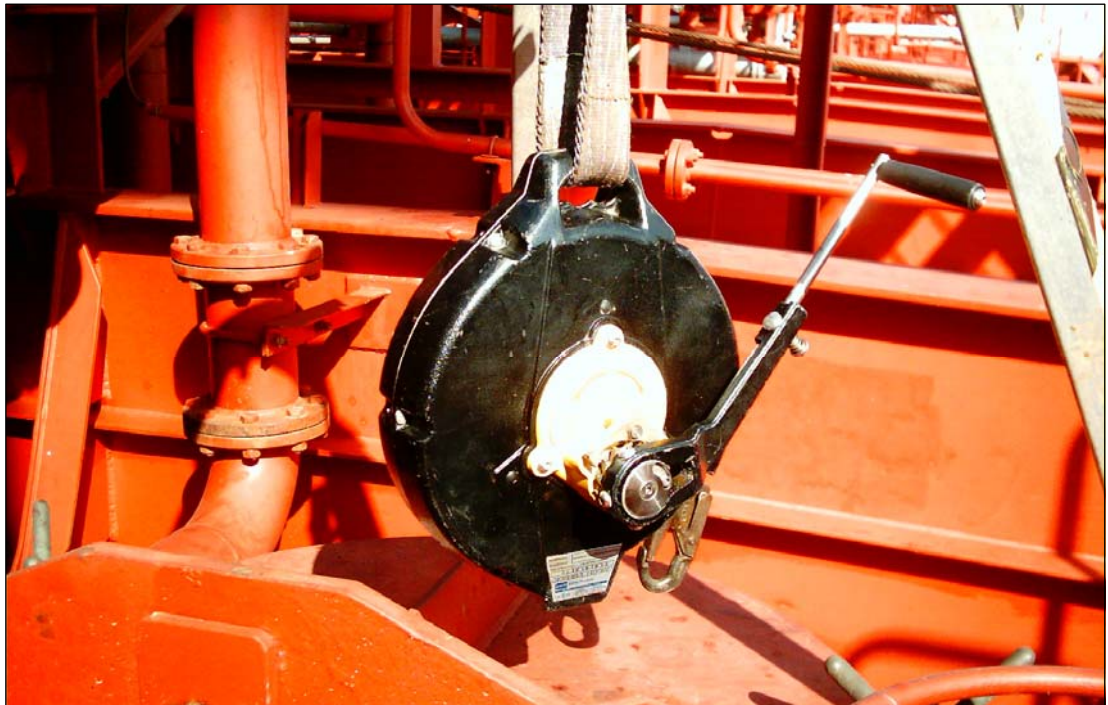
Kuva 5. Nostossa käytetty vinssi

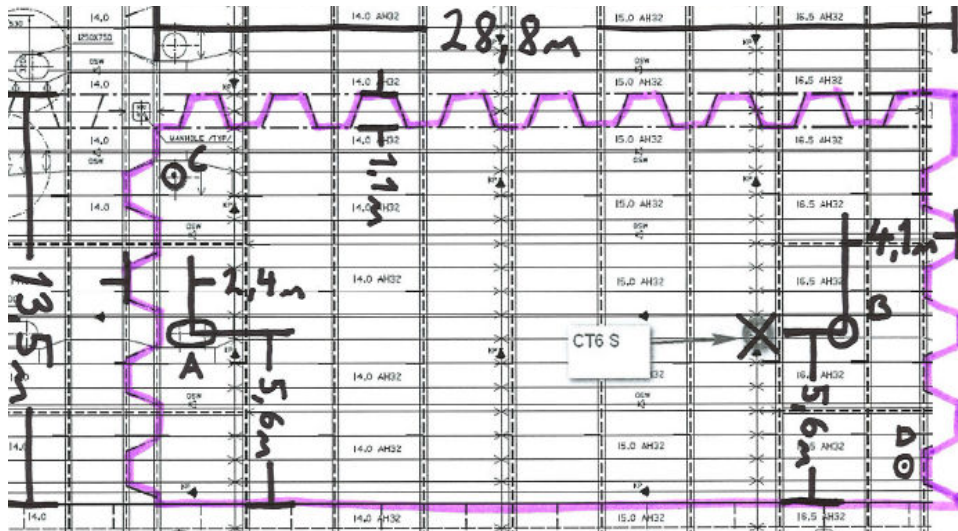
Kuva 1. Onnettomuusalueen lastitankin geometria.

Kuvaan 1 lastitankin sisäänmenoluukku (1800x700mm) on merkitty A kirjaimella. Sisäänmenoluukku toimii tuuletusprosessissa ilmanpoistoluukkuna, jonka kautta tuuletusilma poistuu lastitankista ulkoilmaan. Tuuletusluukku on merkitty kuvaan B kirjaimella, jonka kautta liikutettavan tuuletusjärjestelmän tuuletusputkisukka lasketetaan lastitankin sisälle. Tuuletusputkisukka lasketaan noin 1.5 m etäisyydelle lastitankin pohjasta. Lastitankin sisällä oleva lastiputki C on otettu myös malliin mukaan sen aiheuttaminen virtausvastusten selvittämiseksi. Lastitankin kiinteä tuuletusjärjestelmä on merkitty kuvaan D kirjaimella. Kohdassa D sijaitsee kiinteän tuuletusjärjestelmän syöksypuhallus, jonka kautta tuuletusilma johdetaan lastitankin pohjalle (0.5 m tankin pohjasta). Kiinteän tuuletusjärjestelmän avulla voidaan myös puhaltaa tuuletusilmaa lastitankin yläosaan. Tämä kohta sijaitsee aivan B tuuletusluukun vieressä.

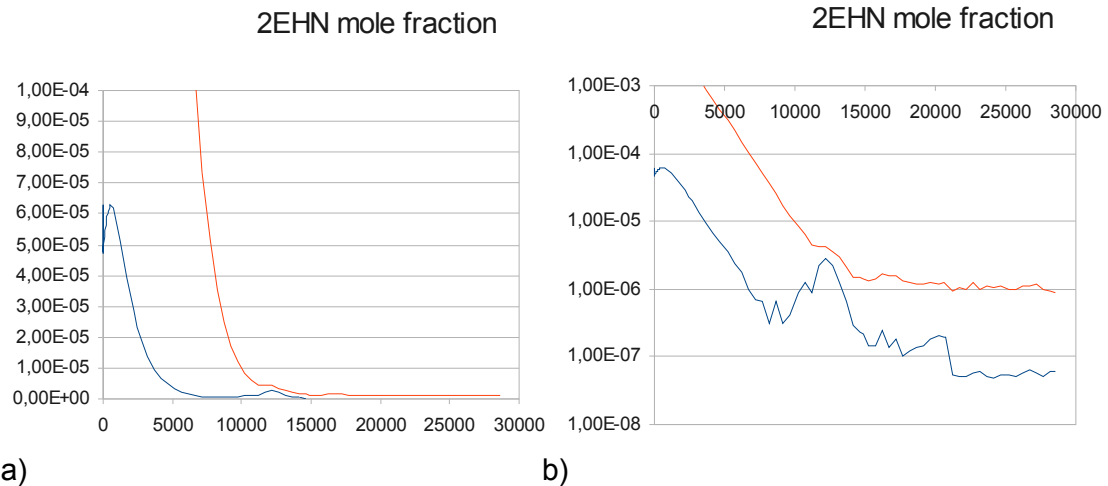
2EHN:n maksimiarvo nousee simuloinnin alkuvaiheessa samalla tavalla kuten edellisissä tapauksissa. Laskennan puolivälissä näkyy taas selvästi milloin laskentatarkkuus loppuu kesken, eli loppuosan virheet pitää taas jättää huomioida.

Tarvittava tuuletusaika tässä tapauksessa on hieman pitempi kuin edellisessä. Tässä tapauksessa 1 ppm:n raja-arvo saavutetaan vajaan 4 tunnin jälkeen.

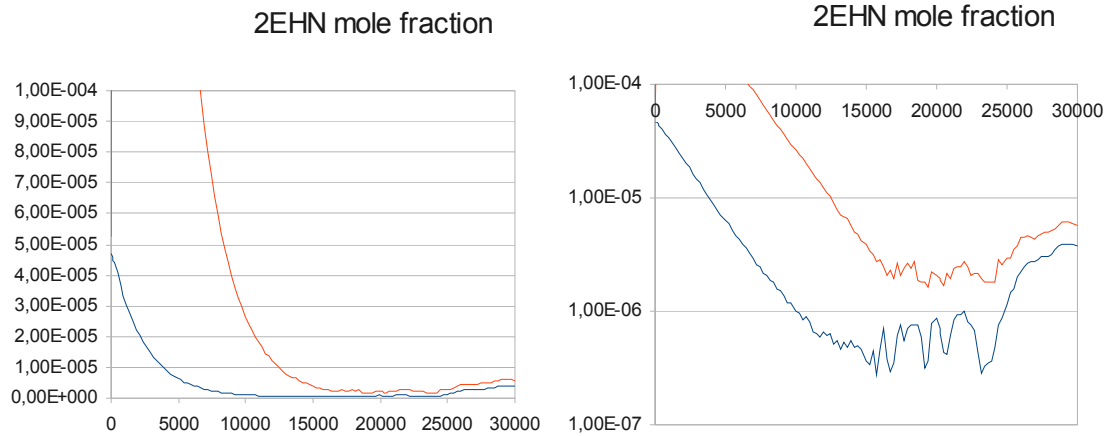
2EHN:n maksimiarvo nousee simuloinnin alkuvaiheessa samalla tavalla kuten edellisissä tapauksissa. Tämä laskenta oli numeerisesti vähän stabiilimpi ja virheet vaikuttavat vasta lopussa.

Tässä tapauksessa 1 ppm:n raja-arvo saavutetaan vajaan 5 tunnin jälkeen.
