DUTCH
SAFETY BOARD

Collision involving crane

Fatal accident on board Lady Christina

The Hague, May 2018

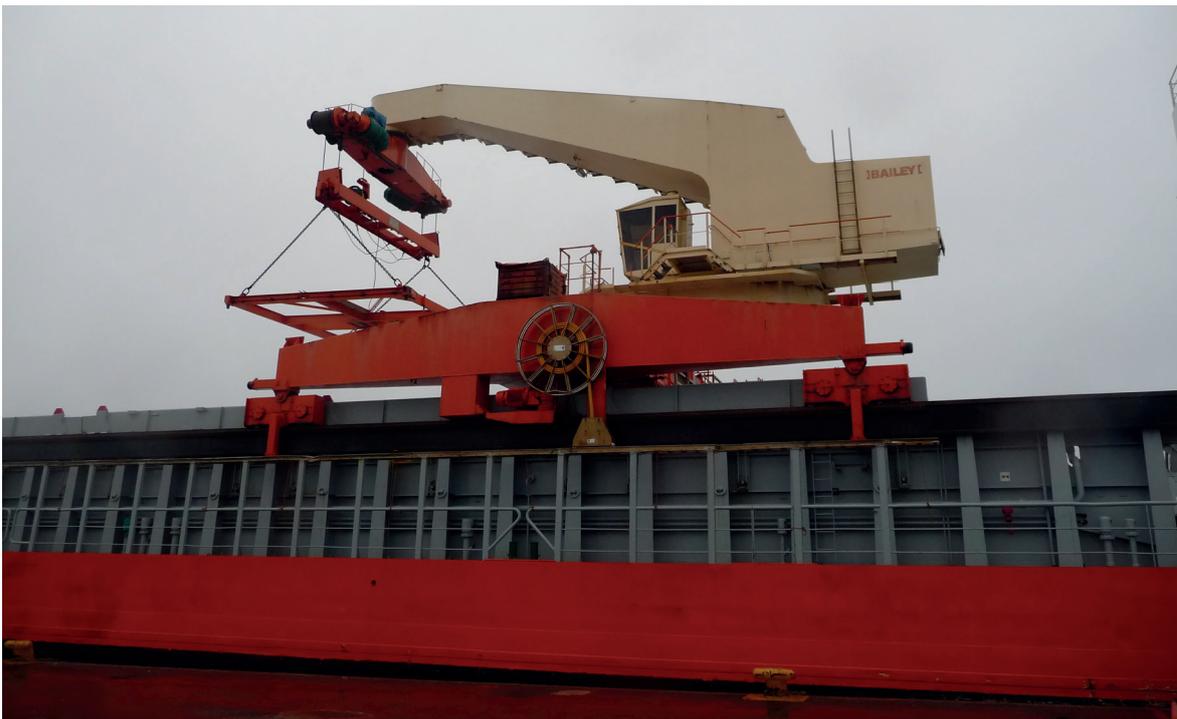
Figure 2: Crane on board the Lady Christina. (Photo: Dutch Safety Board)

The Lady Christina was built in 2000 at the Dutch Koninklijke Niestern Sander B.V. shipyard in Delfzijl, as one of the four ships in the Lady C series. All four ships are owned by Wijnne Barends from Delfzijl. The ships are fitted with a large crane that covers the entire width of the deck, able to bear loads of 35 mt²; see figure 2.
