Serious accident with Finish flag
split hopper barge Boann,
IMO 9808792
occurred on 8 April 2019
in Klaipeda State Seaport

SAFETY INVESTIGATION REPORT

No. (L-19/04) 1A-63
6 May 2020

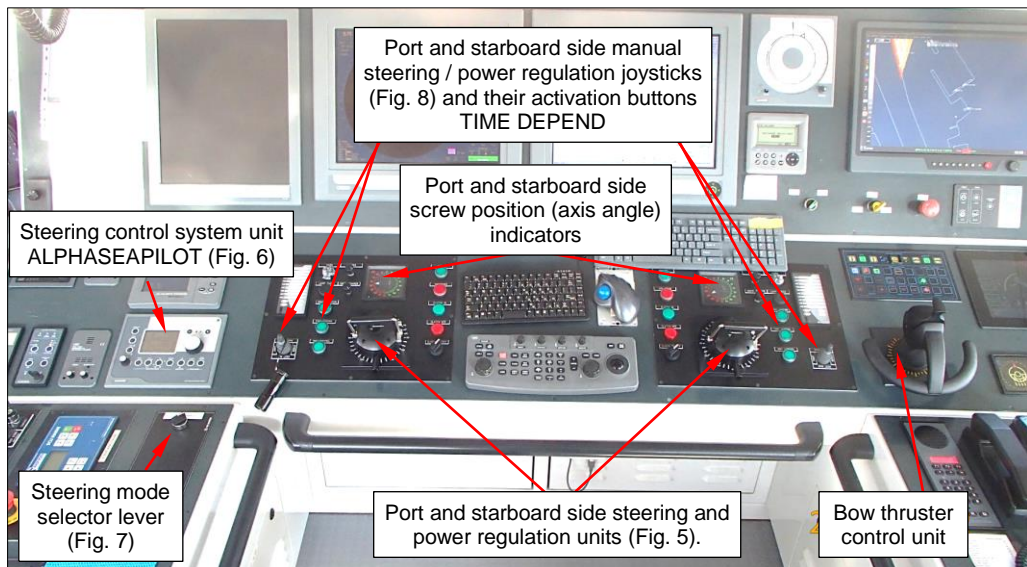
Fig. 4. Arrangement of the steering equipment on the bridge

Automatic steering mode is active when steering mode selector lever is set in the position AUTOPILOT (Fig. 4).

To maintain a predefined course of the ship an automatic steering control system unit ALPHASEAPILOT was used on board (Fig. 4), which was certified in accordance with the requirements of the International Maritime Organization and the European Union. There are no requirements to have such a system on board Boann.

Ship is steered by rotating the two (port and starboard side) steering levers (Figs. 4, 5), which controls (rotates) the position of the port side and starboard side screw shafts and by changing the power of the main engines. When the steering lever is rotated by 180°, the position of the screw axis also rotates by the same angle to the horizontal plane and the propulsion force is applied in the opposite direction. The speed of the ship is controlled by the engines' power regulation levers (Figs. 4, 5).

When the automatic steering mode is enabled, the following steps are required to switch on the manual steering mode: 1) Press the STBY button on the steering control system unit ALPHASEAPILOT (Figs. 4, 6); 2) Turn the selector lever (Figs. 4, 7) clockwise from the position AUTOPILOT to the position MANUAL.

Manual steering and speed change can also be performed using port and starboard side manual steering / power regulation joysticks (Figs. 4, 8). These are activated by pressing the green TIME DEPEND buttons (Fig. 4), which activates the steering / power regulation joysticks irrespectively of the position of the steering mode selector lever (Fig. 7).

When master started to steer the ship with disabled manual steering levers (Fig. 5), he realized that the routinely used manual steering mode does not work. As ship was quickly approaching towards berth No 33 and after 16 sec contacted it, master did not have sufficient time to determine and eliminate the cause of that non operation. Therefore master attempted to avoid contact by trying to steer the ship to the starboard side using a bow thruster. At that time, the ship was moving at a speed of 5.7 knots, so the thrust generated by the bow thruster had a very slight effect on the ship's course: within 16 seconds, the ship changed her course only by 1.6° to starboard. Further action - an attempt to engage the reverse mode by turning the steering levers by 180° and increasing the power of the engines with engines' power regulation levers (Fig. 5) had no impact to the course of the ship, but increased the ship's speed.

It is recommended to Wasa Dredging Oy Ltd, on its Boann-type vessels, to implement permanent arrangements, which enable proper evaluation of the steering mode engaged.'
