Tutkintaselostus

1/1995

The Grounding of the M/S SILJA EUROPA at Furusund in the Stockholm Archipelago on 13 January 1995

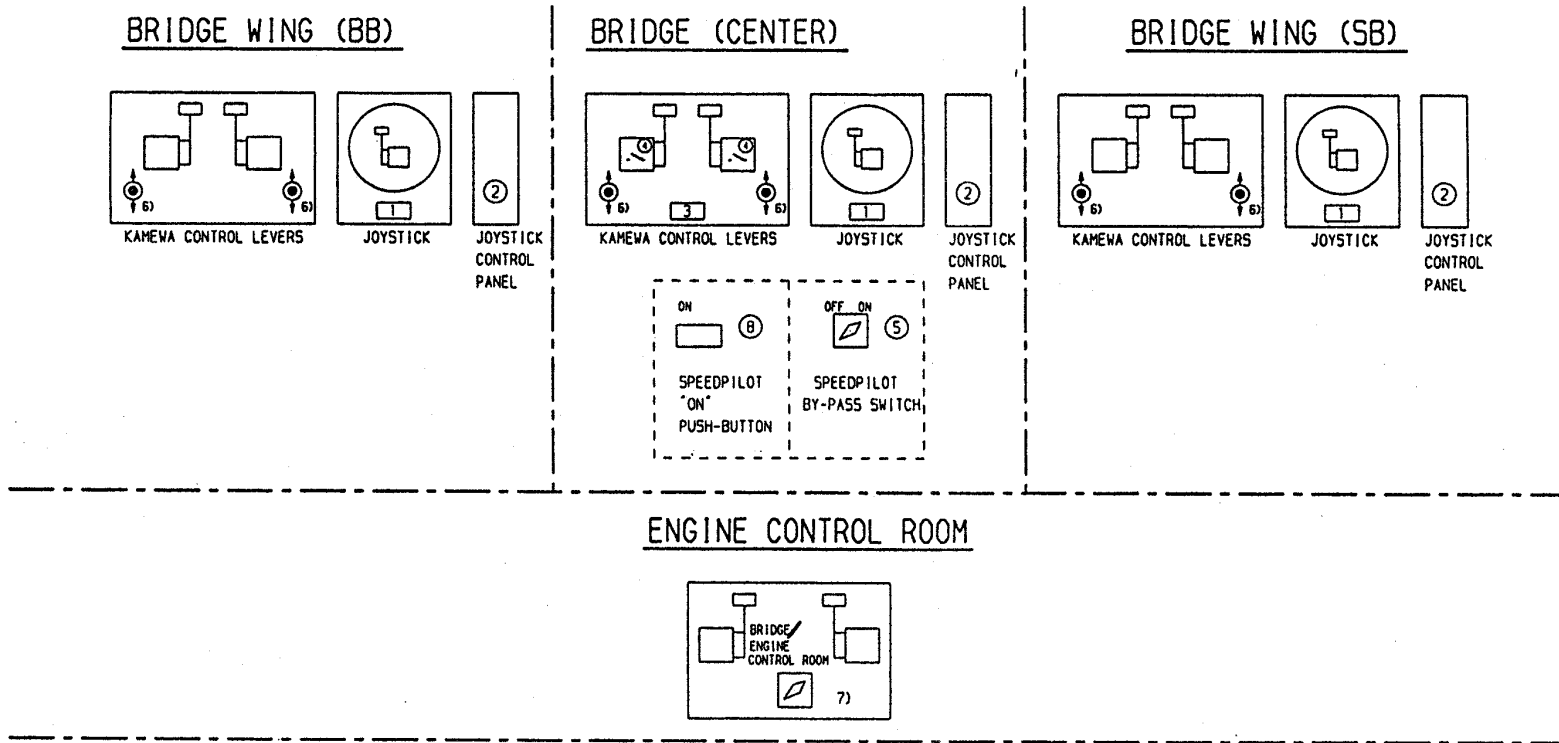
THE LOCATIONS OF THE VESSEL'S SPEED CONTROL UNITS

The locations of the vessel's speed control units on board are shown on page 26. The control units with which the SPEEDPILOT can be switched off are numbered from 1 to 7 on the diagram. The SPEEDPILOT is activated with the SPEEDPILOT ON push button, when all the conditions are fulfilled for activating the SPEEDPILOT (the KaMeWa's control levers are at least 1.5 forward and at least clutches of two main engines are closed).

1. JOYSTICK "COMMAND REQUEST" PUSH-BUTTON. THE SPEEDPILOT IS SWITCHED OFF AND DOES NOT CONTROL THE VESSEL'S SPEED.
2. "HAND CONTROL" PUSH-BUTTON. THE SPEEDPILOT IS SWITCHED OFF AND DOES NOT CONTROL THE VESSEL'S SPEED.

3. "COMMAND REQUEST" PUSH-BUTTON ON KAMEWA CONTROL PANEL. THE SPEEDPILOT IS SWITCHED OFF AND DOES NOT CONTROL THE VESSEL'S SPEED.
4. POSITION OF KAMEWA LEVER'S < 1.5. THE SPEEDPILOT IS SWITCHED OFF AND DOES NOT CONTROL THE VESSEL'S SPEED.

8. THE SPEEDPILOT "ON" PUSH-BUTTON. WITH THIS PUSH-BUTTON IT IS POSSIBLE SWITCH ON THE SPEEDPILOT.

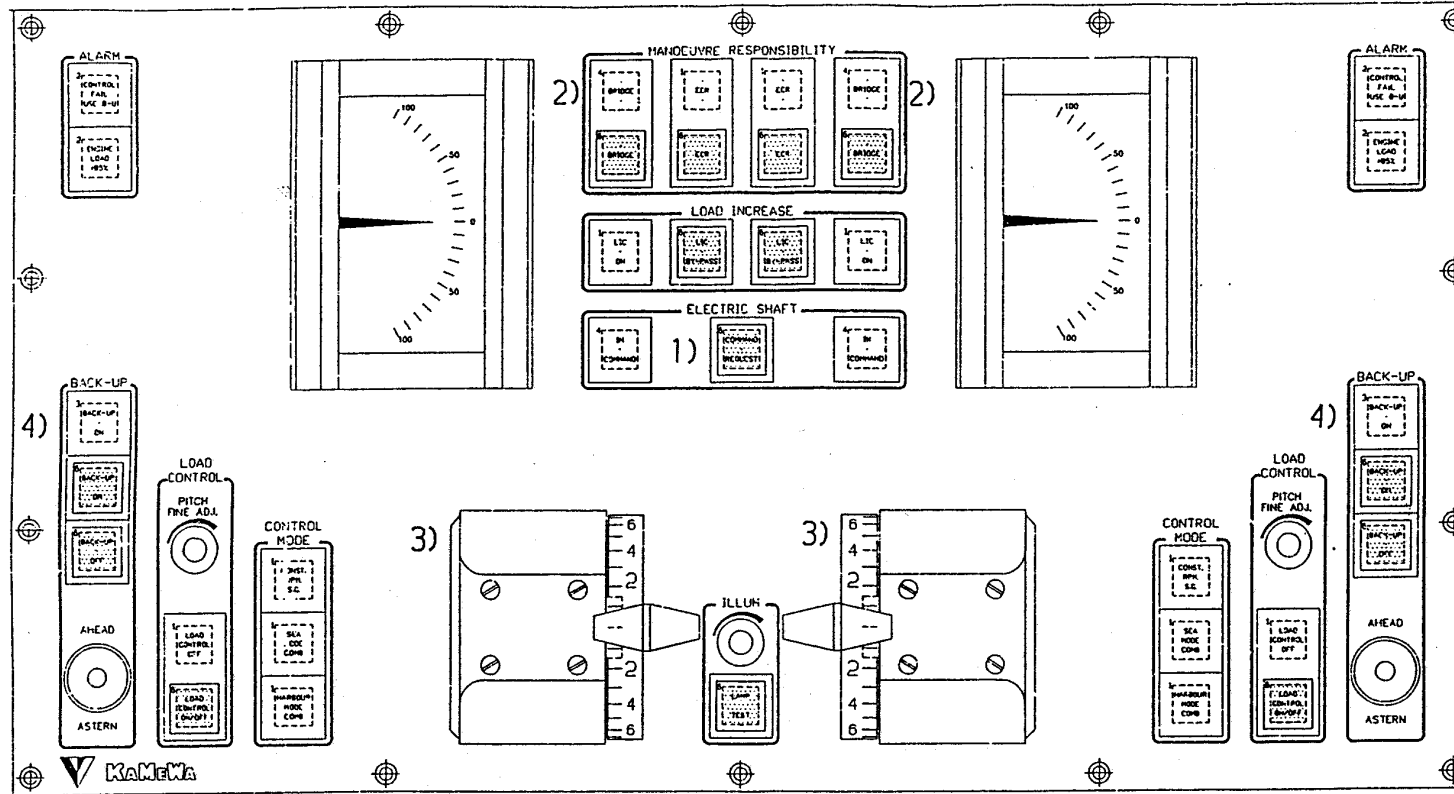
THE KAMEWA CONTROL PANEL ON THE BRIDGE

The pilot reported that all was not well and that the situation could get out of control. He noted that the KaMeWa pitch was at zero. He tried to switch off the SPEEDPILOT by pushing the COMMAND REQUEST button on the KaMeWa control panel and by pushing the control levers forward. However, the SPEEDPILOT was not disengaged, and the control levers returned by themselves to their original position.

1. THE PUSHING OF "COMMAND REQUEST" PUSH-BUTTON SWITCHES OFF THE SPEEDPILOT AND TRANSFERS THE CONTROL OF THE VESSEL'S SPEED TO CONTROL LEVERS.
2. MANOEUVRE RESPONSIBILITY "BRIDGE". LIGHT IN THIS INDICATION LAMP SHOWS, THAT THE CONTROL OF THE VESSEL'S SPEED IS ON BRIDGE.
3. THE VESSEL'S SPEED CONTROL LEVERS. IF POSITION OF THE CONTROL LEVER IS < 1.5 AHEAD WILL SPEEDPILOT SWITCH OFF.
4. THE BACK-UP EMERGENCY CONTROL. THE PUSHING OF "BACK-UP ON" PUSH-BUTTON TRANSFERS THE CONTROL OF THE VESSEL'S SPEED ALWAYS TO THIS UNIT. OVERRIDING ALL THE VESSEL'S OTHER SPEED CONTROL SYSTEMS EXCEPT THE CONTROL FROM ENGINE CONTROL ROOM.

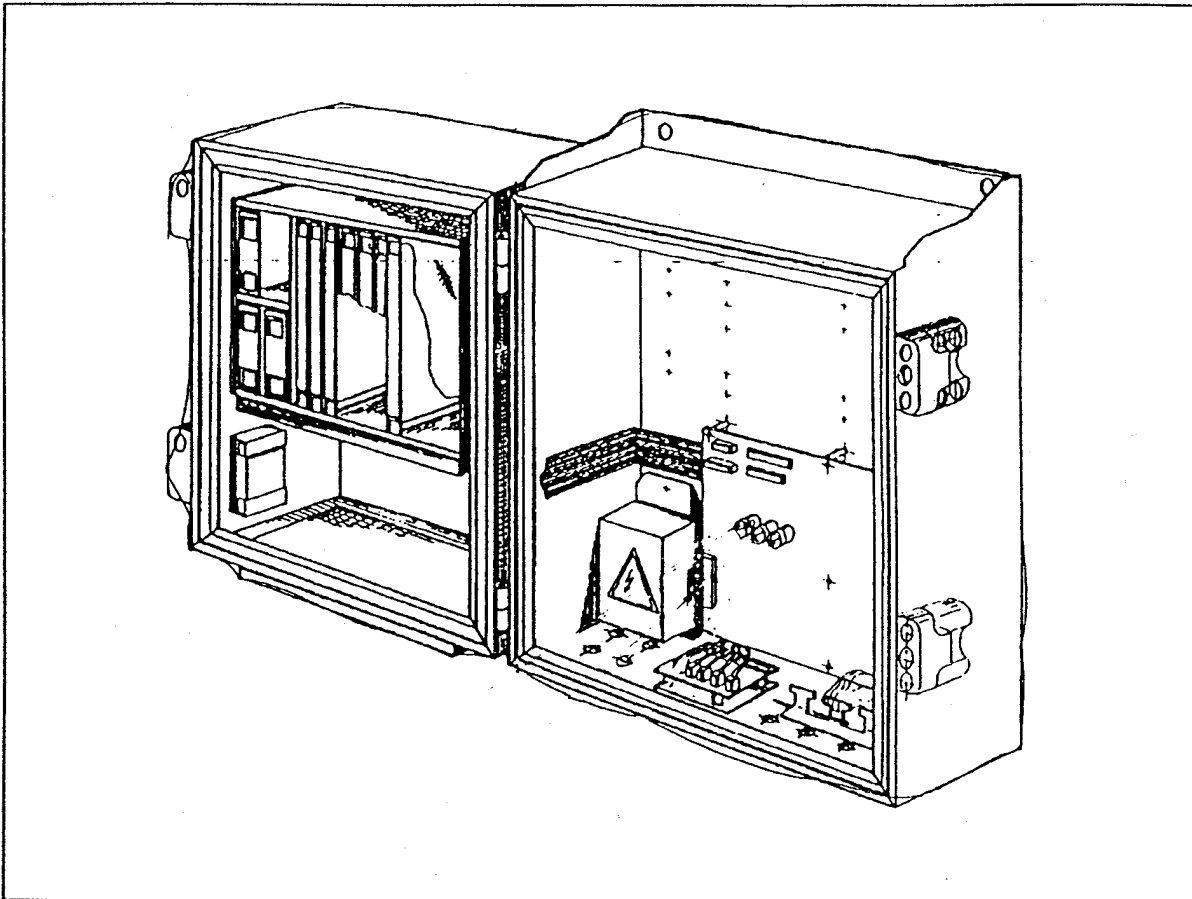
ELECTRONICS CABINET (TRACKPILOT/SPEEDPILOT)

Circuit cards are normally locked to the electronics frame at their front panels with locking screws. The electronics frame of the SILJA EUROPA's SPEEDPILOT provides for the possibility of locking engine interface cards number 1 and 2. As there is vibration on board ships, an unlocked or badly locked circuit card may loosen from its card connector, whereupon it may stop functioning altogether or become uncertain. No one has

The structure of engine interface card 1 is shown on page 25. In the tests at the STN Atlas Elektronik by the Investigation Commission, it was shown that the detachment of this circuit card from its connector caused a corresponding situation to what occurred on the SILJA EUROPA before the grounding. The SPEEDPILOT could not be switched off.

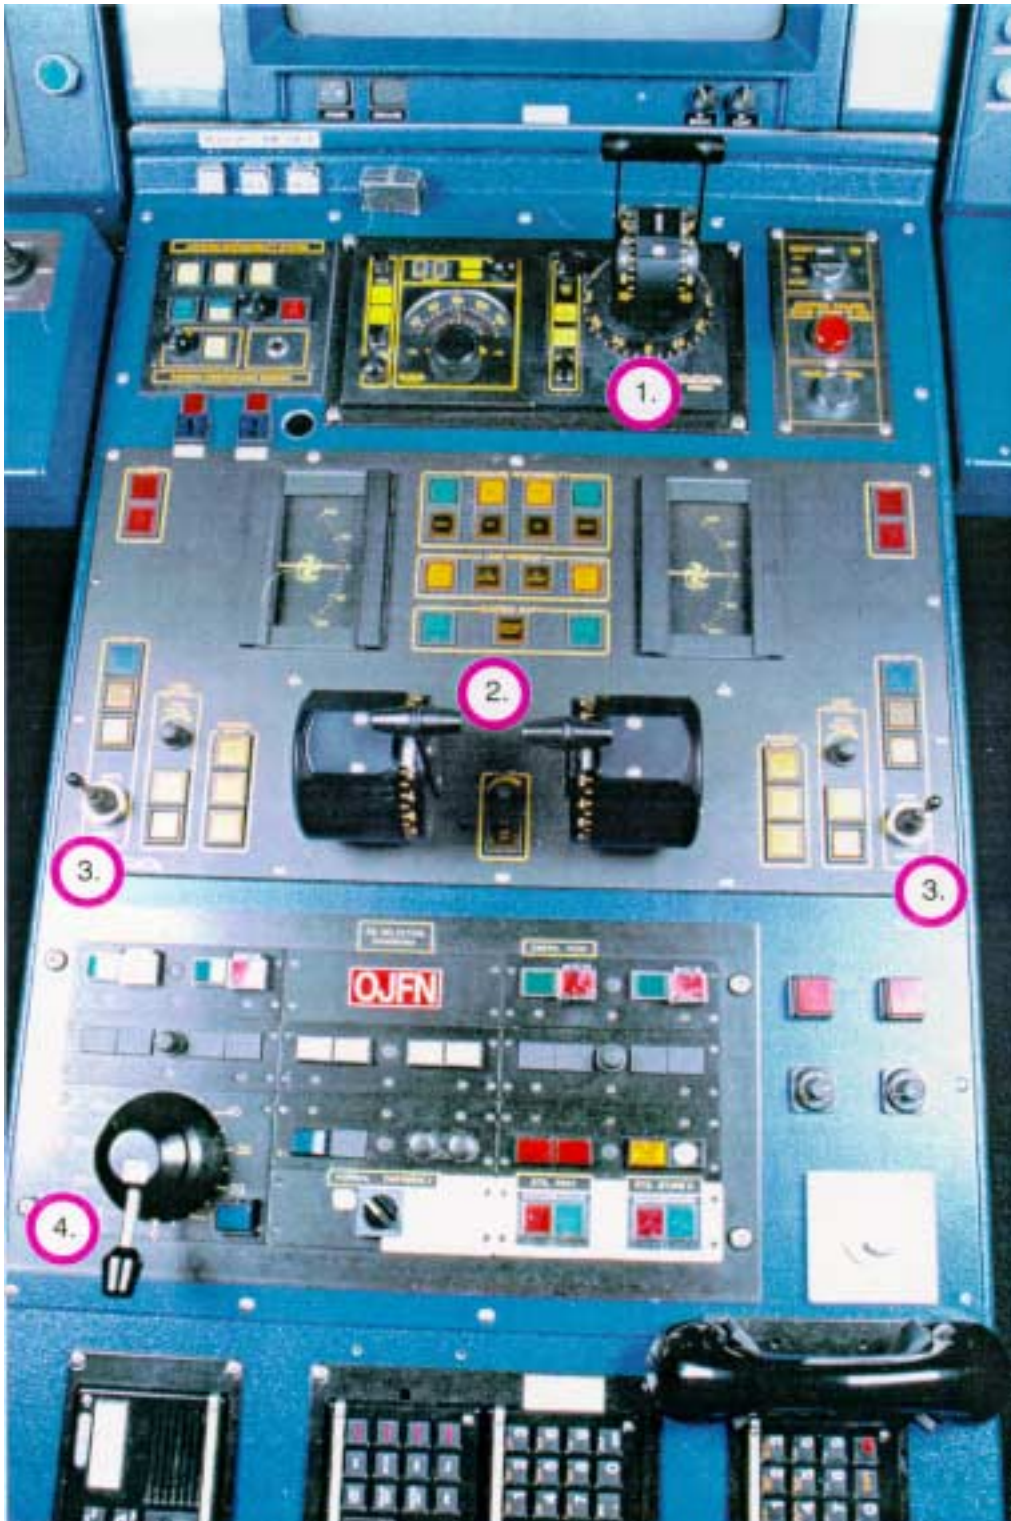
Lack of familiarity with the emergency systems made it even more difficult for the officers on the watch to bring the situation under control before the grounding. Control was not switched to the emergency manual system by the BACKUP push button. The SPEEDPILOT could have been overridden with the BY-PASS switch. This switch, which was installed separately afterwards on this vessel and poorly located ergonomically, was not used.

The right-hand side of the navigation desk. The arrow indicates the location of the BY-PASS switch.

Since the SPEEDPILOT had the highest priority in the SILJA EUROPA's propeller control system, a BYPASS switch in the event of a possible SPEEDPILOT malfunction was installed in the system on the recommendation of the supplier of the equipment.
