Estonian  
Safety  
Investigation  
Bureau

# INVESTIGATION REPORT

ACCIDENT, LOSS OF CONTROL WITH AIRBUS A320-214  
NEAR TALLINN AIRPORT ON 28.02.2018

ESIB: A2802118

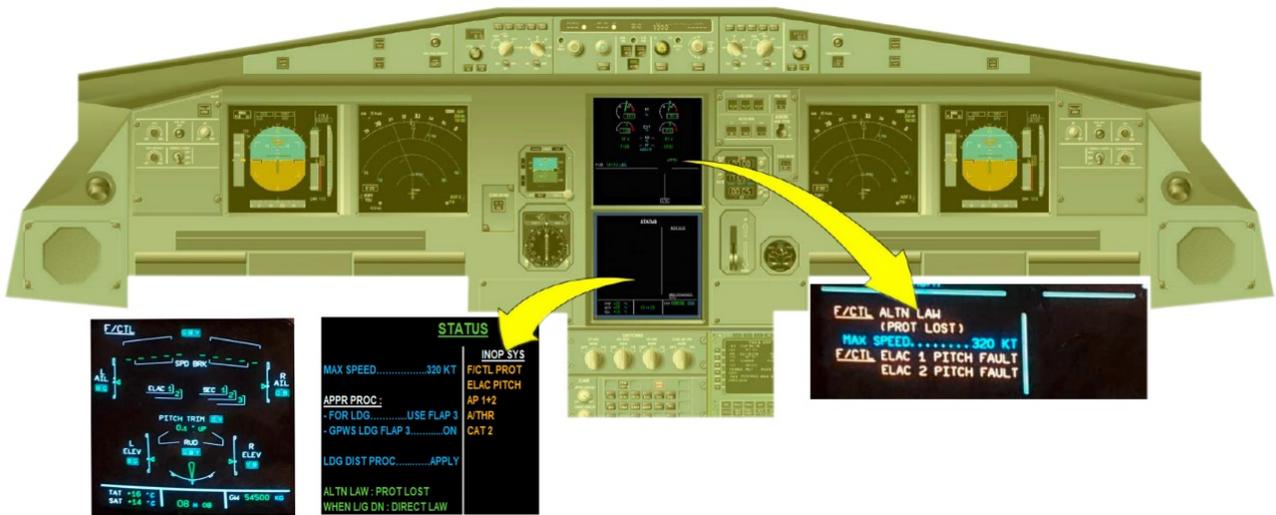
Figure 1. Messages displayed on ECAM on F/CTL ELAC 1 and 2 PITCH FAULT - ECAM F/CTL system page, ECAM status page, ECAM Engine/Warning display

During the flight with the first student, two ELAC1 + ELAC2 PITCH FAULTs were triggered (the first and third touch-down, see Appendix I) at the moment when the instructor was manually stopping the trim wheel at around 1° Nose Up when the THS was returning to 0° after touch down (ground setting). Flight control (FLT CTL) pitch normal LAW switched to alternate 1 law. Due to the fact that ELAC PITCH FAUT message is inhibited by the system in flight phases 4, 5, 7 and 8 (see Figure 21), these failure messages were not displayed on the ECAM display until the aircraft reached 1500 ft. As for this flight with the first student, each time when the aircraft reached 1500ft the ECAM alert F/CTL ELAC 1(2) PITCH FAULT were displayed on the Engine Warning Display (see Figure 1), and a single chime (SC) was triggered related to the reversion of the F/CTL LAW in Alternate. Both ELAC-s were then reset by the crew according to the manufacturers' operational documentation during the following level flight of the flight pattern. FLT CTL pitch normal law was recovered each time after the reset.

In case of a dual ELAC PITCH FAULT, the following alerts are triggered on the same time on the bottom left side of the ECAM Engine/Warning display (Figure 1):

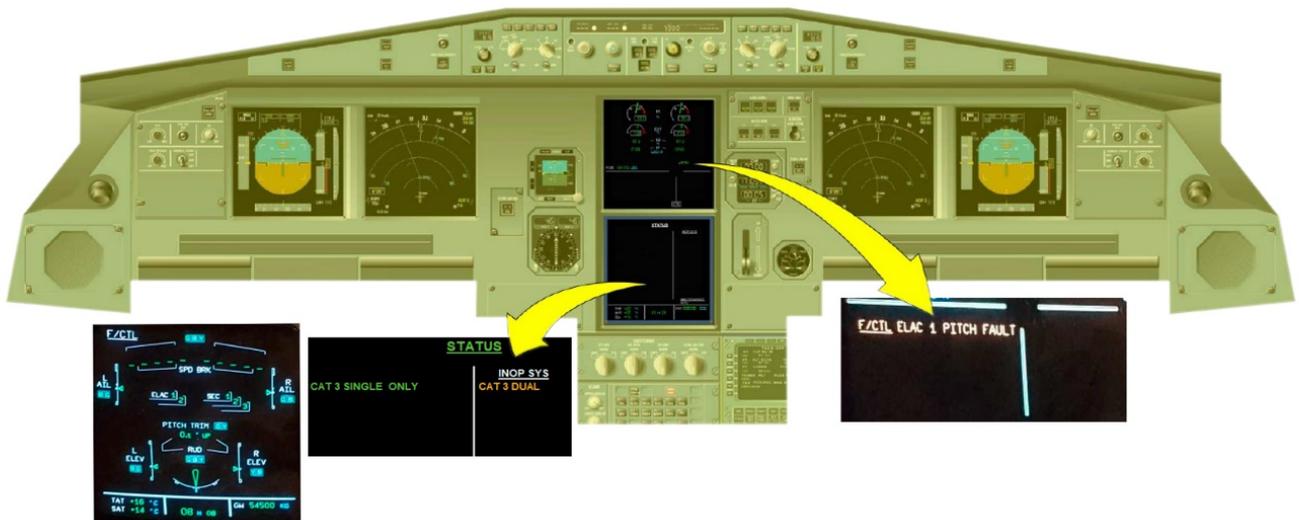
Figure 2. ECAM FC CTL system page, ECAM status page, ECAM Engine/Warning display on the event of ELAC 1 PITCH FAULT

During the flight with the second student, one single ELAC1 PITCH FAULT was triggered while the instructor was manually stopping the trim wheel at around 1° Nose Up as the THS ground setting was returning to 0°, as it had happened previously. The fault was displayed again on the ECAM FLT CTL display as the aircraft reached 1500 ft, only this time, as there was only a single ELAC PITCH FAULT, there was no degradation of flight LAW, and therefore no SC was triggered by the system (see Figure 2). ELAC1 was then reset by the crew after it was displayed on the ECAM display during the following level flight of the flight pattern. The rest of the session with the second student was uneventful.

In case of ELAC 1 (2) PITCH FAULT (as it happened before this accident) on the bottom left side of the ECAM Engine/Warning display F/CTL ELAC 1 (or 2) PITCH FAULT is displayed and on the ECAM status page CAT3 SINGLE ONLY is displayed on the left, and INOP SYS CAT 3 DUAL on the right side of the display (Figure 2). No aural warning or Master Caution Light is triggered. This crew awareness message is inhibited in flight phases 3, 4, 5, 7, 8 (Figure 21) and thus postponed.

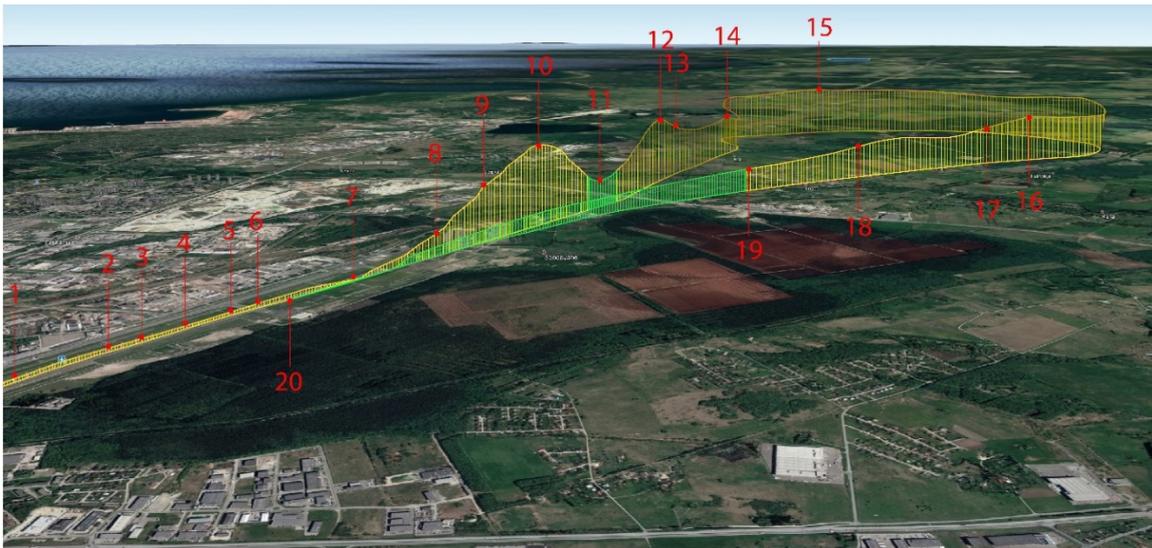
Figure 3. Final flight path. The yellow hatched part of the flightpath is derived from the FDR data. Green parts are reconstructed on the base of aerodrome camera footage, witness statements and CVR recordings. FDR data is lost when both of the engines spooled down.

<sup>1</sup>(see Figure 3). During the third touch-and-go at 15:05:05, an ELAC2 PITCH FAULT was again triggered in the same conditions. FLT CTL pitch normal LAW reverted to alternate 1 LAW, but stayed engaged only for 1 second<sup>2</sup>. As the ELAC2 PITCH FAULT failure message is inhibited during this phase of a flight, so that the flight crew had no indication by the aircraft systems of the aircraft condition at this moment. As the aircraft was reaching rotation speed the instructor asked the student to rotate, after which the student initiated the rotation by pulling the sidestick, and by putting the thrust levers in the TOGA detent. The elevator position was 6.5° Nose Down and started to move towards 0°, the THS position was 3.5° Nose Up and the airspeed was 130 kt. As the instructor noticed the aircraft not rotating, the instructor commanded "Rotate! Rotate!", to which the student replied that he is Rotating (see Figure 4).

10. At 15:05:53, the airspeed was 144kt the aircraft reached maximum height of 1590 ft (see Figure 3) the pitch started to decrease rapidly and the aircraft started to lose altitude.

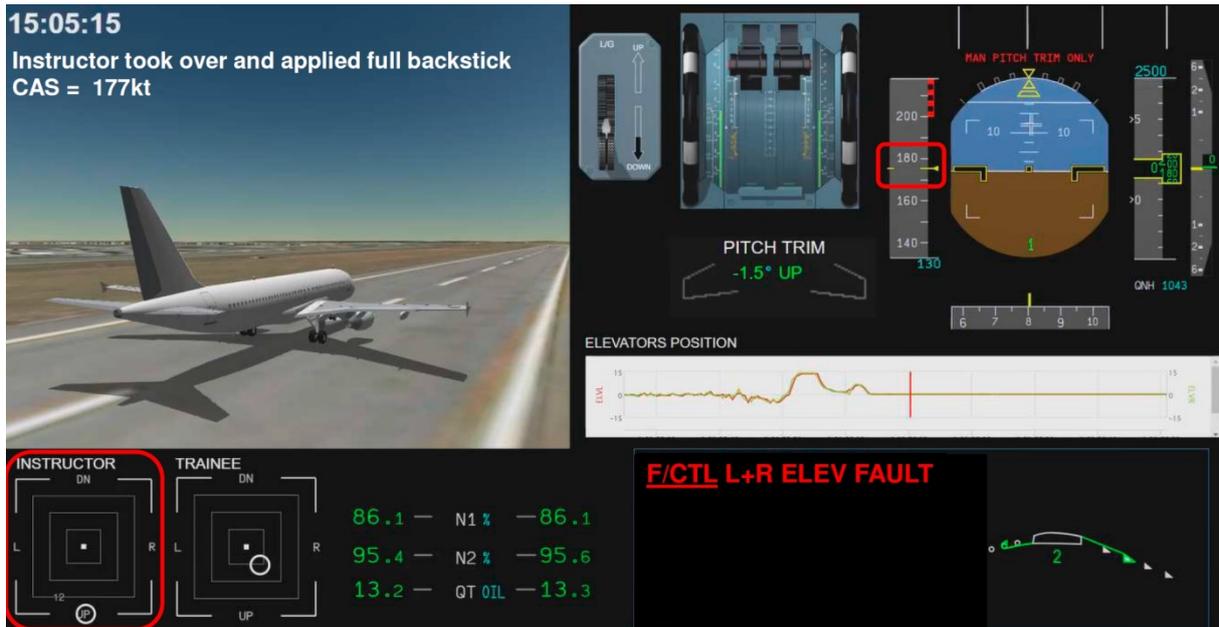
Figure 5. Cockpit inputs and indications at 15:05:15

4. At 15:05:15, the student released the orders on the sidestick while pitch attitude was still 0.3° Nose Up and the aircraft was airborne. The instructor was close to full Nose Up sidestick deflection (this position was kept for 14 seconds) and giving side stick roll position commands +5 and -5 degrees (Figure 5).

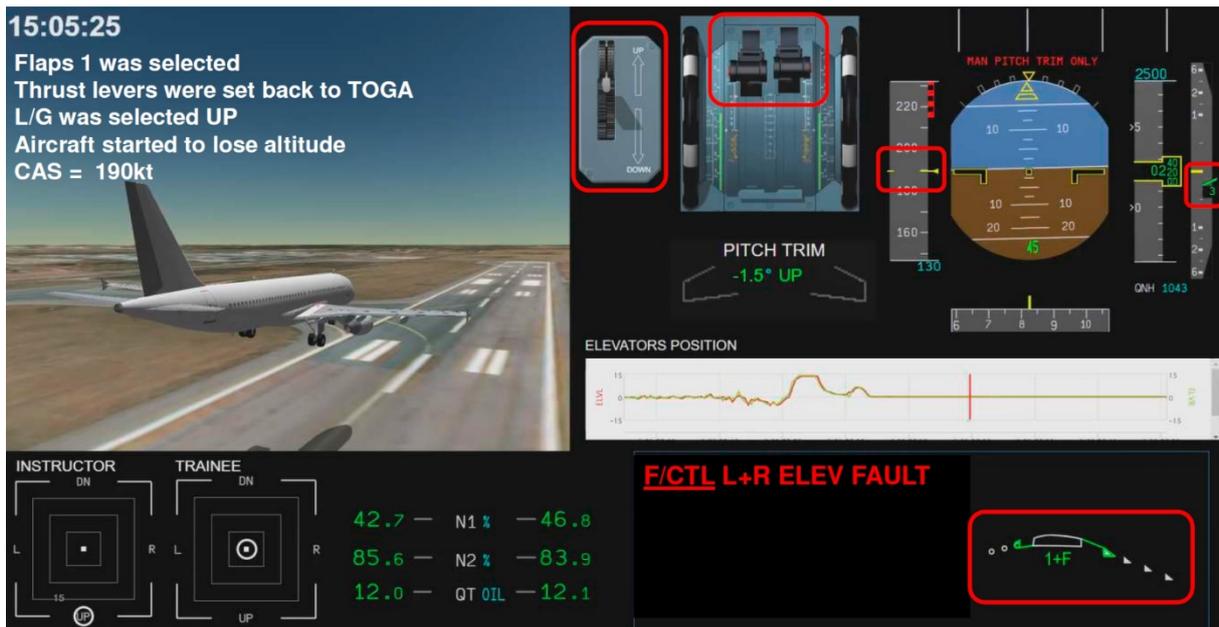
Figure 6. Cockpit inputs and indications at 15:05:25

6. At 15:05:21 the instructor commanded “gear up” and the gear lever was selected to GEAR UP position. Two seconds later the aircraft reached its maximum altitude over the runway – 48ft and started to descend. The pitch attitude was 0.3° Nose Up, THS remained in 1.5° Nose Up position, and thrust levers were set back to TOGA (Figure 6).

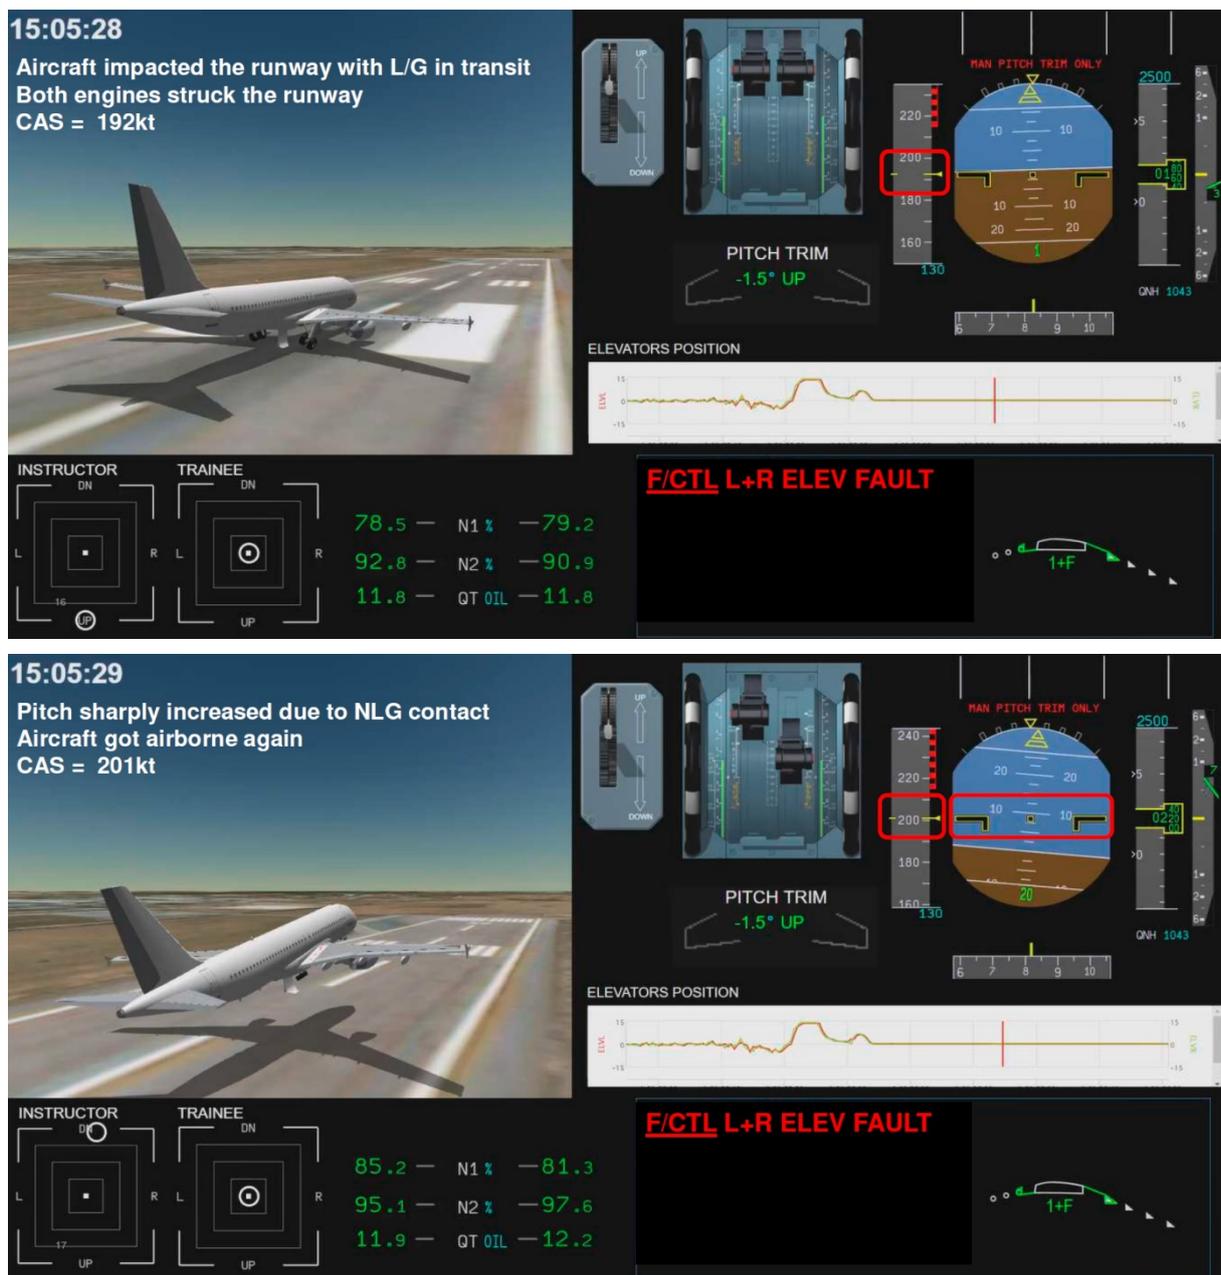
Figure 7. Cockpit inputs and indications at 15:05:28 and 15:05:29

7. While the landing gear was in transit, the aircraft hit the ground with aircraft engines approximately 200m from the end of the runway at 15:05:28 with the vertical acceleration of 2,85 g (see Figures 7 and 8). The pitch attitude was 0.7° Nose Up. The airspeed was 192 kt. Two seconds after the impact, the airspeed increased to 206 kt, the pitch attitude to 9,1° Nose Up and the aircraft started to gain altitude at 6000 ft/min.

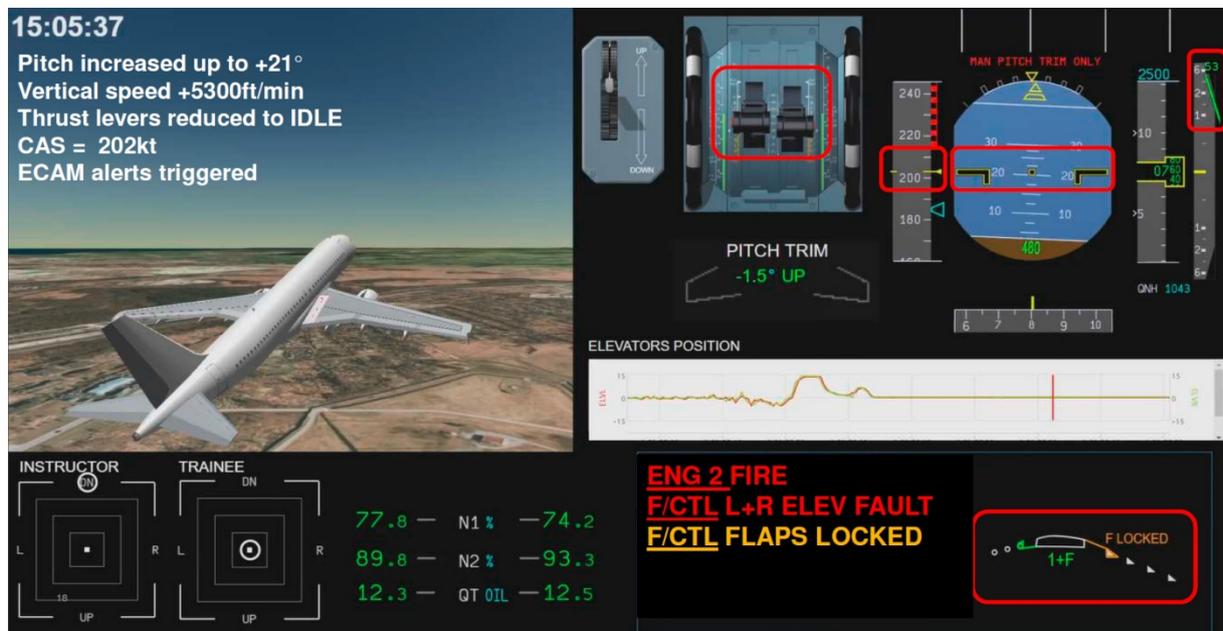
Figure 9. Cockpit inputs and indications at 15:05:28 and 15:05:37

8. Seven seconds later, a FLAPS LOCKED and an ENGINE 2 FIRE were triggered with a MASTER WARNING and audio CRC. The aircraft was at 337 ft, the airspeed was 207 kt and the pitch attitude 19.3° (reaching its maximum of 21.8° pitch up at 15:05:38) (Figure 9).

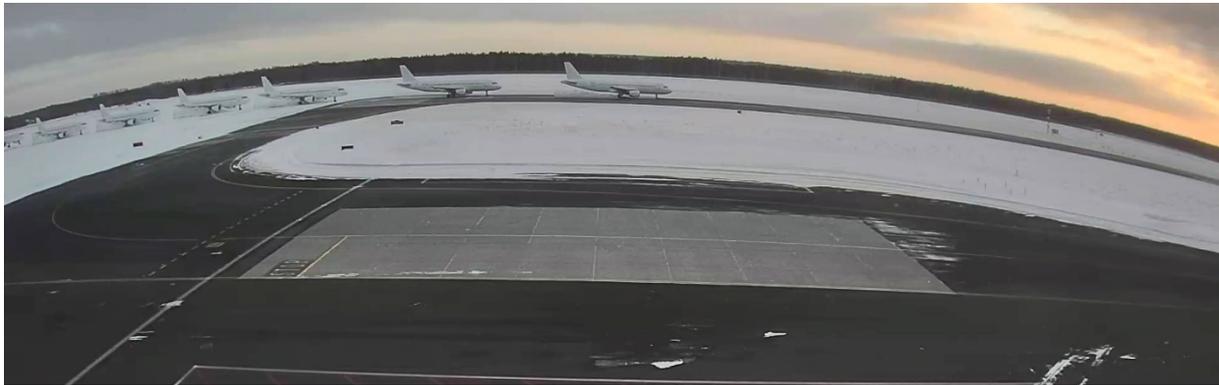
Figure 10. Aircraft touching down (screenshots from the recordings of Tallinn Airport surveillance cameras)

Approximately 15:10:12 the aircraft touched down hardly 150m before the runway threshold, burst all tires, decelerated on the runway and veered off stopping close to the left runway edge (20) (see Figures 10 and 11). During the impact, safety officer and one student suffered minor impact trauma.

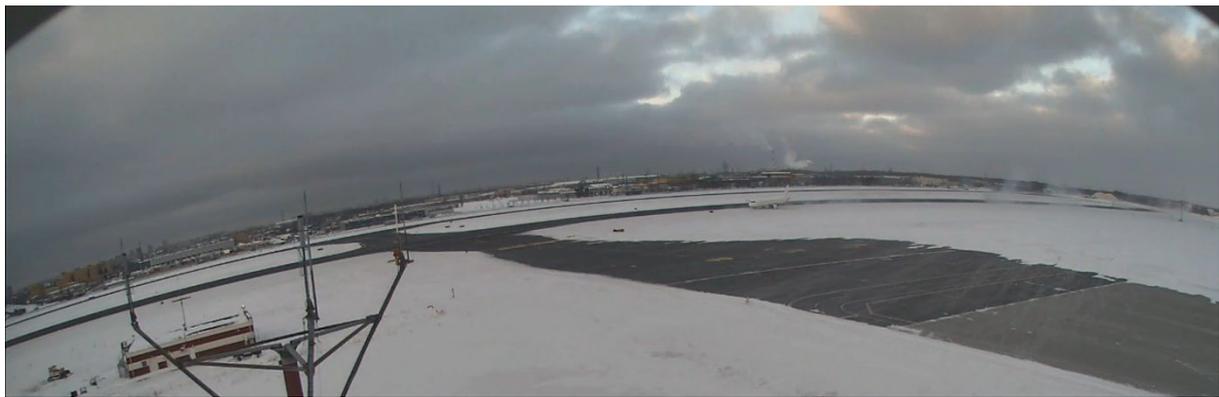
Figure 11. Aircraft position after coming to a full stop (a screenshot from the recordings of Tallinn Airport surveillance cameras)

The aircraft landing gear doors, landing gears, both engine nacelles, engines and aircraft fuselage suffered severe damage in this accident resulting in aircraft hull loss.

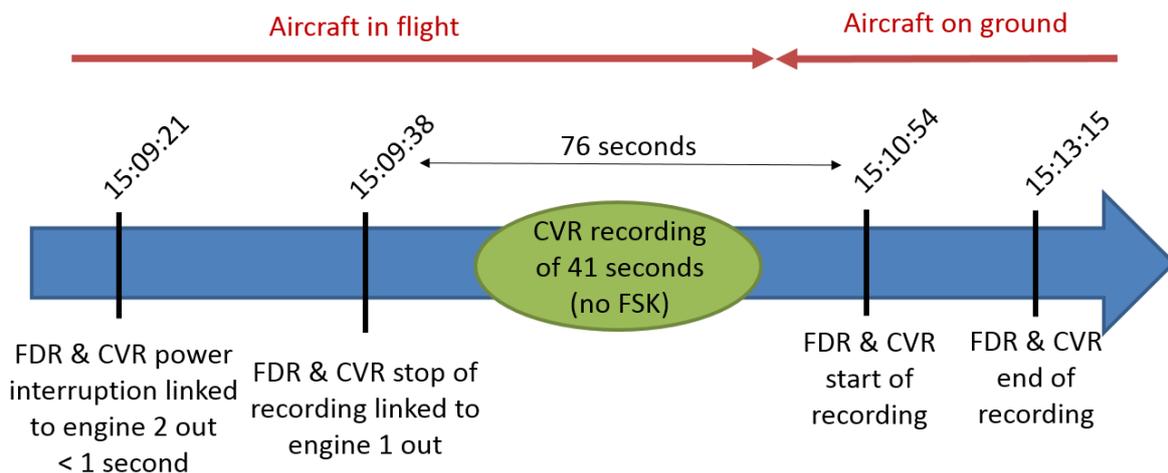
Figure 29 Power interruption of FDR and CVR

- Around 15:09:21, engine 2 spools down in flight
  - a power interruption of the FDR was observed between 15:09:21.125 and 15:09:22.124 (1 second letting the reconfiguration of the 115VAC NORM BUS from AC BUS 2 to AC BUS 1).
- Around 15:09:38 (end of FDR valid data), engine 1 spool down in flight (Figure 29),
  - a power interruption of the FDR was observed at 15:09:38.125.
  - a power interruption of the CVR was also observed at that time.

- Between 15:09:38 and 15:10:54 (76 seconds duration),
  - CVR was powered and was recording for 41 seconds, but no time signal was available (airplane in flight – FDR not powered).
- At 15:10:54 till 15:13:15 (end of data)
  - FDR and CVR were powered (airplane on ground and APU was running).

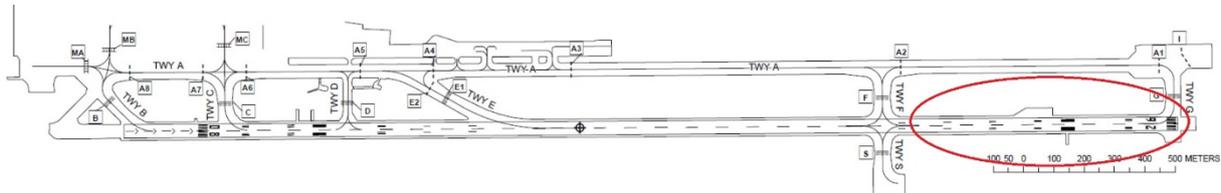
Figure 30 Runway of Tallinn Airport, debris area

The accident occurred at the end of Tallinn airport runway 08. During the take-off phase, the aircraft hit the ground with the engines and L/G doors 200m before the end of the runway, flew for 2 minutes, then turned around and landed 150m before the threshold of runway 26 and came into stop 600m from the runway threshold (Figure 30).

The debris and skid marks from the first impact and the landing were therefore mixed and covered an area approximately 900m in length and 200m in width. Some larger pieces of the landing gear doors were collected a few kilometres from the airfield.

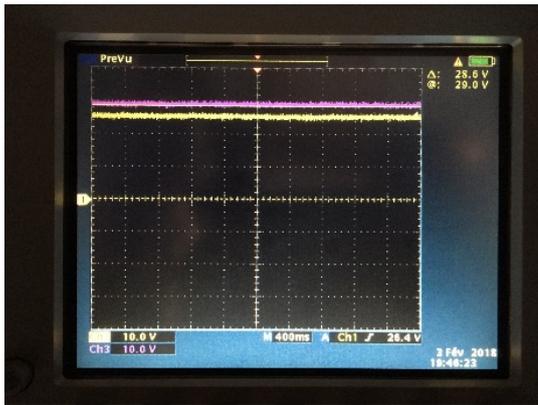
Figure 46 No signal  
(SEC active on ground setting)

Several electronic signatures coming from the PTA were observed:

- No signal – Figure 46,
- Single spike – Figure 47,
- Spike and a step – Figure 48,
- Multiple spikes – Figure 49.

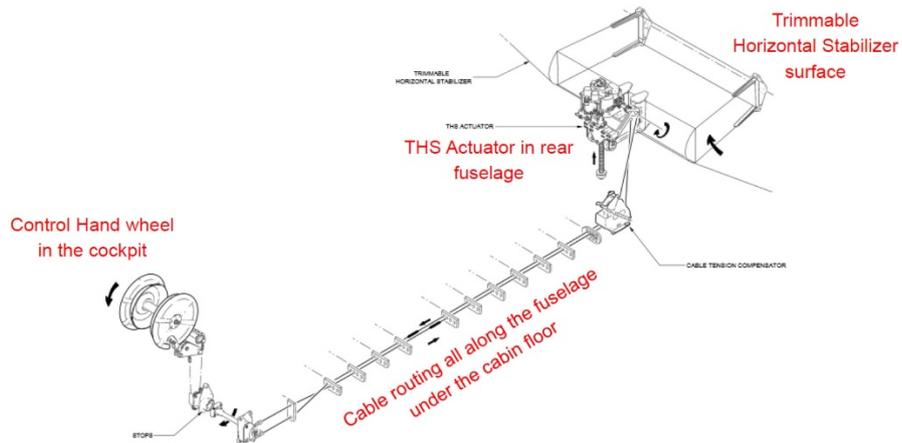
Figure 50 THSA mechanical control linkage

To rule out any mechanical linkage related sources that could contribute to the PTA signal anomalies the THS mechanical control linkage inspection was carried out. The correct routing and tensioning of the cable loop, correspondence for the trim wheel position with input THSA position and the general state of the cable-chain loop was checked (Figure 50).

No hardware (servo controls, wires and flight controls) malfunction was observed.

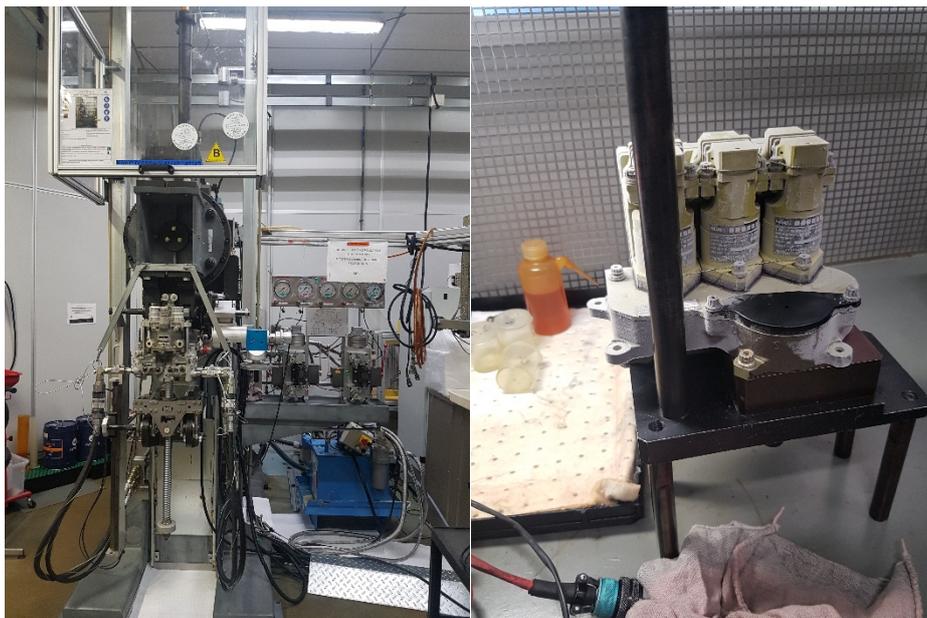
Figure 51 THSA at a test bench; PTA being chilled

Several tests of the THSA were carried out with the PTA at ambient temperature and below 0°C. During the tests, erratic triggering of the micro-switches of the PTA at ambient and cold temperature was observed on several test runs, even if the mechanical overriding function was reached (Figures 52, 53, 54).

During these erratic signal phases non-standard displacement of the OVM output piston was observed. The OVM finger stroke was not sufficient to allow the correct triggering of the PTA micro-switches.

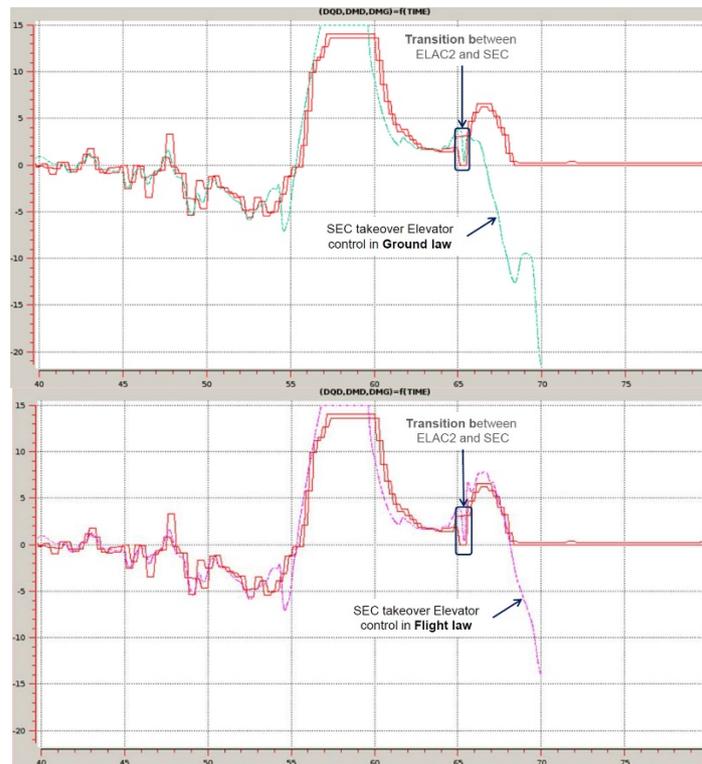
Figure 58 Spike from SEC takeover, initial opposite surface deflection in SEC flight and ground law. On the graph, red lines represent the event, green and magenta lines simulator replay

The conclusions of these two simulations are:

- During the event, SEC2 took over in Flight law (Evolution of the elevator positions of the simulation line in magenta is similar to the event up to the re-centering at 0°)
- Evolutions of the elevator positions in Flight and Ground law are different and sometimes opposite.

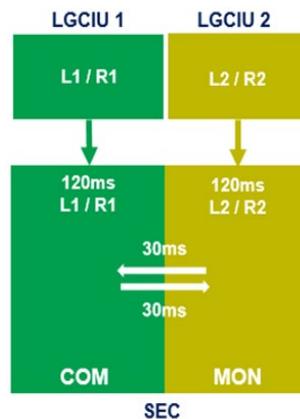
The SEC COM and MON channels as well as LGCIU1 and LGCIU2 units are by design not synchronized. Each LGCIU sends L/G information through the different channels (Figure 57) to both SECs synchronously (it is important to note that as the LGCIU units are not synchronized, although the data sets are sent synchronously, the L/G information is not synchronized). SEC COM and SEC MON received information from their respective LGCIU in every 120 ms and from the other LGCIU every 30ms (Figures 57 and 59). The ground/flight condition is computed by SEC in every 30 ms.

Figure 59 SEC logic is used to consolidate the ground or flight mode

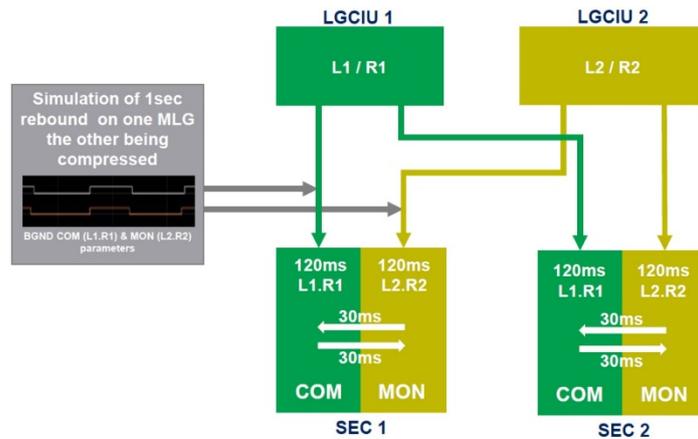
To simulate the event conditions, signals with sequences of 1s rebound were generated through LGCIU A429 input and SEC COM/MON law order was monitored (Figure 60 and 61).

Figure 60 Test set up to simulate the loss of one SEC

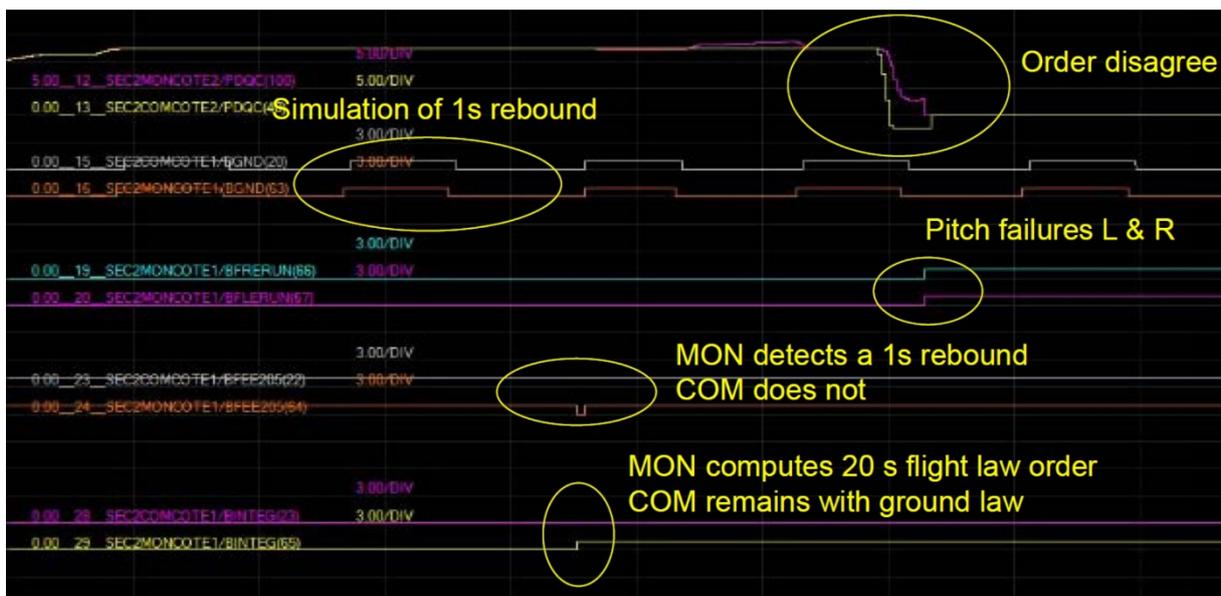
Figure 61 SEC behaviour simulation. COM remains in Ground law, MON reverts in Flight law

Loss of SEC by the discrepancy between COM and MON in the ground/flight condition was reproduced and confirmed in a simulator.

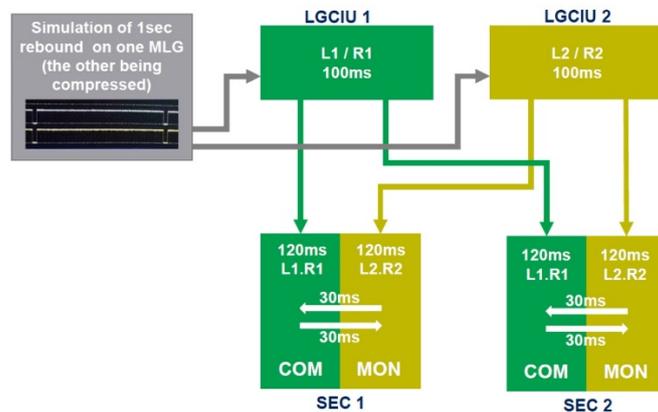
The LGCIUs and SECs were set up in order to simulate real-time asynchronism of the units. A replay of the event sequence was again simulated, by introducing 1s rebound on one MLG at LGCIUs` inputs (Figure 62), and side-stick input in SEC1, 2 and the failure of ELAC2 were simulated.

Figure 62 Simulation setup for MLG 1s rebound test

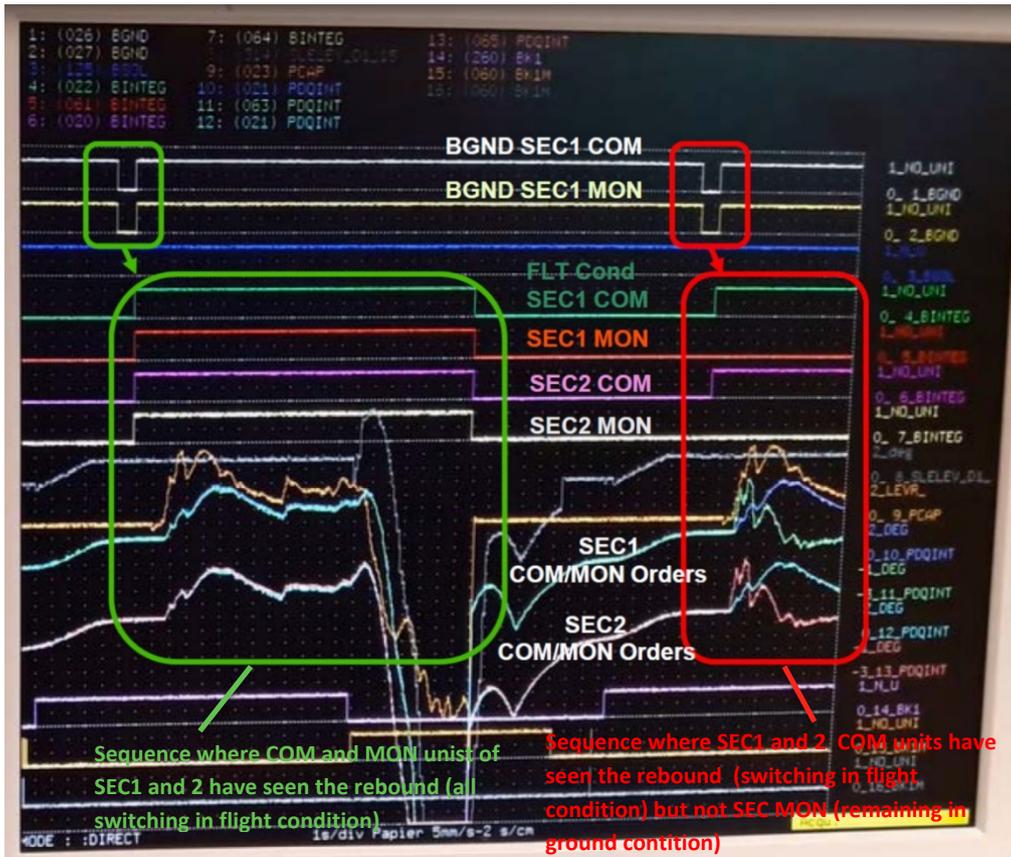
A set of simulation tests were carried out and the sequence where SEC COM initiates a flight condition and MON remains in ground condition was reproduced at several occasions (Figure 63).

Figure 63 Rebound test with two LGCIUs and SECs. SEC COM and MON seeing ground/flight condition

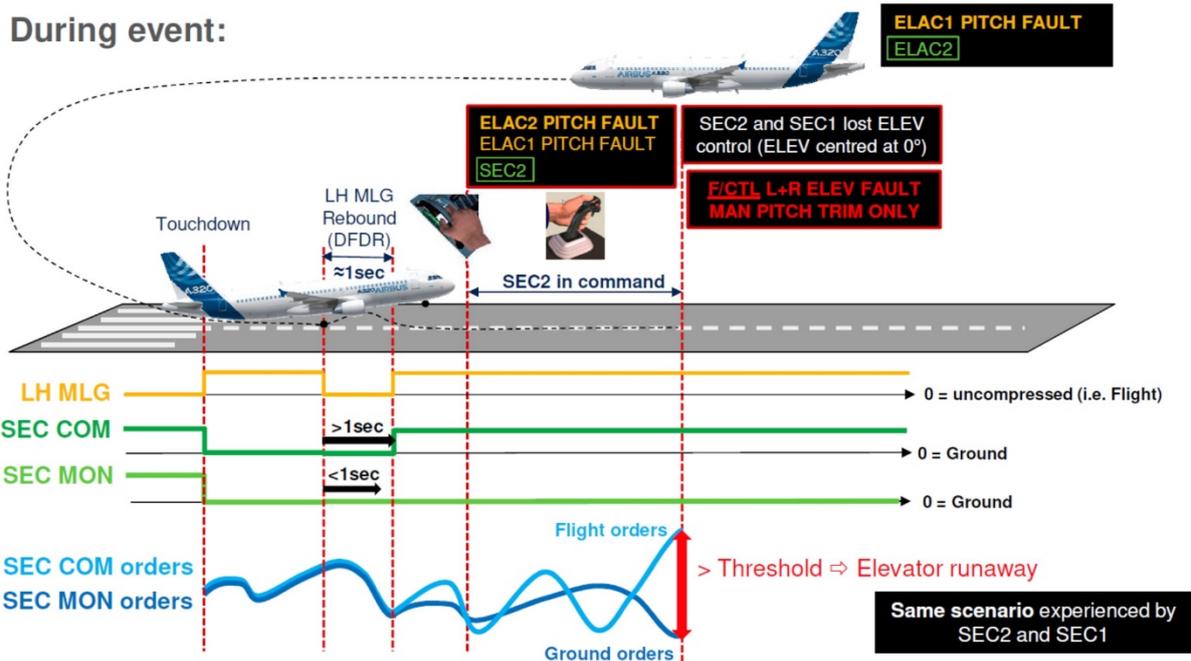
The inability to control the THS and the elevators can be explained by the short rebound of the landing gear during the event flight. As the touch-and-go training was performed without spoilers being armed, it caused the aircraft to have more lift on touchdown and contributed to having the aircraft shortly bounce on the runway. The left landing gear was decompressed during around 1 second (the sampling rate of this parameter is 1 second and do not allow to determine the exact duration – between 0 and 2 seconds) (figure 70). Due to asynchronism between SEC COM and MON lanes, and due to the update of the input parameters (gear compression), one channel can apply Flight mode flight control deflection orders (one landing gear seen decompressed for more than 1.020 seconds) whereas the other one Ground mode orders (one landing gear seen decompressed for less than 1.020 seconds).

Figure 70 Sequence of events, discrepancy in SEC COM and MON orders

This condition can only be met if the decompression lasts around 1 second. Simulations were performed on Airbus test bench, with signal monitoring and this condition could be reproduced, leading to the triggering of the SEC fault messages (SEC-MON OR WIRING TO x y ELEV SERVO VLV) linked to the spool valve runaway monitoring.

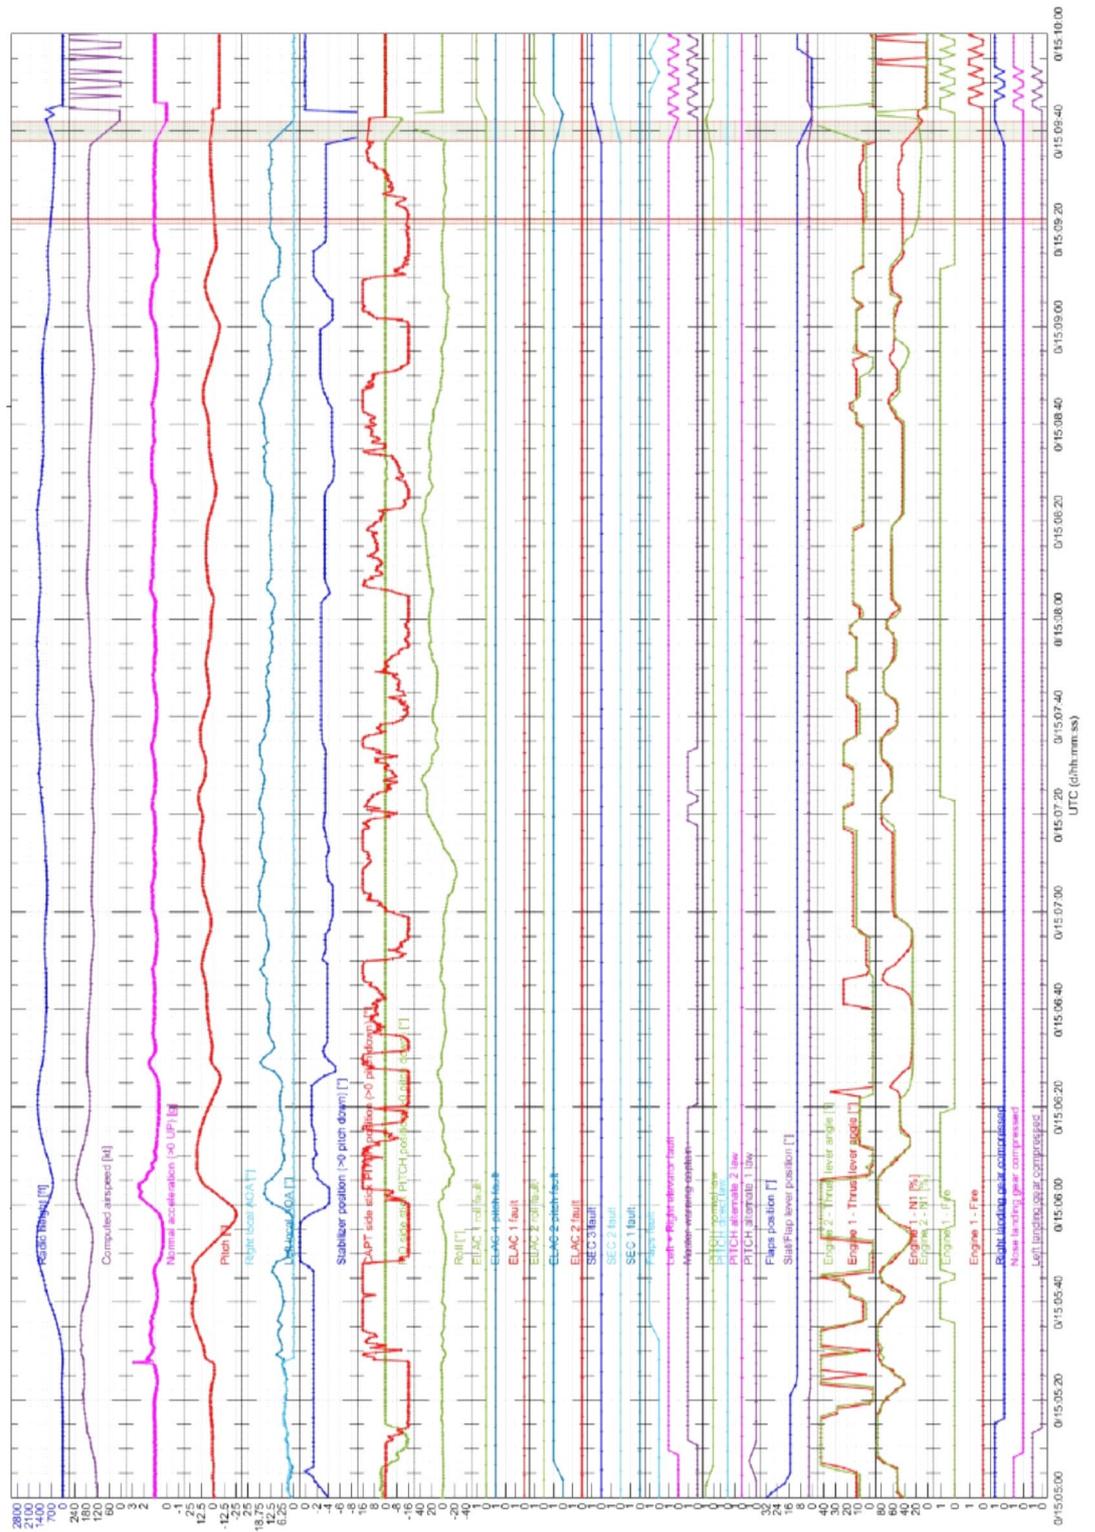
# FDR data, event flight

During the event (see Appendix 1), the left landing gear was decompressed during around 1 second (the sampling rate of the parameter is 1 second and does not allow to determine the exact duration – between 0 and 2 seconds), before the aircraft was firmly on the ground (3 landing gears recorded compressed).
