CASUALTY REPORT

August 18, 2003
Case 199927017

Collision on 12 August 2002 between the Danish fishing vessel EATON and the Finnish cargo vessel FINNMERCHANT

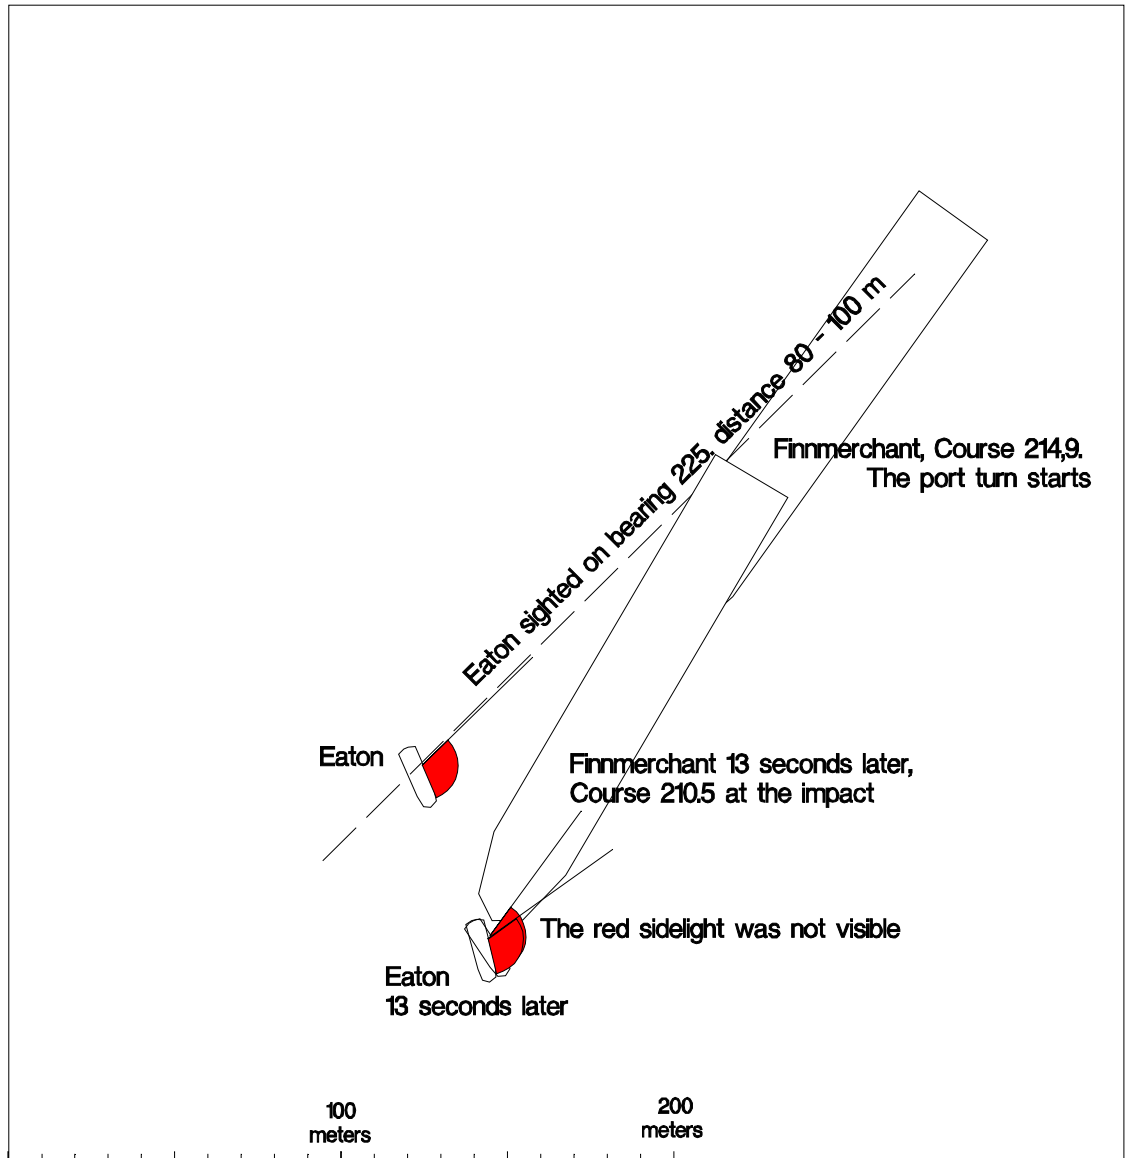
Reconstruction no. 3

Approx 0304: The 2nd officer on FINNMERCHANT observed on radar that EATON altered course to starboard. The echo on the radar was soon after lost.

The main contact between the vessels was on FINNMERCHANT's port bow and EATON got damages in port side.
