## Investigation report

B 6/2004 M

# Ms SUPERFAST VIII, Fall of an MOB boat to the sea in a drill in Hanko West Port on 9.11.2004

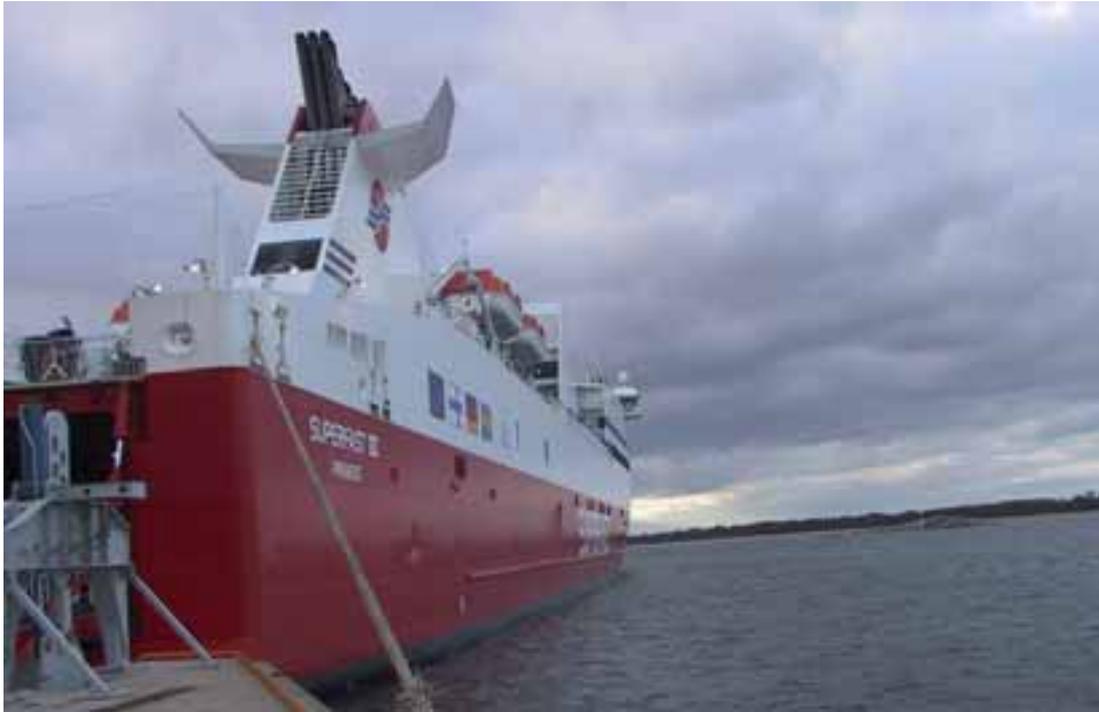
Figure 1. *The M/S SUPERFAST VIII. The boat involved in the accident was behind the bridge slightly fore from midships.*

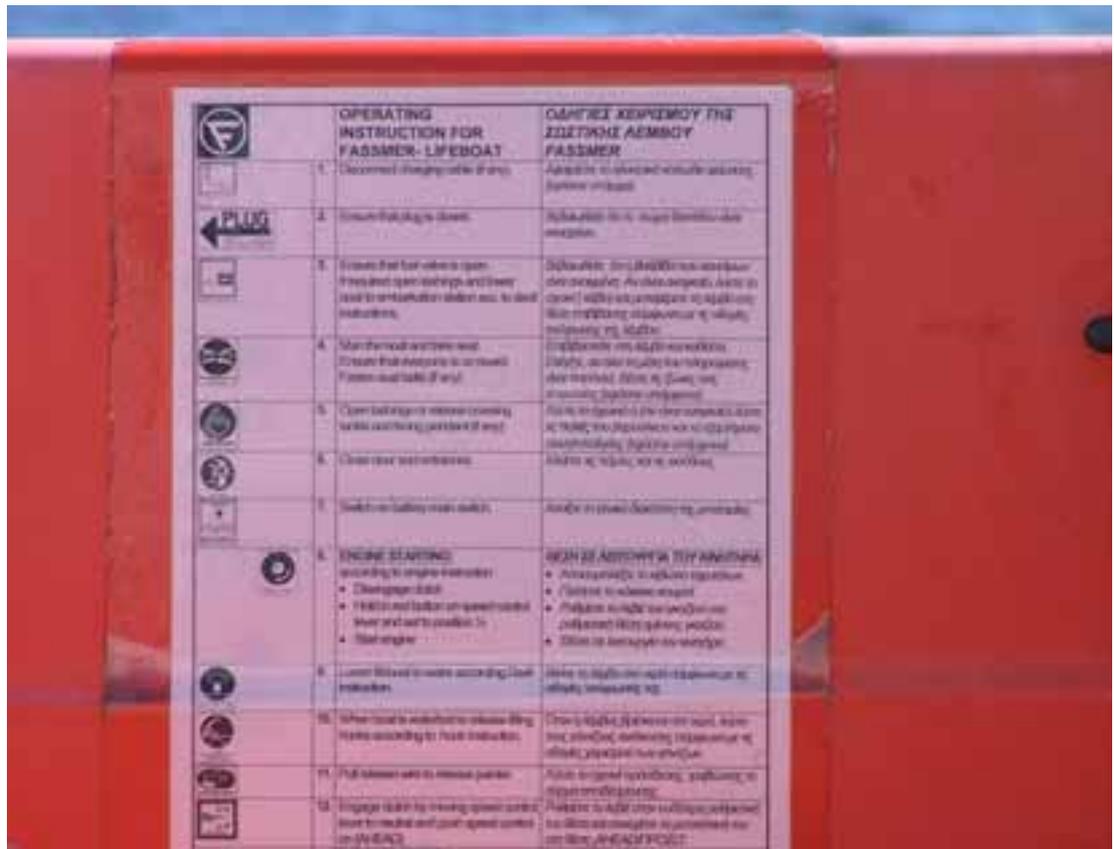
Figure 5.

The boat had the stage-wise operating instruction of the manufacturer with figure symbols. The instruction instructed to release the hook of the lowered boat according to hook instructions. See figure 5 below.
