Investigation Report

C2/2007M

MS CLAUDIA, grounding off Tornio on 23.10.2007

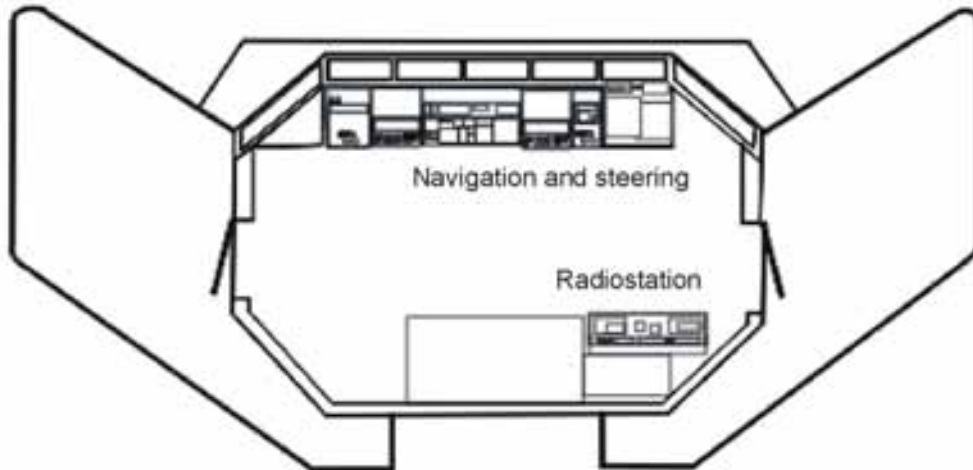
Figure 2. The bridge design of M/S CLAUDIA follows the 1973 plan of the German Sietas shipyard. The bridge arrangement sketch is based on the photos taken by the Accident Investigation Board.

The photo of the CLAUDIA (Figure 1) shows that the bridge construction is based on the German J.J. Sietas shipyard's design "Optimale Brücke" from 1973. Optimale Brücke became very popular, and it can be regarded as the starting point of modern bridge design. The leading idea was the cooperation of two persons, which was carried out in such a manner that two places of work were as close to each other as possible. The manoeuvring equipment was located between these persons and both of them had their own radar displays. The manoeuvring and navigation console was located backwards from the front wall so that display equipment could be protected from sunlight. This made it possible to install the most important manoeuvring and engine indicators above the front windows, directly under the ceiling.

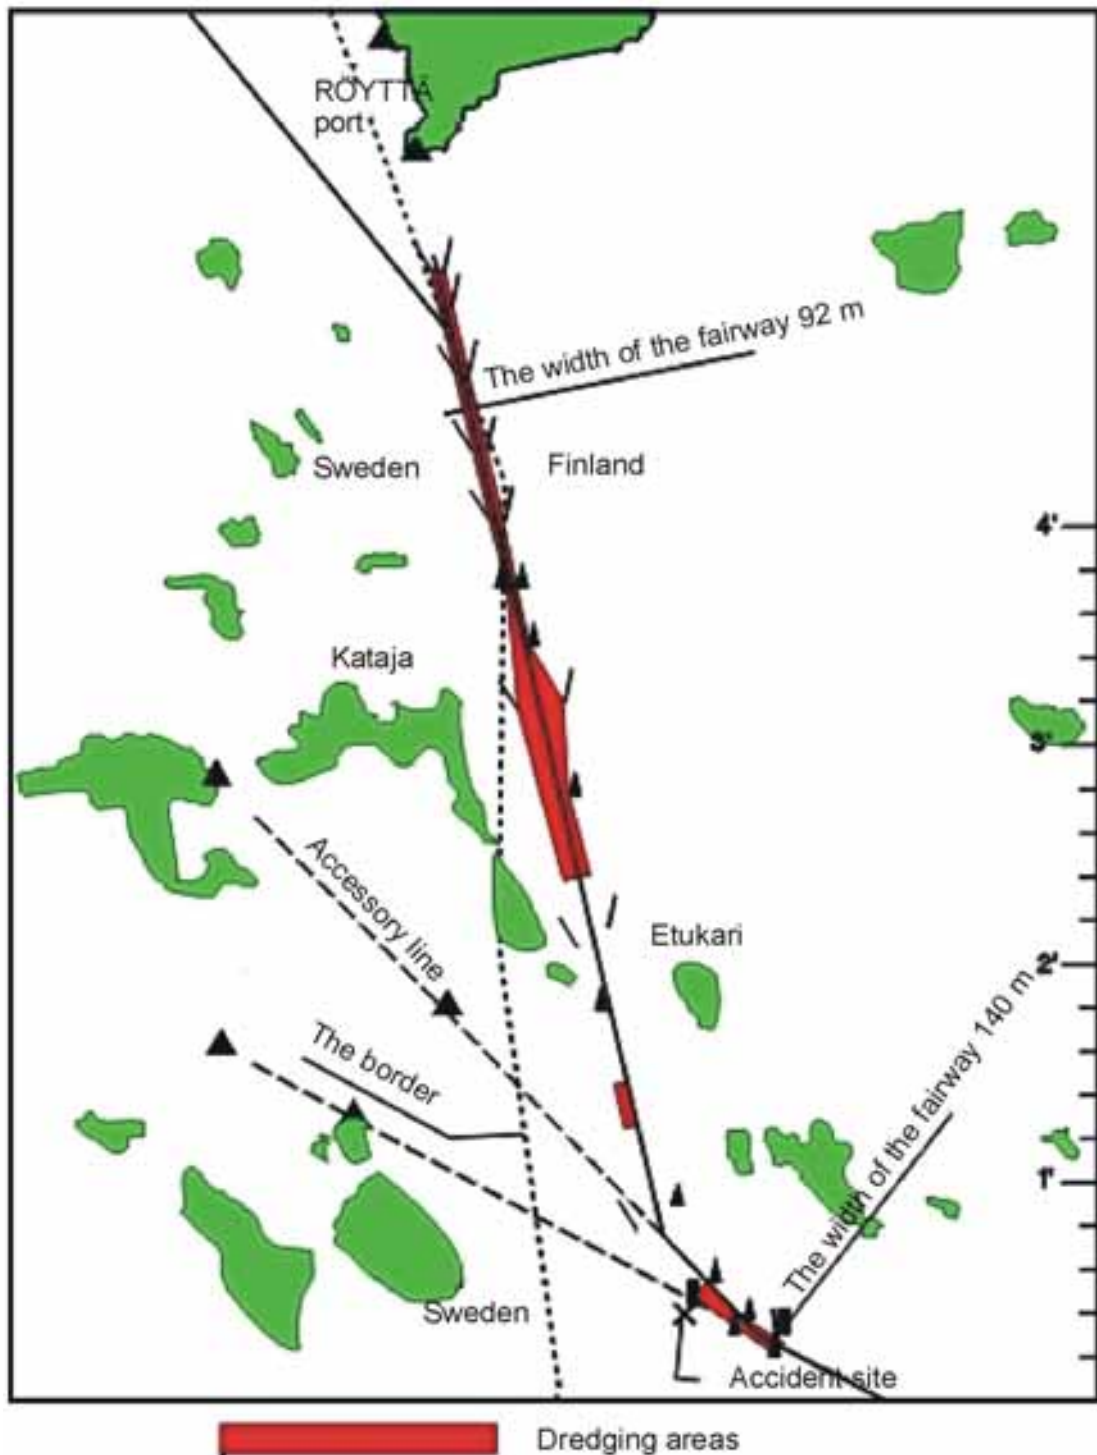
Figure 4. Dredging operations in the Røyttä fairway. The chart data and the dredging areas are copied from the Finnish Maritime Administration notices.

An eight-metre-deep fairway leading to the Røyttä harbour in Tornio parted from the ten-metre-deep Ajos fairway. After the dredging operations were completed, the draught was 9.0 metres. The distance from the crossing to Røyttä was 13 nautical miles. There

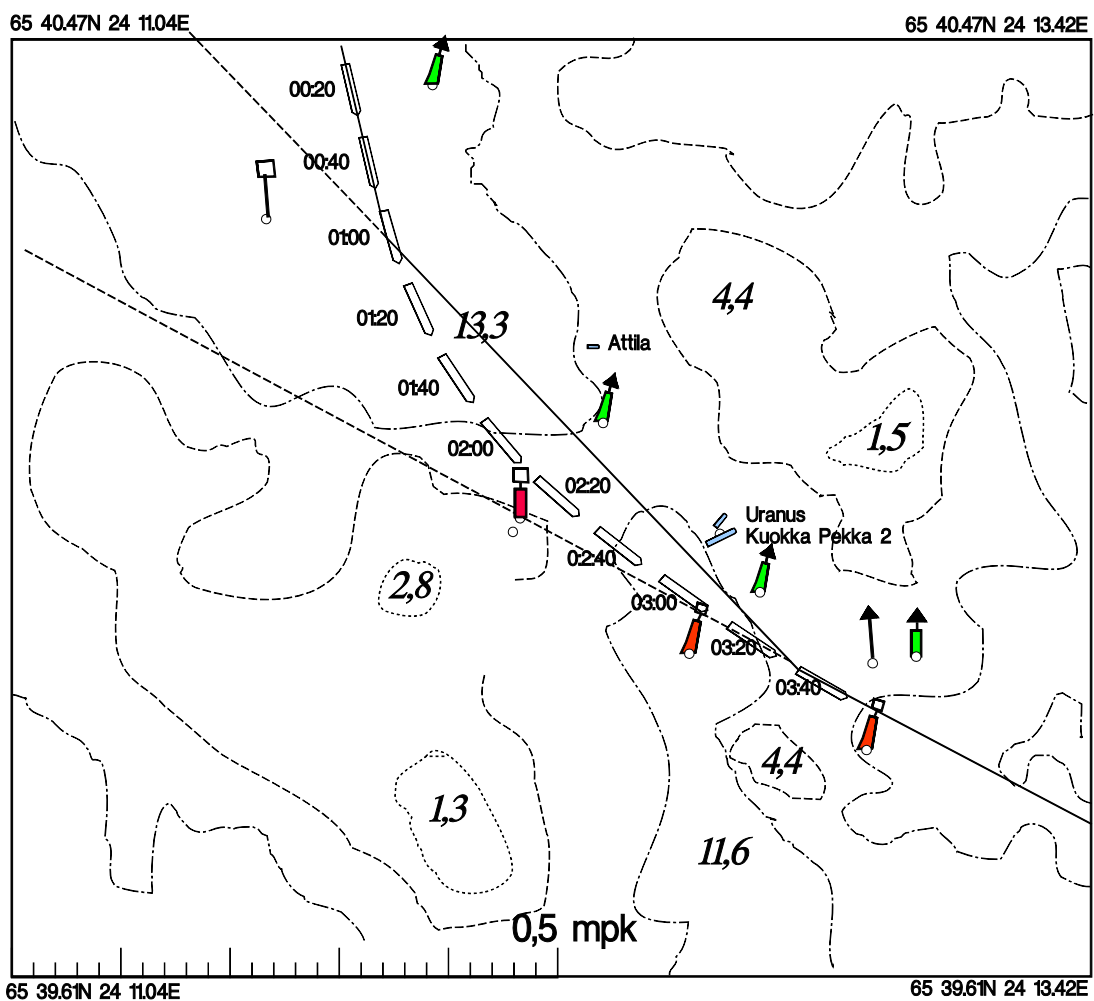
The normal turn described by the pilot was simulated on a working station simulator (Figure 11 and Table 4). The simulated turn was started at 00:32 when the stern of the vessel was approximately at the green buoy. The turn started with a helm angle of 8° (Table 4). The rudder angles were small during the whole turn. Wind affected the manoeuvring in the same way as in the accident situation. If the weather had been calm, the rudder angles would have been even smaller.

Figure 11. The turn described by the pilot was studied with the help of simulation. The times have been measured by the simulator clock starting from the starting moment.

The change of course is 47° from the line 167° to the line 120°. The turn ends at 03:50. The mean value of the angular velocity in the simulations is 13.74°/min to port. The mean value of the speed is 12.63 knots. ($R \approx 0,955 \times (V / \psi)$, V = the speed in knots, ψ = angular velocity ° / minute). The approximate value of the bend radius is 0.88'. The middle part of the bend as measured from the chart is an even arc of 0.61' (Figure 12). The sharper the turn, the shorter the even bend part of the turn. As to manoeuvring, gentle bends are the easiest ones to control.

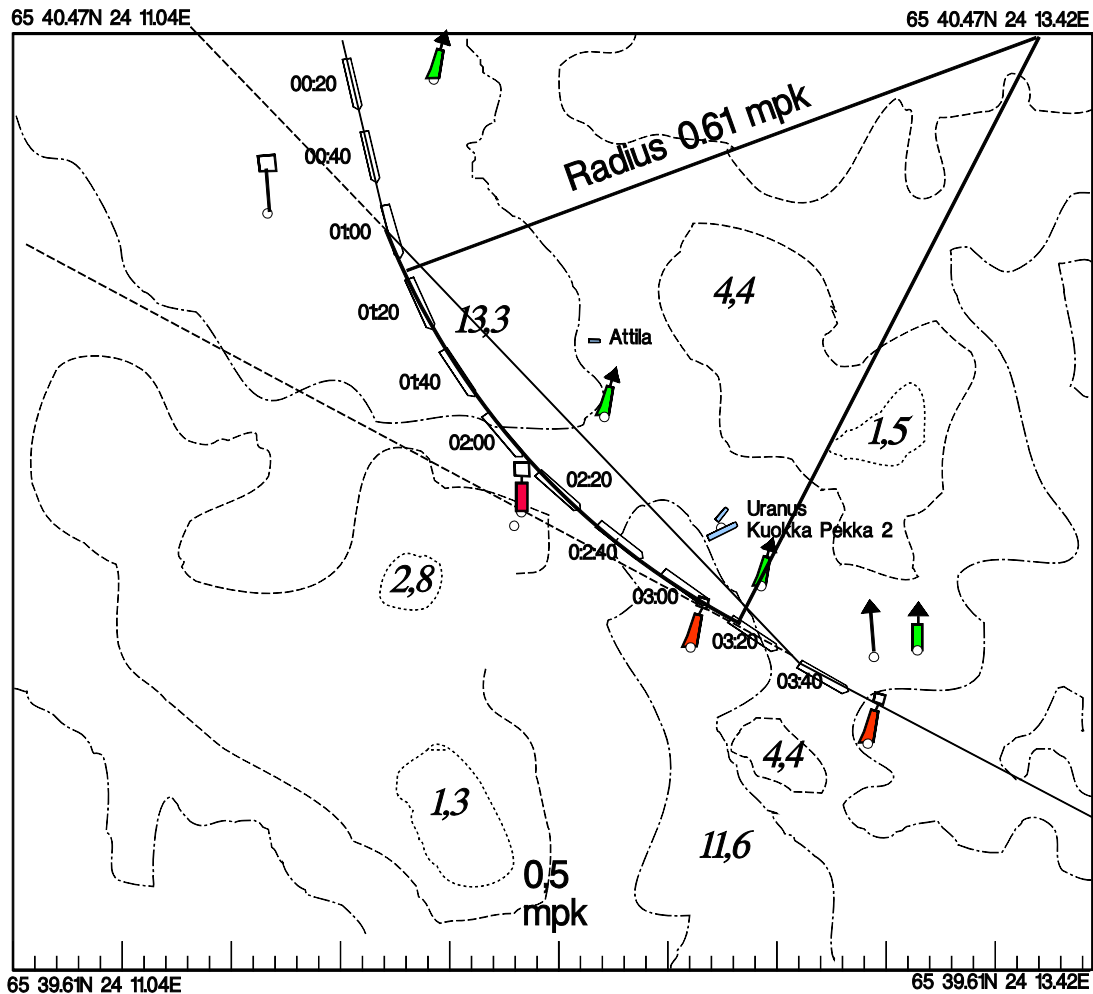
Figure 12. When measured from the chart, the even bend part is 0.61' nautical miles. At first the bend is gentle, then it stabilizes at the middle part of the bend, and becomes gentler again in the end.

The track describes how the vessel enters the narrow passage with an almost steady heading. This is the objective of piloting.

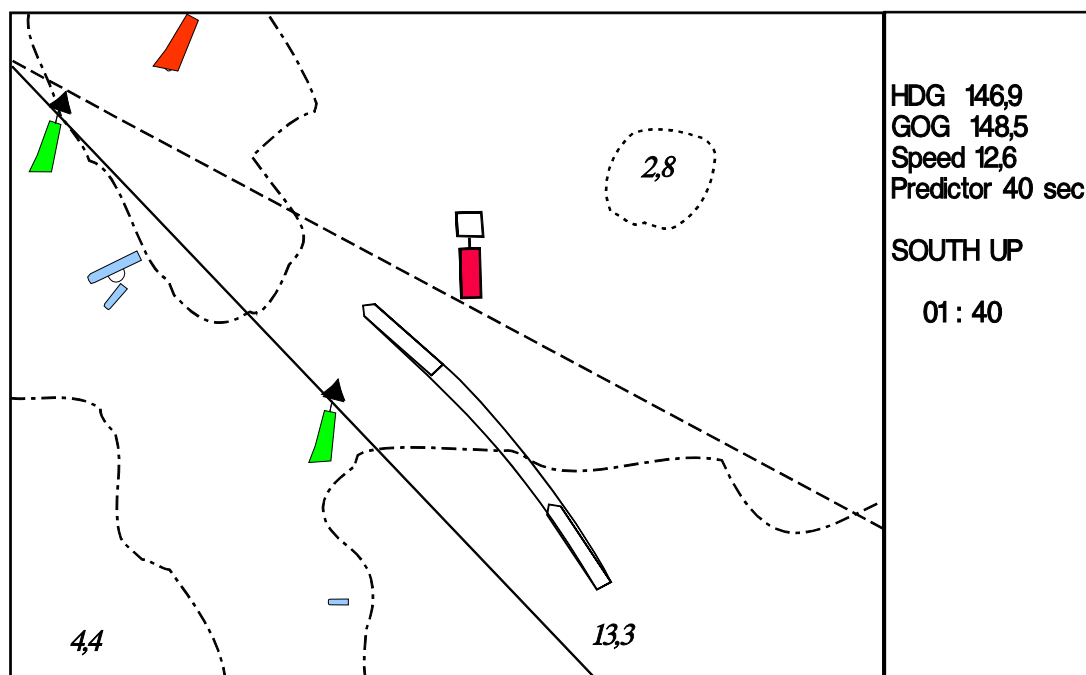
Figure 15. An example of an electronic chartplotter with its predictors; the most important numerical information on the right side of the picture. The chart is in this case turned "south up" so that it would better correspond with the visual view.

Figure 15 corresponds to the simulated situation in Figure 11 in accordance with the time 01:40.

A momentary bend radius, the length of which is 40 seconds, has been drawn on the chartplotter. The prediction presents the same motion of the vessel, which the pilot has always interpreted with the help of the fixed objects seen in the window and the field of vision. According to Figure 15, it is not necessary to change the rudder angle at 01:40. The chartplotter does not take into account the sea clutter of the radar or the dazzling effect of the floodlights.
