Investigation Report

B1/2008M

M/S TALI, grounding in Jössingfjord, Norway, on 29.1.2008

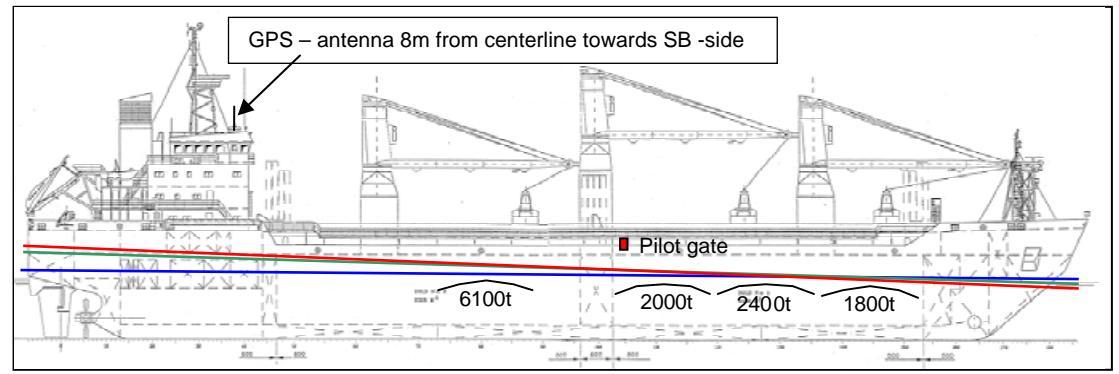
Figure 2. Overall view of M/S TALI. The following have been added to the figure: water lines when the vessel left Jössingfjord (blue), the equilibrium position which resulted from pumping (green) and the position of damage stability calculations¹ when the engine room was full of water (red). The place of the starboard-side pilot gate has also been marked in the picture. It took about 1½ minutes to walk from the pilot gate to the bridge². Moreover; the cargo distribution is shown according to the cargo plan. The loading took place in four stages.

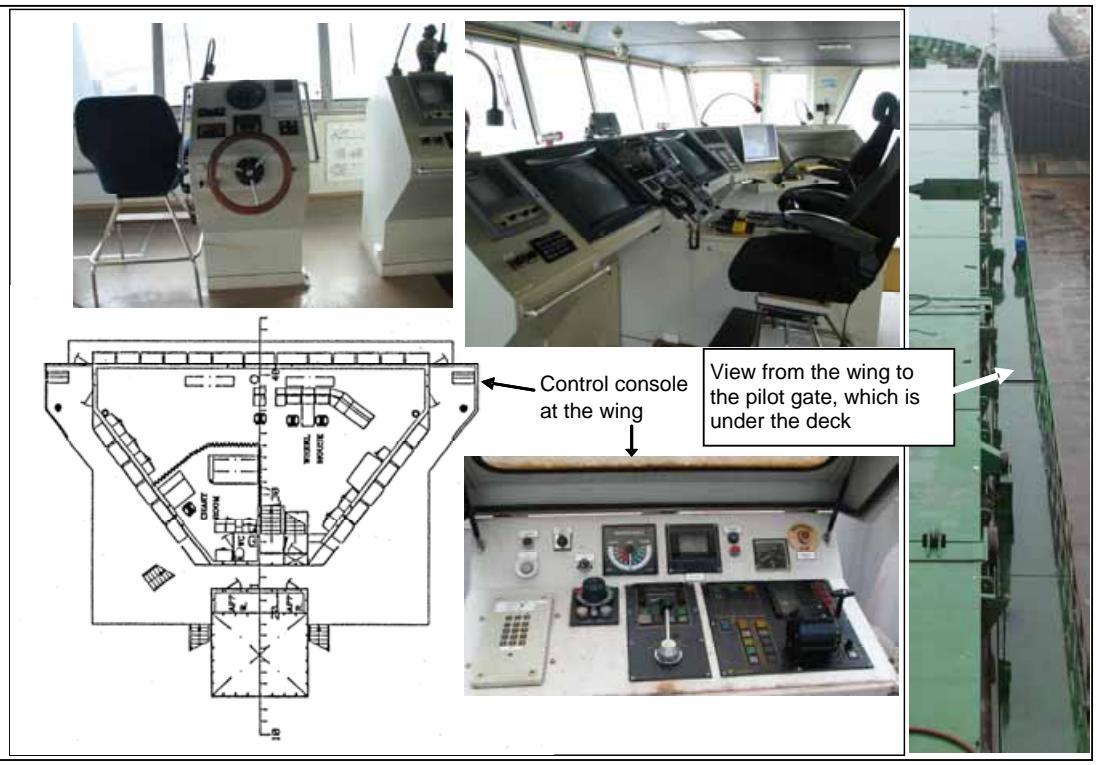
Figure 3. M/S TALI's bridge. The picture on the right shows the view from the manoeuvring place on the wing to the pilot gate.

An extra 25–30-degree turn to 324 degrees had happened because the Master did not have reference of the turning movement due to poor visibility and because he was not at his normal manoeuvring place where he would have noticed the turn on the radar. At the manoeuvring place on the wing there are only control devices for the main engine and the bow thruster, not information received from navigational or position plotting instruments. The visibility from the manoeuvring place is reduced by a folding console cover (Figure 3).

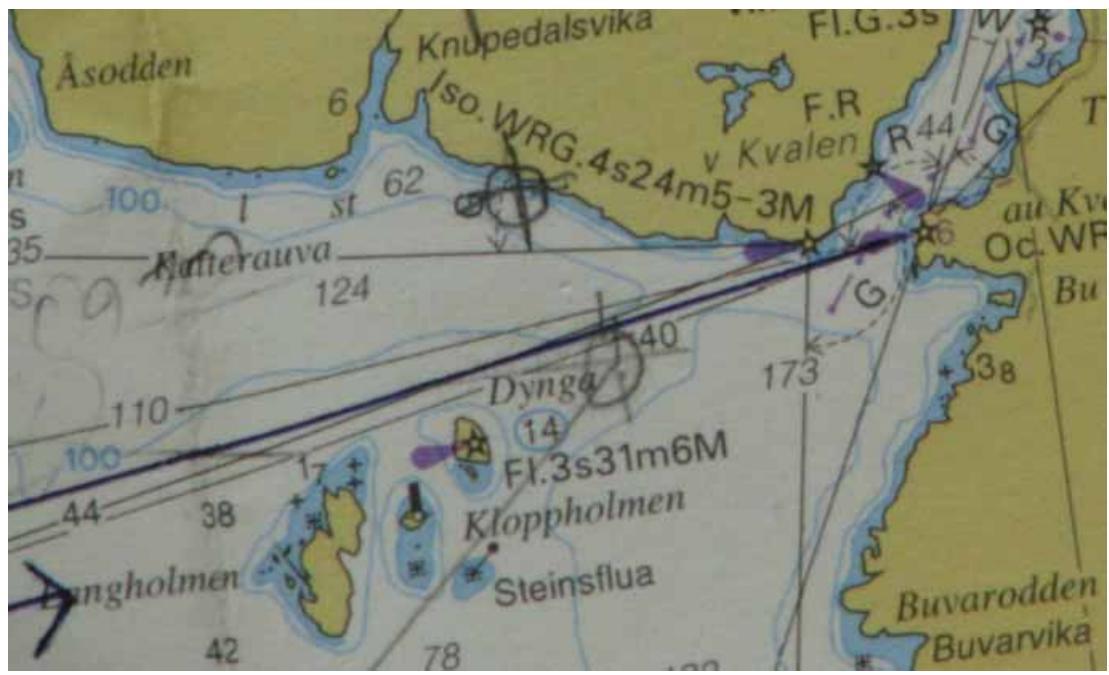
Figure 9. The location of the grounding marked on the vessel's nautical chart.

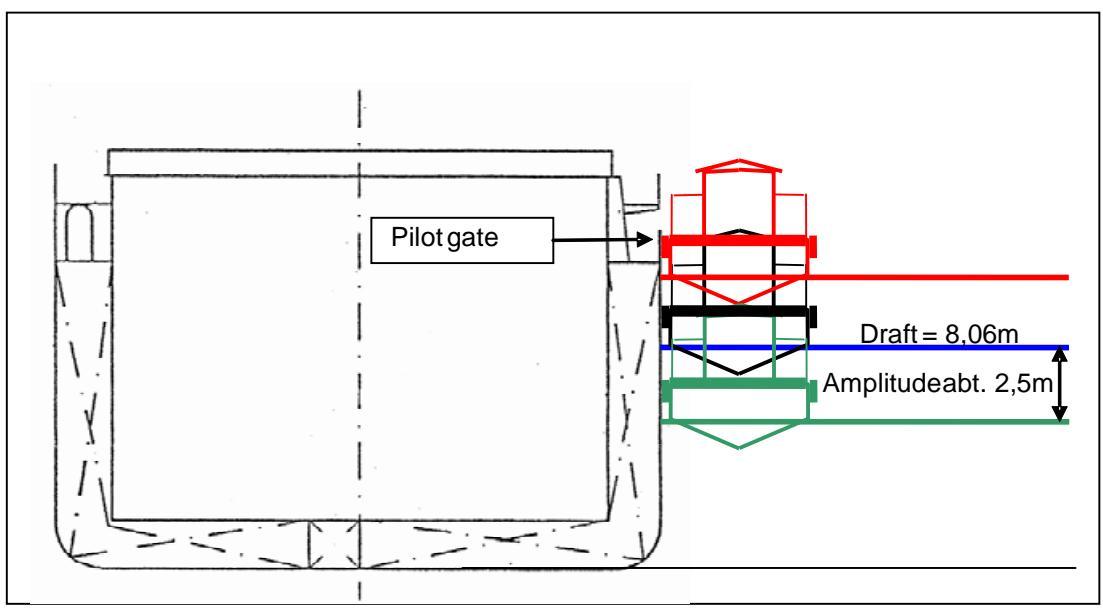
The officer reported on channel 15 that the pilot was ready to board the pilot vessel. The pilot vessel was at the side of M/S TALI, but she moved up and down because of the high sea, and thus the pilot was not able to board the pilot vessel. Several attempts were made, but the pilot vessel was heaving too much (Figure 11). The pilot noticed that M/S TALI had turned more towards the shore. He then ordered the officer to notify the bridge that the vessel had to be turned to port. The Master had then already started a turn hard to port because he had noticed that the distance to the shore was decreasing too much. The Master ran the main engine on "full astern" for some time. The pilot soon noticed that the vessel did not turn and hurried to the bridge. As he was climbing the stairs located at the stern of the vessel, he felt that the vessel's bow thruster was being used. When the pilot came to the bridge at 09:15¹⁵, the stern of the vessel hit the ground.

Figure 11. The pilot vessel's movements at the side of the M/S TALI. The thick line indicates the level onto which the pilot should have jumped.

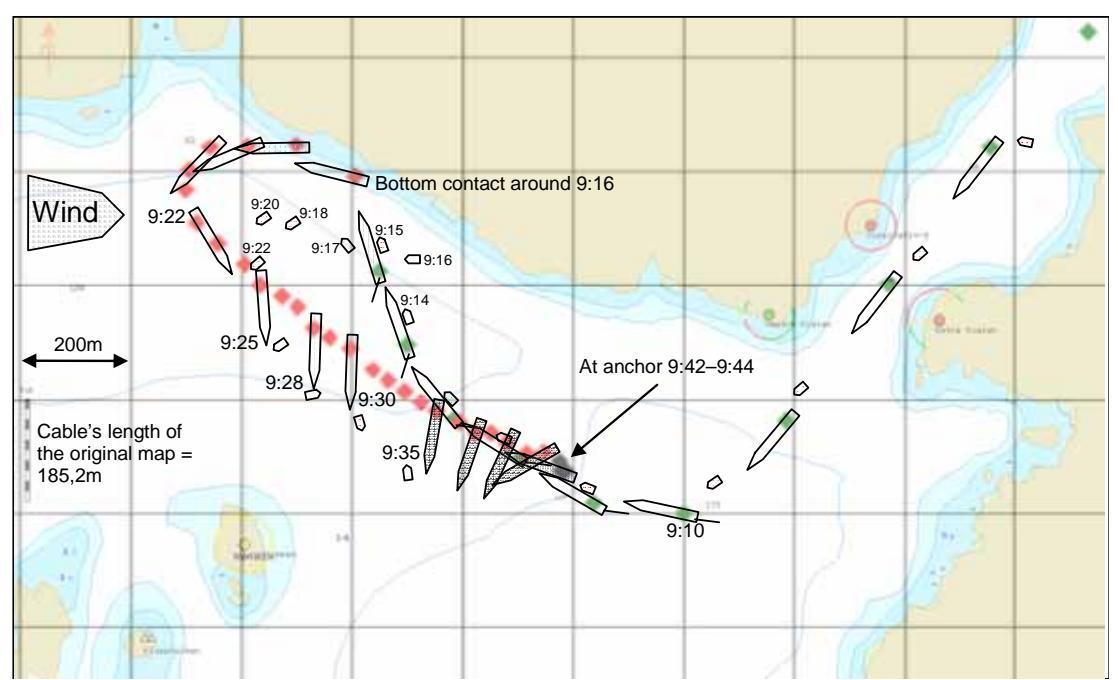
Figure 12. The movements of M/S TALI and pilot vessel. The dots indicating M/S TALI are according to the GPS with one minute's intervals 9:06–9:44. The GPS antenna was on the vessel's starboard side on the roof of the superstructure, approximately 25 metres from the stern of the vessel (the centre of a green or red dot). Depths less than 10 metres are marked with dark blue colour. The vessel anchored at the position indicated with black dots at 9:42–9:44. The green dots indicate the situation before, red ones after the grounding and black ones at anchor. The position of the rudder has also been sketched for the time interval 09:10–09:15. The vessel marked with a darker colour has lowered the anchor. Even after 9:35, the pilot vessel stayed close to the M/S TALI

It has been assessed based on Figure 12 that the stern of the vessel had, when turning and proceeding forwards, hit a rock or a hillock sideways. Apparently the bottom was uneven or rocky, and M/S TALI hit one or several protuberances while the stern of the

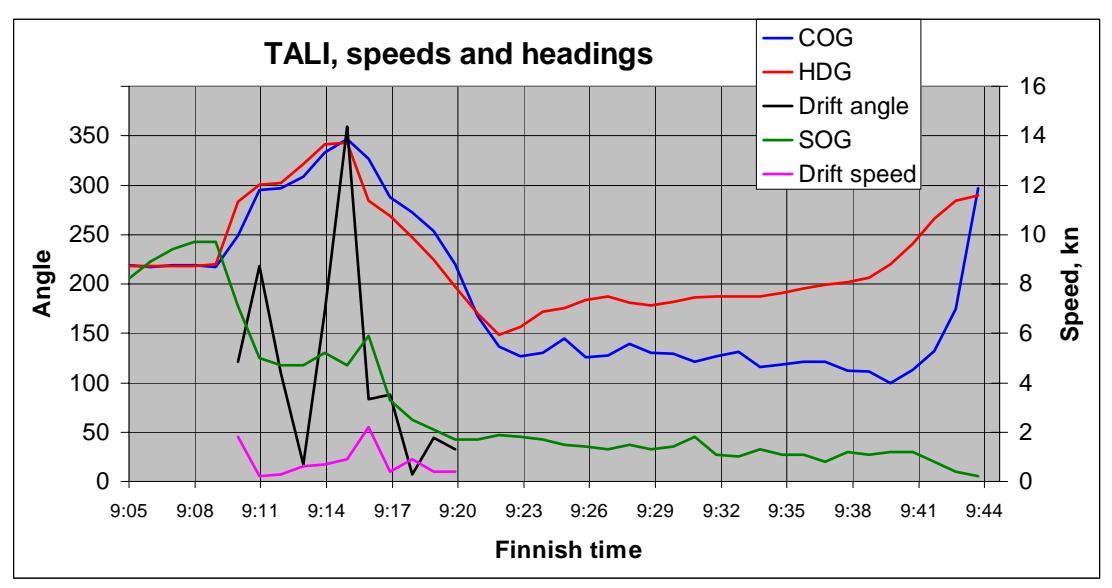
Figure 16. The vessel's speeds and headings at the time of the accident. Drift data is not accurate.

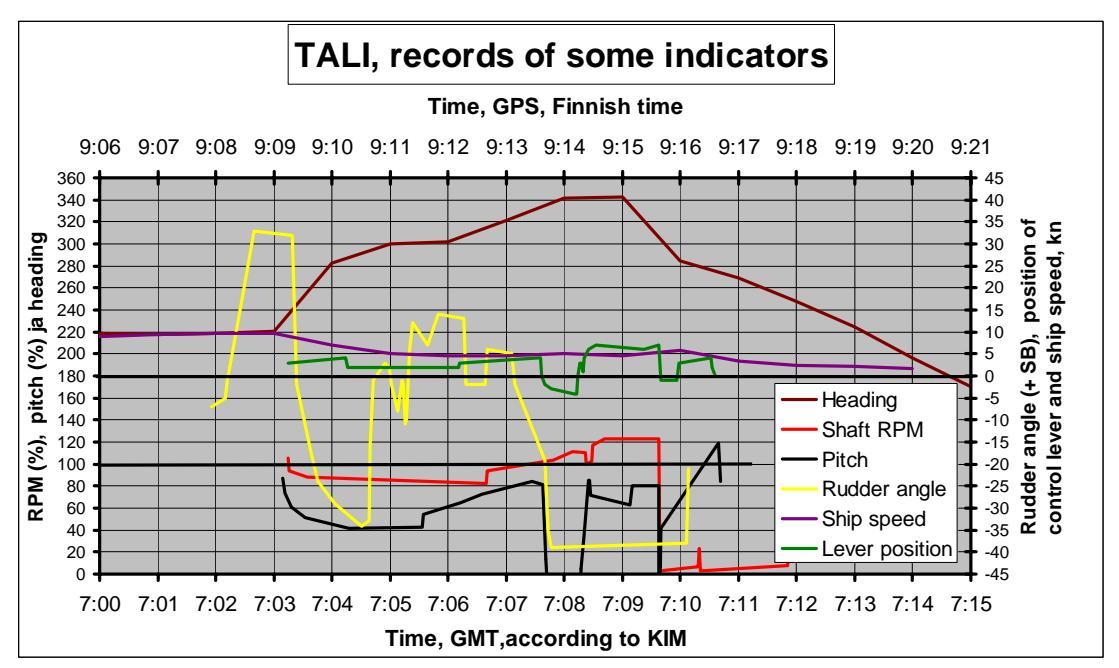
Figure 17. Registrations made by the KIM equipment at the time of the accident. Propeller revolutions in per cent (100% corresponds with the main engine revolutions 450 1/min). Here the time difference has been estimated to six minutes. The speed has been obtained from the GPS registration. At 9:09 the vessel turns away from the fiord. At 9:10–9:11 the course is stabilised at 300 degrees. At 9:11–9:13 more shelter from the wind, the vessel turns further. The turning of the rudder to port begins at 9:13. The rudder hard to port at 9:14–9:16.

According to what the Master remembers, he ended up making better lee by using the helm order "five to starboard". The synchronised²⁸ recording from the KIM recorder shows that three minutes before the helm order in question was given, the rudder had been more than 10 degrees to starboard for several minutes, then midships for a short time, and after that 5 degrees to starboard for half a minute. The vessel had then turned to course 324. After the Master had noticed that the vessel was approaching the shore in an alarming way, he ordered "hard to port" and switched on the bow thruster after that. The Master let the engine run "full astern" for about ½ minute at about 9:14 (Figure 17, the position of the lever, the green curve). Because of the vessel's inertia and the effects of the wind and the swell of the sea, the vessel turned to course 343 before it started to turn towards port. At that point the vessel had already come very close to the shore. It took about two minutes from the moment the rudder started to turn "hard to port" for the vessel to begin the turning. After the turn had started, the stern of the vessel moved even closer to the shore. At the same time the vertical movements of the vessel contributed to its stern hitting the ground.

Two time scales have been presented in Figure 17. KIM follows UTC time, and the upper scale represents Finnish winter time (UTC+2). The KIM time seems to be 5½–6 minutes behind. In the figure, six minutes has been chosen as the difference. The difference in time has been deduced from the grounding taking place just before 9:16. The vessel was turning to port, the heading-angle started to decrease. At the same time the curves for the pitch and revolutions fall sharply. The rudder angle changes abruptly a little bit later.

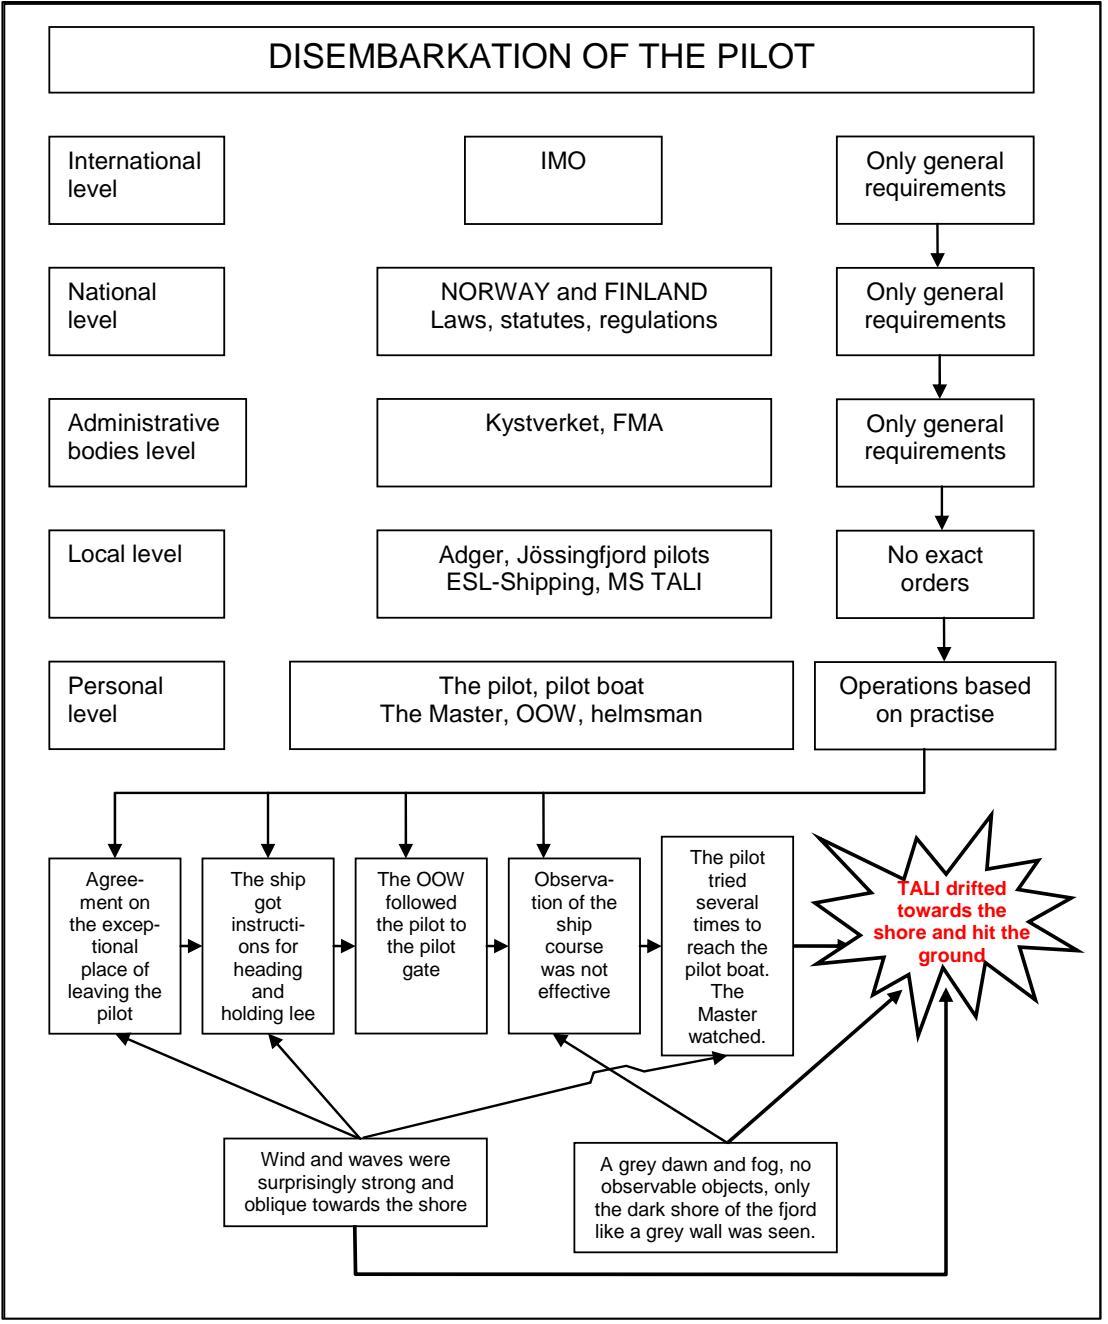
The factors affecting the accident viewed with reference to the disembarkation of the pilot have been compiled in the following figure 18.

Figure 18. ACCIMAP scheme describing the accident. The disembarkation of the pilot.
