Investigation report

C5/2008M

F/V HENDRIK SENIOR and M/S BIRKA EXPORTER, Collision in International Waters 17 NM off the Netherlands, on 8.12.2008

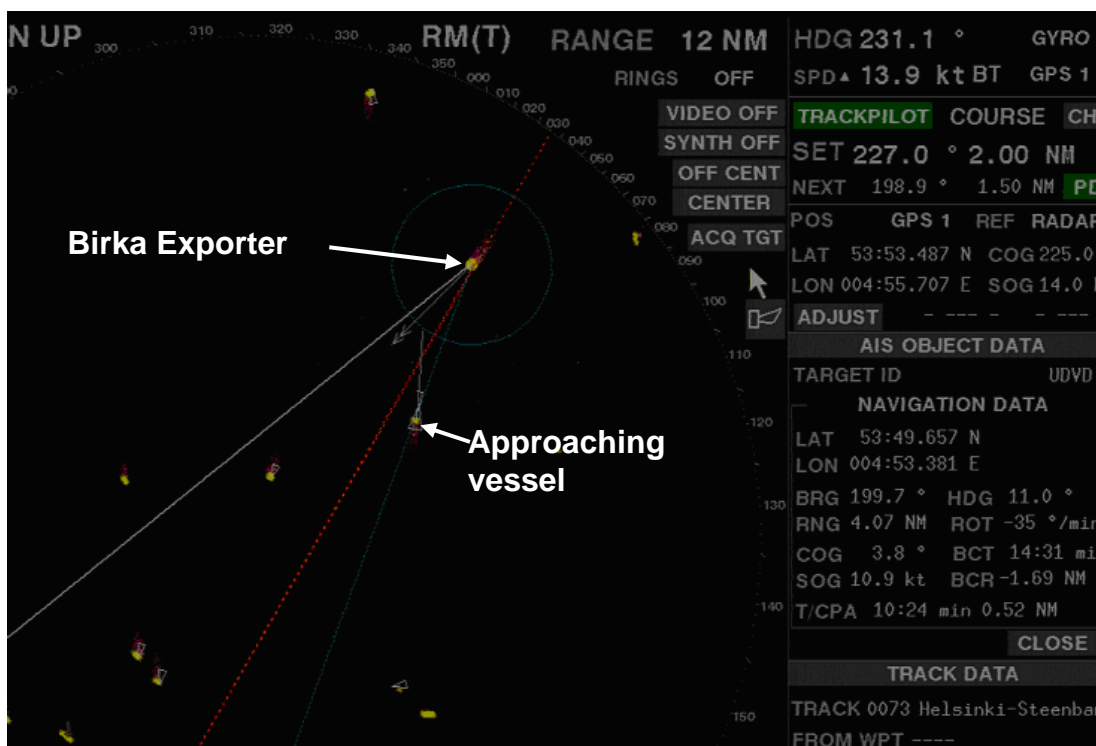
At 03:22 UTC one ship was approaching BIRKA EXPORTER at her port bow with no signs of alteration of the course. The ship was heading 011 degrees with the speed of 11 knots while BIRKA EXPORTER was heading 209.7 degrees with the speed of 15 knots. The OOW on BIRKA EXPORTER used the EBL on the ARPA radar and AIS to determine if there was a risk of collision. To clear the situation BIRKA EXPORTER altered the course 17 degrees to starboard when the ship was at a distance of 4 NM (figure 12). There was no radio contact between the two vessels. BIRKA EXPORTER was using 12 NM range on the S-Band radar.

Figure 12. At 03:22 UTC BIRKA EXPORTER altered the course to starboard to avoid a close passing.

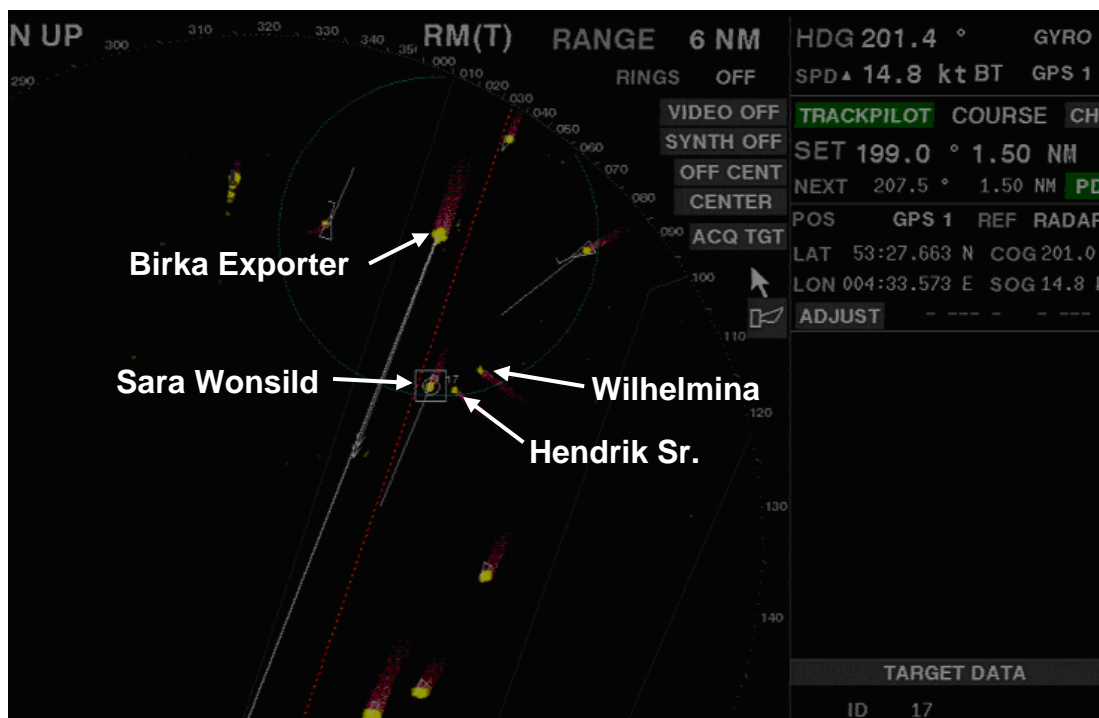
At 05:23:59 UTC HENDRIK SENIOR and WILHELMINA entered into the ring of 2 NM VRM (Variable Range Marker) on BIRKA EXPORTER radar screen (figure 13). According to the OOW this was the first time he notices the fishing vessels visually and on the radar. He had a clear view ahead unobstructed by the cargo. The fishing vessels changed their headings to go astern of another ship 1.92 NM ahead of BIRKA EXPORTER on her port bow. Trails of HENDRIK SENIOR and WILHELMINA showed that they would pass close to BIRKA EXPORTER.

Figure 13. At 05:23:59 UTC fishing vessels HENDRIK SENIOR and WILHELMINA entered the 2 NM VRM area on BIRKA EXPORTER radar screen.

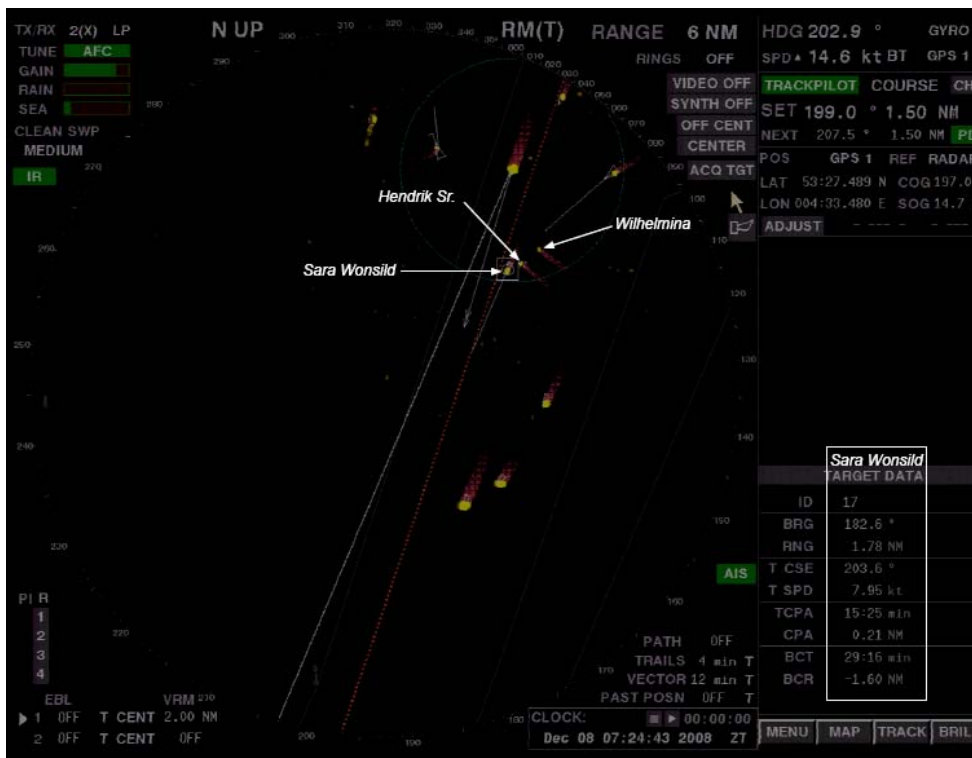
- 05:15:44 UTC HENDRIK SENIOR passed approximately 3 cables astern of a ship travelling in the southbound lane at about 7.5 knots. HENDRIK SENIOR was about 10 NM away from BIRKA EXPORTER at that time (figure 19).
- 05:25 UTC HENDRIK SENIOR passed approximately 3 cables astern of a ship travelling in the southbound lane at 7.5 knots. At that time HENDRIK SENIOR was about 1.6 NM from BIRKA EXPORTER, on a bearing of approximately 180°. HENDRIK SENIOR made no apparent course or speed alterations during these two encounters; no avoiding action appeared to have been taken by either of the two cargo ships, HENDRIK SENIOR just passed clear astern (figure 20).

Figure 20. An extract from BIRKA EXPORTER's radar display at 05:24:44 UTC.

A chemical tanker²² was heading in the same direction 1.9 NM ahead of BIRKA EXPORTER. HENDRIK SENIOR and this vessel were in almost the same bearing from BIRKA EXPORTER several minutes before the collision, which can have caused confusion regarding navigation lights (figures 20 and 21).

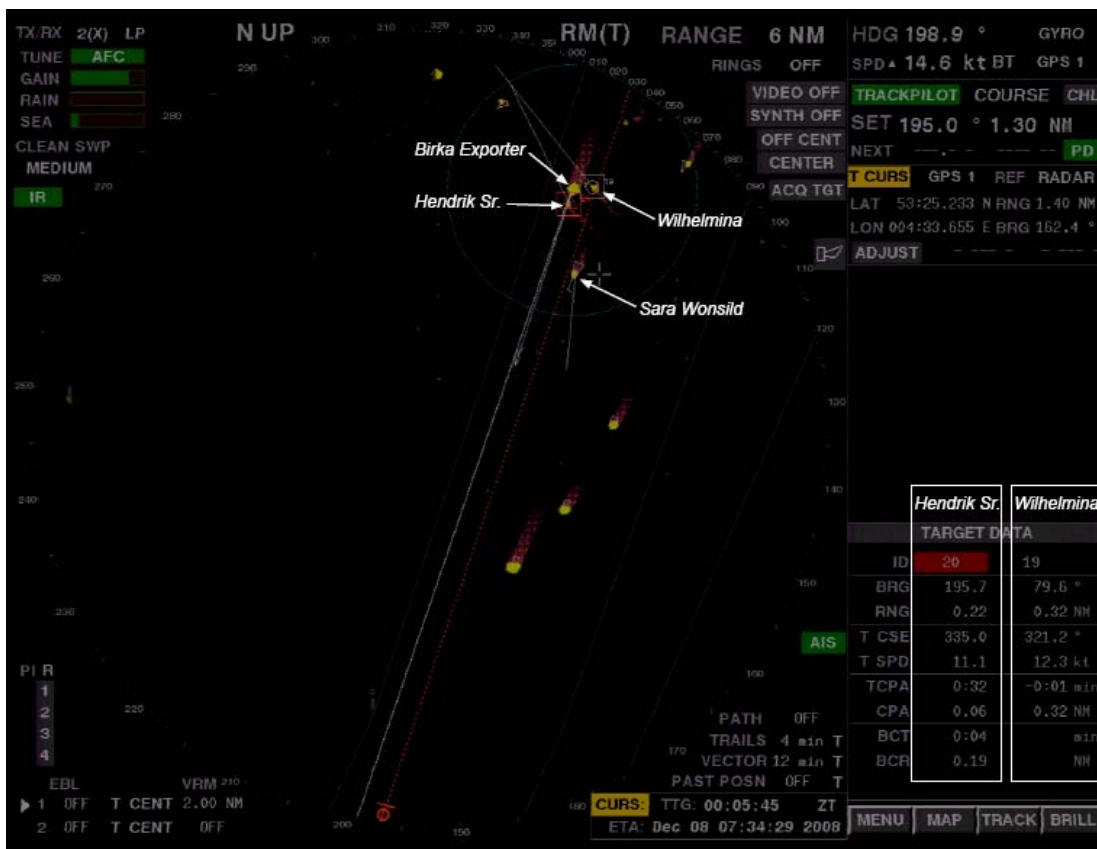
- 05:26:59 UTC WILHELMINA made a course alteration to starboard of about 10 degrees. This took her astern of BIRKA EXPORTER.
- 05:28:25 UTC BIRKA EXPORTER's autopilot Set Course was changed from 199 to 198,5 degrees.
- 05:28:29 UTC BIRKA EXPORTER's ARPA had been used to target HENDRIK SENIOR and WILHELMINA. The ARPA showed HENDRIK SENIOR bearing 191.5 degrees, range 0.33 NM, course 328.9 degrees, speed 11 knots, Time to Closest Point of Approach (TCPA) 0.50 minutes, CPA 0.07 NM. At about this time HENDRIK SENIOR had made or was making the first course alteration to starboard that is discernible when viewing BIRKA EXPORTER's radar replay.
- 05:28:44 UTC BIRKA EXPORTER's ARPA shows HENDRIK SENIOR bearing 195.7 degrees, range 0.22 NM, course 335 degrees, speed 11.1 knots, TCPA 0.32 minutes, CPA 0.06 NM. BIRKA EXPORTER's autopilot Set Course was changed from 198,5 to 195 degrees.

Figure 21. 05:28:44 UTC BIRKA EXPORTER's ARPA shows HENDRIK SENIOR target data.

- 05:28:44 UTC HENDRIK SENIOR can be seen crossing very close ahead of BIRKA EXPORTER, CPA shown as 0.06 NM. HENDRIK SENIOR was seen to be on BIRKA EXPORTER's ARPA vector (set at 12 minutes), resulting in a very small gap between the two vessels (figures 21 and 22). WILHELMINA passed approximately 3.2 cables astern of BIRKA EXPORTER.
- 05:28:55 UTC BIRKA EXPORTER's autopilot Set Course was changed from 195 to 207 degrees. Due to the two small Set Course changes since 05:28:29 the heading of the vessel had changed from 201 to 198,99 degrees.

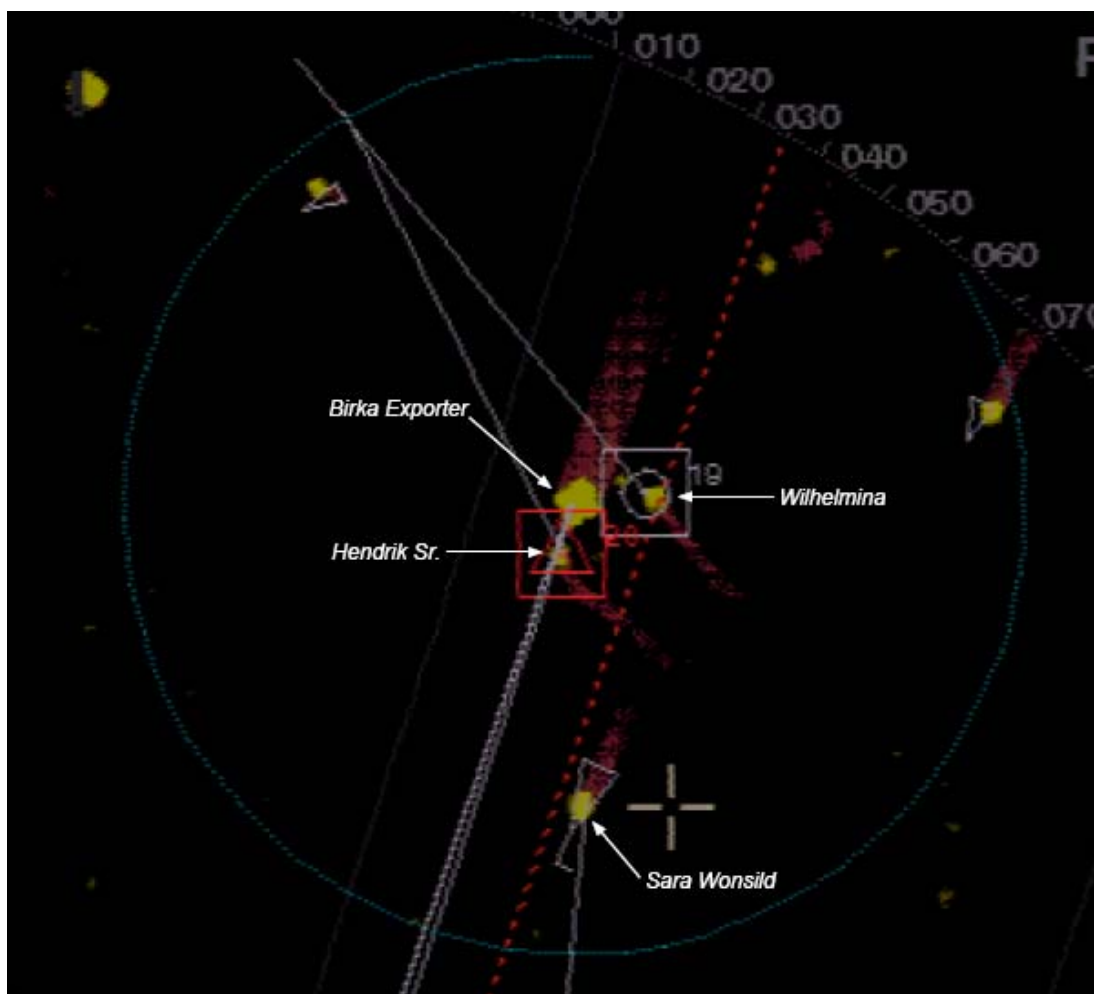
Figure 22. Close passing of BIRKA EXPORTER. Enlargement of figure 21 at 05:28:44.

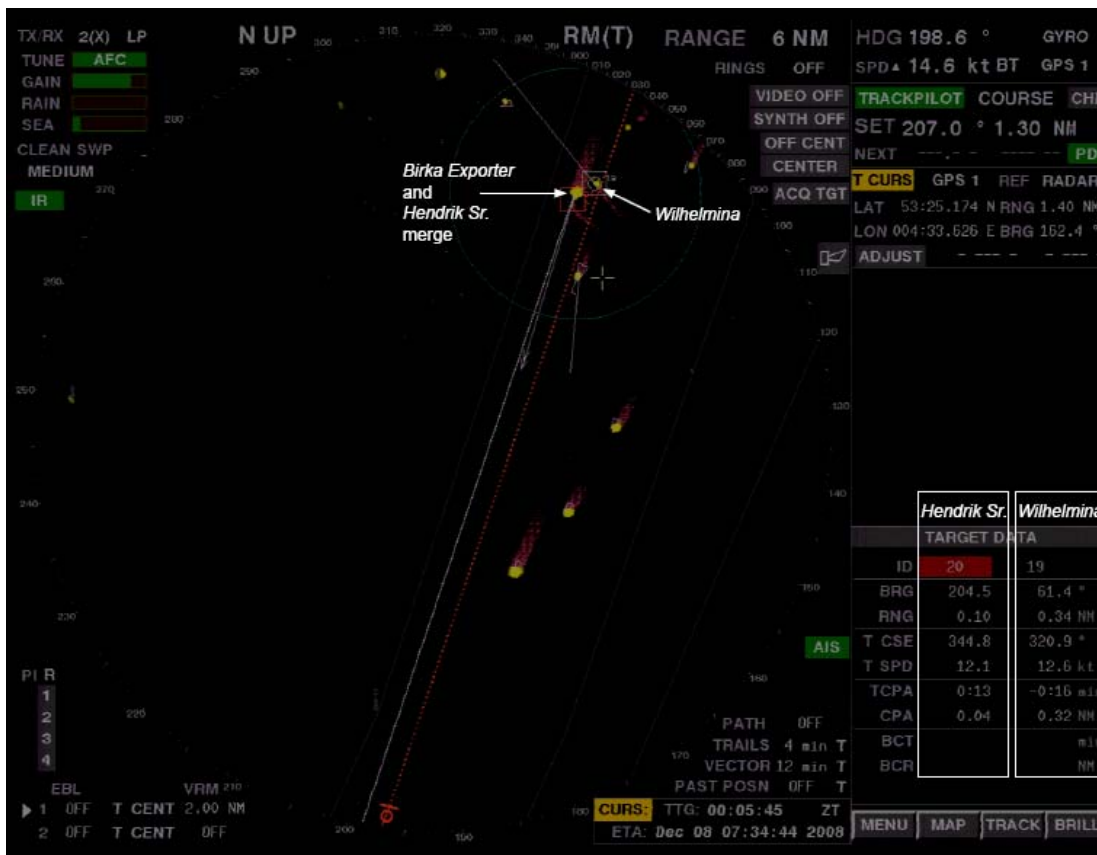
Figure 23. 05:28:59 UTC, at about this point the radar targets for HENDRIK SENIOR and BIRKA EXPORTER did merge.

- 05:28:59 UTC HENDRIK SENIOR can be seen in bearing 204.5 degrees, range 0.10 NM, course 345 degrees, speed 12.1 knots, TCPA 0.13 minutes, CPA 0.04 NM. At about this point the radar targets for HENDRIK SENIOR and BIRKA EXPORTER did merge (figure 23).
- 05:29:01 UTC BIRKA EXPORTER's VDR audio recorded the moment of impact.
- 05:29:05 UTC BIRKA EXPORTER's speed started to slow down from 14,6 knots and at 05:30 UTC it was 6,5 knots.
- 05:30:14 UTC WILHELMINA altered course, in order to return to assist HENDRIK SENIOR.
- 05:34 UTC The first VHF radio contact was recorded; from the master of BIRKA EXPORTER to the skipper of HENDRIK SENIOR.

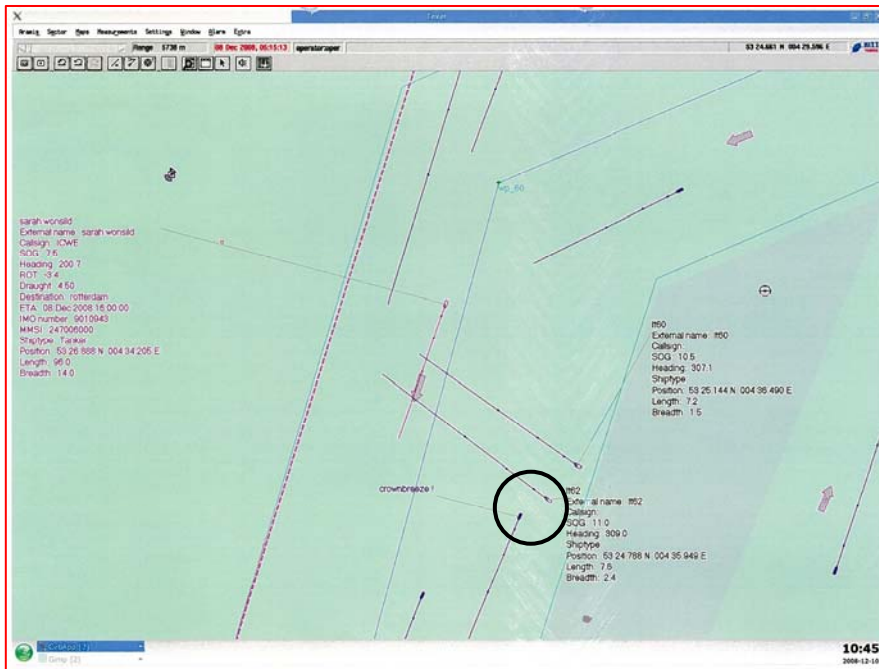
The radar station's graphical plots showed that HENDRIK SENIOR had two close encounters with other traffic heading south, on the eastern side of the south bound TSS lane, before she collided with BIRKA EXPORTER. The first close encounter was at approximately 05:16 UTC, when HENDRIK SENIOR passed less than 3 cables astern of a coaster¹³ travelling in the southbound lane at 7.5 knots (figure 24).

Figure 24. The first close encounter (within the circle) at approximately 05:16 UTC.

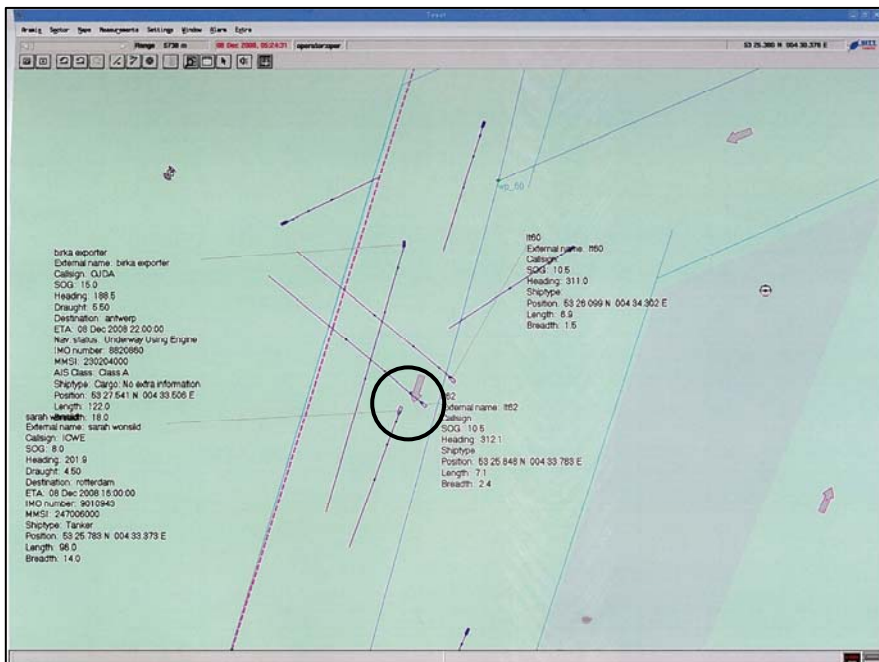
The second close encounter was at approximately 05:25 UTC, when HENDRIK SENIOR with a CPA of approximately 2.6 cables, passed astern of a chemical tanker¹⁴ travelling in the south-bound lane at about 7.5 knots (figure 25).

Figure 25. The second close encounter (within the circle) at approximately 05:25 UTC.

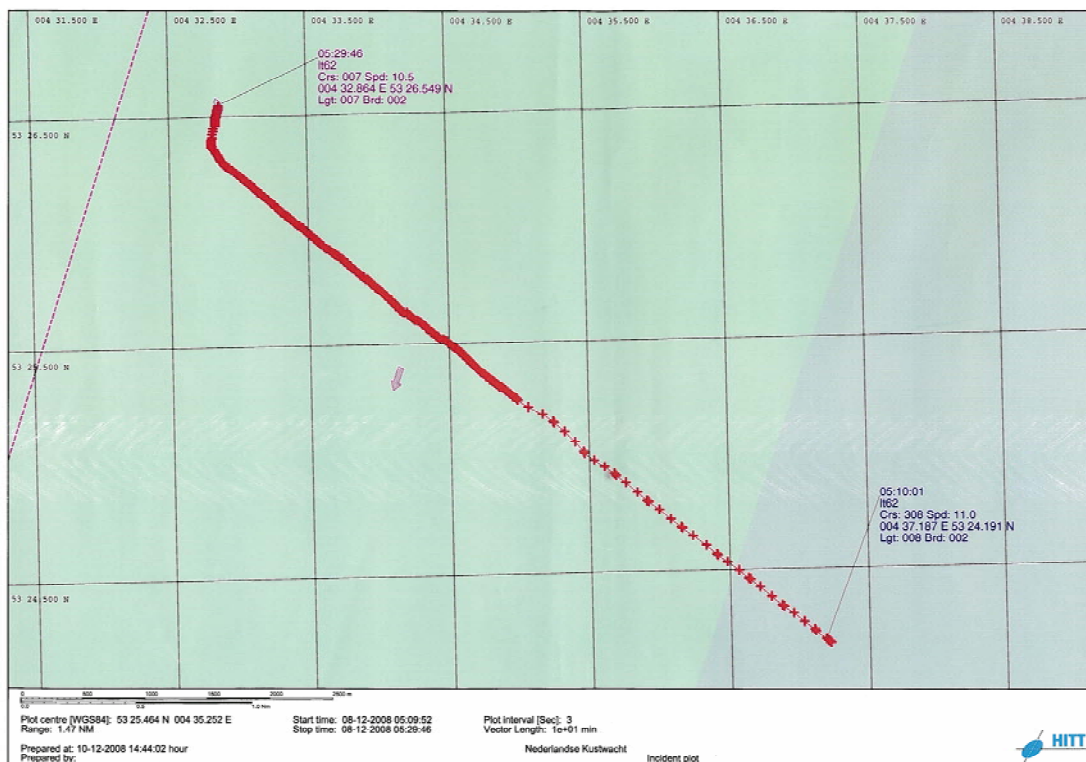
HENDRIK SENIOR made no discernible course or speed alterations during these two encounters. She continued on a steady course and speed throughout; course about 310 degrees and speed 11 knots (figure 26).

Figure 26. HENDRIK SENIOR made no discernible course or speed alterations during these two encounters.

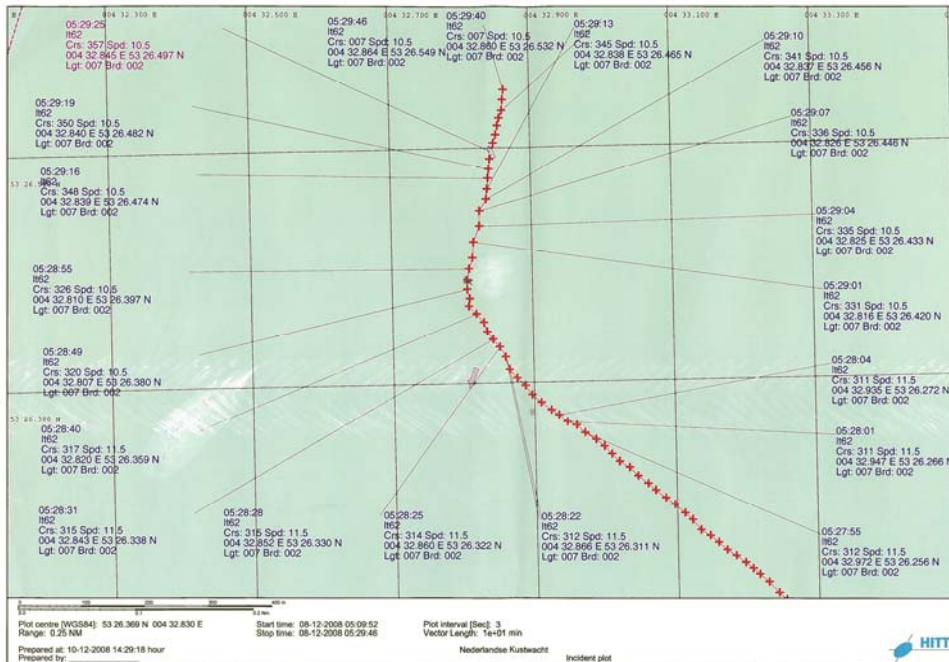
Between 05:28:40 and 05:28:49 UTC HENDRIK SENIOR had started a very late course alteration to starboard (figure 27). The relative positions of the vessels according to these recordings are perhaps debatable. However, the shore radar system clock indicates that this significant course alteration was within about 15 seconds of impact (which took place at 05:29:01 UTC).

Figure 27. Alteration to starboard by HENDRIK SENIOR.

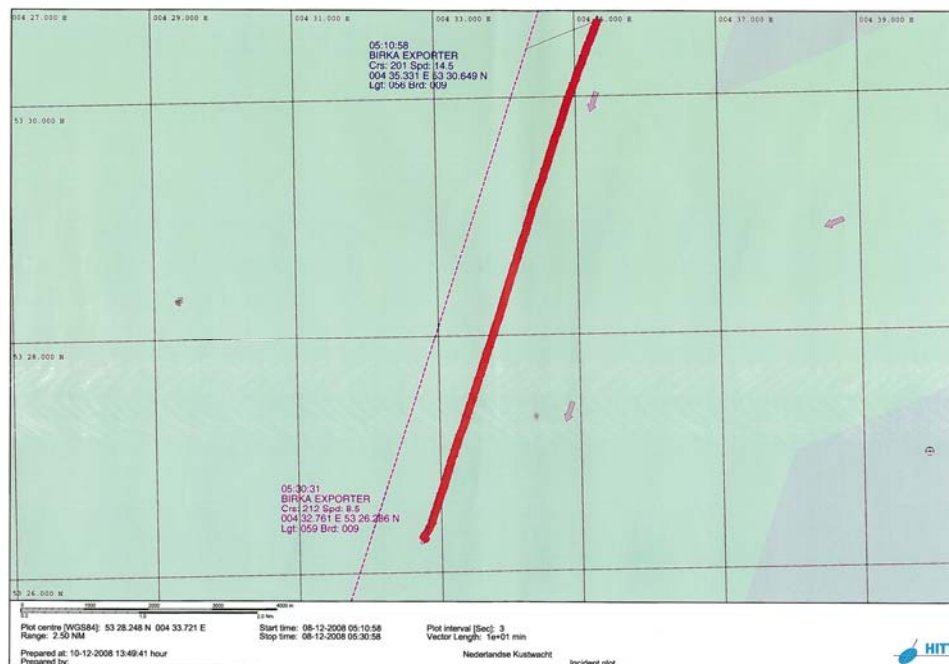
Over a similar time period according to the HITT recording BIRKA EXPORTER maintained steady course of 197 to 200 degrees and a speed of 14,5 knots until 05:29:40 UTC, when there was some indication of a course alteration to starboard and a reduction in speed¹² (see figure 28).

Coastal radar data shows BIRKA EXPORTER continuing on a steady course and speed until the impact; a slight deviation to starboard was then detected in the seconds immediately after the impact (figure 28).

Figure 28. BIRKA EXPORTER keeping steady course and speed.

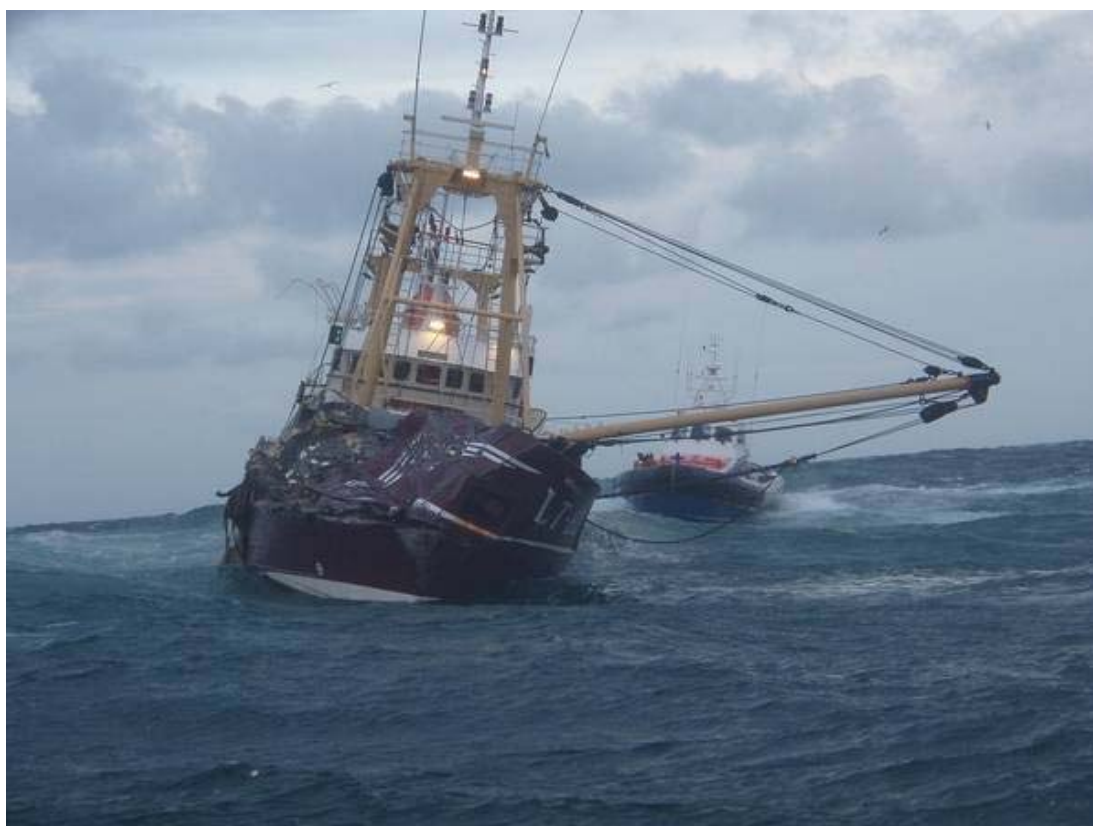
On board HENDRIK SENIOR, it was quickly realised that she was very badly damaged, and in danger of sinking. Inspection showed that both the forward machinery room (FMR) and the fish hold were flooding. Material damage to the gantry, derrick and wheelhouse was evident

Figure 29 HENDRIK SENIOR followed by a lifeboat.

The flooding of the FMR was catastrophic, and the access hatch had been crushed by the impact. The crew had to cut a new access using an angle grinder; they eventually managed to rig salvage pumps supplied by the lifeboat, allowing them to control the

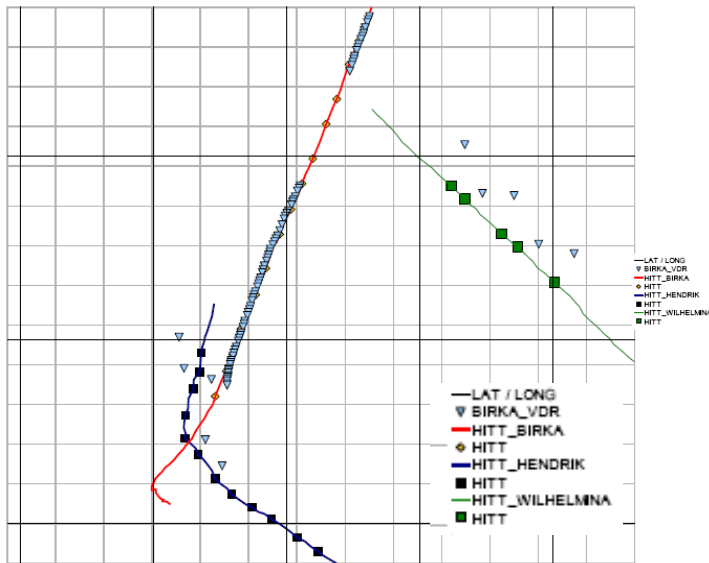
Figure 30a. Ship trajectories and positions derived from BIRKA EXPORTER's S-VDR and HITT coastal station. Small grid squares are 100 x 100 metres. (See also the original HITT recordings in figures 27 and 28.)

In figure 30a the relative accuracies of the GPS positions (BIRKA EXPORTER AIS and VDR data) and the shore radars (HITT recordings) are shown. The assumed track of HENDRIK SENIOR, which is analysed later in the text, is also shown in the figure 30b. As the accuracy of the recorded data for HENDRIK SENIOR is not as good as BIRKA EXPORTER's, there are also uncertainties in its reconstructed track. These uncertainties in the reconstructed positions of HENDRIK SENIOR are shown in the figure as a light grey area of its possible approach tracks.

HITT ARPA tracking of the fishing vessels was compared also to BIRKA EXPORTER's ARPA plotting. The OOW of BIRKA EXPORTER did plot HENDRIK SENIOR and WILHELMINA just before the accident and a few reference plots were available in BIRKA EXPORTER's S-VDR recording for comparison. There is a pattern of differences between BIRKA EXPORTER's ARPA calculation and HITT recording. If HENDRIK SENIOR's ARPA position relative to BIRKA EXPORTER's own DGPS position at a certain moment is compared to the respective HITT recording, we learn that HITT ARPA is about 80 metres off in SW direction. BIRKA EXPORTER's ARPA calculation for WILHELMINA gives the same result (figure 30a).

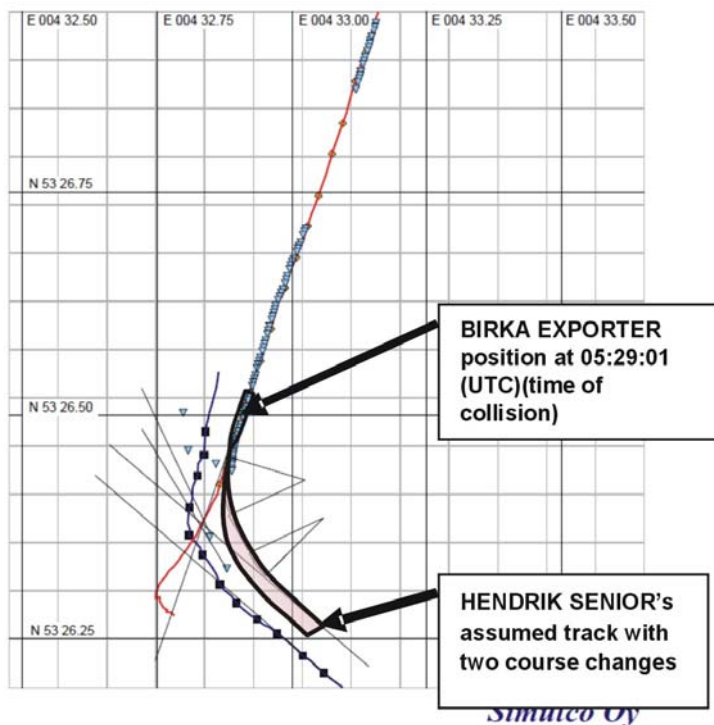
Figure 30b. The track of BIRKA EXPORTER with its position at the time of collision 05:29:01 (marked with ship shape in scale) and HENDRIK SENIOR's assumed track with two course changes to starboard drawn with the turning radius of one cable lengths. The uncertainties in the reconstructed positions of HENDRIK SENIOR are shown as a light grey area of its possible approach tracks.

It is assumed, based on the discussion above, that HENDRIK SENIOR's track was somewhat closer to BIRKA EXPORTER than shown in HITT recordings (figure 30b). The analysis of the tracks is also elaborated in later sections of the report.

It is assumed further, according to the following analysis, that HENDRIK SENIOR made two course alternations as her watchkeeper has stated (see figure 30b). The approximate turning radius was about 160 metres (0,9 cables) which led just ahead of BIRKA EXPORTER, which held her course steady at 198 degrees. One constant radius turn of about 65 - 70 degrees ending up to a head-on collision course with BIRKA EXPORTER has not been the case.

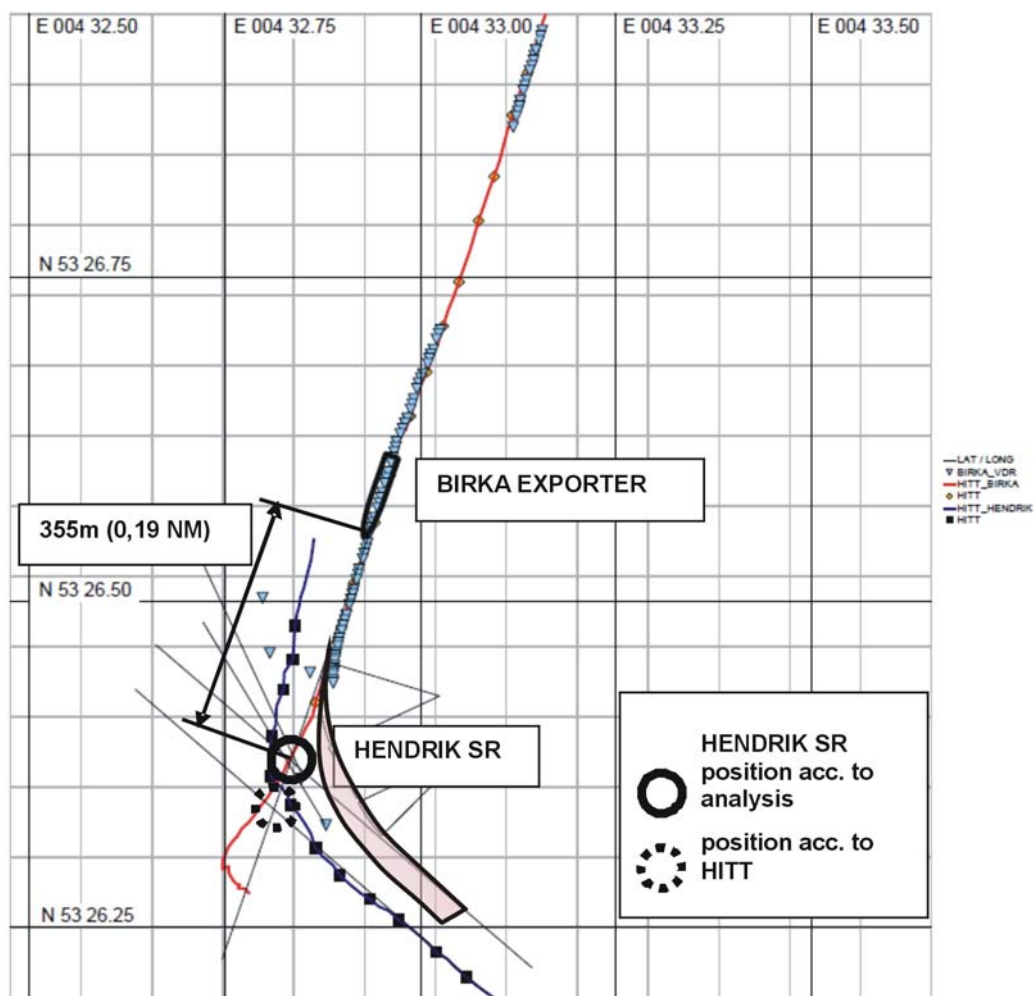
The trawler approached BIRKA EXPORTER from the southeast on a steady course and speed. Initially, HENDRIK SENIOR appeared to be going to cross very close ahead of BIRKA EXPORTER. The bow crossing without HENDRIK SENIOR's course alterations would have taken place at about 05:28:33 UTC. The bow crossing distance in this case would have been about 0,2 nautical miles (370 metres). This situation is shown in figure 31. Depending on the assumed approach track the distance is between 355 metres (0,19 NM) and 440 metres (0,24 NM).

Figure 31 Time 05:28:33 UTC. The moment when HENDRIK SENIOR would have crossed the path of BIRKA EXPORTER if the trawler had continued straight ahead. The distance between the vessels measured from BIRKA EXPORTER's bow would have been at its shortest 355 m (0.192 NM). The corresponding distance to HITT track extension is about 440 m (0.24 NM).

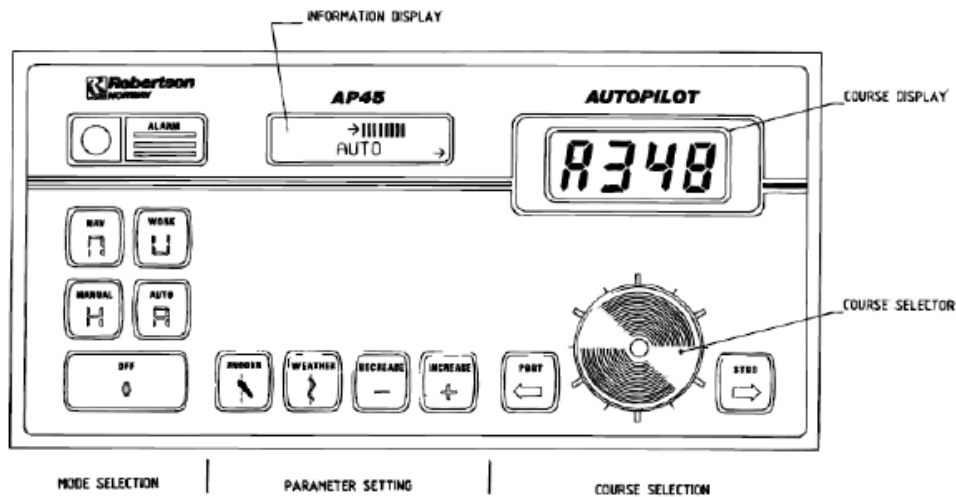
Use of the autopilot. According to HENDRIK SENIOR's watchkeeper, he was viewing the sea by the window and making estimates about the traffic situation by sight. After evaluating the distance to BIRKA EXPORTER he began the manoeuvre. HENDRIK SENIOR had a Robertson AP-45 autopilot. The easiest way to activate a turn with the autopilot is to first to press and release the course dial of the control unit (Figure 32) and then turn the dial for an immediate turn. The dial will change the course setting by 60 degrees with a full turn. The autopilot user interface is most likely designed to perform a 30 degree turn with a half a turn of the dial. The ergonomics of a human hand allows a 180 degree twist (half a turn of the dial) with an ease. The course change of 30 degrees is normally used when avoiding other vessels. This kind of manoeuvre will give a clear indication to other vessels about ones intentions and is usually sufficient when executed in good time. If the watchkeeper estimated BIRKA EXPORTER's position as safe dis-

tance away, he may have executed the turn with the pre-set radius setting. The watchkeeper could have twisted the dial about half a turn in order to commence a turn of approximately 25 degrees to starboard, which for him could have been a normal avoidance manoeuvre. After that he walked back to his lookout position by the window.

Figure 32. Robertson AP 45 Autopilot control unit.

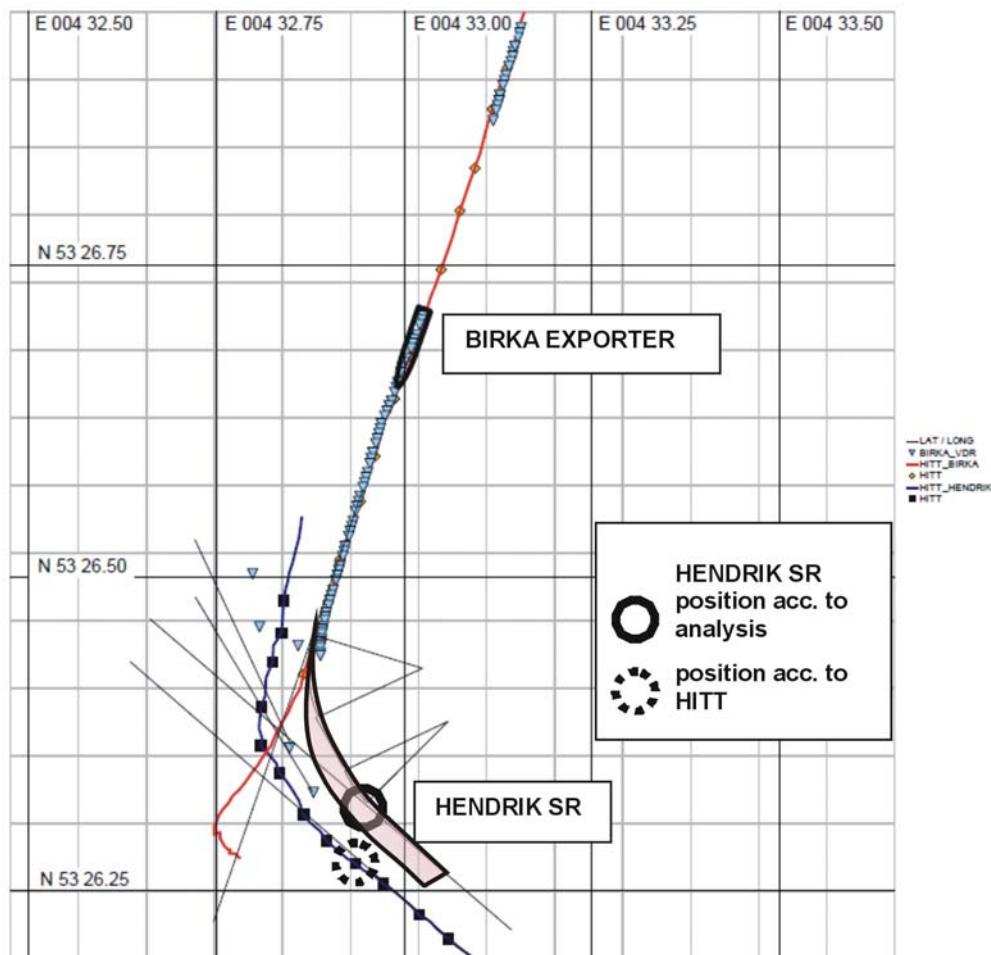
First turning manoeuvre is assumed to be started at 05:28:05 UTC and the vessel positions are shown in figure 33. The distance to the BIRKA EXPORTER was between 610 and 640 metres (0.33 – 0,35 NM). HENDRIK SENIOR turned about 25 degrees to starboard and the autopilot terminated the turn.

Figure 33. Time 05:28:05 UTC. The first turning manoeuvre of HENDRIK SENIOR starts, the distance between HENDRIK SENIOR and BIRKA EXPORTER was between 610 and 640 metres (0.33 – 0,35 NM). From HITT registered position the distance was 710 metres (0,38 NM).
