## Investigation report

D14/2008M

# Loss of consciousness by two persons in the cargo tank of a tanker on 4 Nov 2008

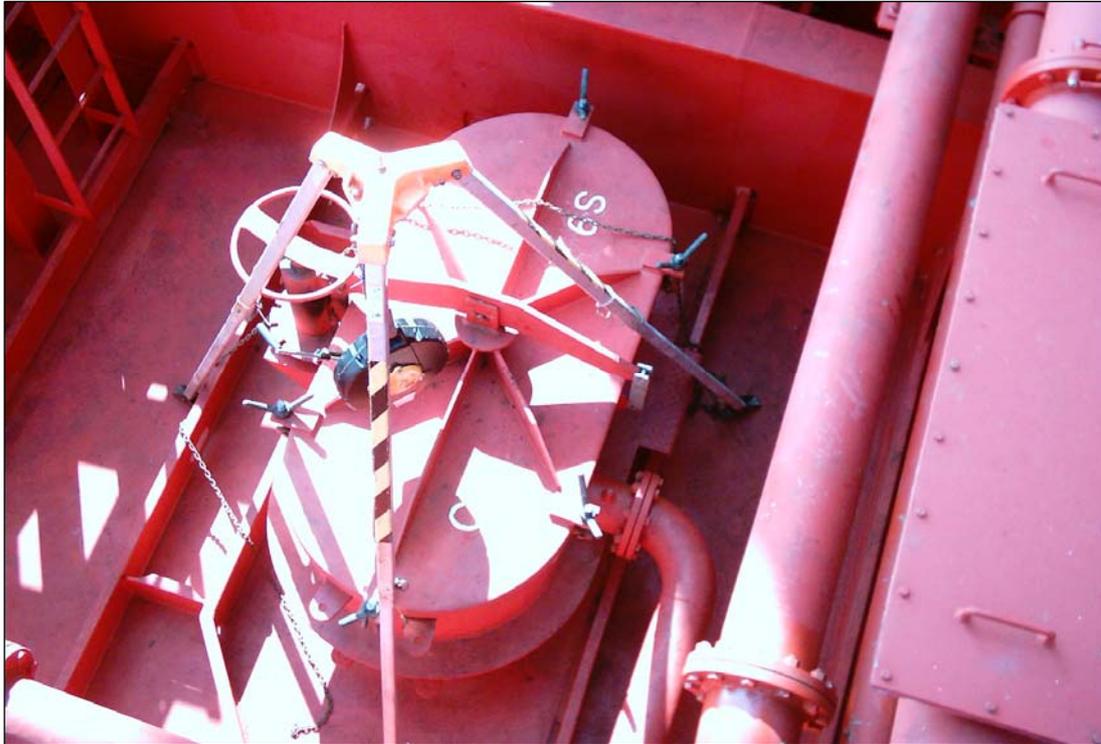
Figure 4. Tripod and winch on tank hatch of cargo tank 6S

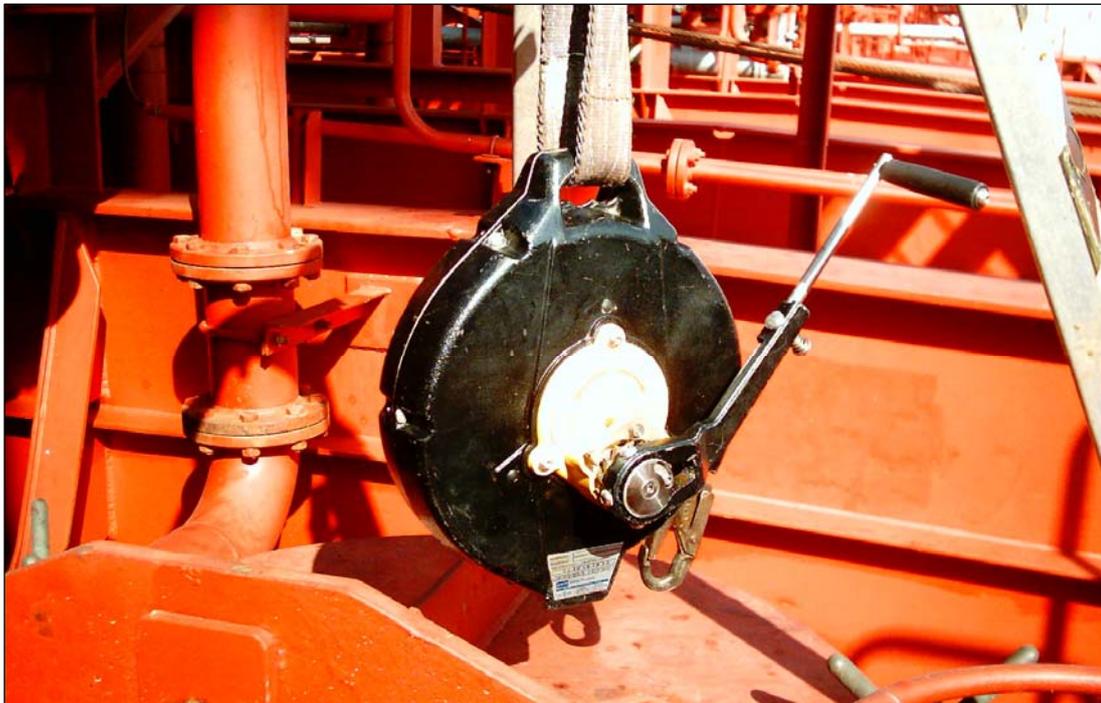
Figure 5. Winch used in the hoistings

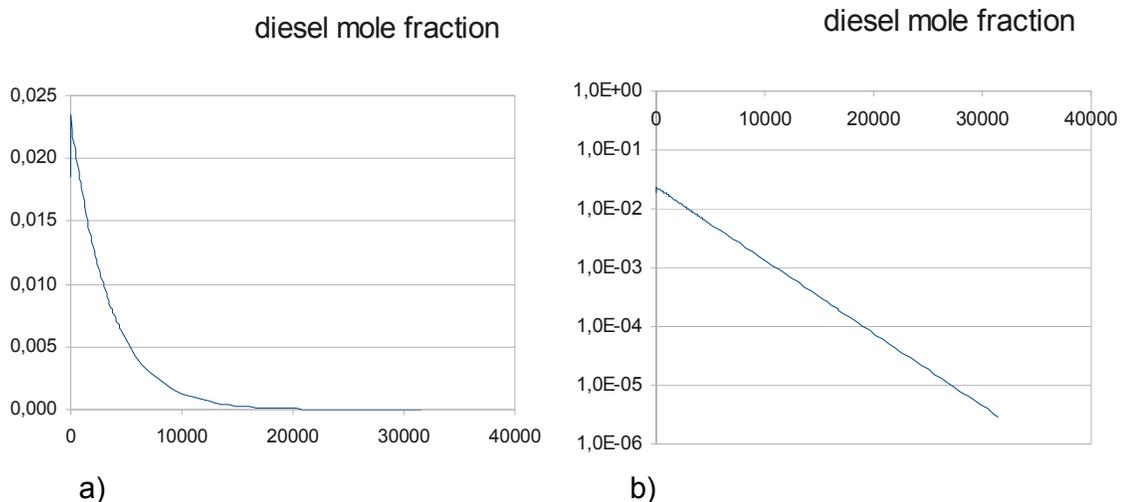
Kuva 11. Dieselin konsentraatio tankissa ajan funktiona. b) logaritminen skaala

Räjähdykskaasun pitoisuus vähenee hyvin tasaisesti ajan funktiona. Siinä ajassa kun 2EHN:n on tuuletettu pois, niin räjähdysvaaraa ei enää ole.

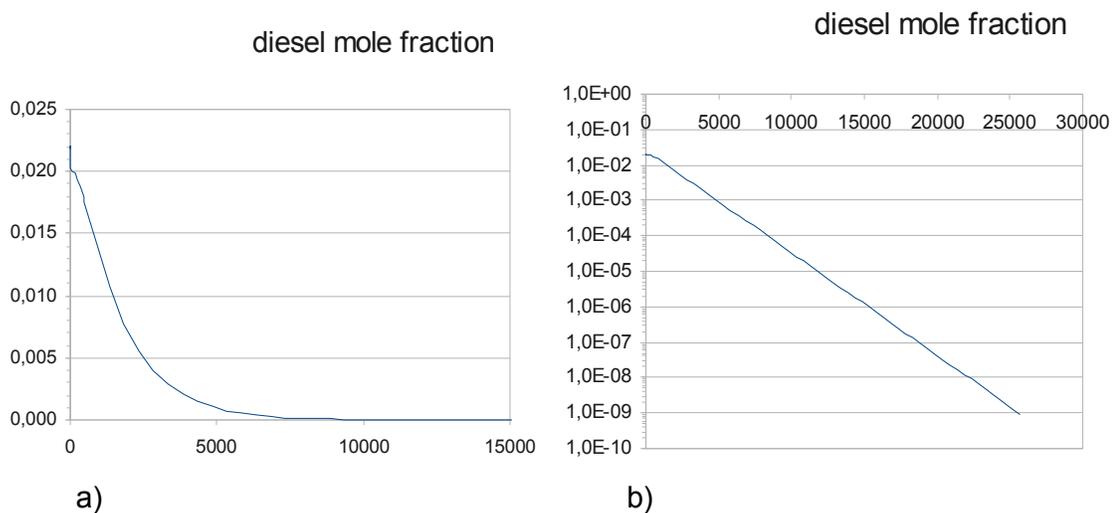
Kuva 16. Dieselin konsentraatio tankissa ajan funktiona. b) logaritminen skaala

Räjähdyskaasun pitoisuus vähenee hyvin tasaisesti ajan funktiona. Siinä ajassa kun 2EHN:n on tuuletettu pois, niin räjähdysvaaraa ei enää ole.

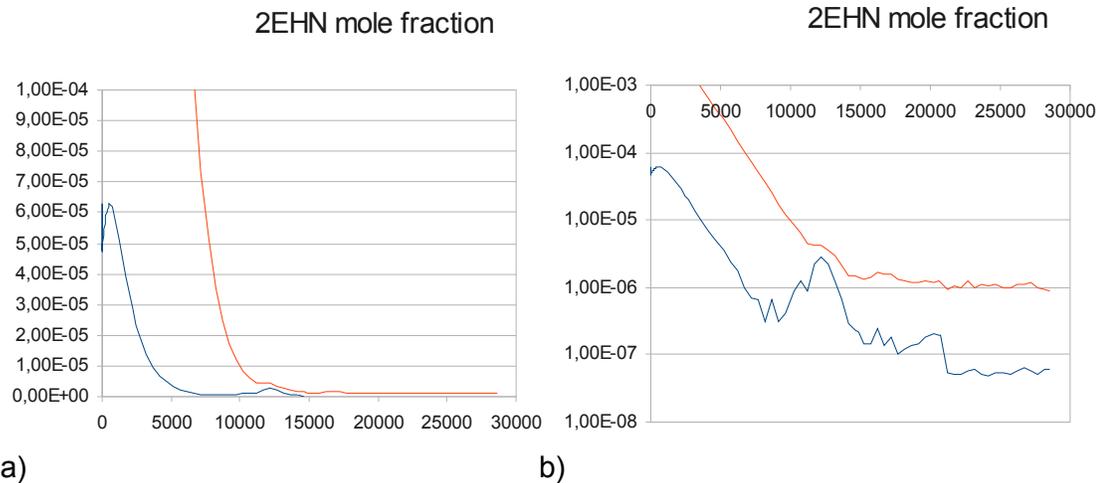
2EHN:n maksimiarvo nousee simuloinnin alkuvaiheessa samalla tavalla kuten edellisissä tapauksissa. Laskennan puolivälissä näkyy taas selvästi milloin laskentatarkkuus loppuu kesken, eli loppuosan virheet pitää taas jättää huomioida.

Tarvittava tuuletusaika tässä tapauksessa on hieman pitempi kuin edellisessä. Tässä tapauksessa 1 ppm:n raja-arvo saavutetaan vajaan 4 tunnin jälkeen.

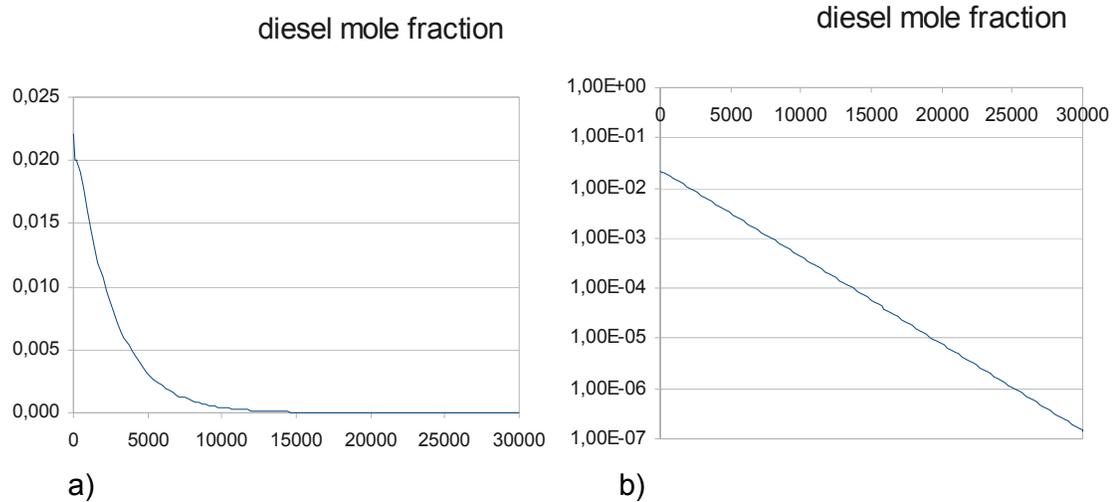
Kuva 24. Dieselin konsentraatio tankissa ajan funktiona (sekunteina). b) logaritminen skaala

Räjähdyskaasun pitoisuus vähenee hyvin tasaisesti ajan funktiona. Siinä ajassa kun 2EHN:n on tuuletettu pois, niin räjähdysvaaraa ei enää ole.
